Service: Condo Inspection

Prepared for: Sample Report

WIN Inspector

Damien Devine

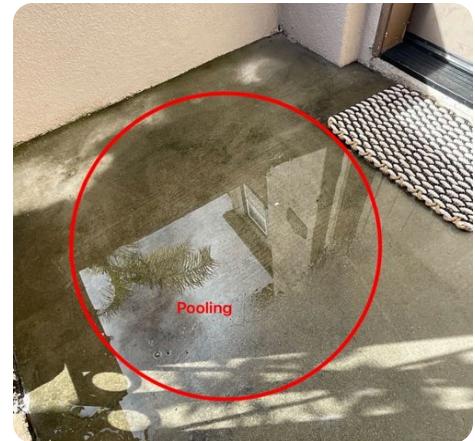
**2 Grading Recommendations****Repairs Recommended****Location: Front Porch**

The grading around the perimeter of the foundation should be maintained to adequately drain excessive surface and roof runoff water away from the structure. Due to the soil type and/or amount of water from surrounding areas, even flat lots may hold water. It is recommended that the grade slope away from the structure at least 6" for the first 6'-10' away from the foundation.

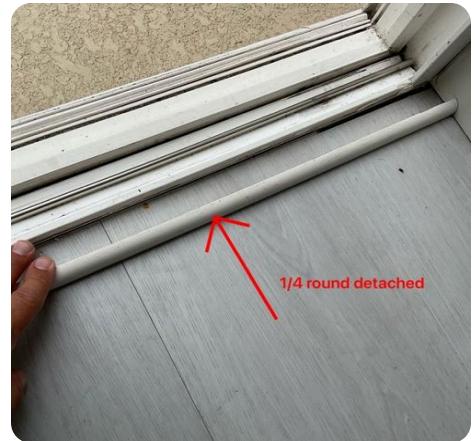
The sliding glass door at the exterior does not slide smoothly, which could pose inconvenience and potential security risks. It is recommended to have a qualified window and door company or a trade professional evaluate and repair the sliding glass door to ensure proper functionality.

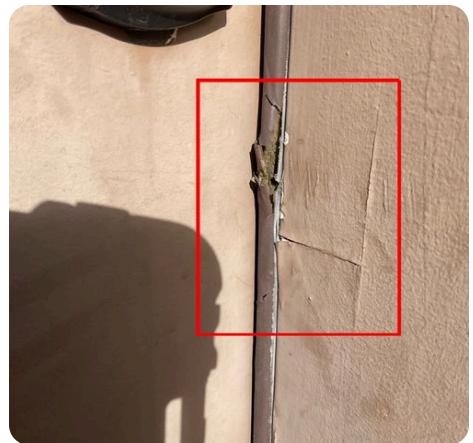
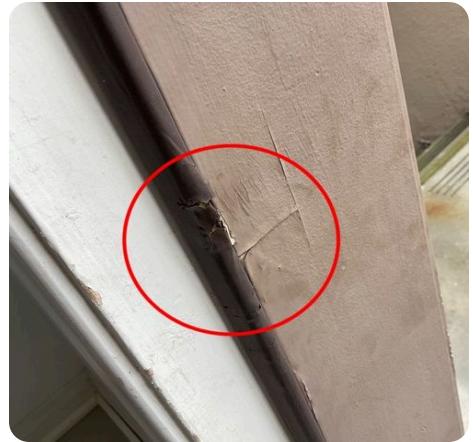
5 Repainting, Weather Stripping, And Door Stopper Replacement

The exterior door shows signs of wear, especially on the paint which helps protect the door from elements. Repair or repaint any areas of concern to prevent deterioration. Additionally, check and replace the weather stripping as needed to improve energy efficiency and weather protection. Lastly, consider replacing the door stopper to prevent interior damage and ensure proper functionality.

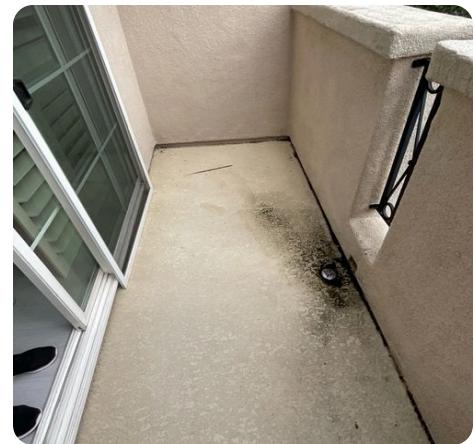
The foundation, or underside, is not visible due to the type of installation or low clearance. Issues may exist that are not visible. If examination is needed, contact a qualified professional for further assessment.

The drain requires cleaning to prevent flooding.

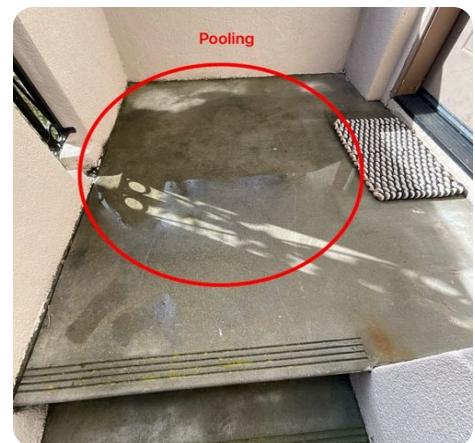
7 Pooling Water At Stairs

Pooling of water at the top and bottom of the stairs is observed. This could lead to safety hazards and potential water damage to the structure over time. It is recommended to evaluate the drainage in these areas and make necessary repairs to prevent water accumulation.

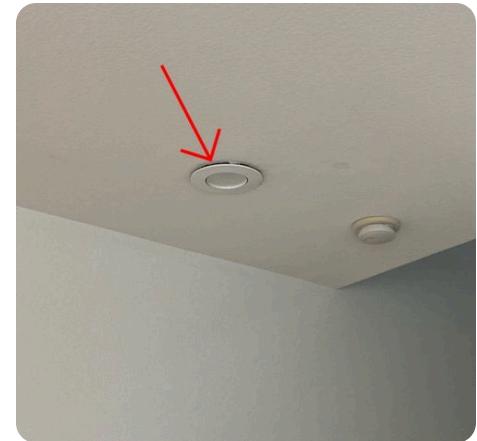
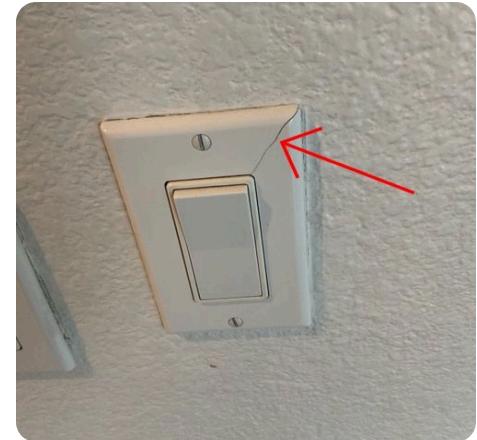
The condition of the outlets, switches, and junction boxes that were visible and accessible at the time of the inspection, were evaluated. Electrical outlets are recommended to be replaced if cracked/damaged to prevent arcs which might be caused by a worn outlet. Occupied homes often have furniture and stored items covering electrical outlets, switches, and junction boxes that limit their accessibility.

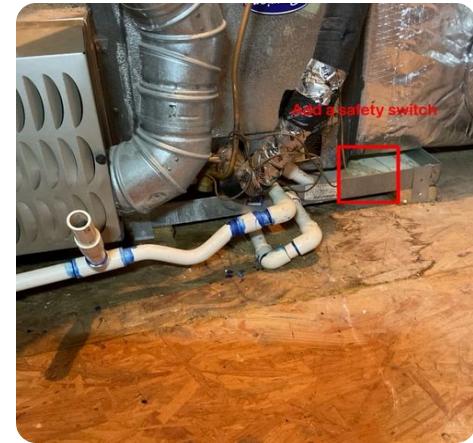
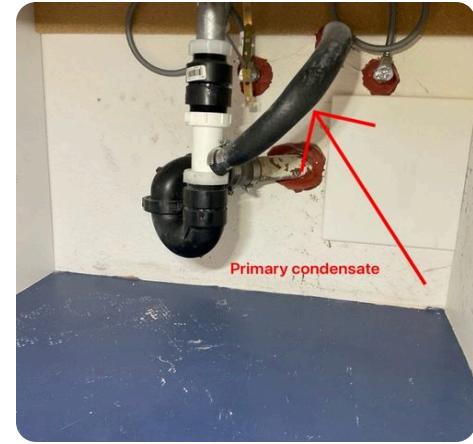
11 Condensate System Evaluated (Moisture Stains)

The condensate system is a critical component of your HVAC system, responsible for removing condensation produced by the evaporator cooler. Ensuring the condensate system is functioning properly helps prevent moisture damage. If you notice any leaks, blockages, or unusual noises, it is advised to have a qualified HVAC technician evaluate and repair the condensate system.

Moisture stains noted in and around the drain tray in the attic. Contact a qualified HVAC company for flushing the condensation lines and adding a safety switch to prevent flooding.

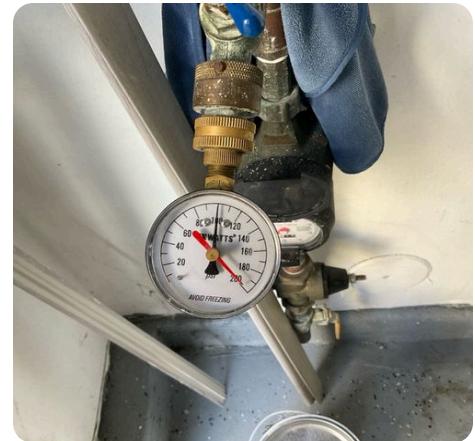
The water pressure at the exterior faucets is approximately 100 +- psi. Recommended water pressure is between 40 and 70 psi. We suggest a pressure regulator be installed, adjusted or replaced if the pressure exceeds 80 psi. Note: The excessive water pressure can reduce the life expectancy of the plumbing lines, void warranties of certain appliances, and cause premature leaks in fittings, landscape irrigation and faucets.

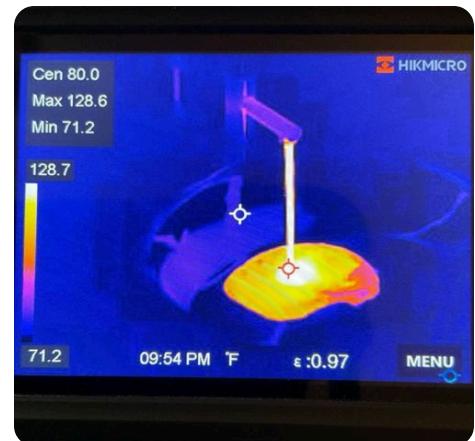
**Water Heating Equipment****16 Caution! Water Too Hot****⚠ Repairs Recommended****📍 Location: Garage**

The water temperature at the faucet was too hot. Lowering the setting is recommended. Temperature settings on water heaters should be set so that the temperature of the water at the faucets is 120°F or lower. This will provide the most efficient operation and also reduce the danger of potential burns from scalding. Temperature adjustment can be made at the dial on the water heater.

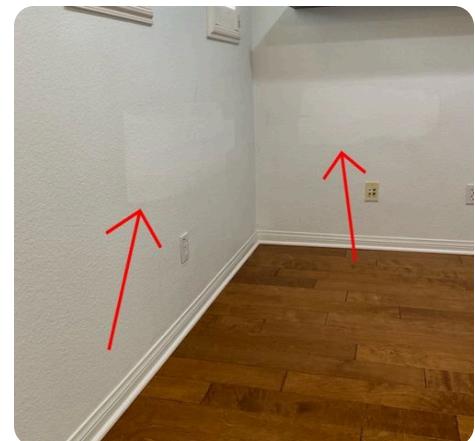
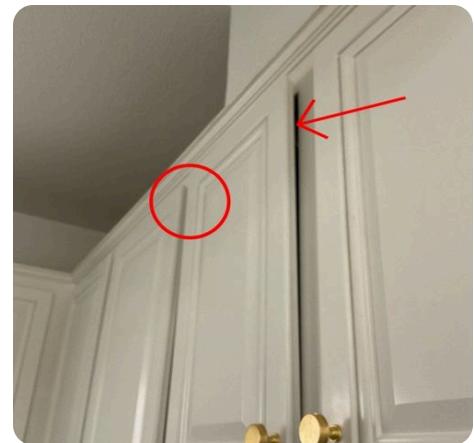
17 General Cosmetic Damage

The floors, walls, and ceilings exhibit some general cosmetic damage, which is typically superficial and does not impact the structural integrity of the property. It is recommended to assess and address these cosmetic issues for aesthetic reasons. Depending on the extent of the damage, options may include patching or replacing affected areas, repainting or refinishing surfaces, or seeking assistance from a professional contractor for more substantial damages.

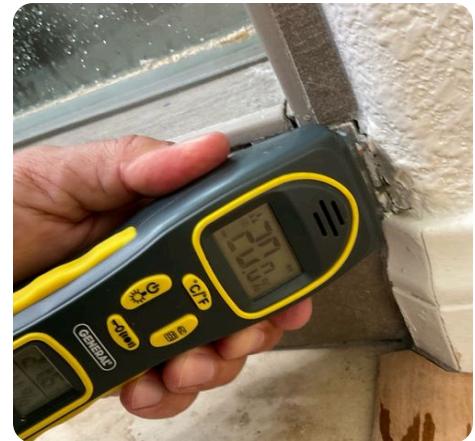
18 Moisture Issue Outside Of Shower

The presence of moisture outside of the shower area is a common issue that can lead to mold growth and water damage. It is recommended to properly seal any cracks or gaps in the shower enclosure to prevent water seepage. Additionally, ensuring that the shower door is properly sealed and that the ventilation fan is functioning effectively can help mitigate moisture buildup.

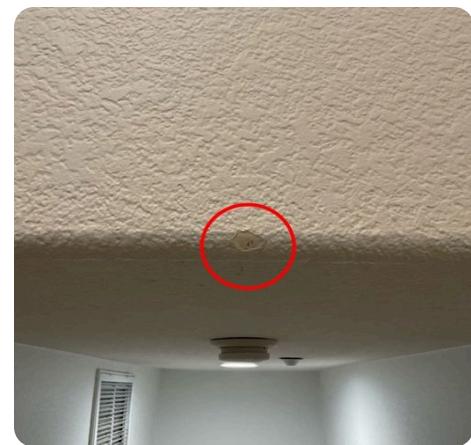
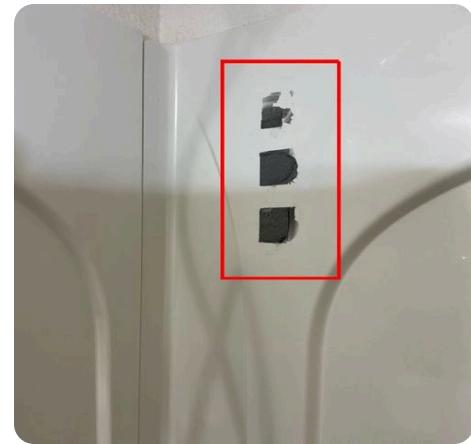
19 General Cosmetic Damage

The floors, walls, and ceilings exhibit some general cosmetic damage, which is typically superficial and does not impact the structural integrity of the property. It is recommended to assess and address these cosmetic issues for aesthetic reasons. Depending on the extent of the damage, options may include patching or replacing affected areas, repainting or refinishing surfaces, or seeking assistance from a professional contractor for more substantial damages.

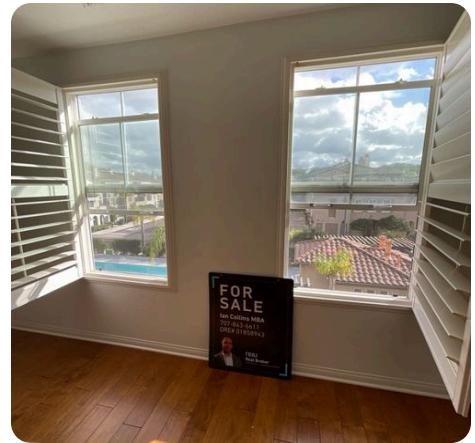
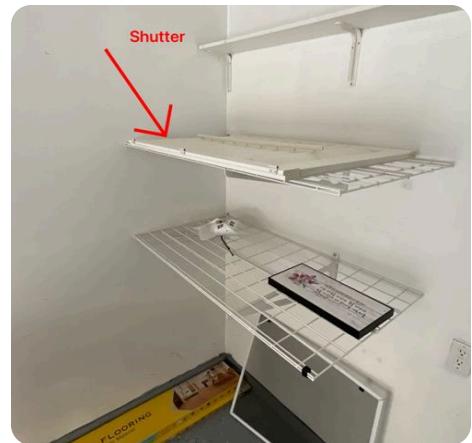
The kitchen window shutter was found in the garage. This was likely removed due to the height of the faucet blocking the window covering from opening. Consider a lower faucet or a different type of window covering.

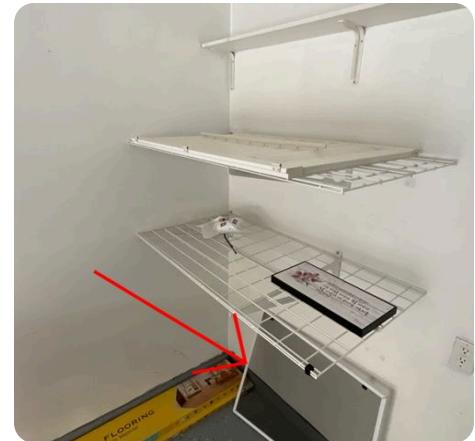
**24 Missing Window Screen****☒ Repairs Recommended****📍 Location: Den, Rear of Home, Guest Bedroom, Front of Home**

Isolated windows in the home were missing screens. Asking the seller for the location of any additional screens placed in storage is recommended in addition to confirming that one screen is available for every window. Slight damage was noted on a rear windows. Contact a qualified window or screen company for evaluation and repair.

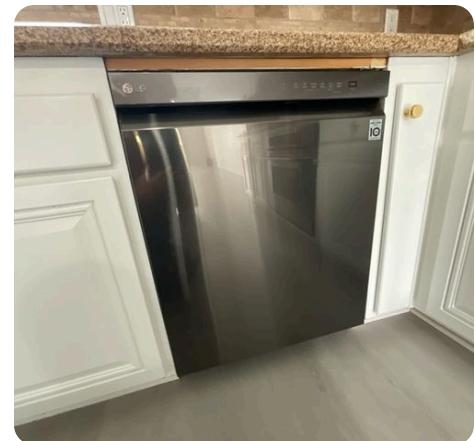
25 Inadequate Air Gap Installation In Dishwasher

The dishwasher is in working condition but the air gap is not properly installed, which could lead to water leakage into the cabinetry and walls. It is recommended to remove the soap dispenser and reconnect the air gap correctly to ensure proper drainage into the sink. A qualified plumber should be contacted for further evaluation and repair.

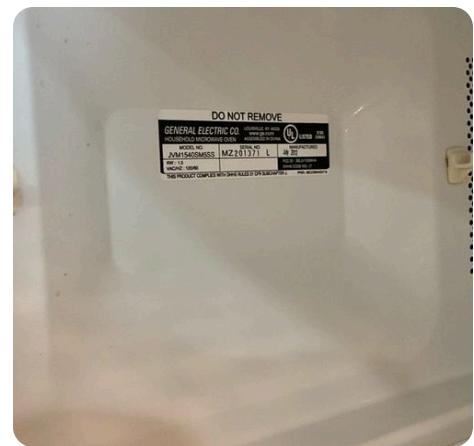
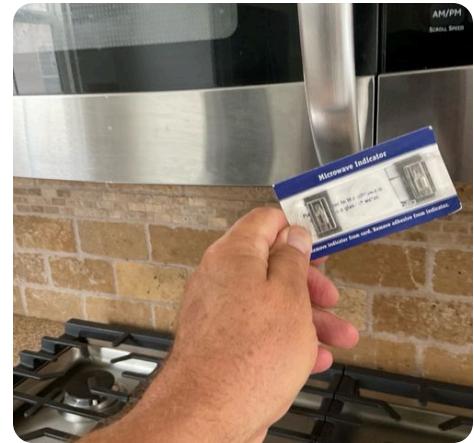
The microwave oven was not functional. The door panel is melted and falling off. This can cause exposure to microwaves which is known to have negative health impacts. It is recommended to have replacement done by a qualified professional and verify functionality before closing of escrow.

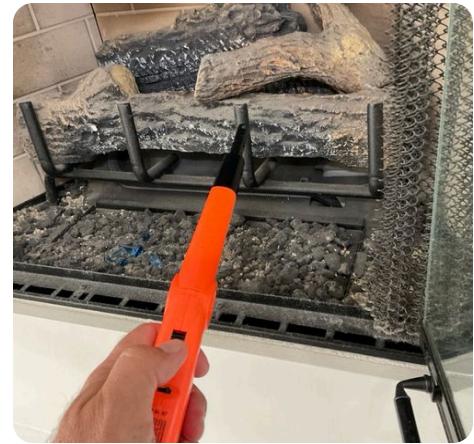
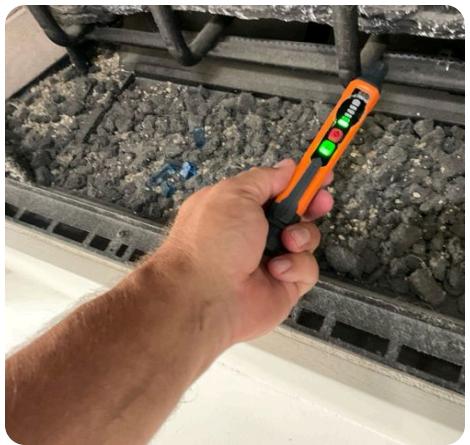
The gas for the fireplace was off at the time of inspection and was tested. The gas may be shut off, as it did not ignite. It is recommended having a fireplace technician evaluate, ignite, and test the unit to ensure proper functionality and safety.

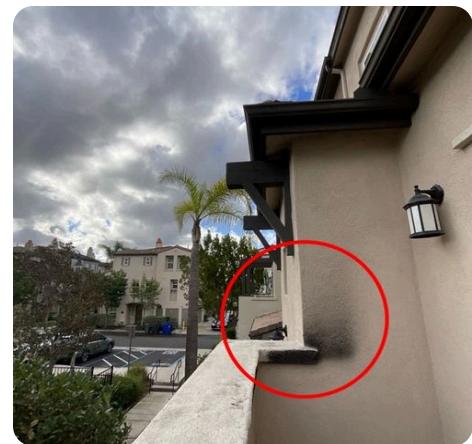
Stucco Burn Marks From Barbecue

The burn marks on the stucco at the balcony from the barbecue could indicate potential fire hazards and structural damage. It is recommended to evaluate the extent of the damage and repair as necessary to ensure safety and prevent further deterioration. A licensed contractor or stucco repair specialist should be consulted for appropriate repair options. Contact the HOA for evaluation and painting or repairs.

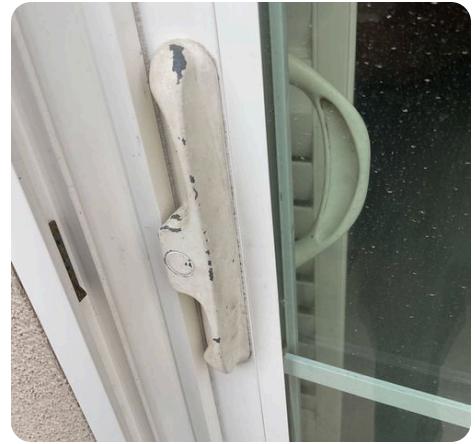
The sliding screen door at the exterior is off track. It is essential to fix this issue to ensure proper functionality of the door and to prevent any damage or inconvenience. It is recommended to contact a qualified repair person or a door repair specialist to evaluate and repair the sliding screen door.

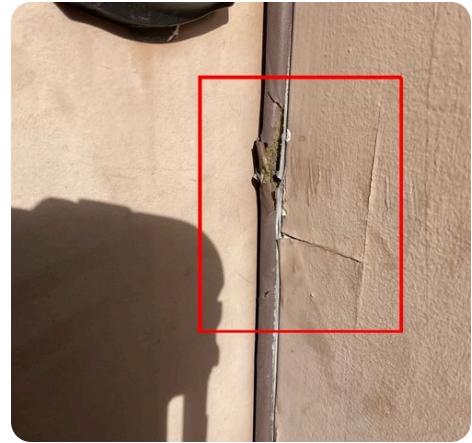
**Repainting, Weather Stripping, And Door Stopper Replacement**

The exterior door shows signs of wear, especially on the paint which helps protect the door from elements. Repair or repaint any areas of concern to prevent deterioration. Additionally, check and replace the weather stripping as needed to improve energy efficiency and weather protection. Lastly, consider replacing the door stopper to prevent interior damage and ensure proper functionality.

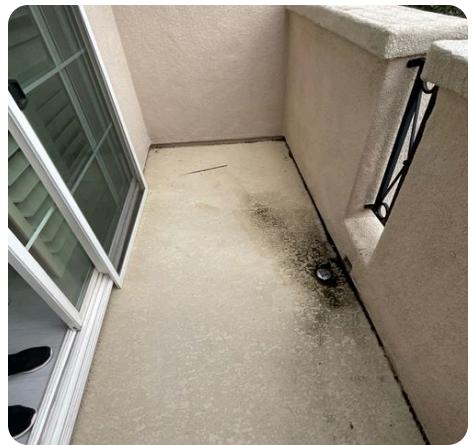
The foundation, or underside, is not visible due to the type of installation or low clearance. Issues may exist that are not visible. If examination is needed, contact a qualified professional for further assessment.

The drain requires cleaning to prevent flooding.

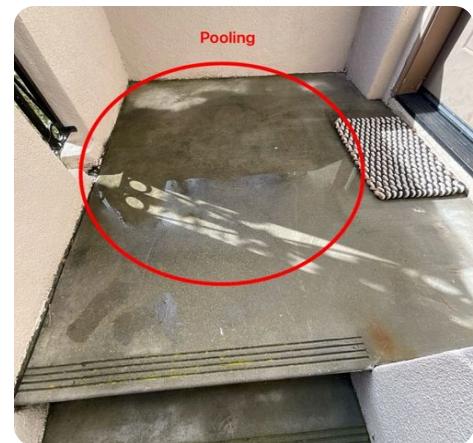
Pooling of water at the top and bottom of the stairs is observed. This could lead to safety hazards and potential water damage to the structure over time. It is recommended to evaluate the drainage in these areas and make necessary repairs to prevent water accumulation.

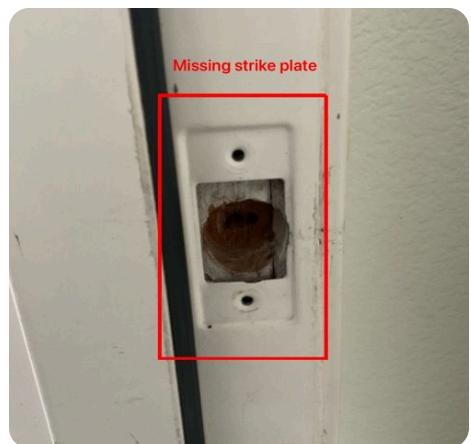
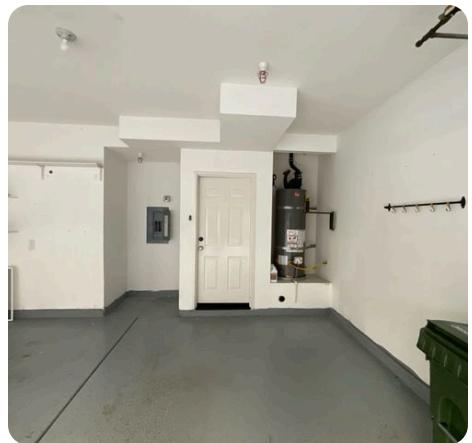
All openings of more than 1/8" are recommended to be sealed to maintain a proper firewall barrier. Increase tension in self closing hinges to ensure the fire door closes completely. The strike plate is missing.

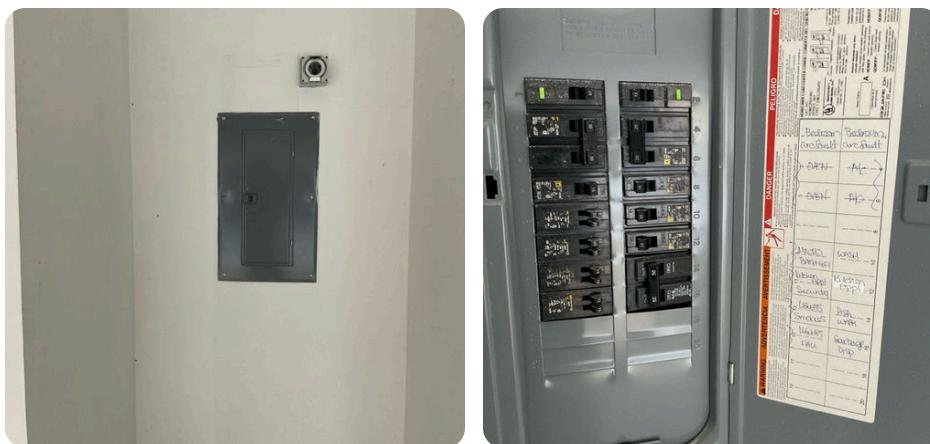
The main panel in the condo unit is actually a sub-panel and does not have a main disconnect. Sub-panels are not always required to have a main disconnect. It is recommended to have a qualified electrician evaluate this setup to ensure proper safety measures are in place. Adding a main disconnect can provide a convenient way to shut off all power to the unit in case of emergencies or maintenance. Recommend questioning the condo association in regard to the location of the main service panel/main disconnect to the unit in case of emergencies.

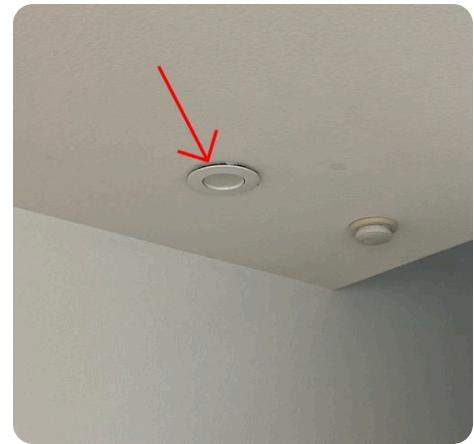
The condition of the outlets, switches, and junction boxes that were visible and accessible at the time of the inspection, were evaluated. Electrical outlets are recommended to be replaced if cracked/damaged to prevent arcs which might be caused by a worn outlet. Occupied homes often have furniture and stored items covering electrical outlets, switches, and junction boxes that limit their accessibility.

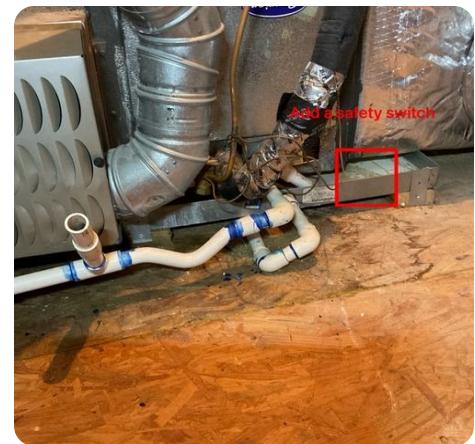
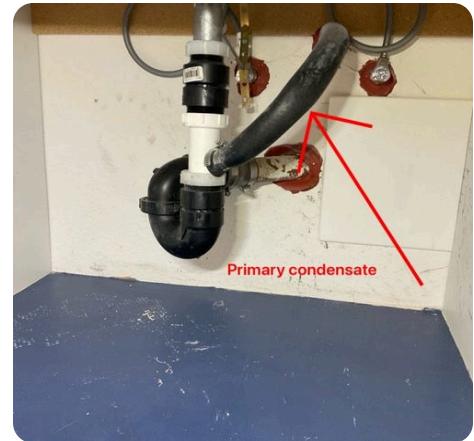
Moisture stains noted in and around the drain tray in the attic. Contact a qualified HVAC company for flushing the condensation lines and adding a safety switch to prevent flooding.

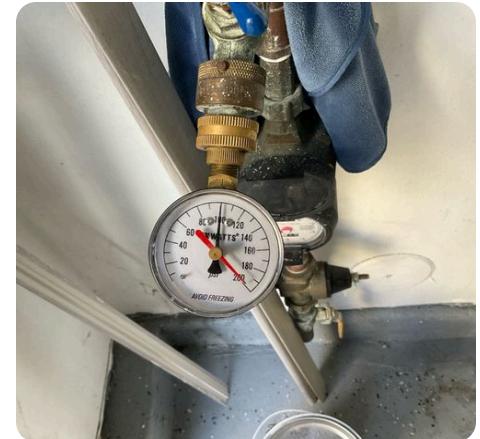
The water pressure at the exterior faucets is approximately 100 +- psi. Recommended water pressure is between 40 and 70 psi. We suggest a pressure regulator be installed, adjusted or replaced if the pressure exceeds 80 psi. Note: The excessive water pressure can reduce the life expectancy of the plumbing lines, void warranties of certain appliances, and cause premature leaks in fittings, landscape irrigation and faucets.

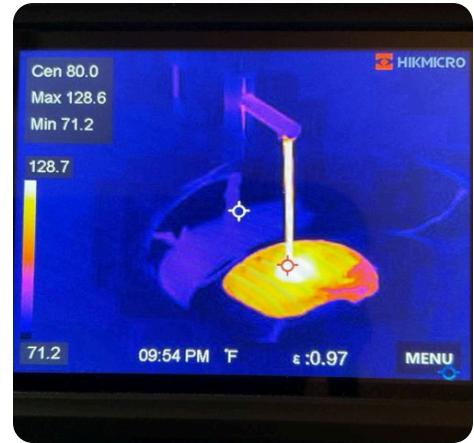
The water temperature at the faucet was too hot. Lowering the setting is recommended. Temperature settings on water heaters should be set so that the temperature of the water at the faucets is 120°F or lower. This will provide the most efficient operation and also reduce the danger of potential burns from scalding. Temperature adjustment can be made at the dial on the water heater.

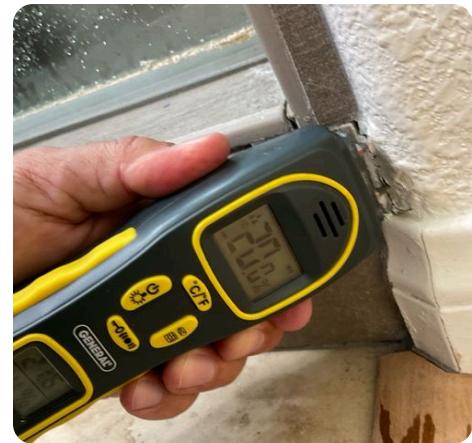
The presence of moisture outside of the shower area is a common issue that can lead to mold growth and water damage. It is recommended to properly seal any cracks or gaps in the shower enclosure to prevent water seepage. Additionally, ensuring that the shower door is properly sealed and that the ventilation fan is functioning effectively can help mitigate moisture buildup.

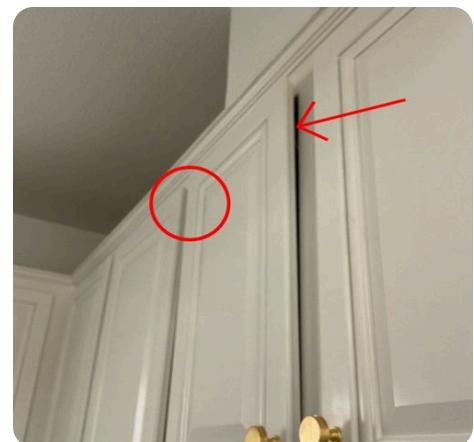
The floors, walls, and ceilings exhibit some general cosmetic damage, which is typically superficial and does not impact the structural integrity of the property. It is recommended to assess and address these cosmetic issues for aesthetic reasons. Depending on the extent of the damage, options may include patching or replacing affected areas, repainting or refinishing surfaces, or seeking assistance from a professional contractor for more substantial damages.

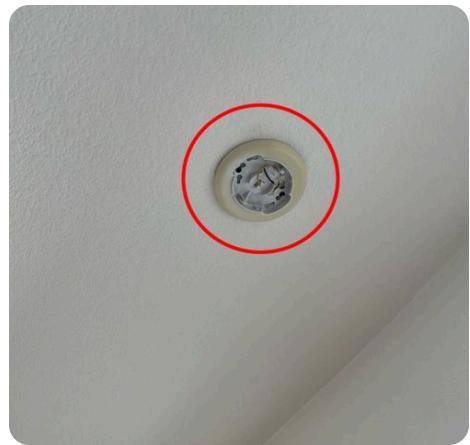
One or more smoke alarms is missing. Smoke alarms are required on all levels and outside all sleeping areas. Recommend further evaluation and installation of a functional smoke alarm for safety.

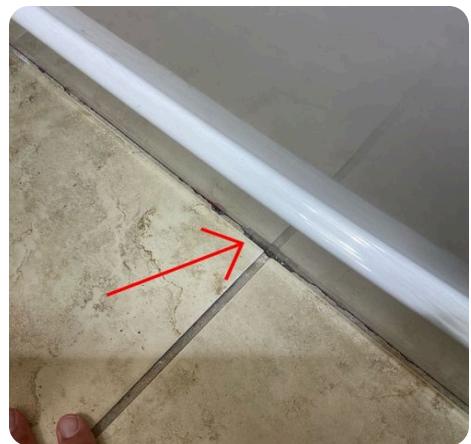
The caulking in the interior areas such as around the bathtub, shower, or sink is showing signs of wear and tear. It is recommended to recaulk these areas to prevent water seepage and maintain the integrity of the surfaces. A qualified handyman or plumber can evaluate and repair this caulking to ensure proper sealing and prevent any potential water damage.

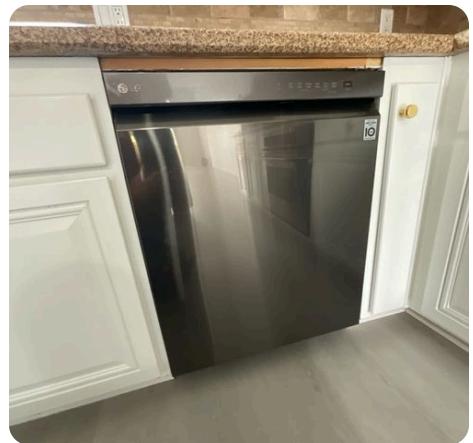
The dishwasher is in working condition but the air gap is not properly installed, which could lead to water leakage into the cabinetry and walls. It is recommended to remove the soap dispenser and reconnect the air gap correctly to ensure proper drainage into the sink. A qualified plumber should be contacted for further evaluation and repair.

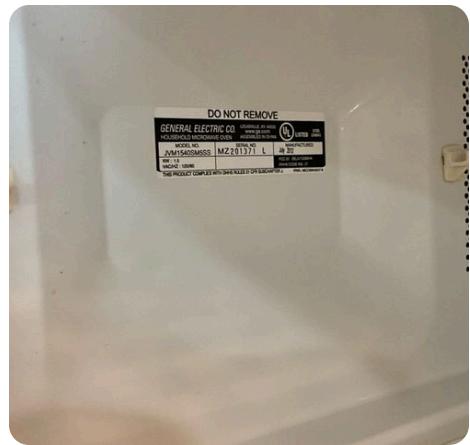
The microwave oven was not functional. The door panel is melted and falling off. This can cause exposure to microwaves which is known to have negative health impacts. It is recommended to have replacement done by a qualified professional and verify functionality before closing of escrow.
