**Property Address:** 123 Sample Drive, Clemson, SC 29676

## WIN Home Inspection

### Full Home Inspection

**Service Date:** 11/17/2023

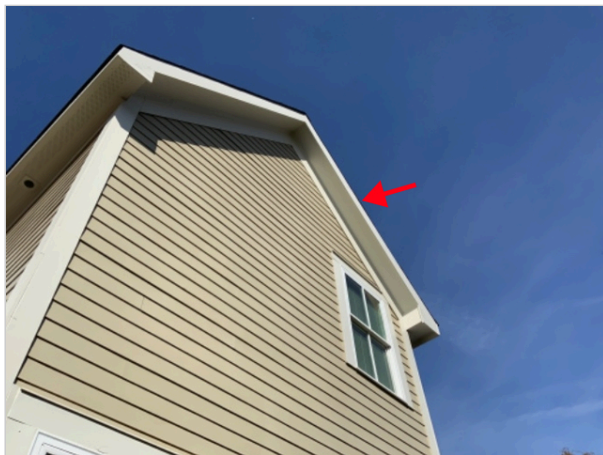
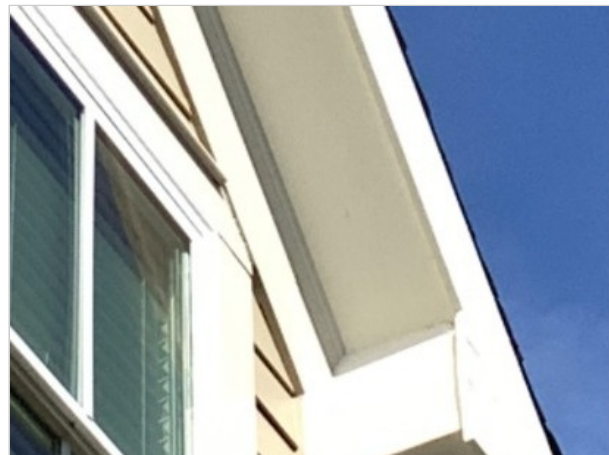
Left Side

The edge of the shingles do not extend far enough over the fascia. Generally, they should extend between 1 inch to 1/2 inch depending on the manufacturer's specification and if there is a drip edge installed or not. It is recommended to have a licensed roofer further evaluate and correct as needed.

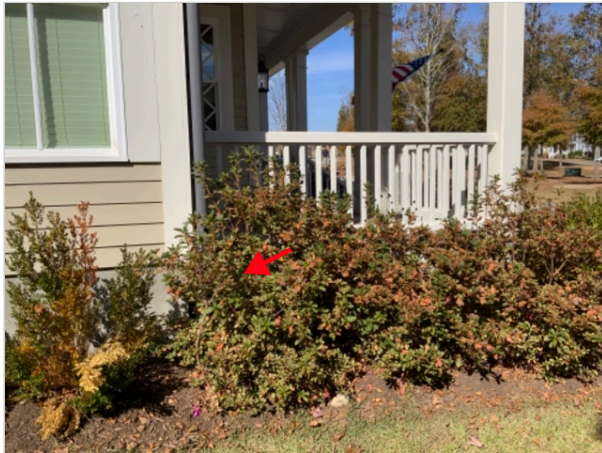
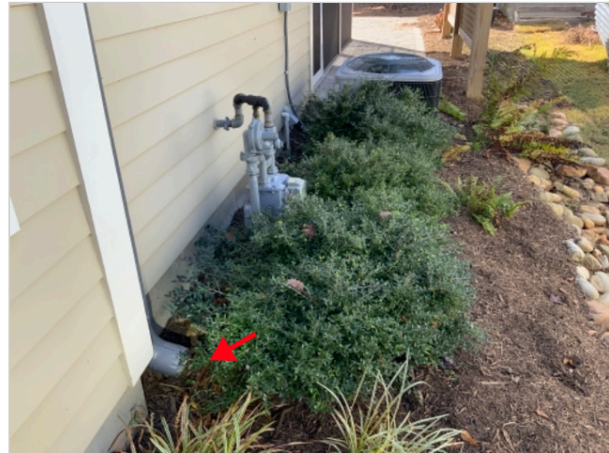
There are downspouts emptying next to the foundation. This can cause erosion and damage. Correct as needed.

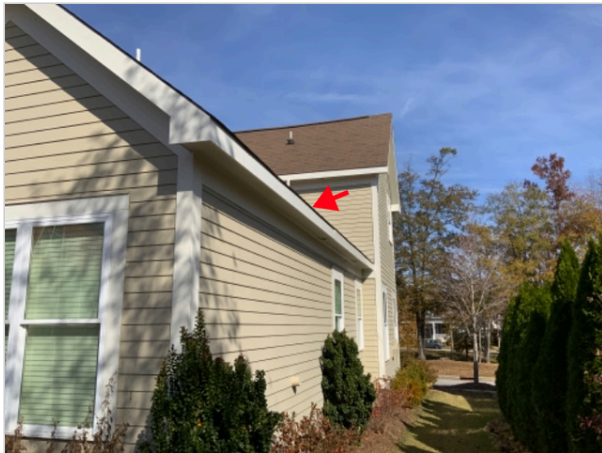
Left Side

There is not a complete gutter system installed. Installing a complete gutter system will help move water properly away from the structure to prevent water damage.

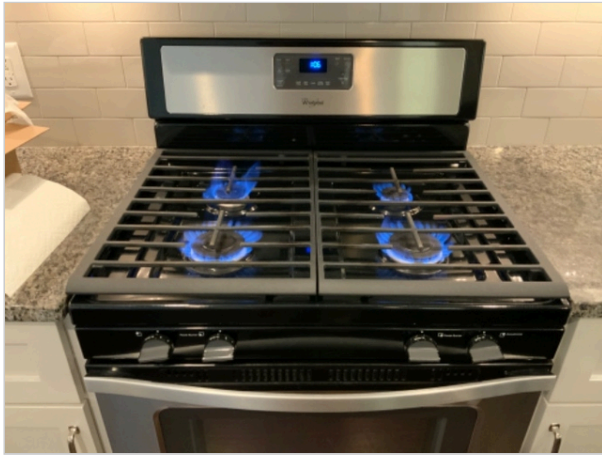
All the burners turn on but there is an unusually long delay when lighting. This is typically due to a clogged or wet ignition port. Correct as needed.

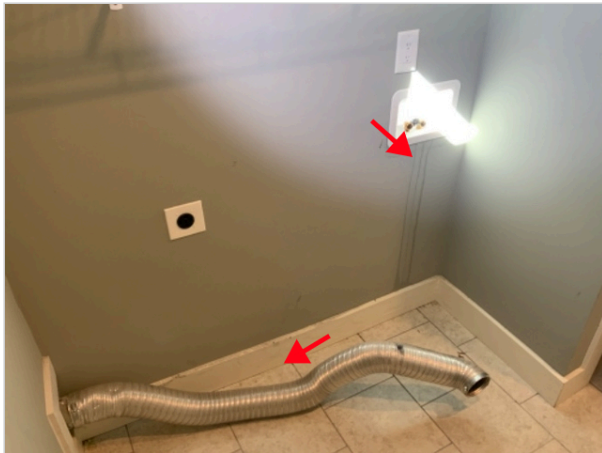
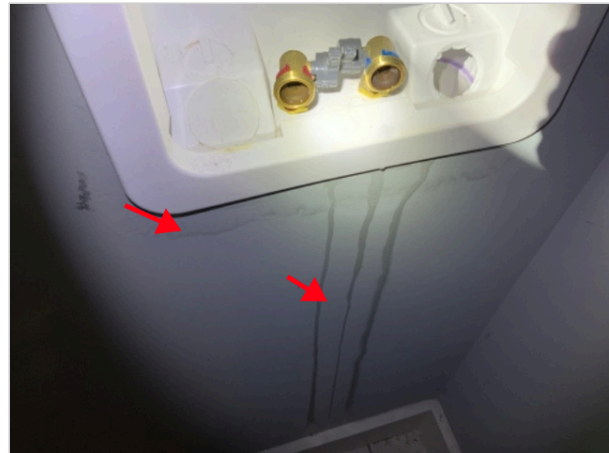
Area

When the homeowner removed the washing machine yesterday, the cold water hook-up was not turned off all the way so a little water was leaking onto the floor. The inspector turned it off, towel-dried the area, and notified the Listing Agent.

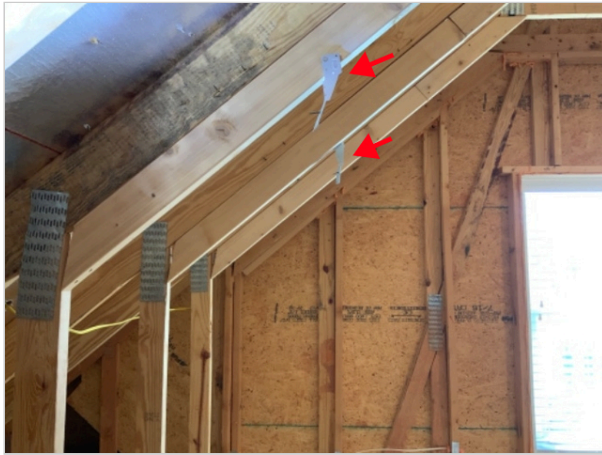
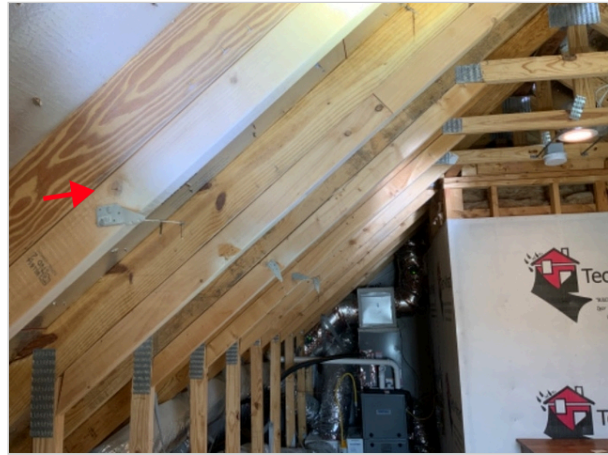
The trusses appear to have had sections removed and wood members added. This was most likely done to provide more access into the area. It is recommended to have a qualified contractor confirm that the modifications are acceptable.

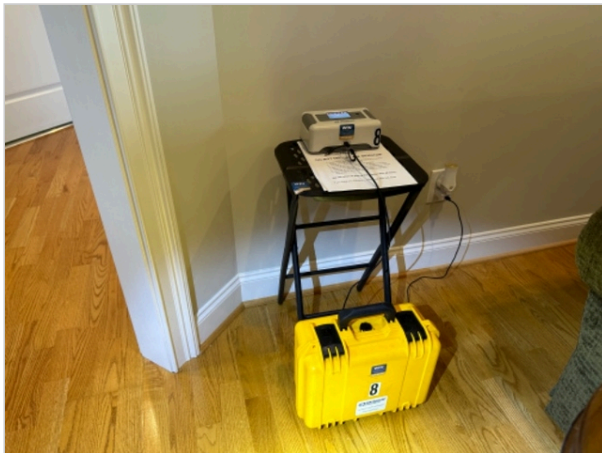
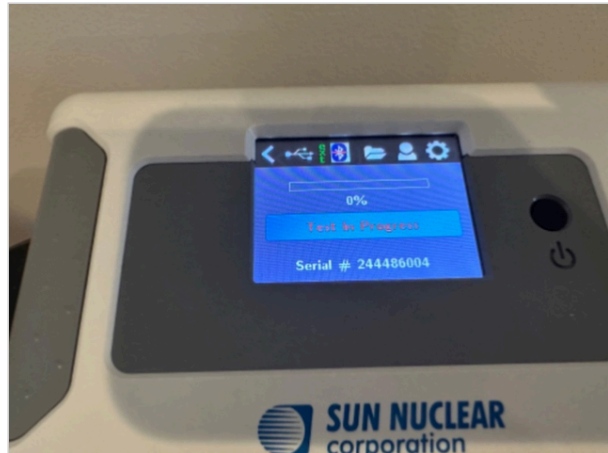
The inspector did not locate a radon mitigation system. The inspector set out a radon monitor and will provide those test results in another report.

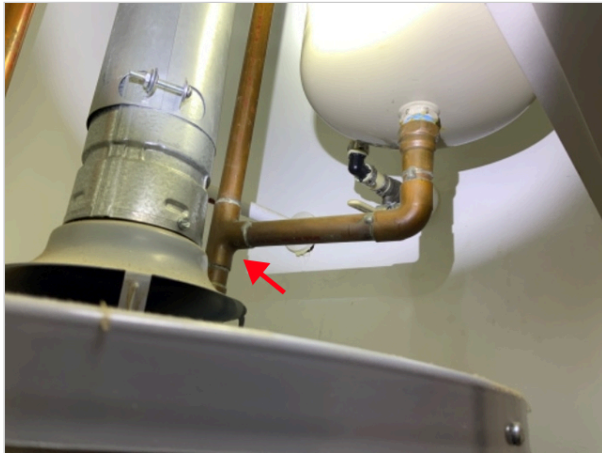
The average life of an expansion tank is 5-10 years. The best practice is to have it tested annually when water heaters are flushed.

Also, it is recommended that horizontally installed expansion tanks are supported. The concern is that the tank and the weight of water in the tank could weaken the fittings. Straps or other support are commonly used.

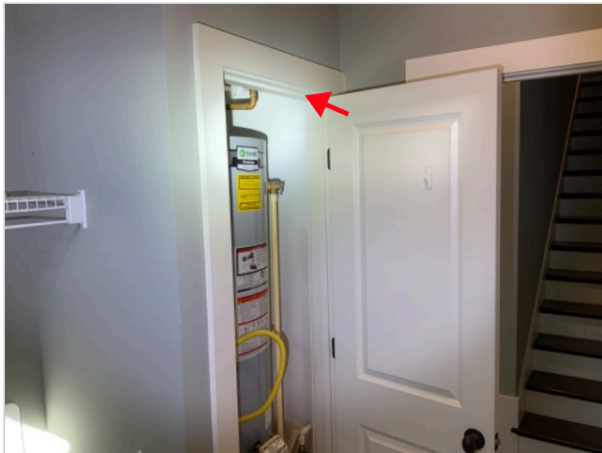
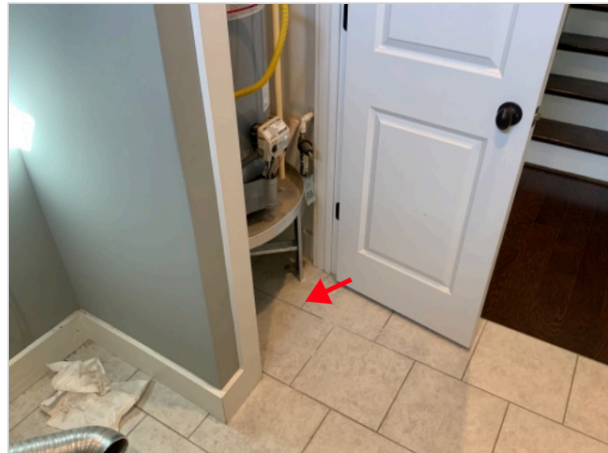
For improved safety, the door to the gas water heater should be fully sealed since it is installed inside the living area.

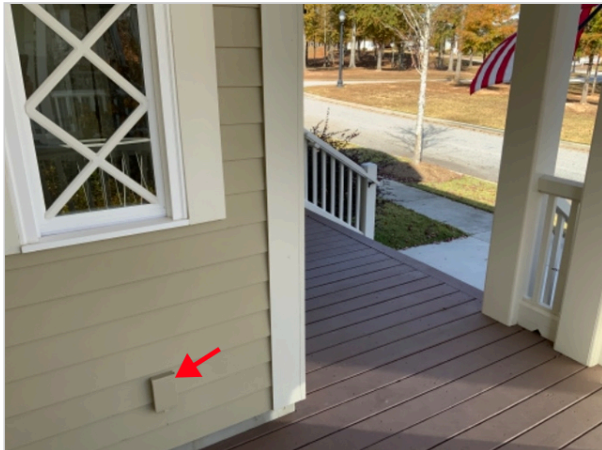
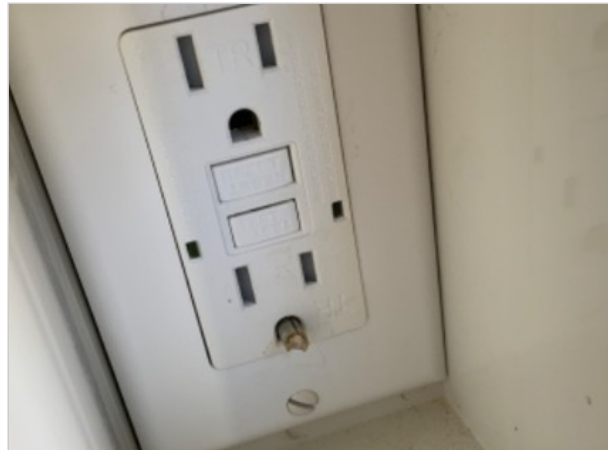
Front Porch

There is a broken piece of a plug in the receptacle. Repair as needed.

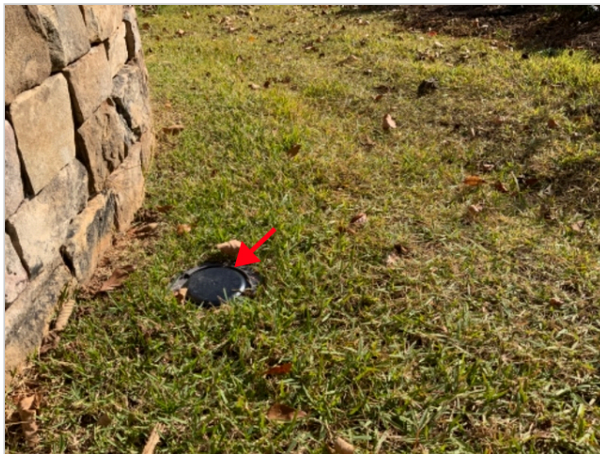
There is a termite prevention system installed. The inspector recommends asking the seller about any transferable warranties or bonds and about their knowledge of any past or present termite activity.

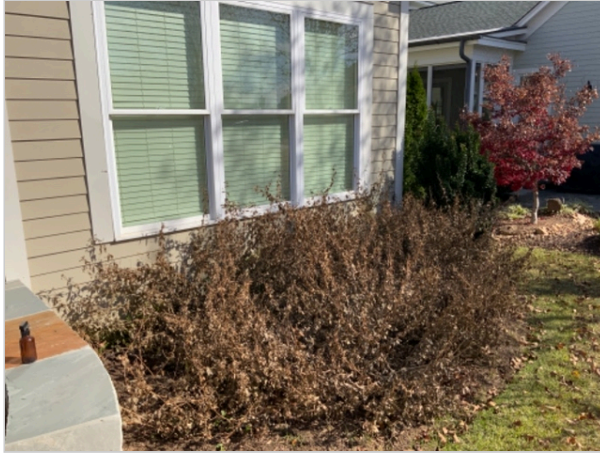
Back Left

There is vegetation growing up against the exterior surface. All vegetation should be trimmed at least 6 inches away from the structure to reduce the chance of damage to the surface and pest infestation.

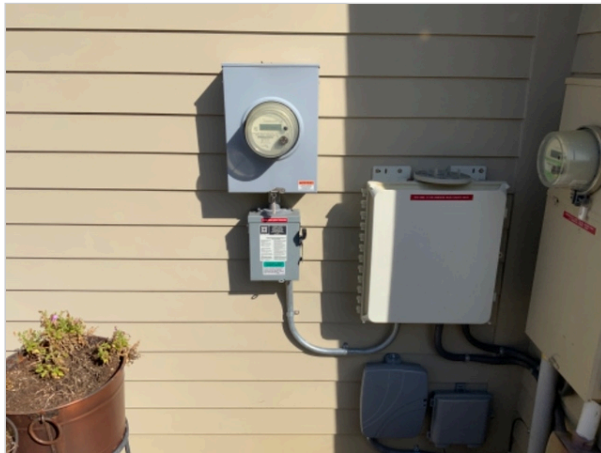
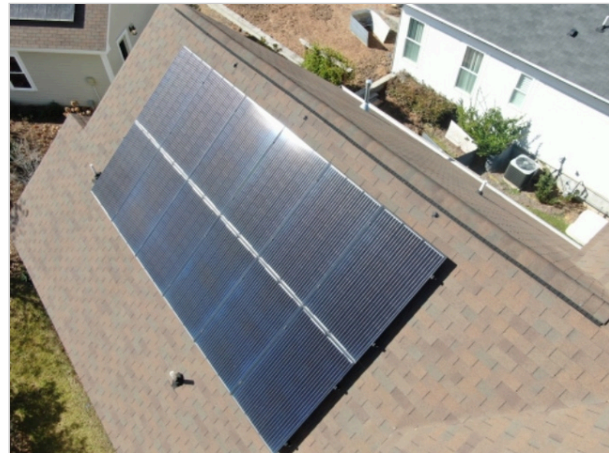
There is a solar panel system installed. This was not tested by the inspector. It is recommended to ask the seller for operational instructions and the service history. Also, please note that due to the solar panels, there are areas of the roof that are not accessible for visual inspection.

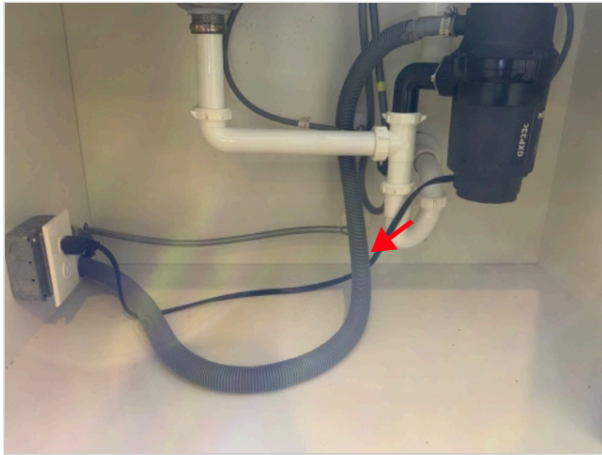
The current best practice is that drain lines for the dishwasher are attached as high as possible to prevent water from the sink from entering the dishwasher. Lifting the drain line and attaching it to the cabinet is recommended.

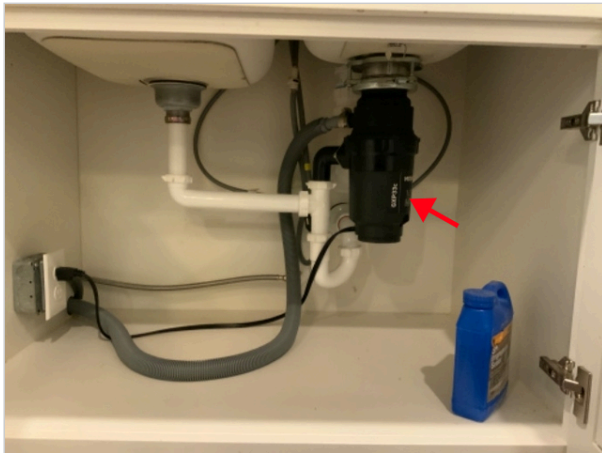
There are one or more items in the garbage disposal. It is recommended to have any items safely removed.

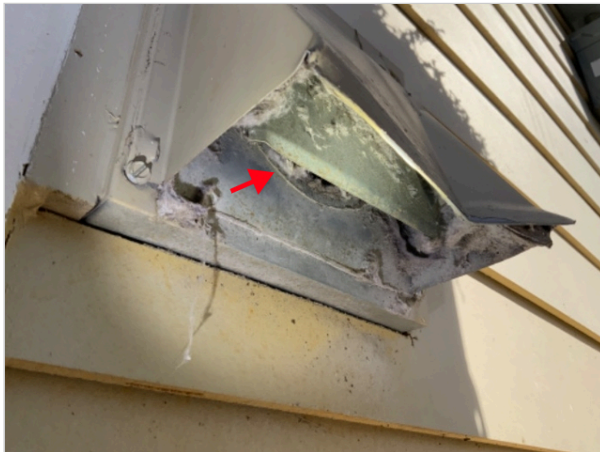
Right Side

This vent doesn't close fully. Correct as needed.

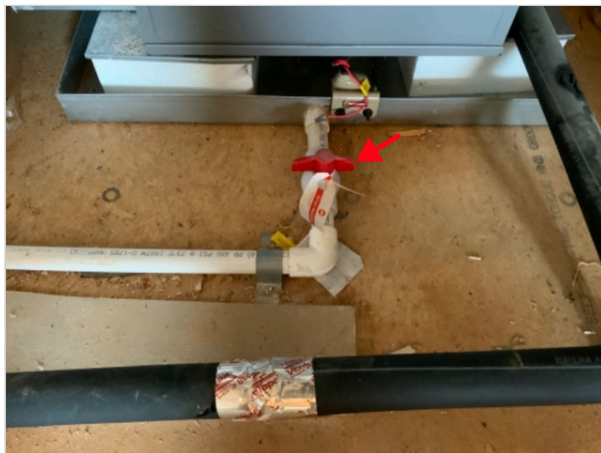
Attic

The drain line is turned off for the catch tray. There is a float switch installed should water build up in the catch tray. It is recommended to open the valve for catch tray so any water collected can drain away.

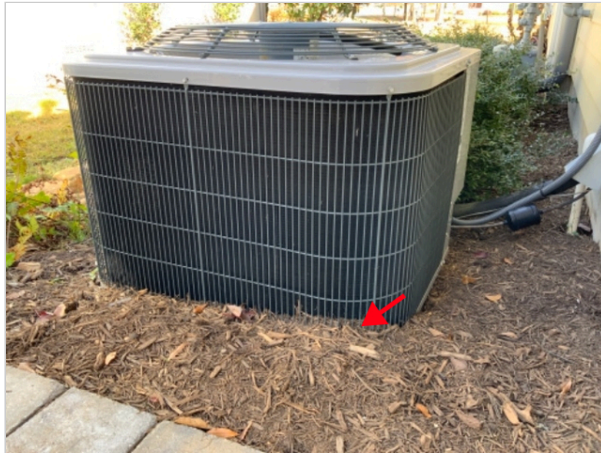
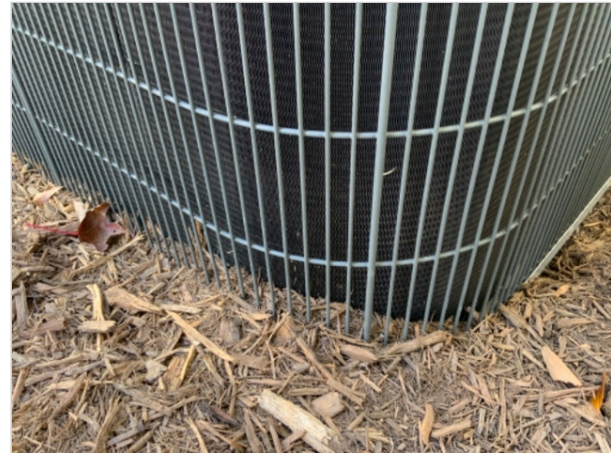
Right Side

It is recommended to remove any mulch that is blocking the condensing unit's fins because this will reduce airflow across the coils and the efficiency of the unit.

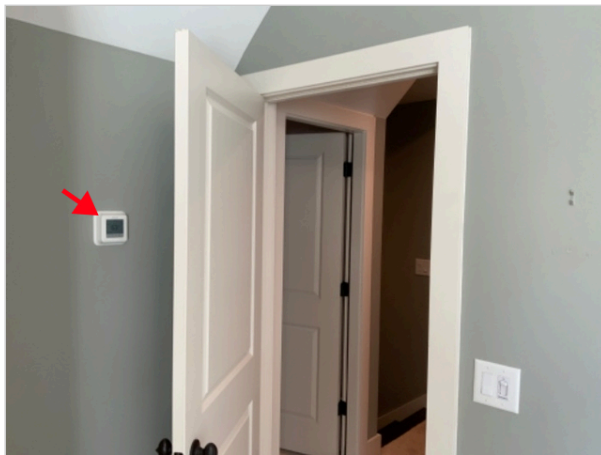
The upstairs thermostat is located behind the left bedroom door. It is functional but the best practice is for it to be placed in an unblocked central area such as the hallway.

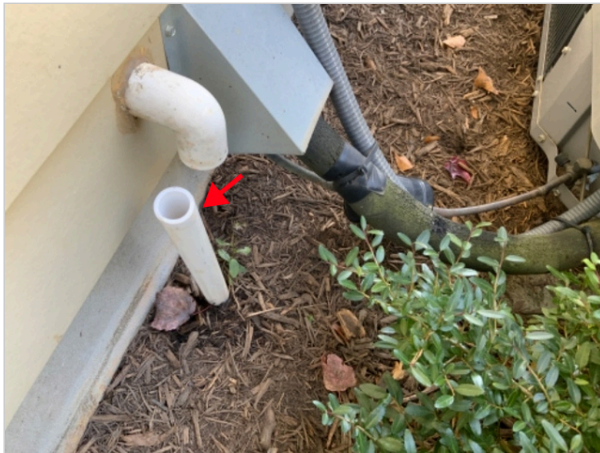
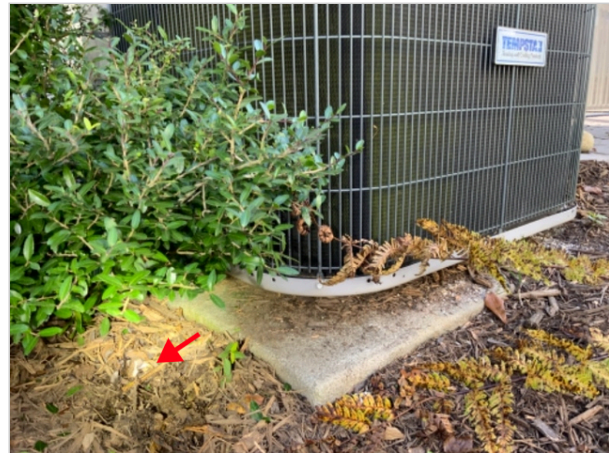
Right Side

The drain line for the attic furnace is functional but the extension is disconnected and it is in the mulch so it is clogged. Correct as needed.

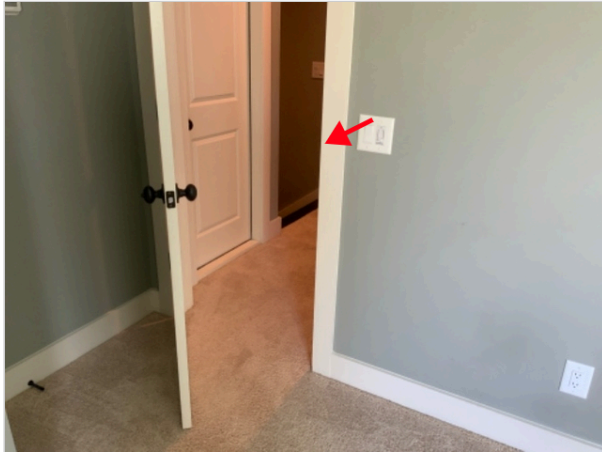
Left Guest Bedroom

The strike plate for this door needs adjustment for proper latching.

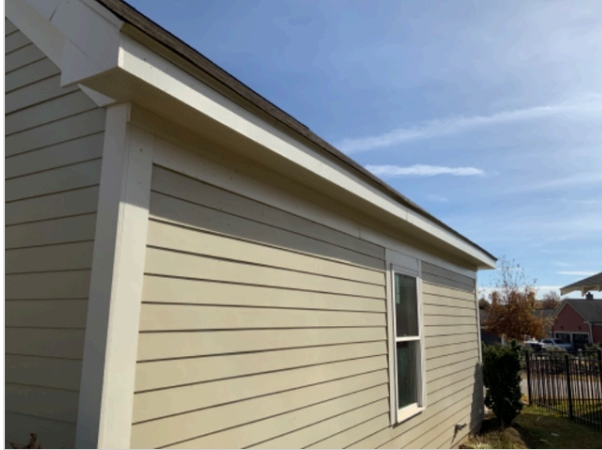
There is no gutter system installed. Installing a gutter system will help move water properly away from the structure to prevent water damage.
