**Service:** Full Home Inspection

Site Address: **Quality Drive, Vacaville, CA, 95688**

Service Date And Time: **August 31, 2026 At 10:00 AM**

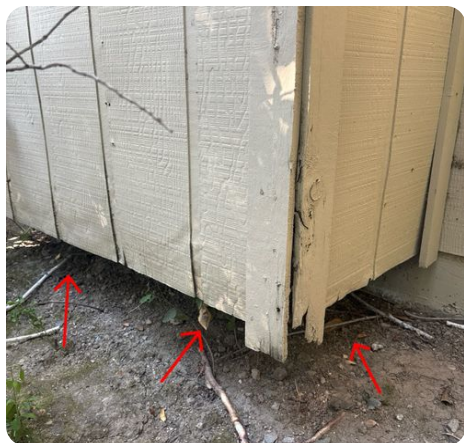
Moisture related damage was observed at the exterior siding and/or trim and it is recommended that the structural pest control report be consulted for additional information regarding this observation, as well as any recommendations for further evaluation, treatment, repair, or replacement.

Moisture related damage at exterior siding and trim serving fireplace chase.

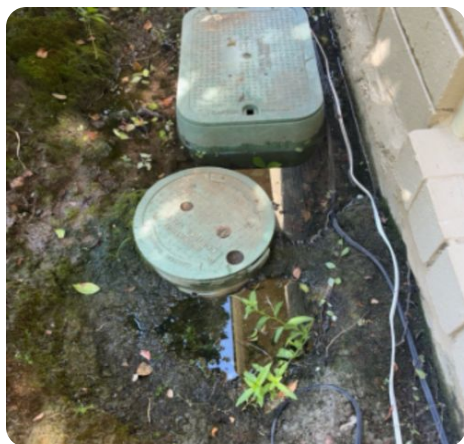
Faulty grade conditions coupled with an irrigation sprinkler have contributed to trapped, standing water at the exterior of the structure. Replacing the existing sprinkler head with a drip style head will reduce water usage, while regrading and/or supplementing existing drainage measures will allow moisture to drain away from the structure. Further evaluation by a qualified professional may be warranted.

Trapped standing water at landscaping adjacent to garage exterior.

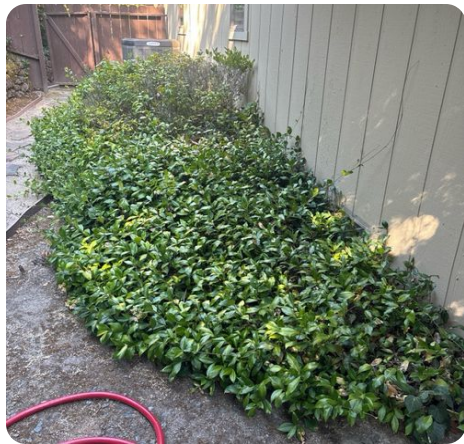
Vegetation was found to be in direct contact with the exterior siding and/or roofing surface at the time of the inspection. Vegetation growth limits siding and trim ventilation while providing a conducive condition for pest infestation. It is recommended that vegetation be trimmed and maintained away from the structure.

Vegetation in contact with exterior siding material.

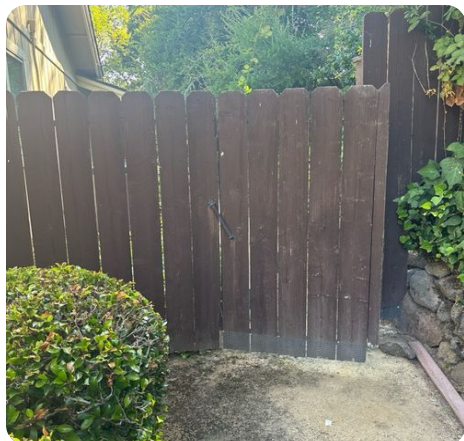
With the presence of a pool or spa, perimeter gates are required to contain operable self-closing devices and latches and ideally the gate hardware should also be oriented to open outwards. The gate was found to be misaligned when tested and it is recommended that the installation be further evaluated and either adjusted or replaced. Periodic evaluation and maintenance is recommended.

Perimeter gate makes contact with fence preventing closure.

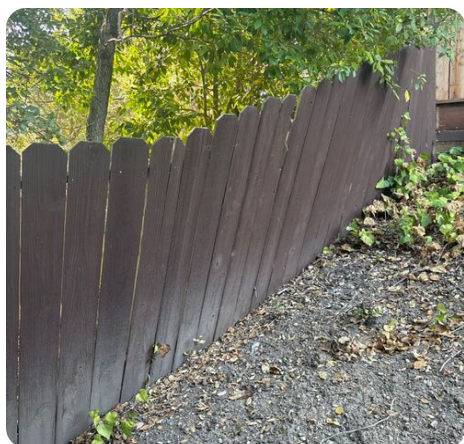
Perimeter fencing is typically a shared expense between neighbors, but becomes a more critical concern with the presence of a pool and/or spa. The fencing segments were found to be leaning and/or damaged and contained unsecured fence boards. It is recommended that perimeter fencing be further evaluated and either repaired or replaced by a qualified professional to ensure the yard remains secure.

Leaning perimeter fence segment.

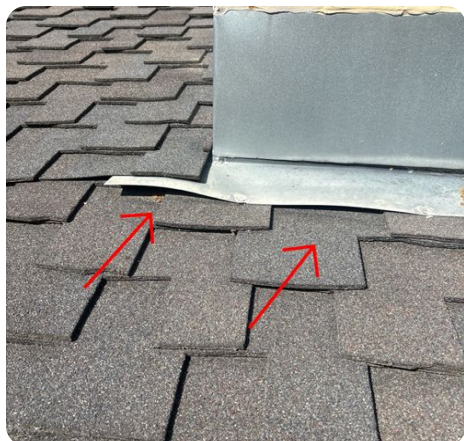
The flashing installed at the base of the chimney structure was found to be lifting or elevated and it is recommended that the flashing be further evaluated and secured by a roof professional.

Lifting flashing at base of chimney structure.

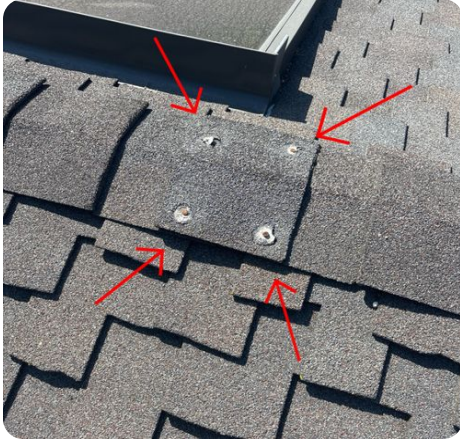
Exposed nail heads were observed at the ridge shingles and caps and it is recommended that the nail heads be sealed by a qualified roof professional to prevent moisture intrusion.

Exposed nail heads at ridge cap.

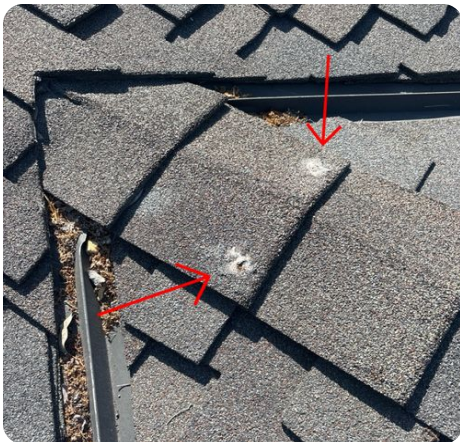
Exposed nail heads at ridge shingle.

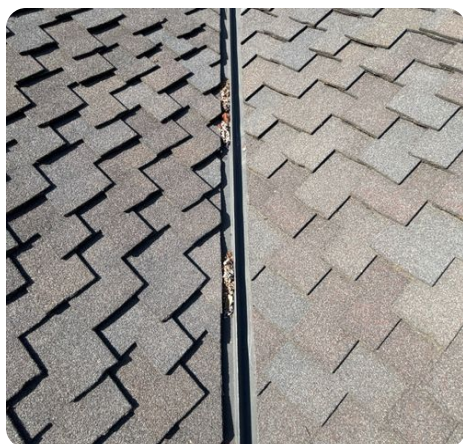
Debris accumulation was observed at the roof surface at the time of the inspection and it is recommended that debris be periodically removed to promote positive drainage.

Debris accumulation at roof surface.

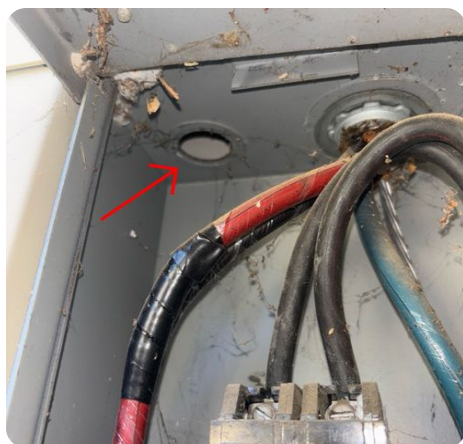
An open knock-out was observed at the top of the main electrical panel, while the knock-out at the base of the panel lacks a bushing designed to secure and protect the electric cable. The openings provide an entry point for pests and debris and it is recommended that the openings be capped, sealed, and secured to address these concerns.

Open knockout at top of main service panel.

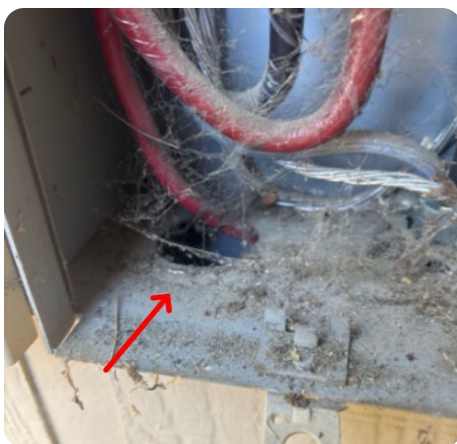
Knock-out lacks a bushing at base of main panel .

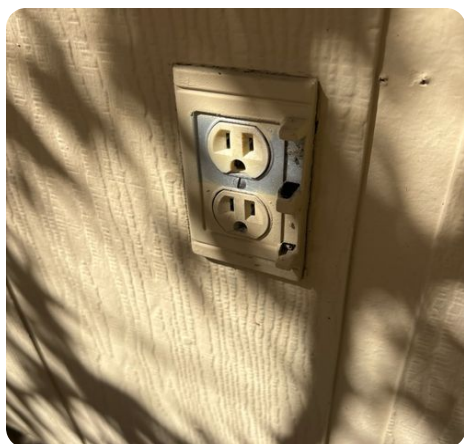
A damaged or missing weather proof cover was observed at the exterior of the structure and it is recommended that replacement cover plate be installed.

Damaged weatherproof outlet cover at rear of home.

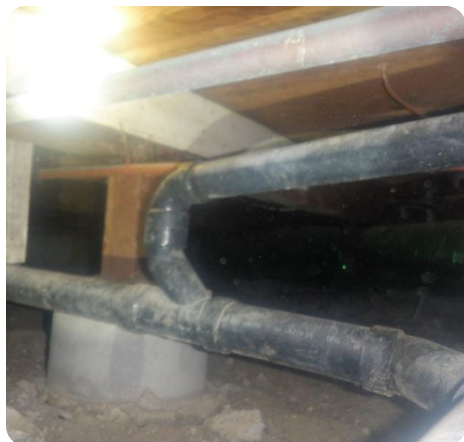
An active plumbing leak was observed within the crawl space at the kitchen sink drain and it is recommended that the pipes, fittings, and connections, be further evaluated and repaired by a plumber or other qualified professional.

Wet soil below leaking kitchen waste plumbing fitting.

Leaking waste fitting below kitchen.

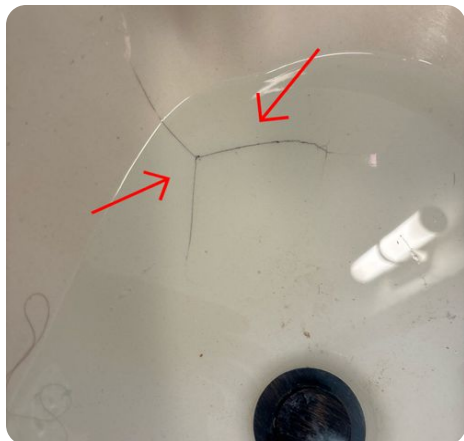
A bathroom basin was found to be cracked, but did not display any indication of leakage. Periodic evaluation of the fixture is recommended.

Cracked master bathroom basin.

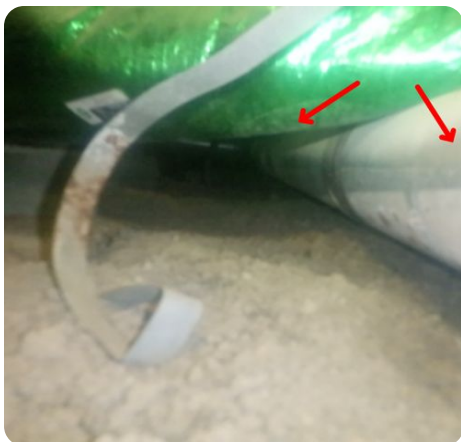
The crawl space soil was found to be dry at the time of the inspection, but contained indications of elevated moisture levels at some point in the past. Water/silt lines were observed at the cook-top ventilation ducting and HVAC ducting. Consulting the current homeowner for additional information regarding this observation is recommended.

Water/silt lines at cooktop fan ducting.

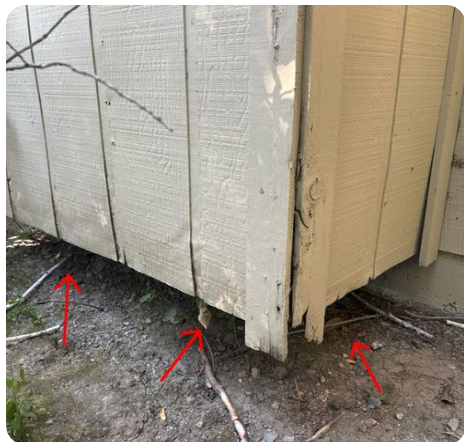
Moisture related damage was observed at the exterior siding and/or trim and it is recommended that the structural pest control report be consulted for additional information regarding this observation, as well as any recommendations for further evaluation, treatment, repair, or replacement.

Moisture related damage at exterior siding and trim serving fireplace chase.

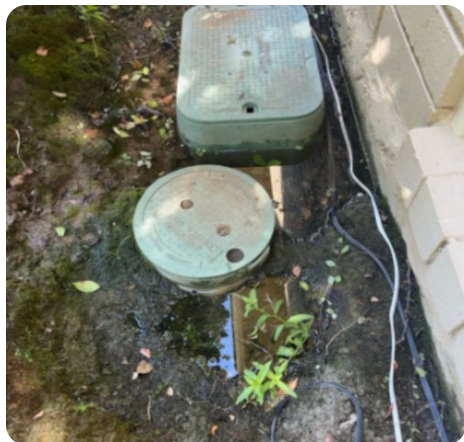
Faulty grade conditions coupled with an irrigation sprinkler have contributed to trapped, standing water at the exterior of the structure. Replacing the existing sprinkler head with a drip style head will reduce water usage, while regrading and/or supplementing existing drainage measures will allow moisture to drain away from the structure. Further evaluation by a qualified professional may be warranted.

Trapped standing water at landscaping adjacent to garage exterior.

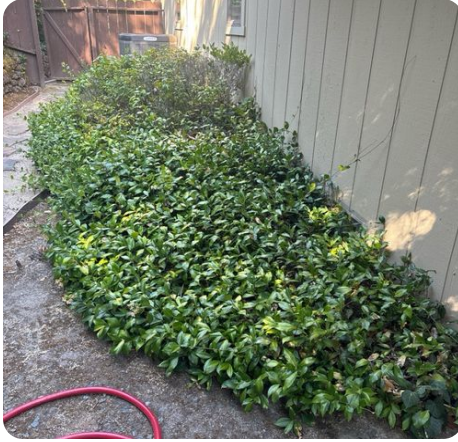
Vegetation was found to be in direct contact with the exterior siding and/or roofing surface at the time of the inspection. Vegetation growth limits siding and trim ventilation while providing a conducive condition for pest infestation. It is recommended that vegetation be trimmed and maintained away from the structure.

Vegetation in contact with exterior siding material.

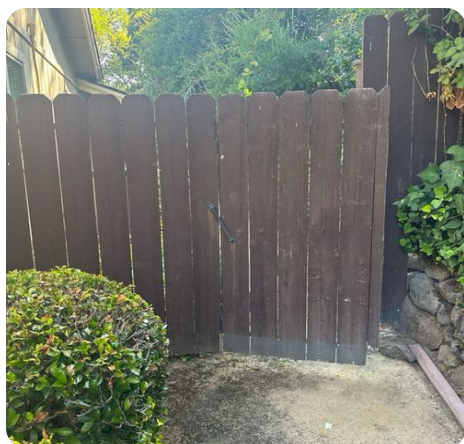
With the presence of a pool or spa, perimeter gates are required to contain operable self-closing devices and latches and ideally the gate hardware should also be oriented to open outwards. The gate was found to be misaligned when tested and it is recommended that the installation be further evaluated and either adjusted or replaced. Periodic evaluation and maintenance is recommended.

Perimeter gate makes contact with fence preventing closure.

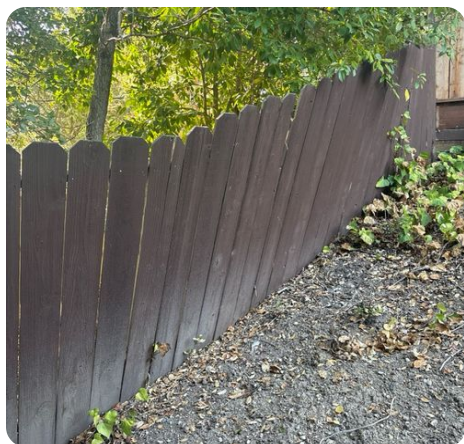
Perimeter fencing is typically a shared expense between neighbors, but becomes a more critical concern with the presence of a pool and/or spa. The fencing segments were found to be leaning and/or damaged and contained unsecured fence boards. It is recommended that perimeter fencing be further evaluated and either repaired or replaced by a qualified professional to ensure the yard remains secure.

Leaning perimeter fence segment.

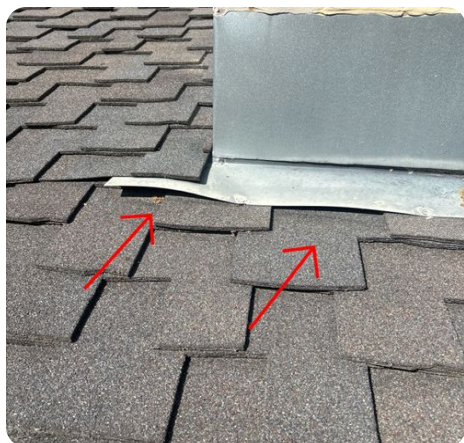
The flashing installed at the base of the chimney structure was found to be lifting or elevated and it is recommended that the flashing be further evaluated and secured by a roof professional.

Lifting flashing at base of chimney structure.

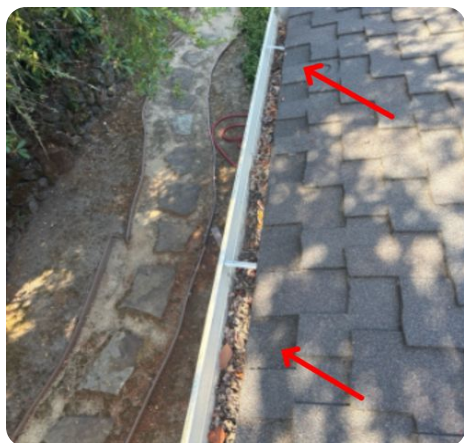
The gutter system was found to contain debris and it is recommended that the gutters and downspout system be periodically evaluated and maintained to ensure positive drainage during inclement weather conditions. Portions of the gutter system are equipped with screen material.

Debris accumulation within gutter system.

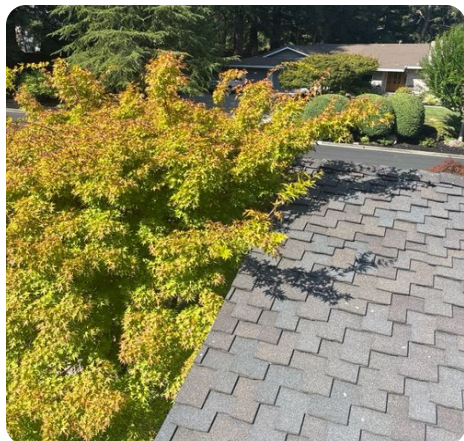
The trees located at the exterior of the home were found to overhang or be in contact with the roof surface at the time of the inspection. It is recommended that the trees be trimmed and maintained away from the structure to limit premature wear.

Tree overhanging garage roof surface.

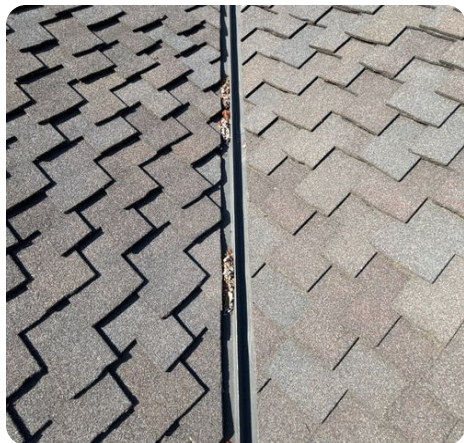
Debris accumulation was observed at the roof surface at the time of the inspection and it is recommended that debris be periodically removed to promote positive drainage.

Debris accumulation at roof surface.

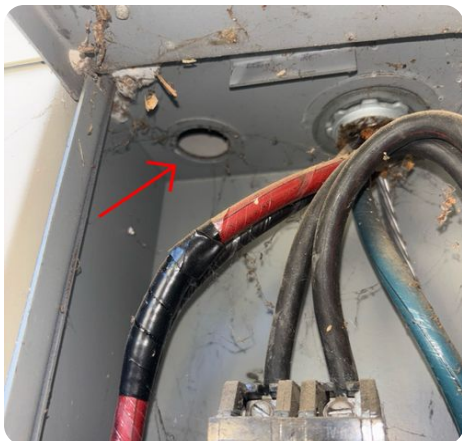
An open knock-out was observed at the top of the main electrical panel, while the knock-out at the base of the panel lacks a bushing designed to secure and protect the electric cable. The openings provide an entry point for pests and debris and it is recommended that the openings be capped, sealed, and secured to address these concerns.

Open knockout at top of main service panel.

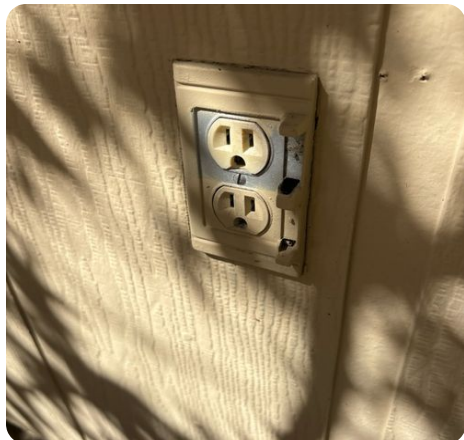
A damaged or missing weather proof cover was observed at the exterior of the structure and it is recommended that replacement cover plate be installed.

Damaged weatherproof outlet cover at rear of home.

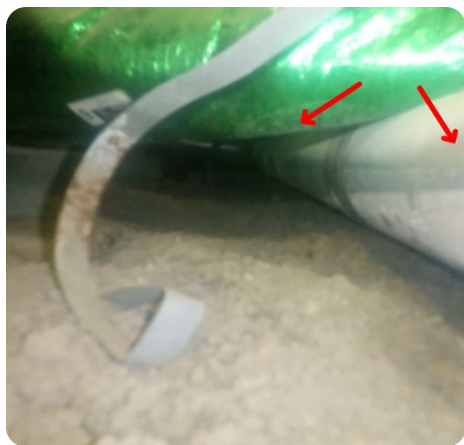
Water/silt lines at cooktop fan ducting.
