Prepared For: Jane and Jack Buyer

Property Address: 8320 Vista Monterra, Monterey, CA 93940

Inspector: Robert Vierra
Company: RLV Inspection Services
dba WIN Home Inspection Monterey
(831) 637-2194
rvierra@wini.com

Full Home Inspection

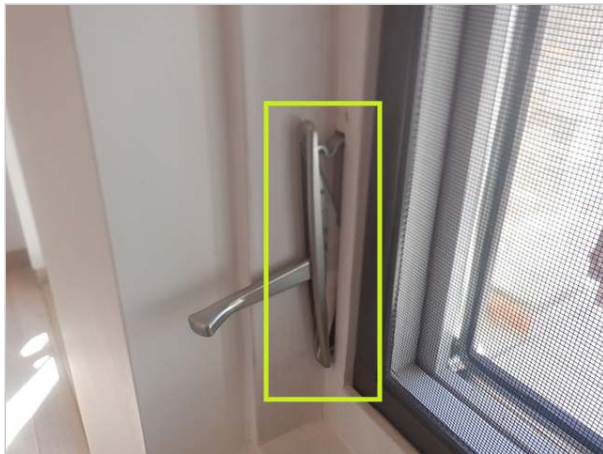
The windows in the home were functional; however, the lock handle sleeves were loose from the frame at several windows, and may need preventative repair. Appropriate repairs or modifications are recommended by a qualified trade.

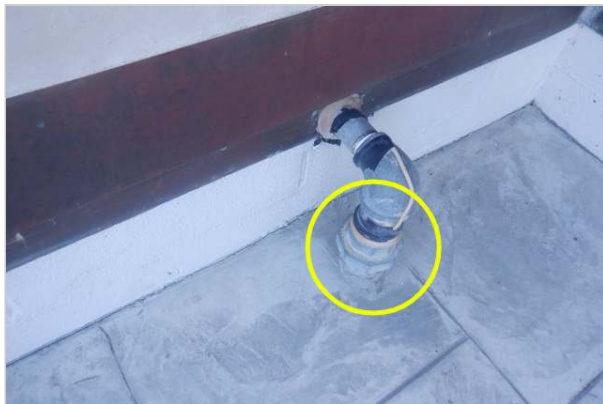
2. Utility Services - Service Shut Off(s)

Exterior of garage

The gas line pipe at the West side of the home is embedded in the concrete walkway along the structure. This installation could cause the pipe to be damaged due to seismic and/or soil movement affecting the concrete. It is recommended the pipe run through a sleeve or other modifications to help prevent mechanical damage to the pipe. Modifications by a qualified trade would be recommended.

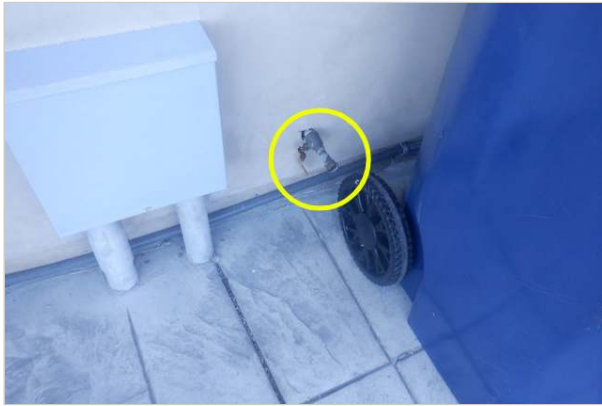
3. Patios/Decking/Porches - Natural Gas Service/Equipment

Attention - cap line

There appears to be a gas-line, which should be capped off when not in use, at the exterior West side wall of the garage. Appropriate repairs are recommended to prevent a possible leak if the handle were bumped or turned.

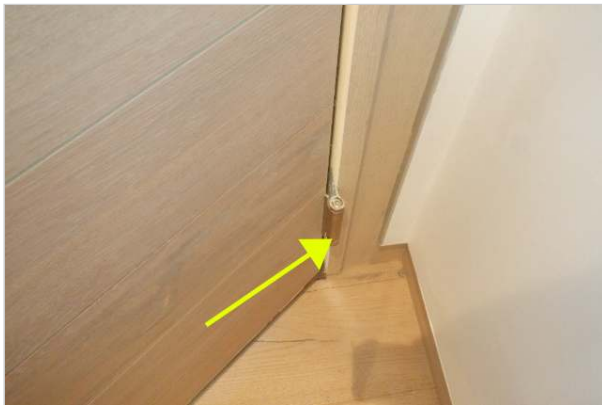
4. Attached Garage - Door(s), Garage - Building

Attention - door closers

The auto-closing door hinges on the door leading into the house are not functioning properly. Appropriate repairs are recommended so the door completely shuts after being opened. It is suggested the hinges be installed and functioning to help prevent fumes from a vehicle or flames in the garage from entering the home. Appropriate repairs are recommended for proper use.

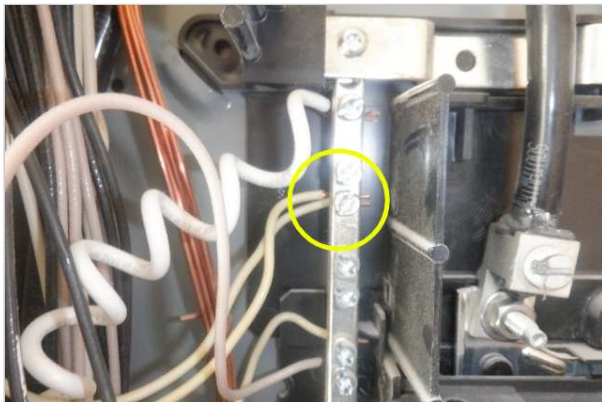
5. Electrical Service - Panel Cover(s) Removed

Yes - Attention - Double lugged neutral wires

There are neutral wires in the electrical sub panel #1 which are double lugged at the terminal bars. Standard electrical practice calls for single lugging of neutral or ground wires at the terminal bars. The inspector recommends an approved modification to the system. We suggest you call a qualified professional electrician for their recommendations.

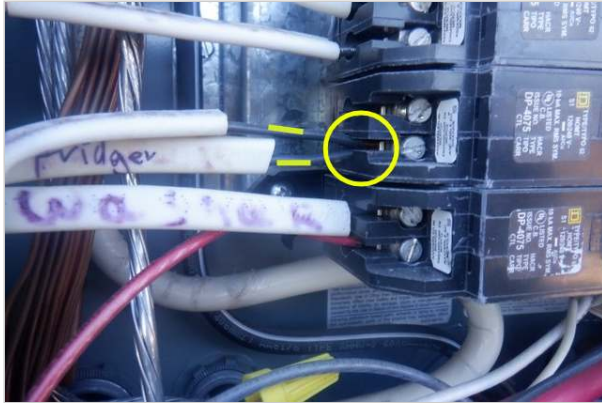
6. Electrical Service - Breaker Configuration

There is a 15 amp breaker in the main panel which is double-tapped (two wires leading to one breaker). Standard electrical practice calls for single-tapping of individual breakers. The inspector recommends an approved modification to the system. We suggest you call a qualified electrician for recommendations/repairs.

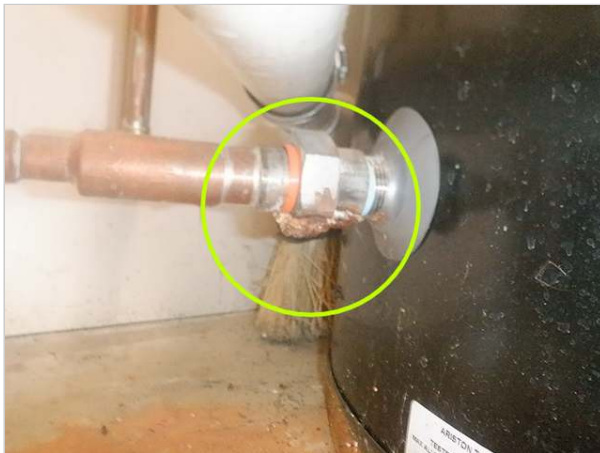
8. Water Heater - Evidence of Encrustation

Yes - corrosion at fittings

There are encrustations/corrosion at the fitting from the drain valve, near the bottom of the hot water heater tank. These deposits usually indicate past leaks or are the result of other conditions that could lead to leaks in the future. We recommend periodic inspection of the unit.

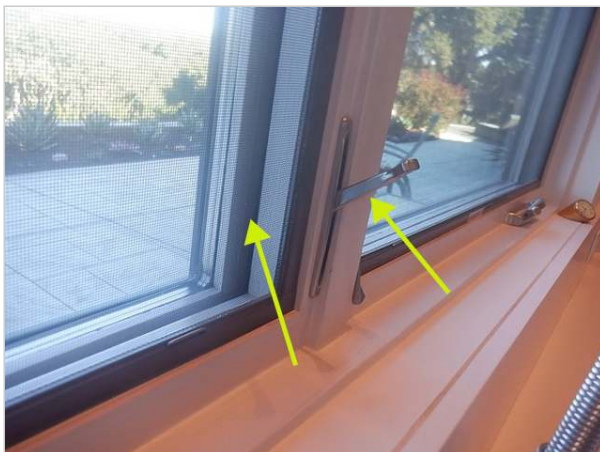
9. Kitchen(s) - Kitchen Windows

Attention

The left side window would not properly latch at the bottom of the window in the kitchen. Repairs are needed for proper operation. We recommend you contact an appropriate trade for evaluation/repairs.

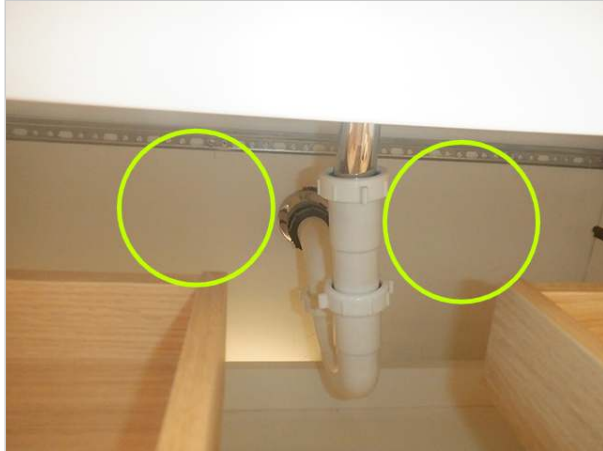
10. Bathroom(s)/Washroom(s) - Sink/Fixtures

Attention - no shut-off valve

There were no shut-off valves accessible beneath several of the bathroom sink basins. Shut-offs valves would be needed in order to perform repairs without turning off water service to the entire home. Contact a qualified plumber for further investigations and/or repairs.

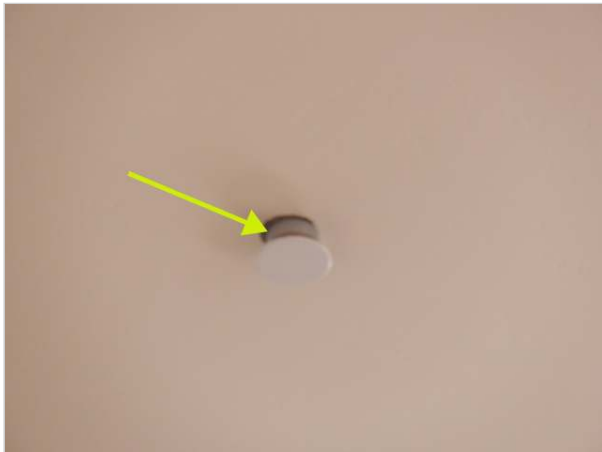
The structure is equipped with a fire sprinkler system which should provide for added safety. One of the sprinkler heads is loose from the ceiling in the garage. Appropriate repairs are recommended to maintain a seal firewall system. The sprinkler system was not tested/inspected under the scope of the inspection. There are several types of sprinkler systems which are associated with past or present recalls. The brand or type of these sprinkler heads is not known. The inspector recommends contacting a fire sprinkler company, and/or the local fire department on any inspections or maintenance procedures needed for the system.

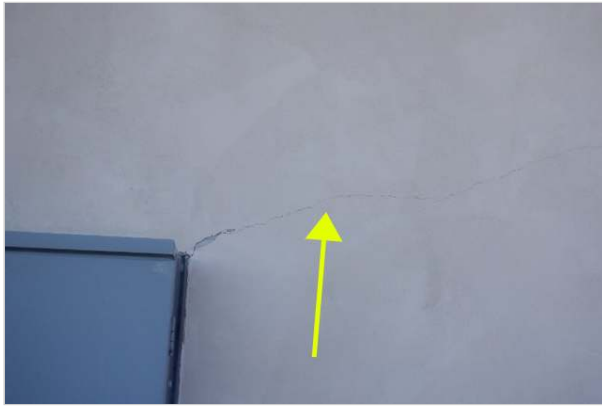
2. Siding Condition

Functional - cracks

The siding is in functional condition; however, there are cracks at the stucco siding material at various areas of the structure. These type of cracks may be due to movement, curing at application, or other issues. We suggest the cracks be properly patched/sealed to prevent moisture intrusion, and to monitor for future movement. Proper care and maintenance such as painting and periodic pressure washing is also recommended.

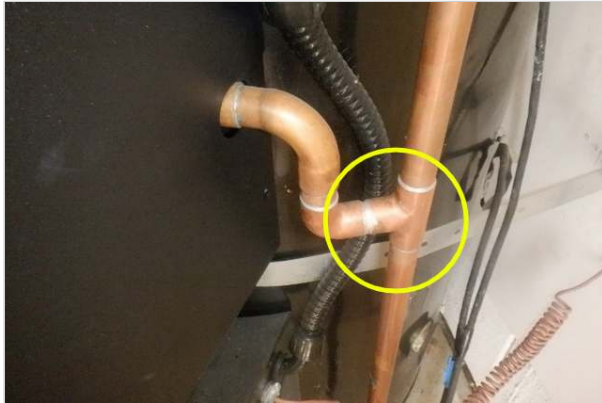
The inspector recommends modifications to the discharge pipe from the water heater. The pipe is joined with the discharge piping from the boiler for the radiant heating system. These pipes should be separate from one another. We recommend you contact an appropriate trade for evaluations/repairs.

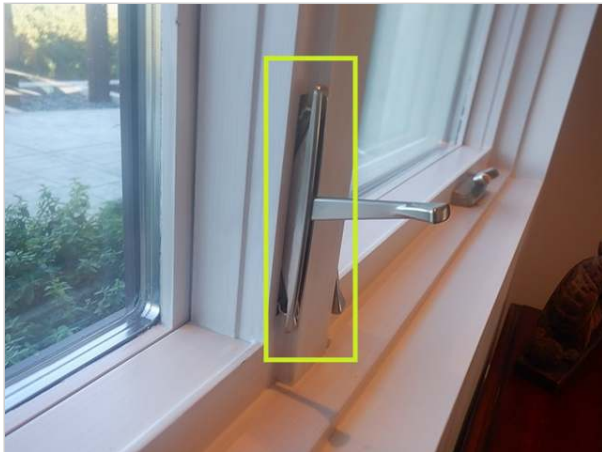
Attention

The window in the dining room area was functional; however, the lock handle sleeve was loose from the frame and may need repair. Appropriate repairs or modifications are recommended by a qualified trade.

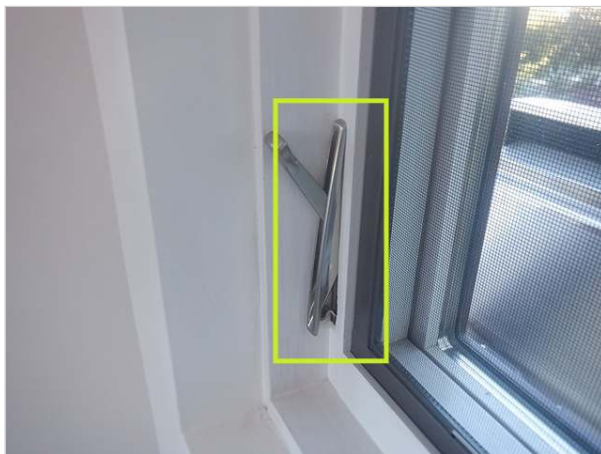
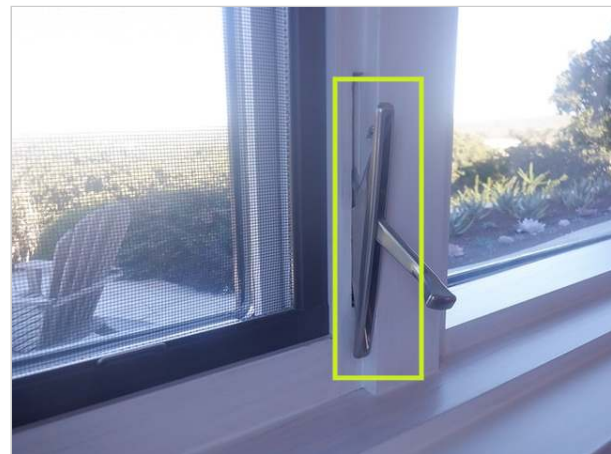
The left side window would not properly latch at the bottom of the window in the kitchen. Repairs are needed for proper operation. We recommend you contact an appropriate trade for evaluation/repairs.

The windows in the breakfast nook area were functional; however, two of the lock handle sleeves were loose from the frame and may need repair. Appropriate repairs or modifications are recommended by a qualified trade.

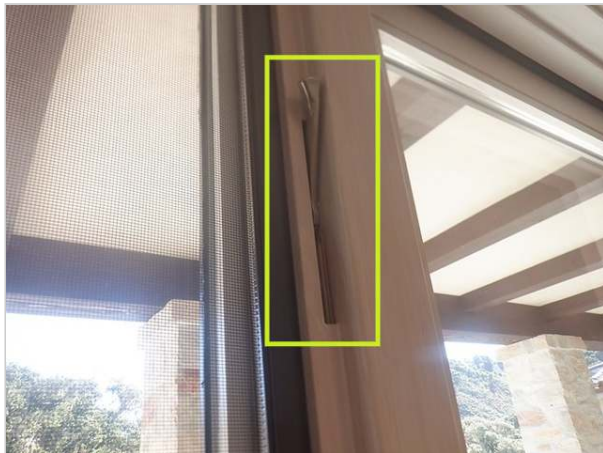
Attention

The window in the guest bedroom #4 was functional; however, the lock handle sleeve was missing from the frame and may need repair. Appropriate repairs or modifications are recommended by a qualified trade.

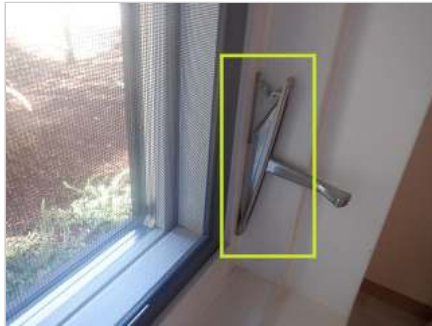
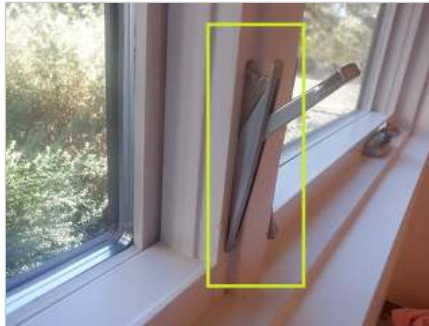
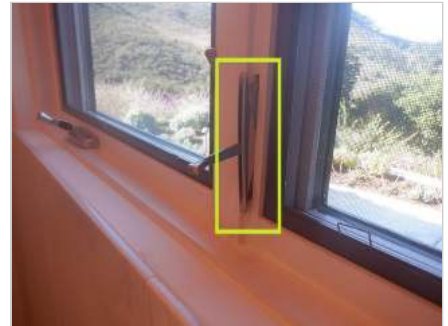
Attention

The windows in the master bathroom area and guest bathroom #2 were functional; however, the lock handle sleeves were loose from the frame at some of the windows and may need repair. Appropriate repairs or modifications are recommended by a qualified trade.

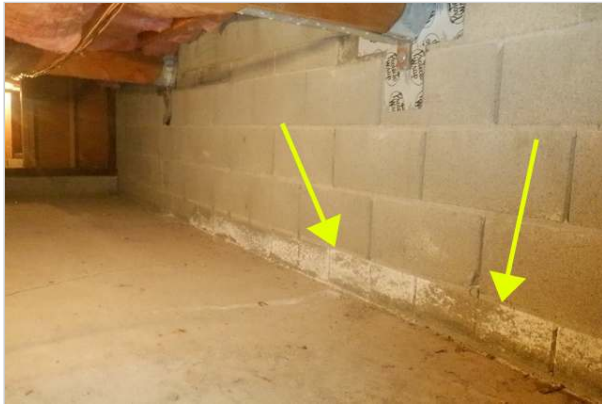
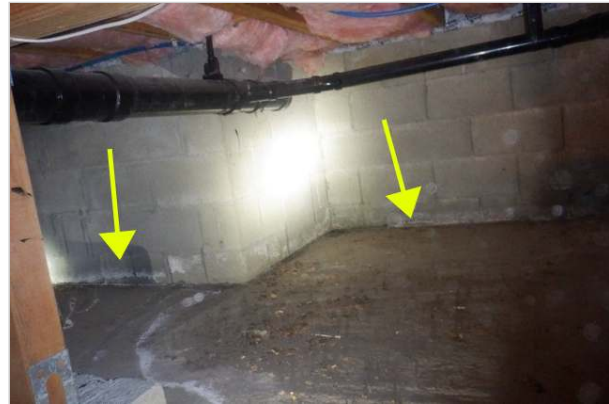
Attention - stains/efflorescence

There was efflorescence in areas of the crawl space at the time of the inspection. This is evidence of past moisture in this area. At the time of the inspection, it was noted there was no standing water or dampness under this structure. During the rainy season, occasional moisture in the crawl space area is possible. We suggest you monitor the area on an annual basis, to determine if there are periods of standing water. If further information is needed, the inspector recommends contacting a drainage contractor.
