**Prepared For:** Sample Homebuyer

**Property Address:** 1234 Easy St., Cape Coral, FL 33993

**Inspector:** Jason Vernier  
**Company:** Vernier Enterprises, Inc.  
dba WIN Home Inspection Fort Myers  
jvernier@wini.com

## Standard Full Home Inspection

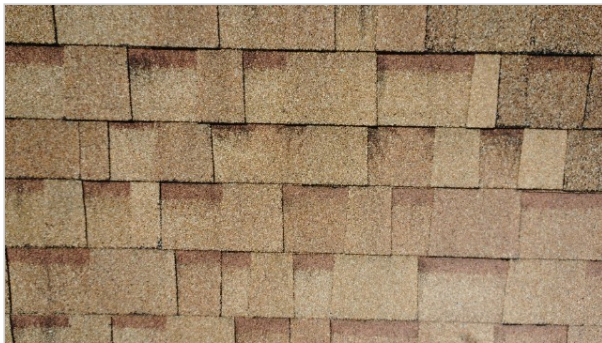
Although the asphalt composition shingles covering the roof of this structure are not new, they appear to be in generally serviceable condition at the time of the inspection. However, Florida insurance regulations vary and generally roof covers older than 15 years may not be approved for insurance coverage although the shingles have not reached the end of manufacture service life. Recommend checking with your insurance carrier in this regard and further evaluation by a licensed roofer.

Roof cover greater than 15 years per posted permits.

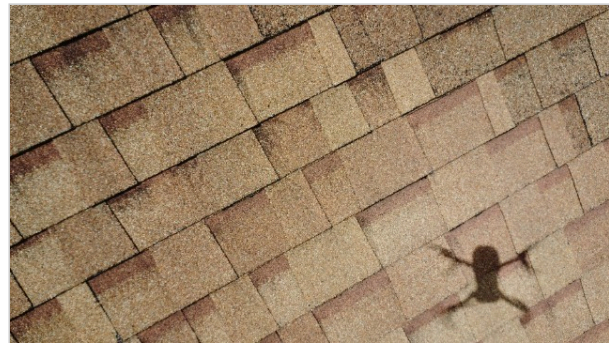
Roof cover greater than 15 years per posted permits.

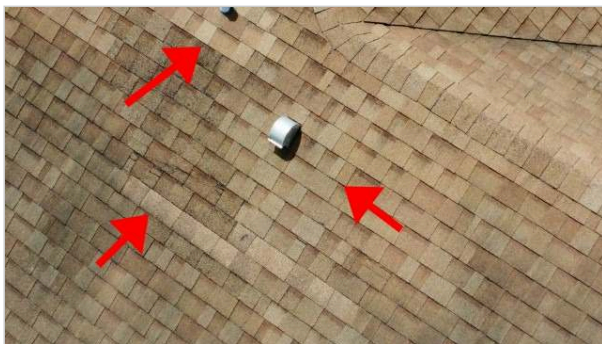
There are areas of the roof cover that appear to have been previously repaired or replaced. Additionally, there are dry moisture stains under these repaired areas in the attic space. It appears a past leak at the dryer vent may have been repaired. Recommend questioning the seller as to the nature of the repairs and if indicated further evaluation by a licensed contractor.

Repaired areas.

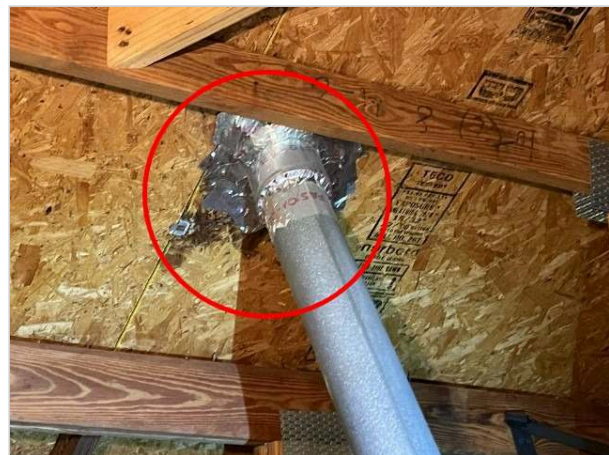
Past stain and repair.

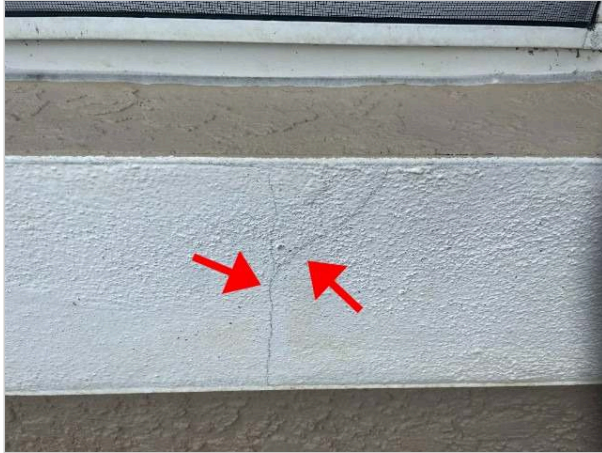
One or more areas of the siding are damaged and should be repaired to prevent moisture and pest intrusion. Recommend repair by a qualified specialist.

Minor crack.

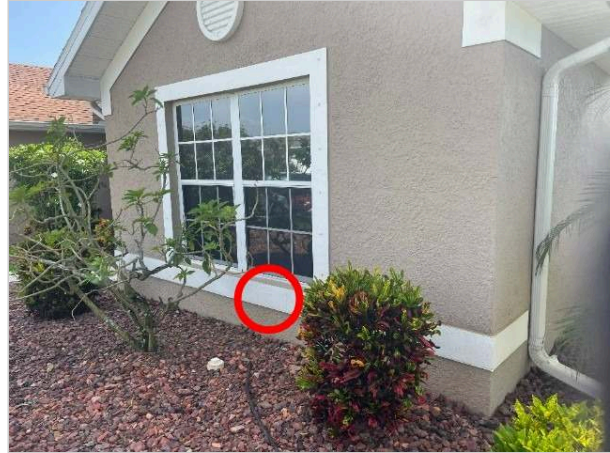
Affected area in front.

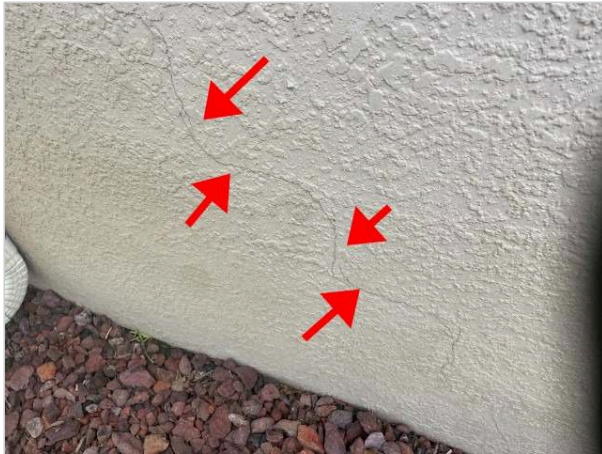
Minor crack.

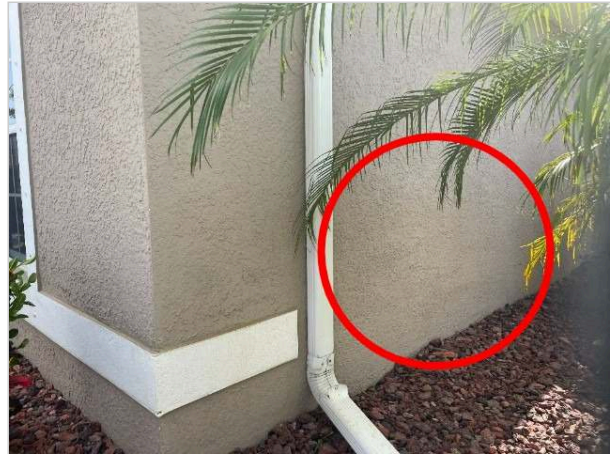
Affected area on South side.

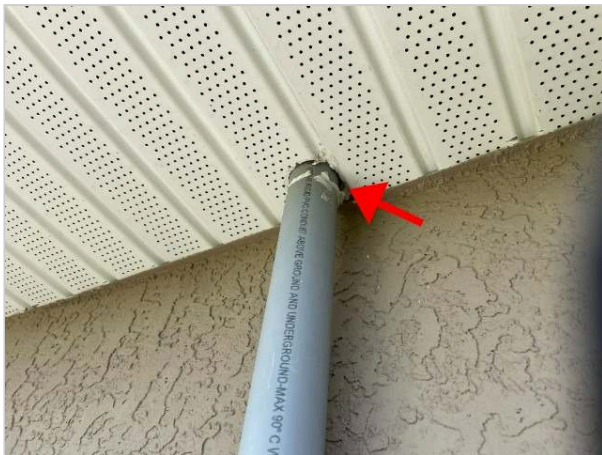
There are utility penetration(s) into the structure that have gaps and should be caulked or sealed to prevent moisture and pest intrusion. Recommend adding silicone or similar all weather caulking or sealant to all utility gaps

Penetration needs re-sealed on South side.

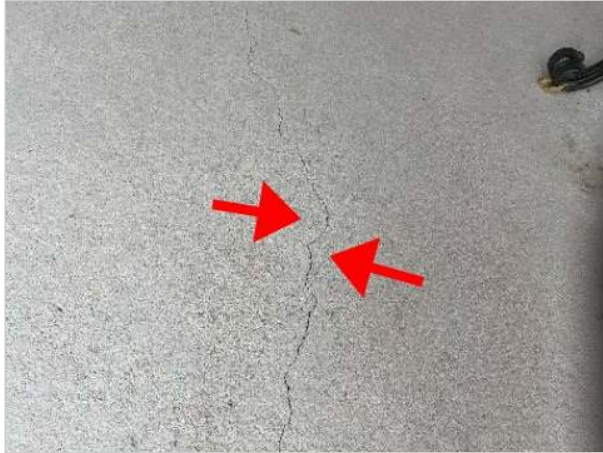
One or more areas of the concrete has cracks. Cracks less than 1/8th of an inch and less than 18 inches in length are generally considered minor. All concrete is subject to cracks and chips. This is a natural part of the process of being exposed to the elements and settling. Recommend monitoring and application of an epoxy sealant or polyurethane caulking as needed.

Minor crack in front porch slab.

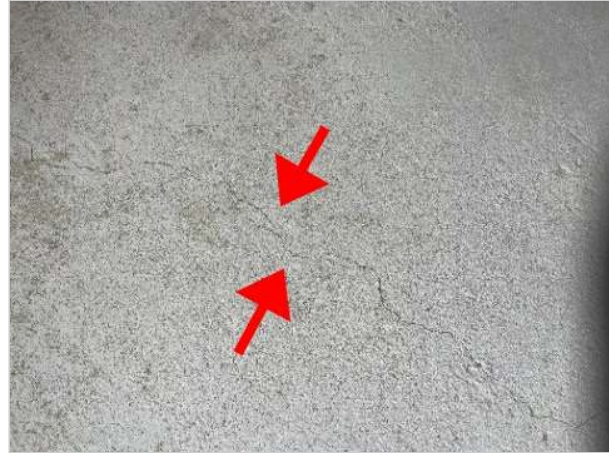
Minor crack in front porch slab.

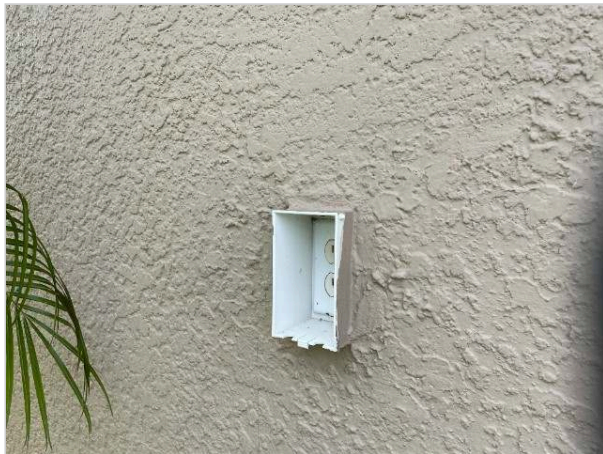
There are one or more exterior outlet covers that are damaged or are not functional. Recommend repair or replacement by a qualified specialist.

Exterior outlet cover missing on North side.

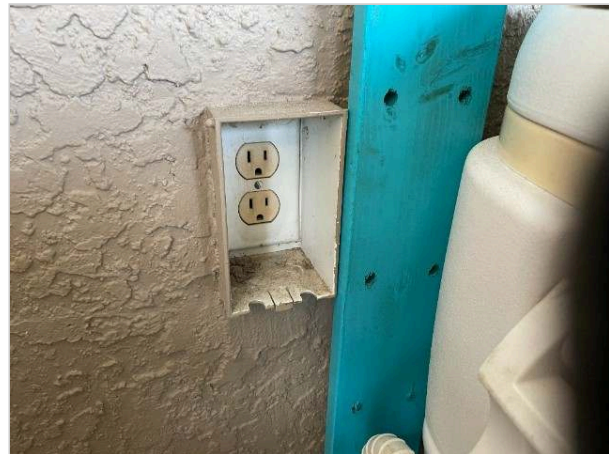
Exterior outlet cover missing in back.

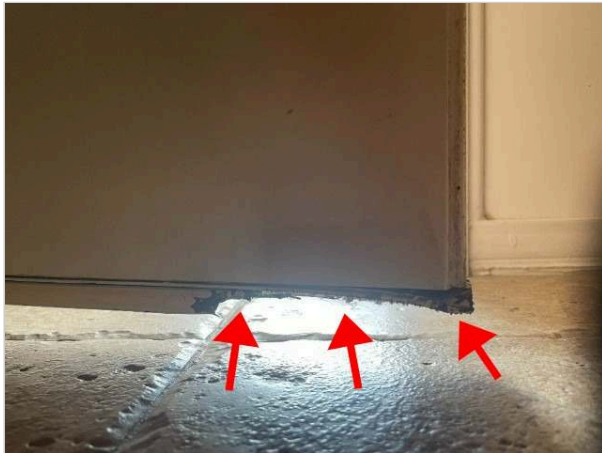
Consideration should be given to repairing or replacing the weather stripping on the main entry door. The weather strip is important for maintaining energy efficiency. Recommend evaluation and repair of the affected weather strip.

Damaged weather strip on bottom of door.

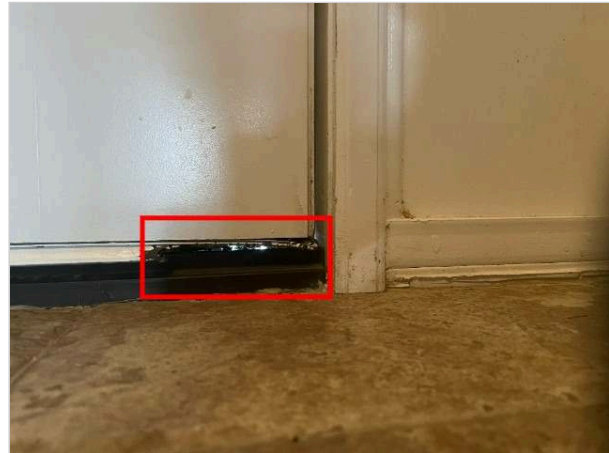
Gap at damaged weather strip.

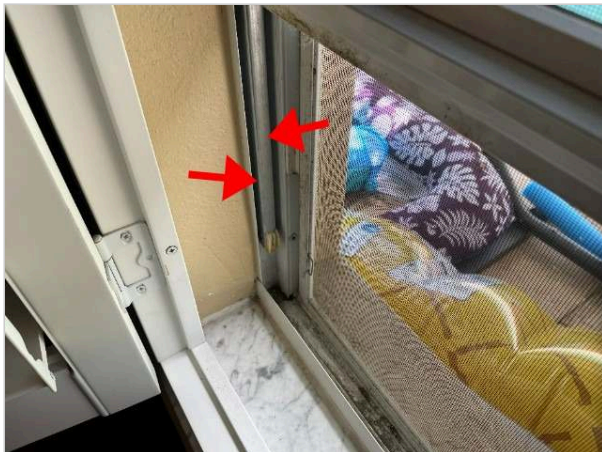
There are one or more windows in the structure that have a damaged or disconnected sash balance. This condition stresses the remaining balance as applicable or may not stay in the up position and can lead to unexpected failure of the window and injury. Recommend repair by a qualified window specialist for safety.

Balanced damaged.

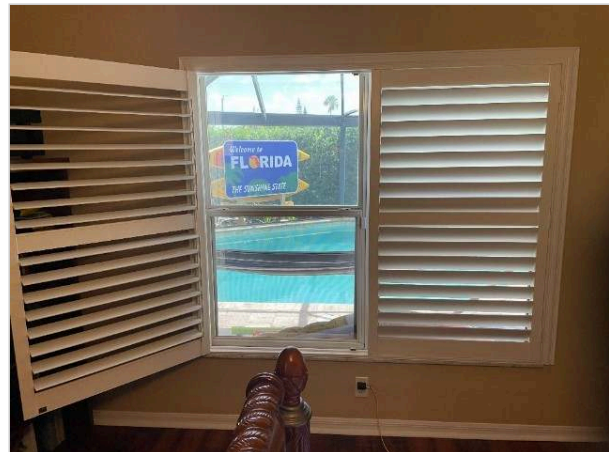
Affected primary bedroom window.

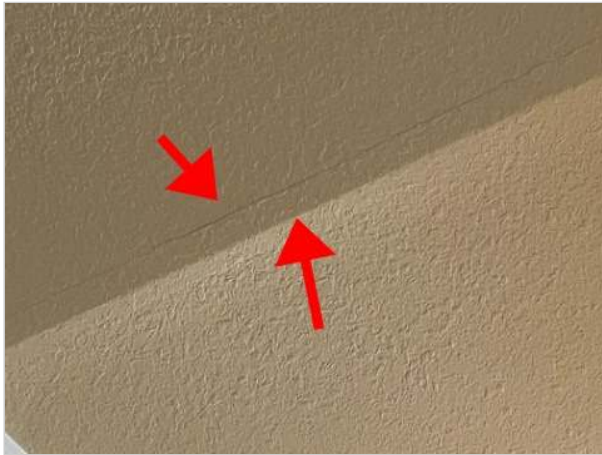
There are visible blemishes in the ceiling. These areas appear to be nail pops, drywall peeling and hairline cracks and as the structure settles more cosmetic blemishes may develop. The blemishes are considered cosmetic and do not appear to represent a condition that is in need of attention at this time. For further information, recommend questioning the seller as to the nature of the blemishes.

Drywall tape peeling in LR ceiling.

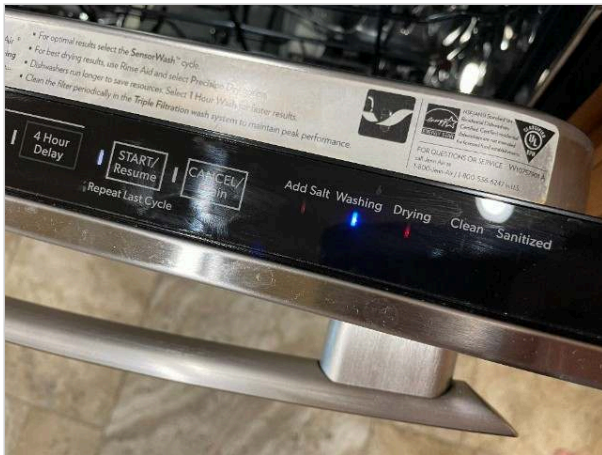
The dishwasher is not draining properly. Recommend evaluation and repair of the dishwasher drain by a qualified specialist.

Blinking lights on this model indicates problem with dishwasher.

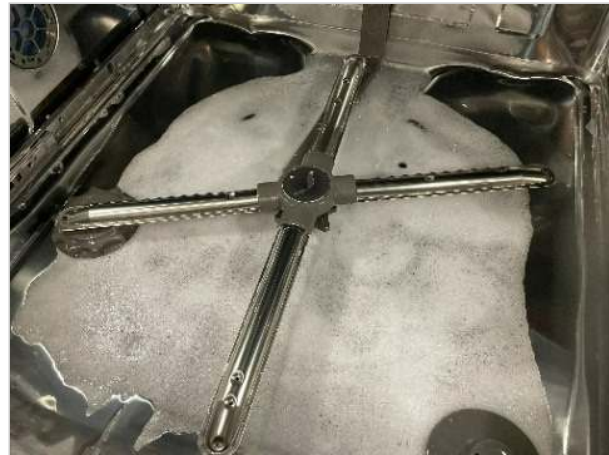
Unit not draining properly.

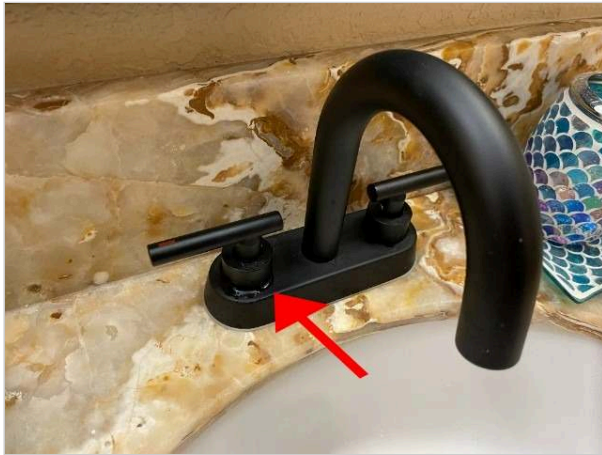
The guest bathroom sink handle leaks in the open position. Recommend evaluation and repair by a qualified specialist.

Handle leaks.

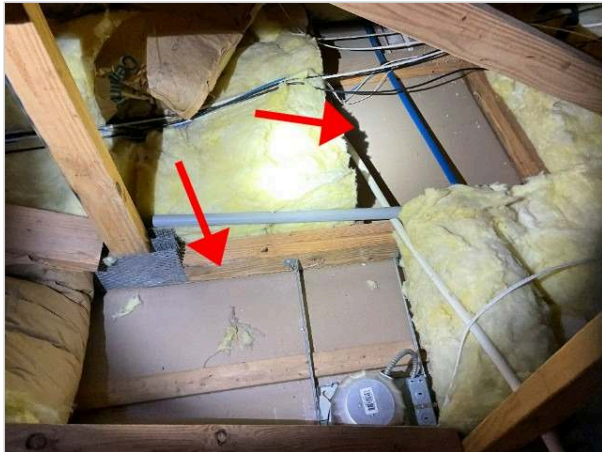
There appears to be areas in the attic space that do not have proper insulation or the insulation has been disturbed/damaged. Although most areas did have the proper insulation, the identified areas should be repaired for proper energy efficiency. Recommend repair or replacement of the insulation in the affected areas by a qualified specialist.

Missing insulation.

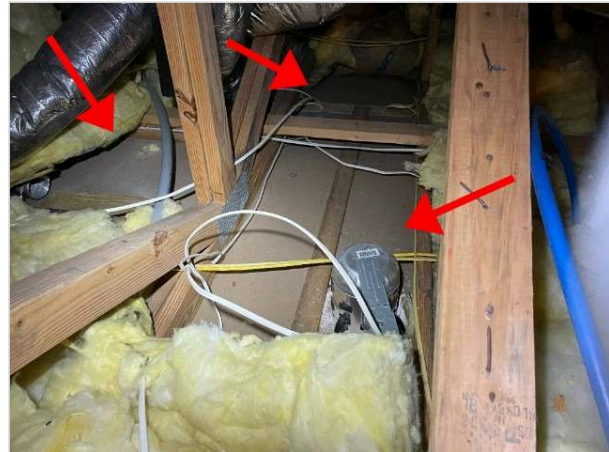
Missing insulation.

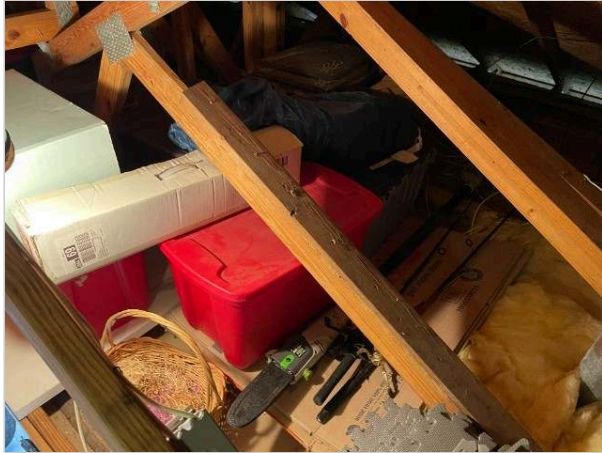
There was a significant amount of stored items in the attic that limited the inspectors ability to inspect all areas of the attic. A truss constructed attic of this type is not suitable for storage because the bottom member of a typical truss (referred to as a cord) is not designed to support a storage load. The cord is only designed for a dead load of 10 pounds per square foot. The truss will support its own weight, the gypsum ceiling below, insulation and light fixtures. It is not designed to support the weight of stored objects.

Stored items over the garage.

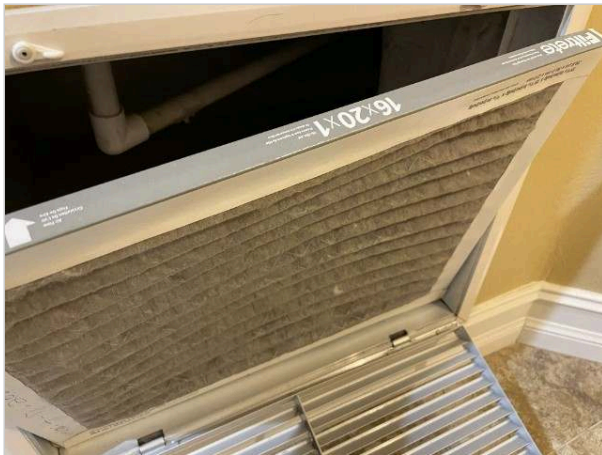
The HVAC system filter(s) dirt build up warrants replacement at this time. Recommend changing or cleaning the filter(s) every 90 days or per manufacturer recommendation.

Filter is dirty.

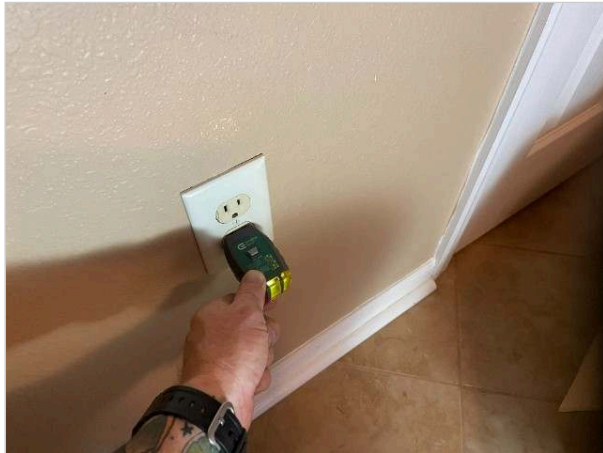
There are one or more outlets that are damaged, loose or not functional. This condition could lead to electrical shock. Recommend evaluation and repair by a licensed electrician.

Loose outlet in primary bedroom West wall.

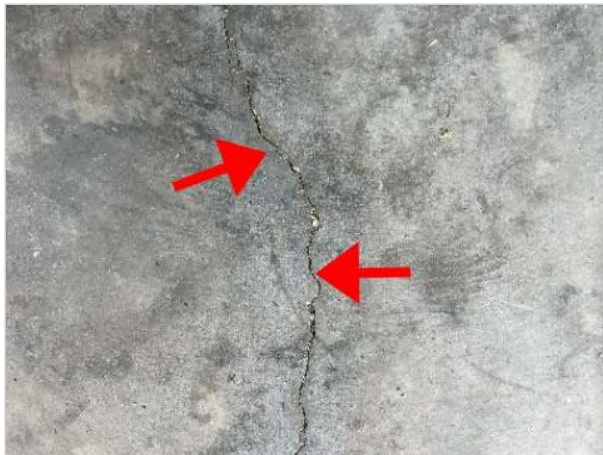
The concrete floor has minor cracks. All concrete is subject to cracks and chips, this is a natural part of the process of settling. Recommend monitoring and application of an epoxy sealant or concrete caulking.

Minor crack in garage floor.
