**Property Address:** 157 Lucille Ave, Elmont, NY 11003

Extended Full Home Inspection

**Service Date:** 10/26/2023

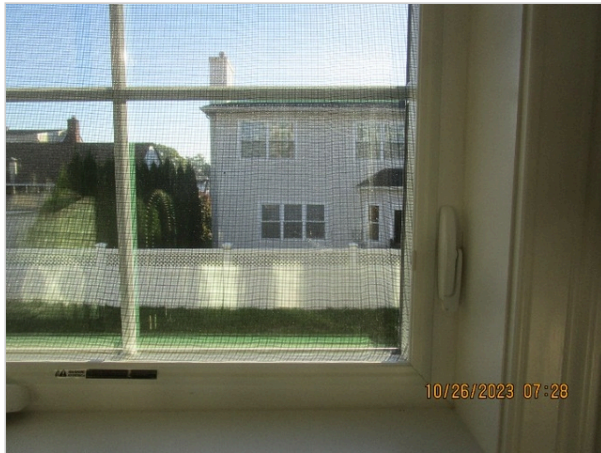
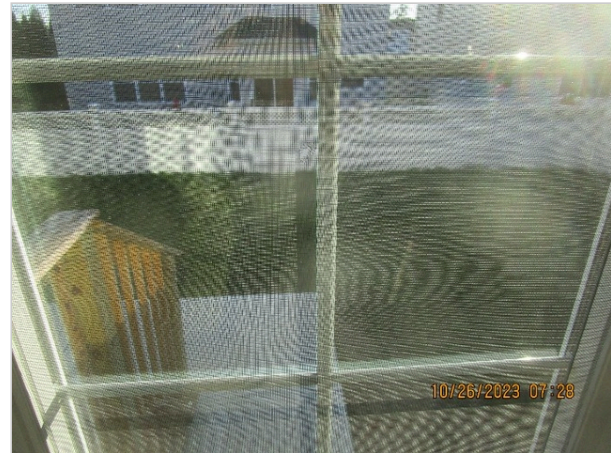
## 1. Exterior Structure - Window Screens

There are two window screens that are torn and need to be replaced.

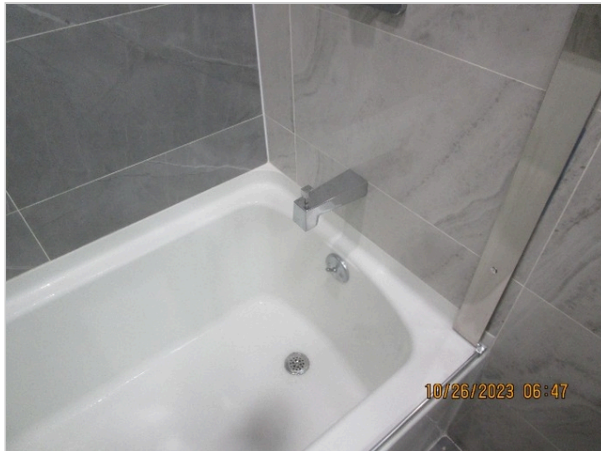
## 2. Structure - Bathroom(s)

The second floor hallway bathroom stopper was not functioning at the time of the inspection.

*The second floor hallway bathroom stopper was not functioning at the time of the inspection.*

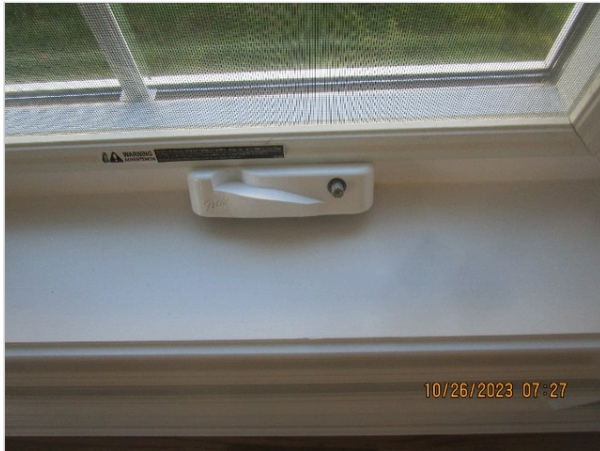
## 3. Structure - Windows, Latches/Locks

There was one handle missing at the time of the inspection.

*There was one handle missing at the time of the inspection.*

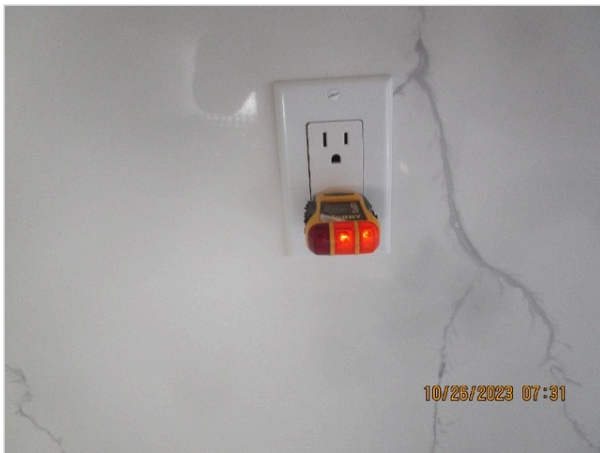
#### 4. Electrical Service - G.F.C.I. Protection

At the time of the inspection there needs to be a GFCI installed in the kitchen. A licensed expert should be brought in to make the necessary modifications.

*At the time of the inspection there needs to be a GFCI installed in the kitchen. A licensed expert should be brought in to make the necessary modifications.*

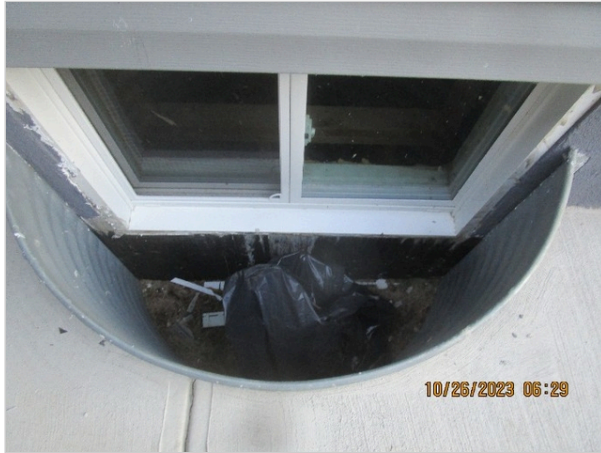
## 12. Window Wells

Need cleaning

Plant debris should be cleared out of the window wells. The inspector recommends gravel be placed in the window well to help with drainage.

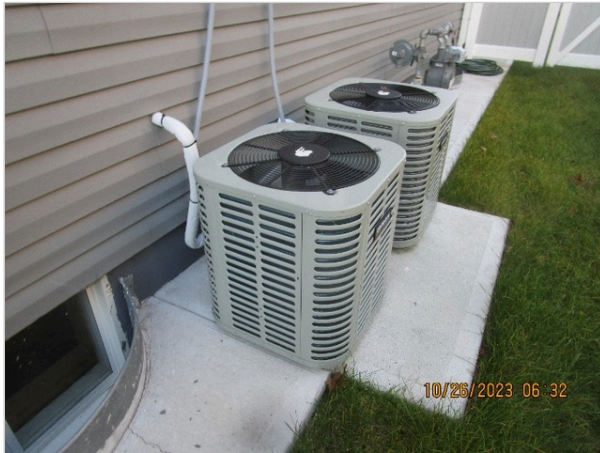
The manufactures date of the unit is 2022. The life expectancy of a unit is 15-20 years.

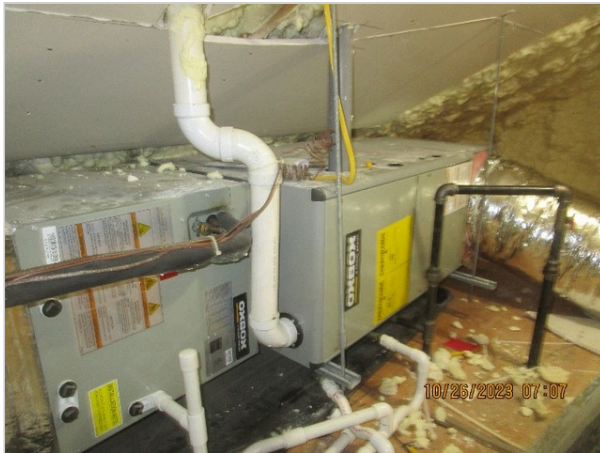
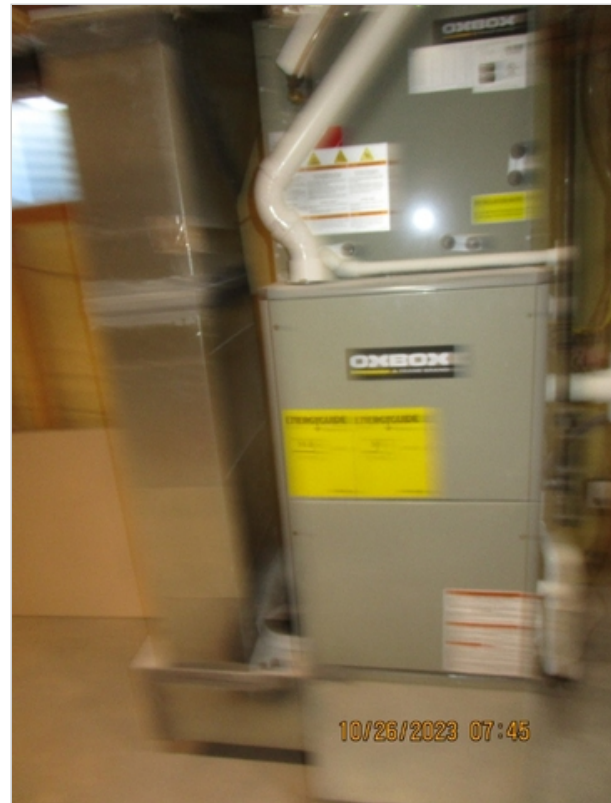
There was one unit in the attic and one unit in the basement.

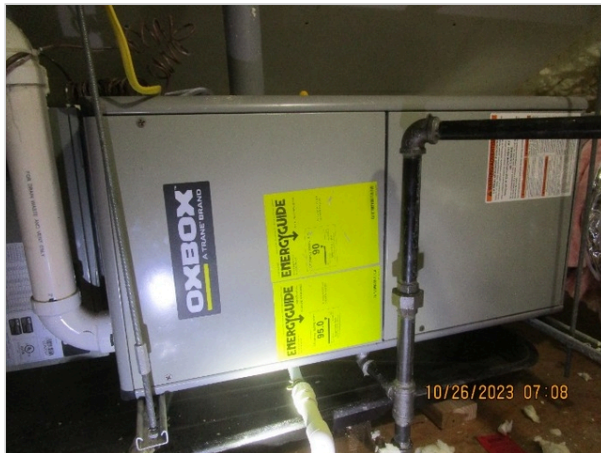
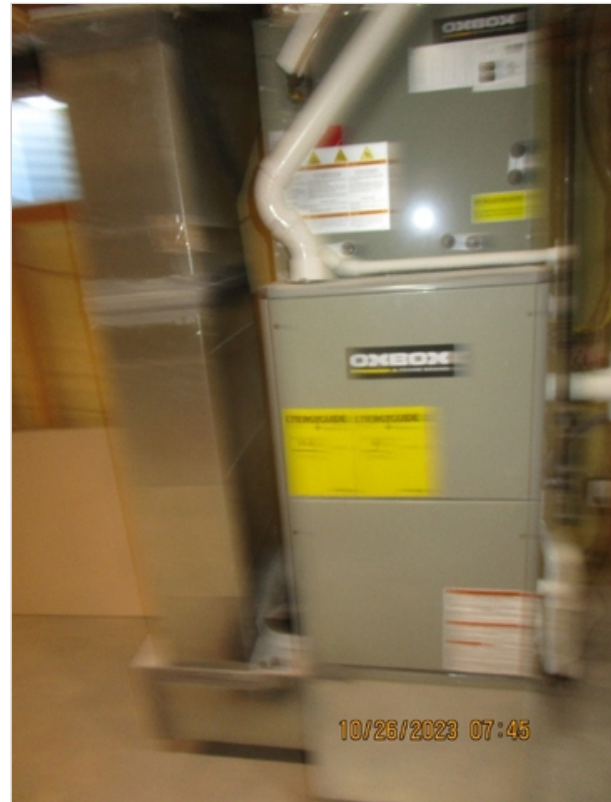
There was a unit in the basement and the attic.

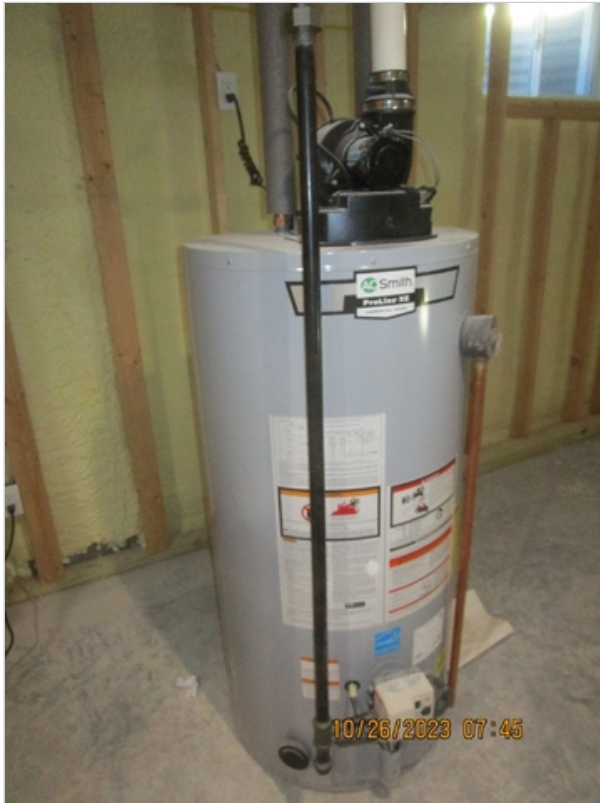
The date of installation, as shown on the installation sticker, read 2022. The life expectancy of a water heater is typically 10-12 years from the date of installation, although there are exceptions on both sides.

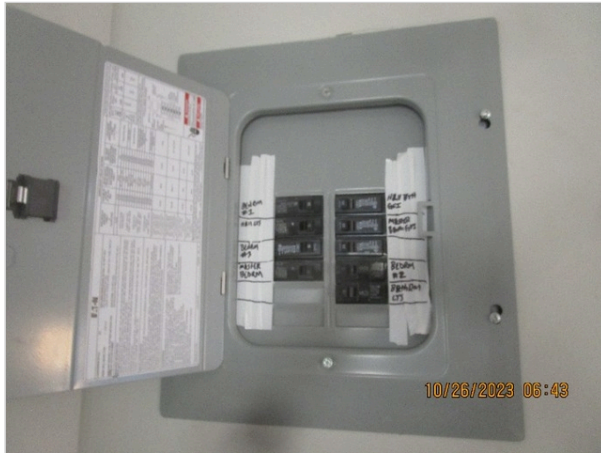
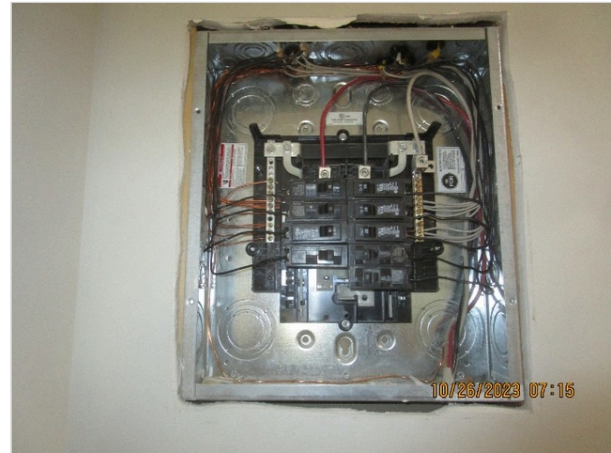
There was a sub-panel in the hallway. The inspector removed the cover to inspect the sub panel.

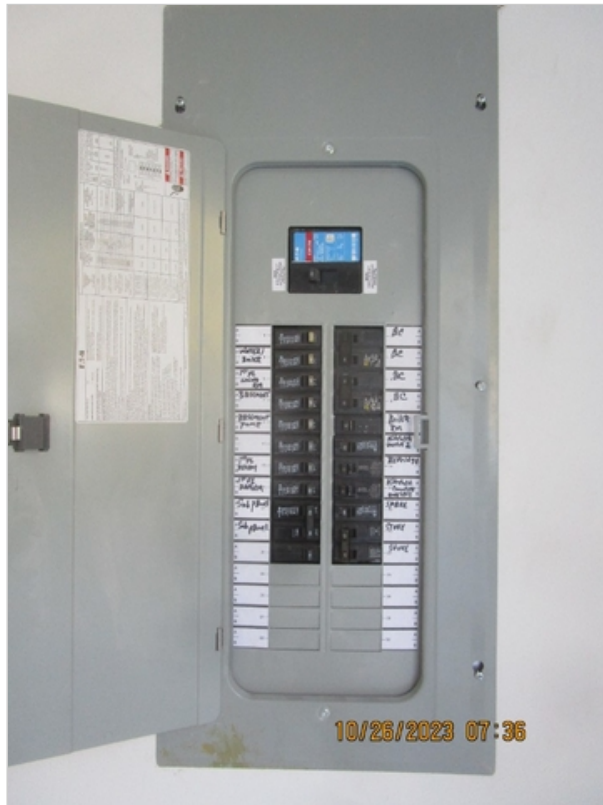
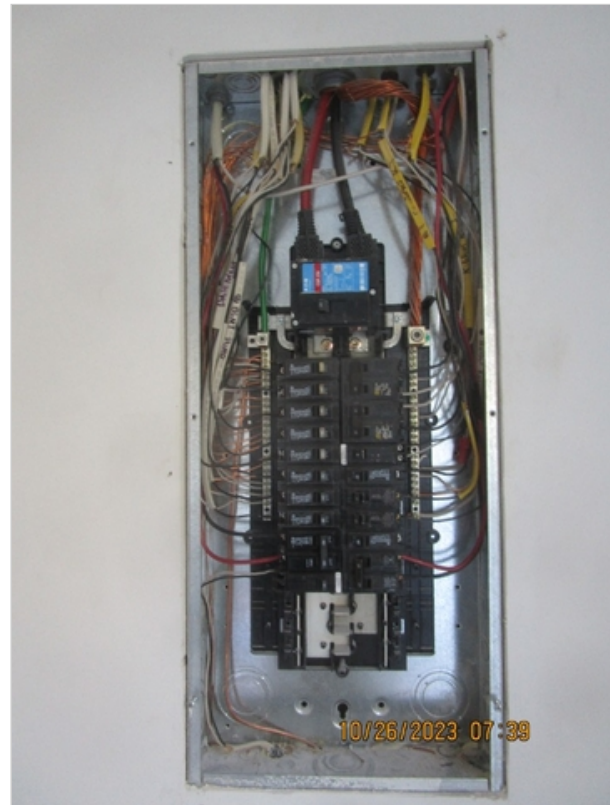
The cover was removed at the time of the inspection.
