Gopherwood Ventures

12/2/2023

TREC Inspection - Amarillo

# PROPERTY INSPECTION REPORT FORM

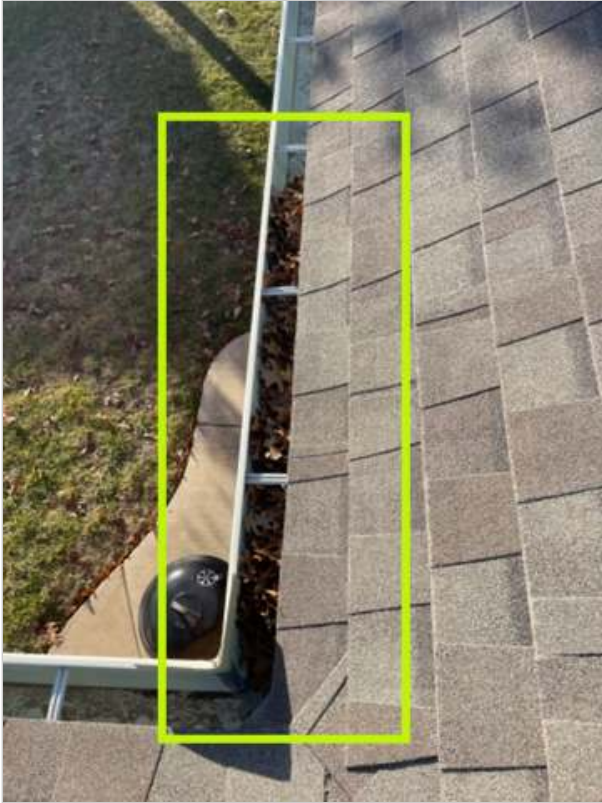
\*\*\* Leaves and debris were observed in the rain gutters which limits the flow of water. Recommend cleaning the rain gutters and verify water is flowing freely in the rain gutters. Regular cleaning of the rain gutters is encouraged.

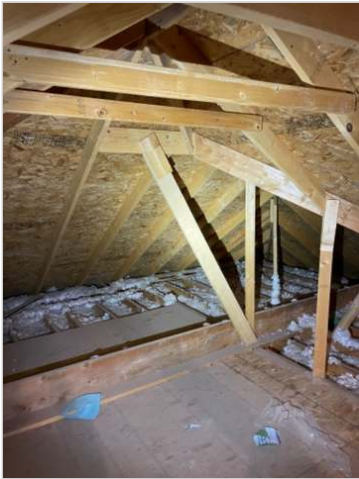
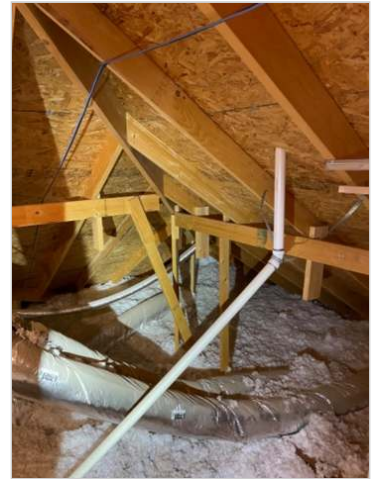
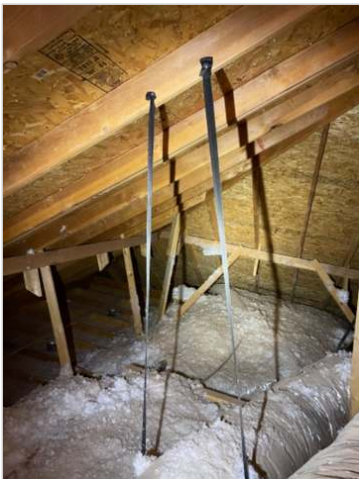
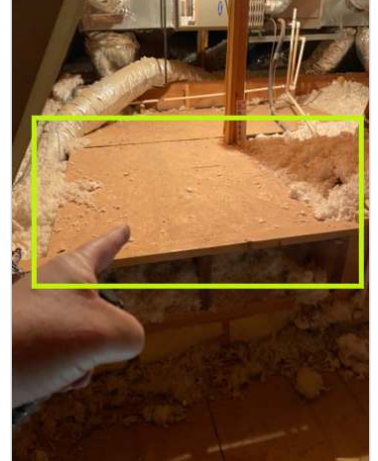
Thin service decking

Condition of service decking: \*\*\* One section of thin service decking that flexed. Recommend adding another layer of decking material and/or providing additional support.

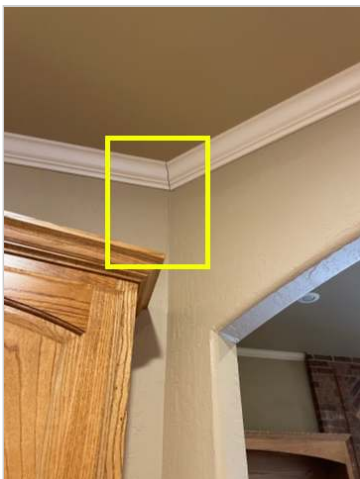
Kitchen

- Minor cracking in drywall material - kitchen

\*\*\* Gaps between cabinets and walls - kitchen, butler pantry, master bathroom

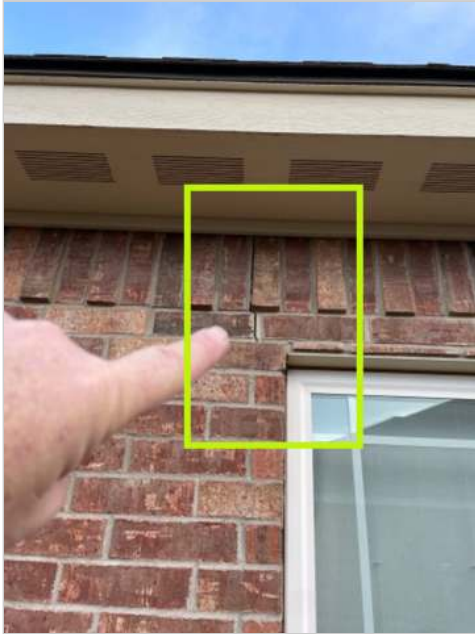
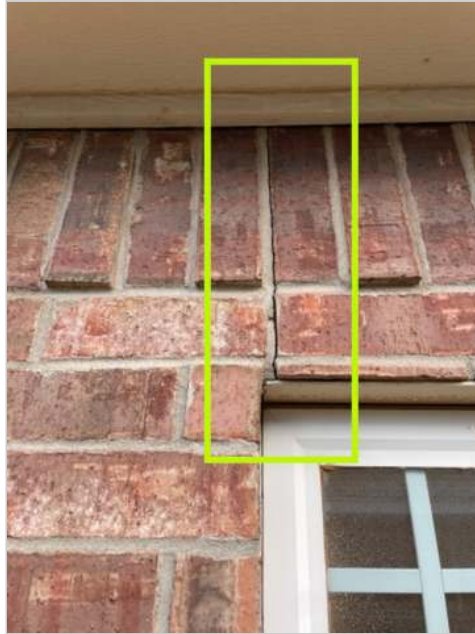
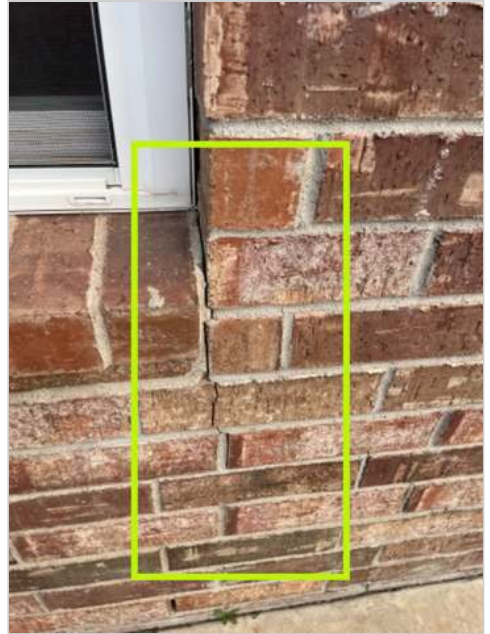
\*\*\*Larger cracking in the brick veneer. - west side above a window

- Minor cracking in the brick veneer mortar which was not a structural concern. A few sample pictures follow.

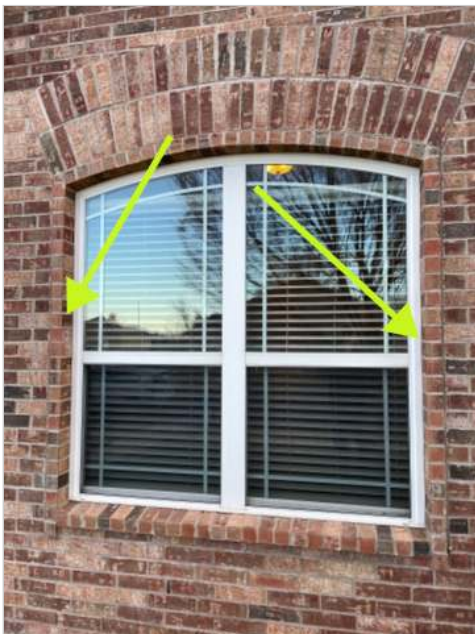
\*\*\*Missing caulk between the brick veneer and the window frames. Recommend caulking. A couple of example pictures follow.

Missing caulk

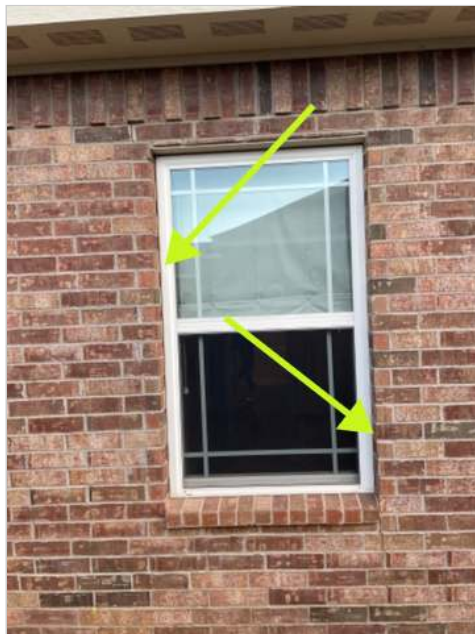
Missing caulk

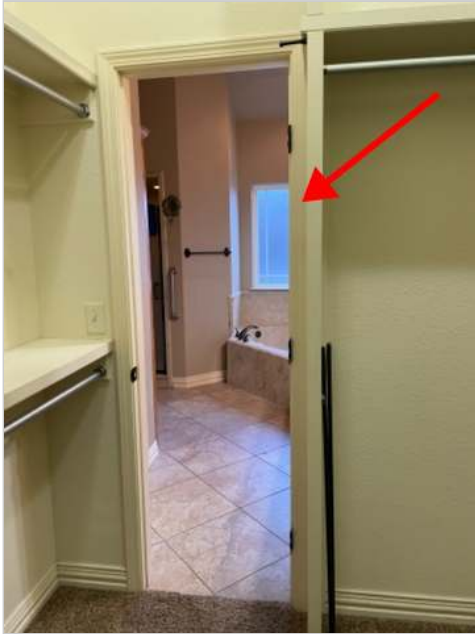
Master closet

\*\*\*Missing doors - master closet

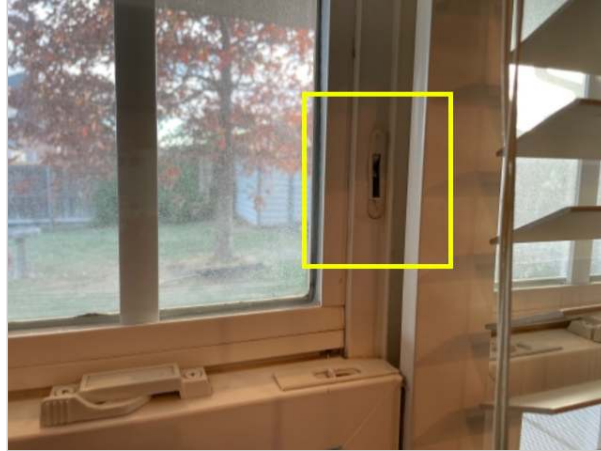
\*\*\*Broken safety latch at east master bedroom window.

Broken safety latch

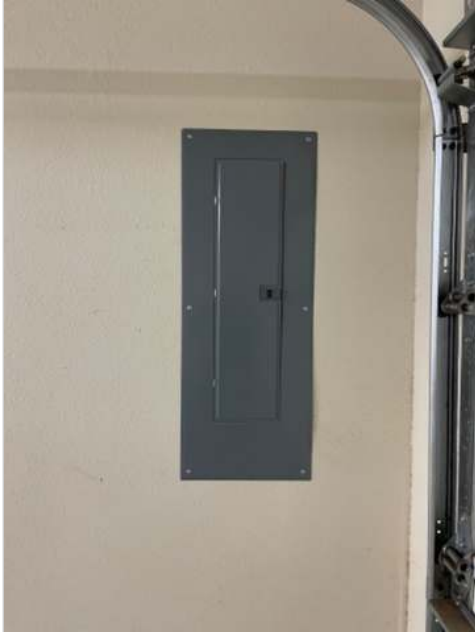
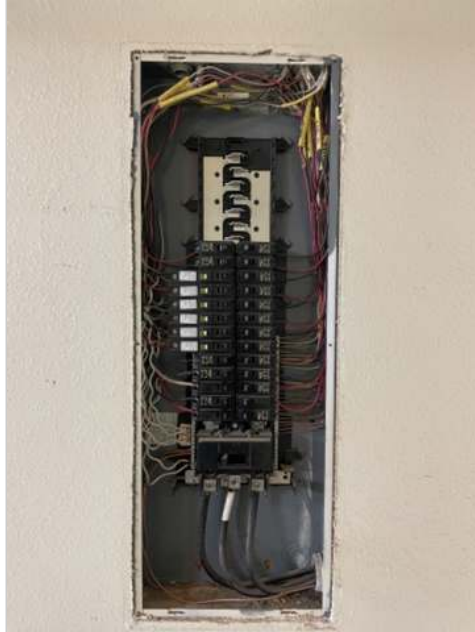
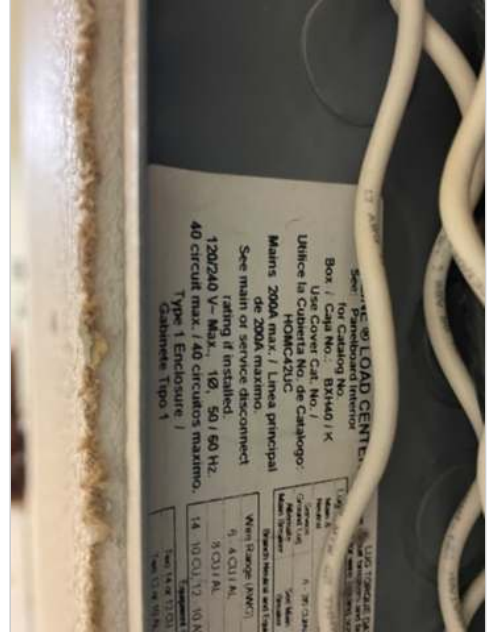
Is the service panel labeled: \*\*\* No. Fully labeled panels are recommended.

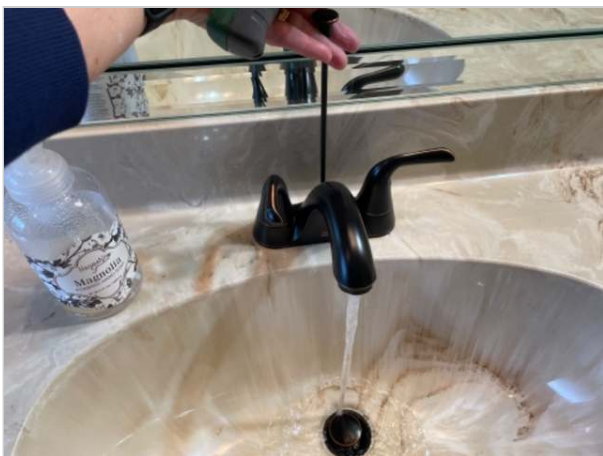
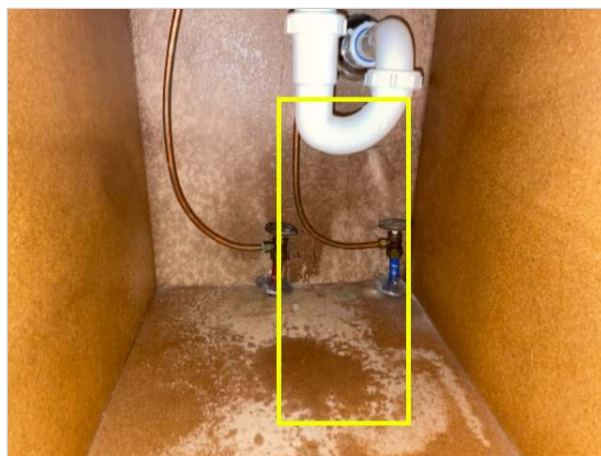
\*\*\*Leak at drain pipe - Jack and Jill lavatory

Leak

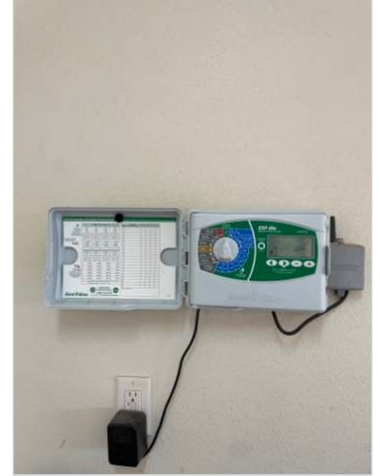
Zone 1 - not working

\*\*\* Recommend further evaluation and repair as needed.
