Property Address: 506 Madison Ave, Brentwood, NY 11717

Inspector: Santo Guinta
Company: Brookhaven Home Inspections, LLC
dba WIN Home Inspection Long Island
(631) 874-0011
wininspection.santo@gmail.com

Standard Full Home Inspection

Work Order Number: 022121SG

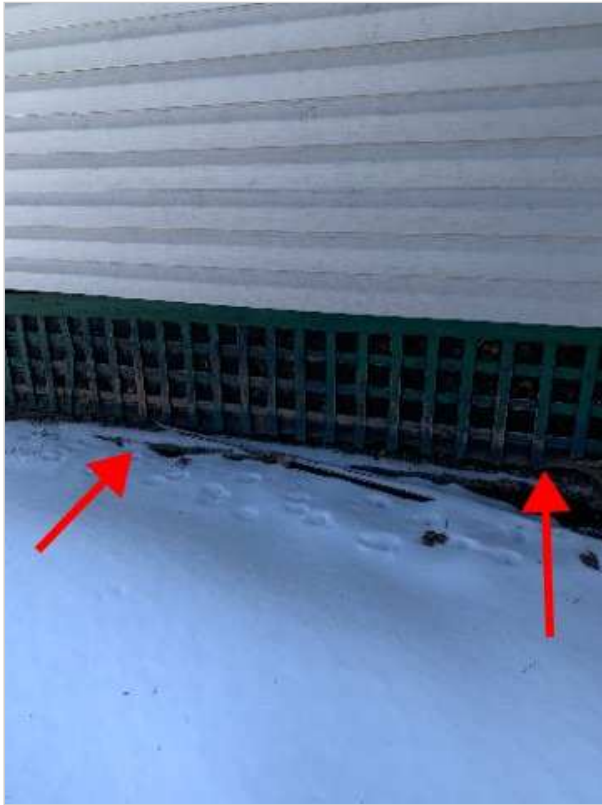
back of house left side

The inspection has revealed earth to wood contact around the perimeter of the structure. There should be no contact between the earth and the exterior wood members to prevent wood deterioration and a conducive condition for pest infestation. The inspector recommends providing at least 4-6 inches of clearance between the earth and wood material as a preventive maintenance measure.

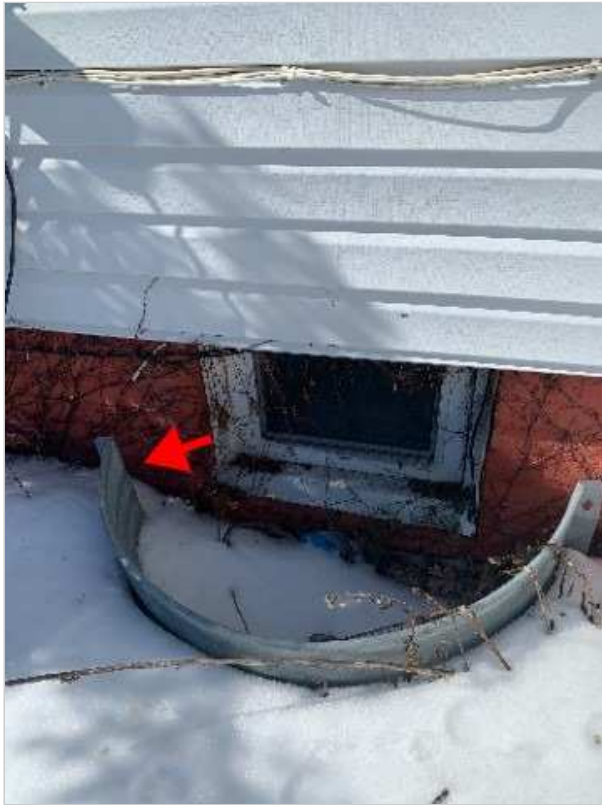
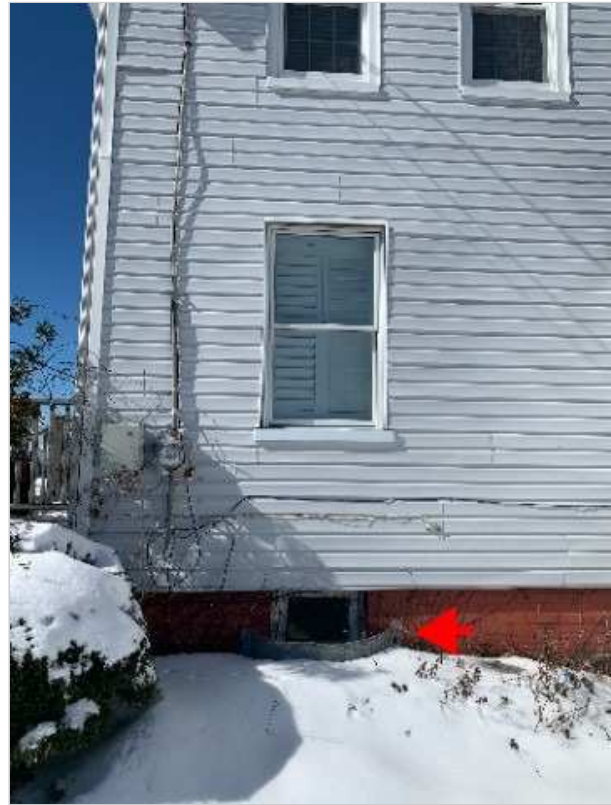
3. Structure Perimeter Exterior - Window Wells

window wells are installed but are pulling away from fondation

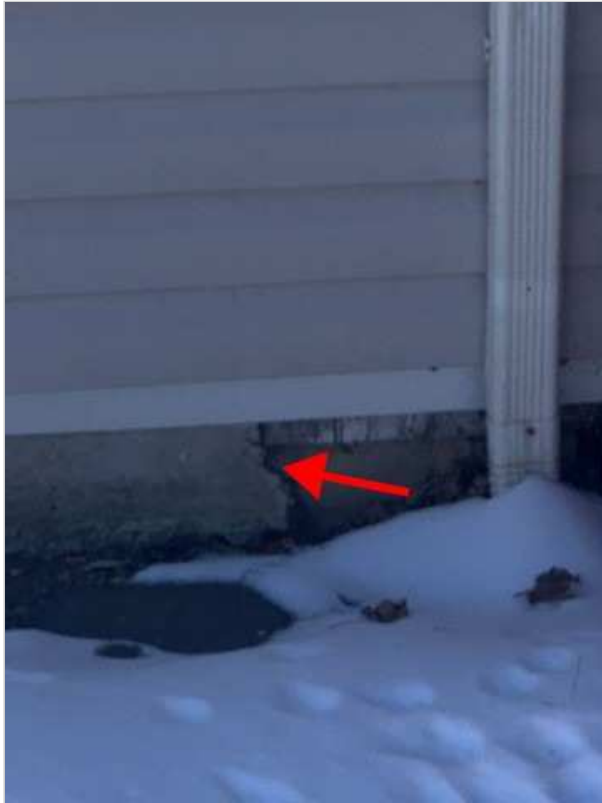
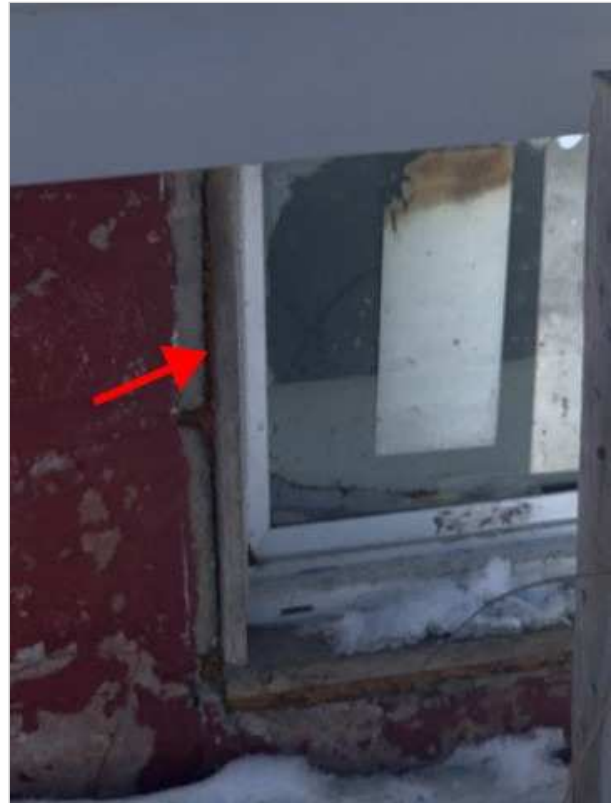
4. Structure Perimeter Exterior - Visible Cracks

Visible cracks were noted along the foundation. Some are due to settlement and normal curing process of concrete. Recommend a contractor evaluate and repair.

recommend contractor repair

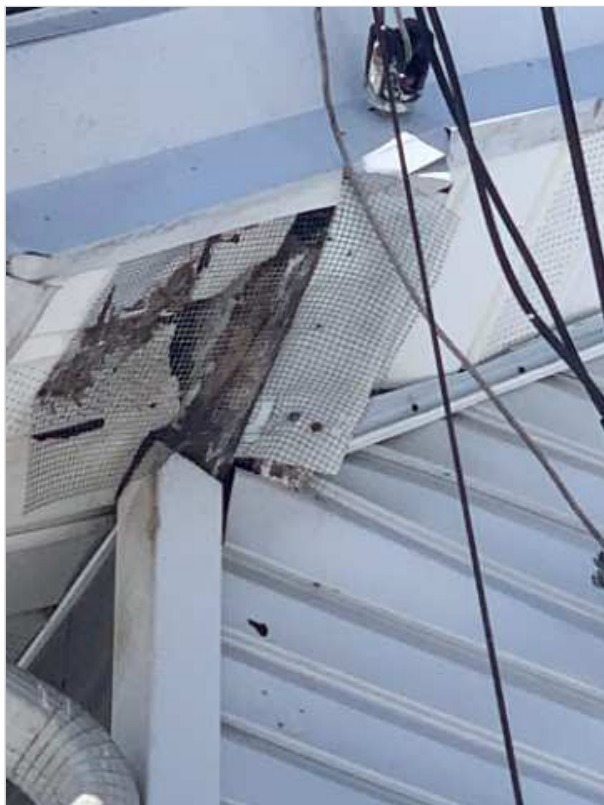
front rt under gutter screens installed to keep out rodents recommend asking seller about problem

hole next to electrical box shows rodent tunnel

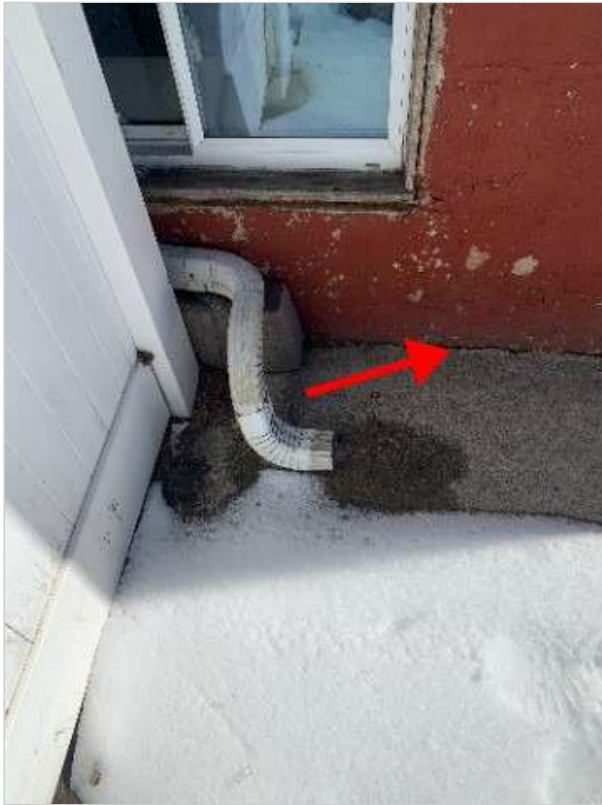
rt side

There was a crack with about a 1/4 inch in size. Recommend having the crack patched and sealed as well as any others along the walls and floor. Recommend questioning the seller on any related issues. Suggest contacting a contractor for estimates and evaluation of repair.

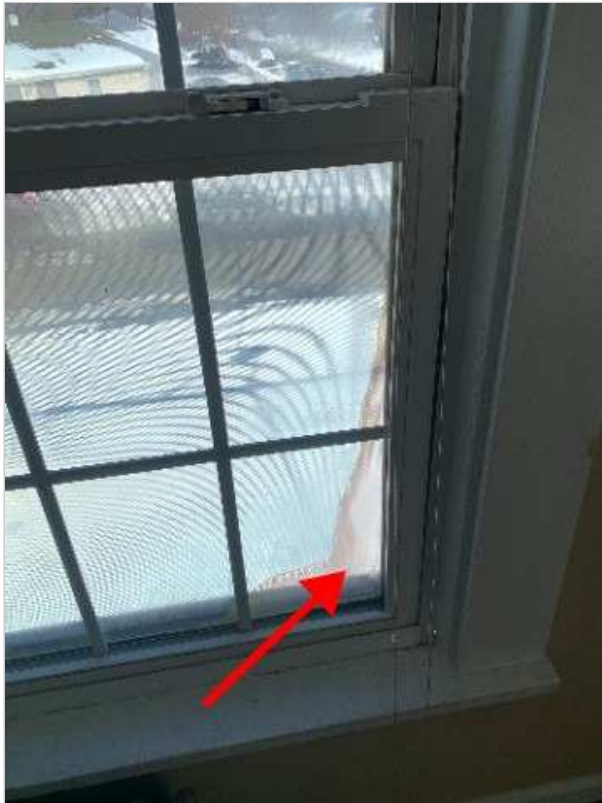
left front bedroom

The inspection has identified a double pane insulating window that has lost its vacuum seal between the panes of glass. The condition is identified by signs of fogging or condensation build up in between the glass panes. This condition will reduce visibility out of the window over time. The condition reduces the insulating value only slightly. Replacing the window glass may be considered at some time in the future as the visibility out the window reduces.

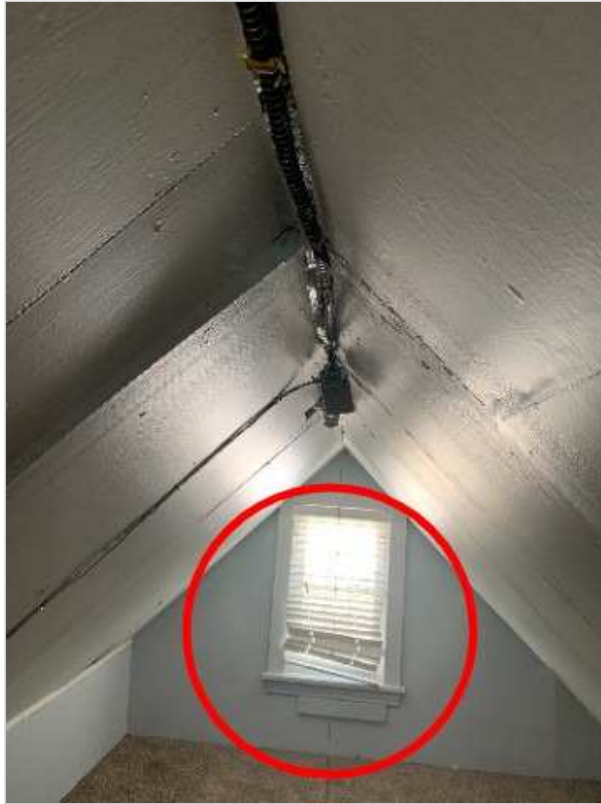
Many windows through out the house do not stay raised in place. It appears that the sash cords are in need of replacement/repair. Contacting the window manufacturer is recommended.

does not stay raised

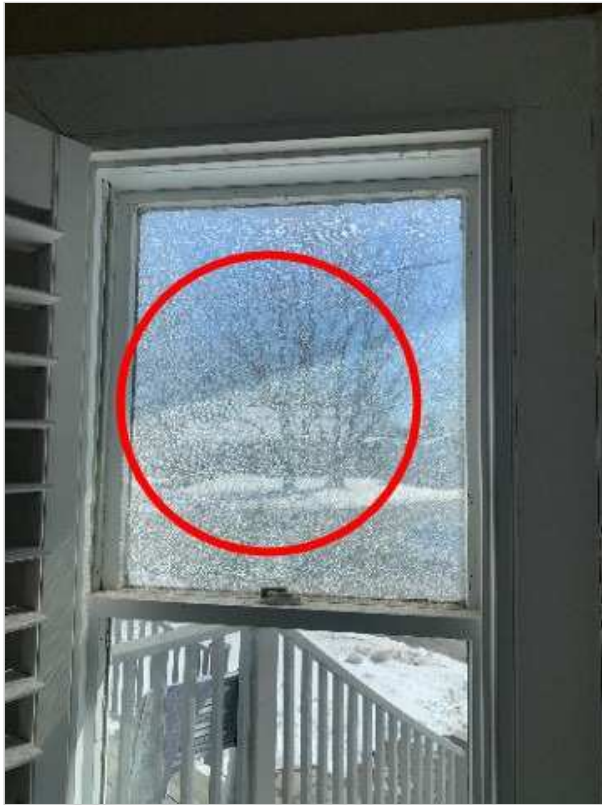
front left

There is a window that has a crack in the glass. Consideration may be given to repairing at this time.

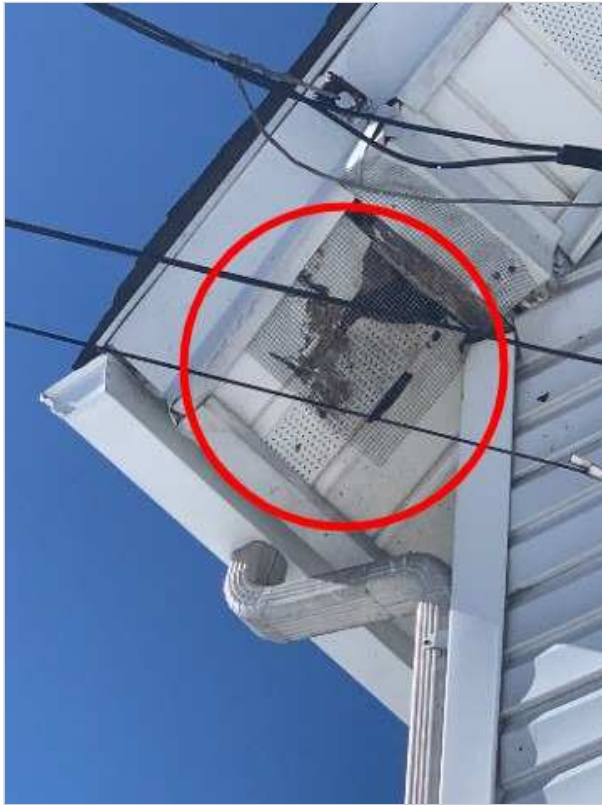
soffit rt front

The inspector has noted a wood deterioration on the eave/soffit areas around the structure. Recommend repairing as required.

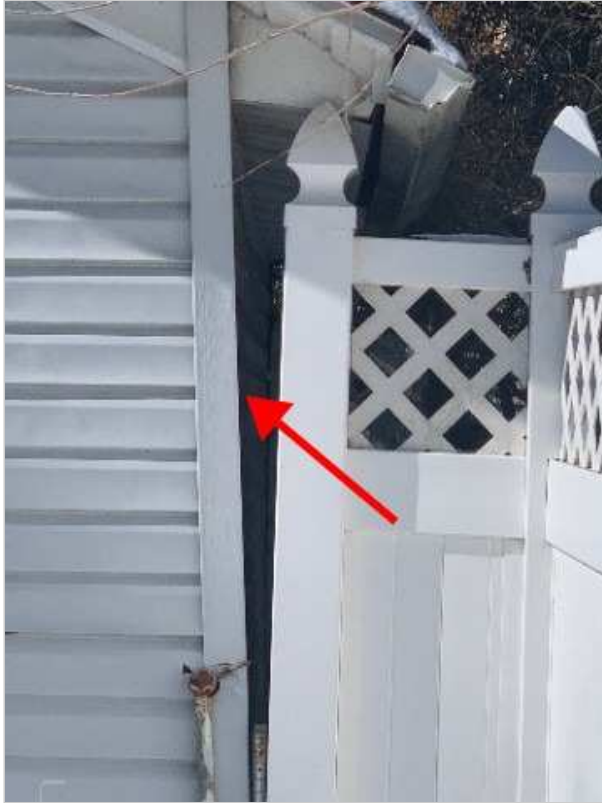
the garage structure leans to left and is loaded with a lot of storage recommend contractor evaluate

post is straight garage leans left

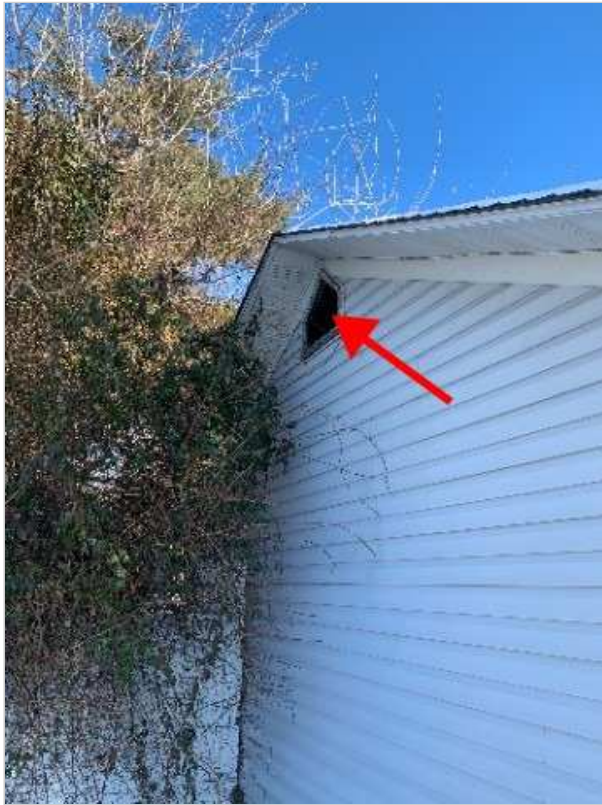
missing window back lets rain snow rodents in recommended install

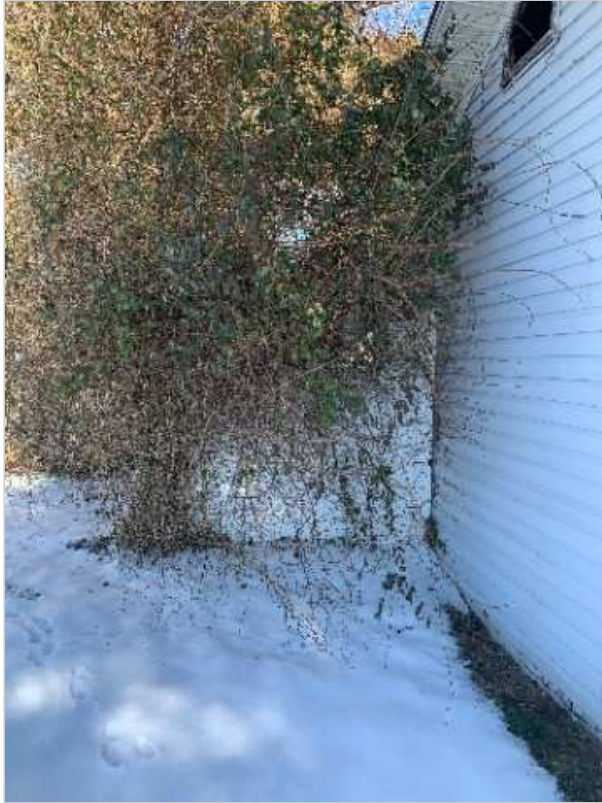
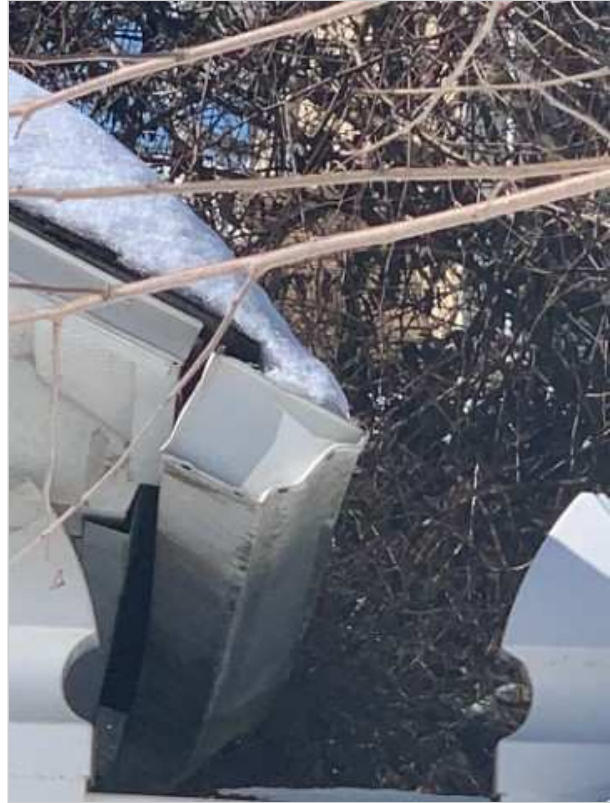
12. Detached Garage - Vegetation Clear From Structure

There is vegetation growing up against the exterior surface material. All vegetation should be trimmed at least 6-12 inches away from the structure to eliminate a common avenue for pest infestation and damage to the exterior structure material as well as limiting the view of the home. It is recommended that any over-hanging tree branches be trimmed.

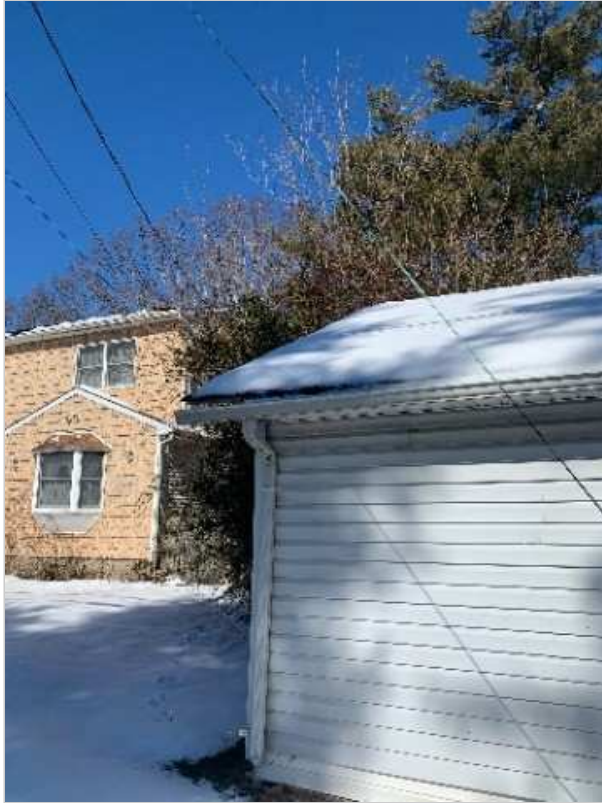
13. Detached Garage - Roof Condition

roof covered with snow recommend roofer evaluate

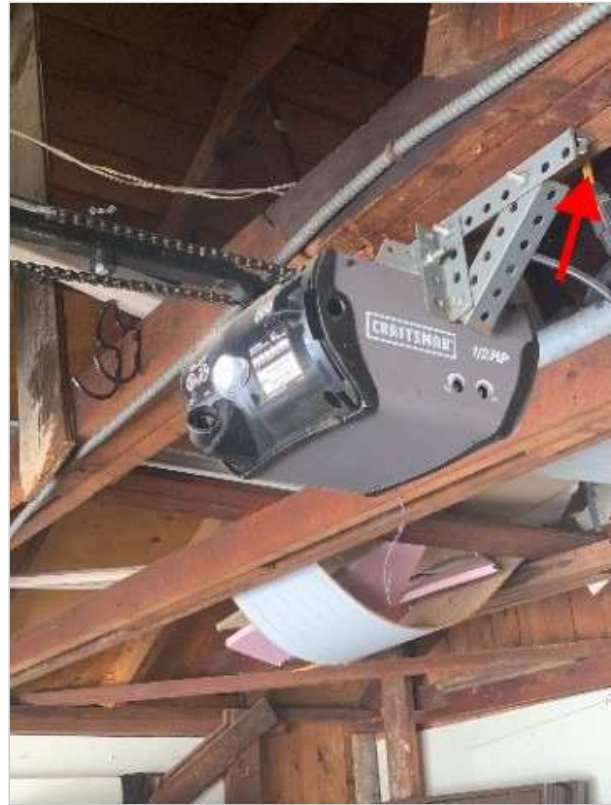
garage opener should have its own electrical outlet not extension cord for power

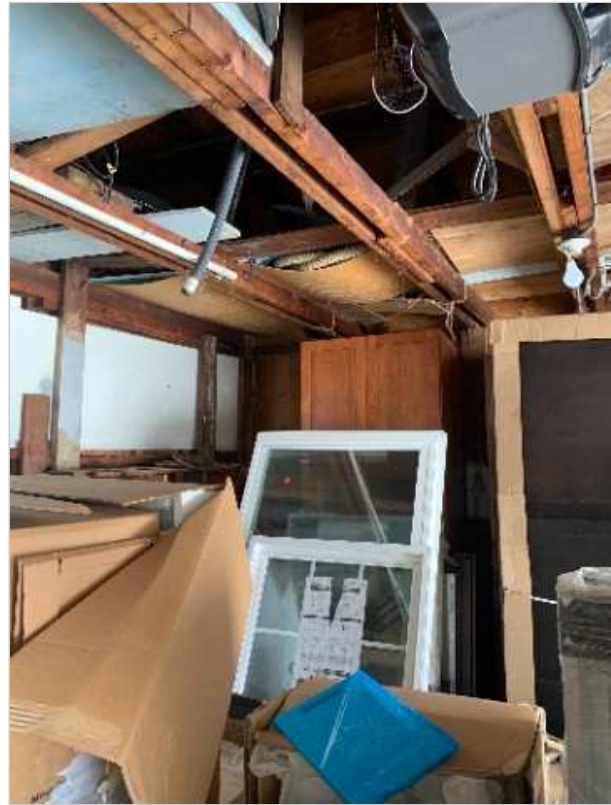
17. Detached Garage - Floor/Foundation

The accessible areas of the garage floor appeared to be functional at the time of the inspection. There were many areas that were inaccessible to inspection due to the large amount of stored items in the garage (cluttered condition). A condition may exist that was not visible at the time of the inspection. Reinspecting the garage area is recommended as issues may become visible once the structure is vacated.

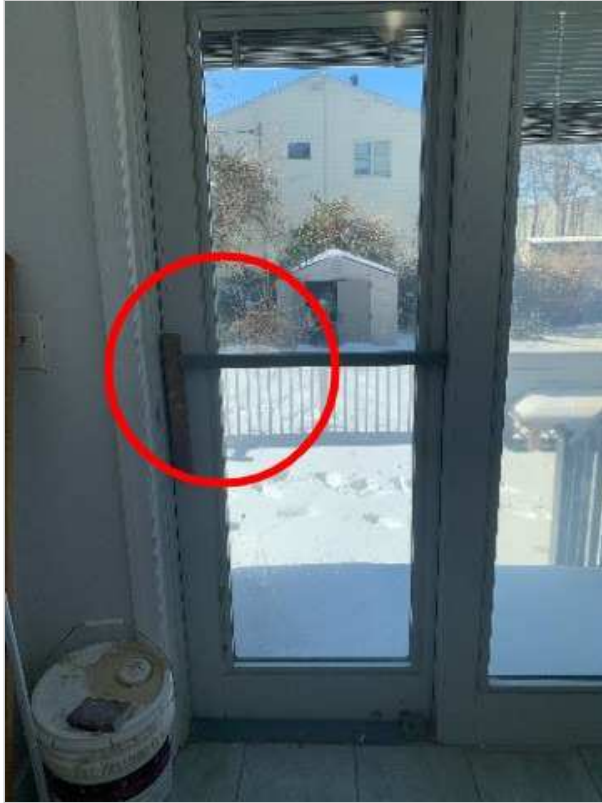
no locks and door handle installed recommend contractor install

no locks or handle

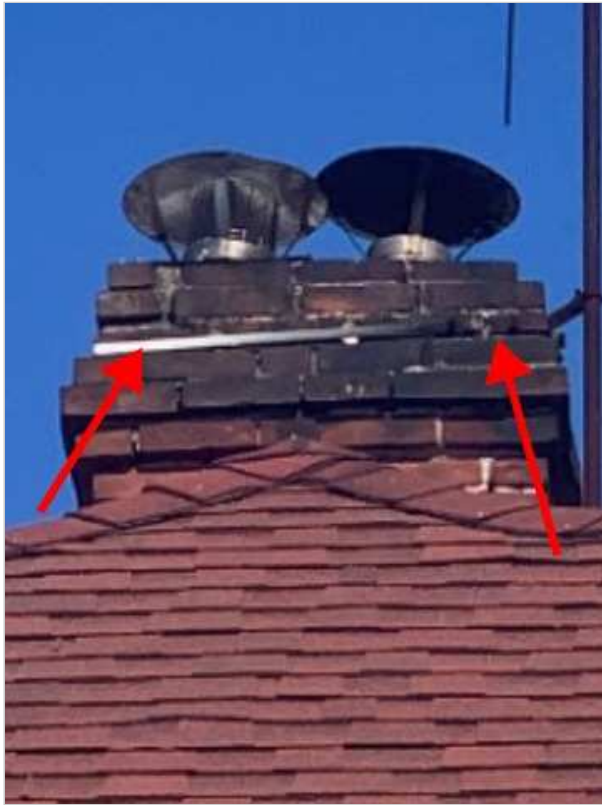
21. Roof - Vents/Chimneys/Covers

the brick work around chimney need to be repaired recommend mason to evaluate and repair

covers too close to each other recommend repair

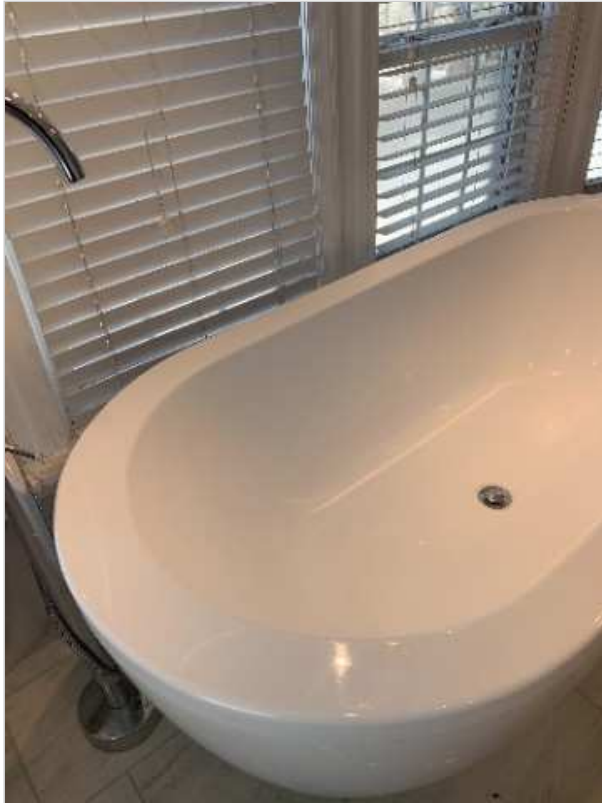
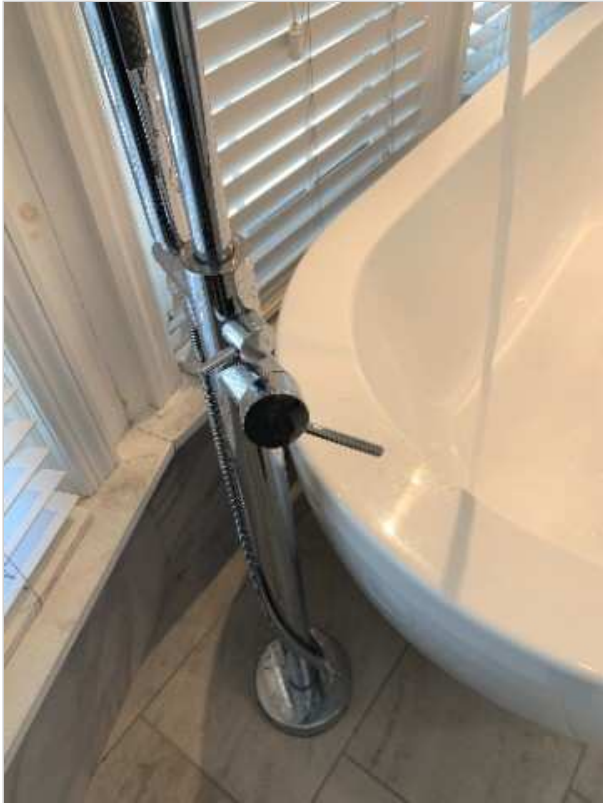
master tub and faucet not installed properly recommend plumber evaluate and repair

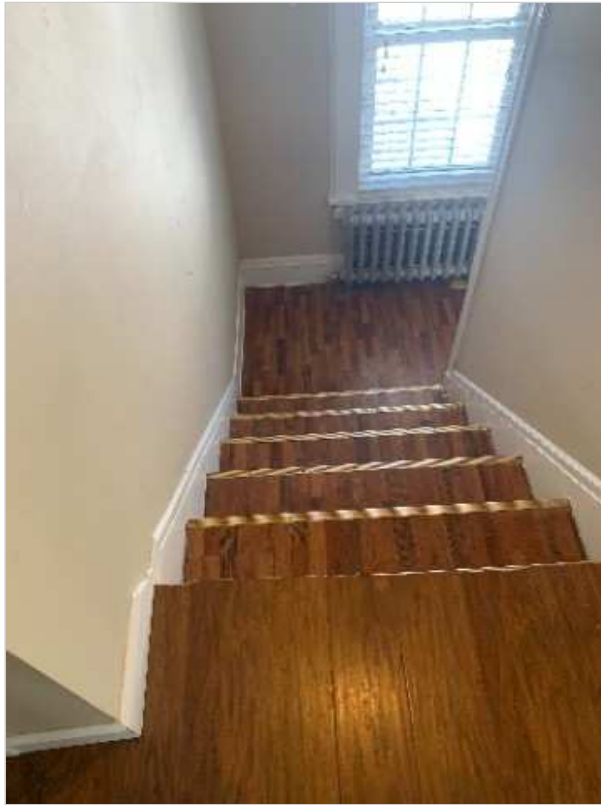
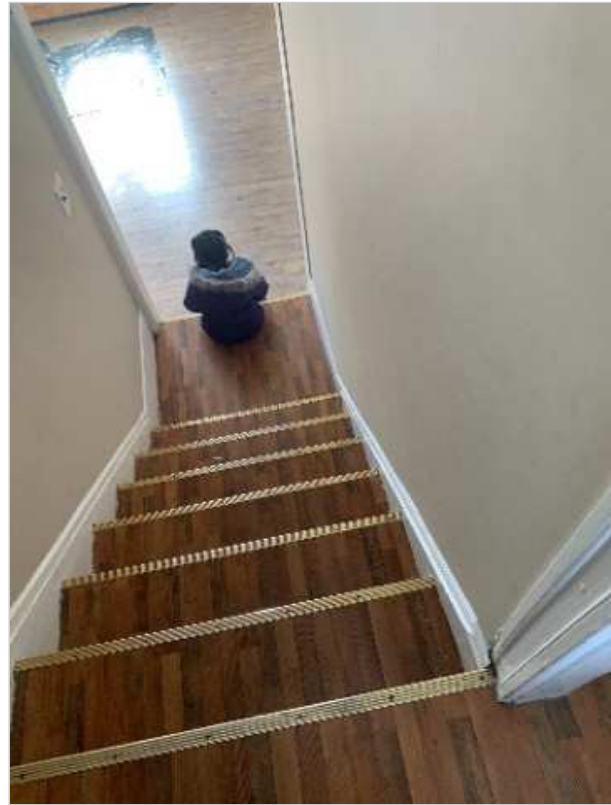
23. Structure - Interior Stairway Structure

There is no stairway banister, recommend installing to provide safe use of the stairs.

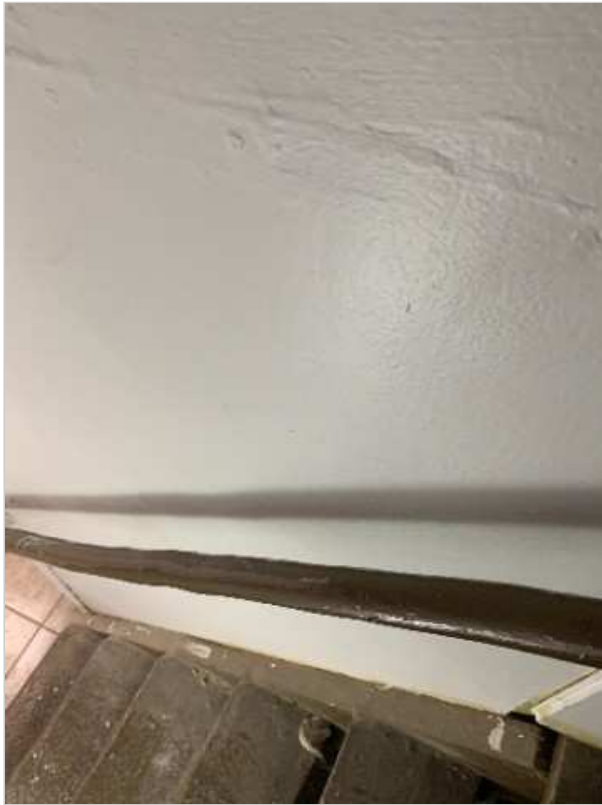
stairway to attic

The stairway banister is loose and should be resecured to provide safe use.

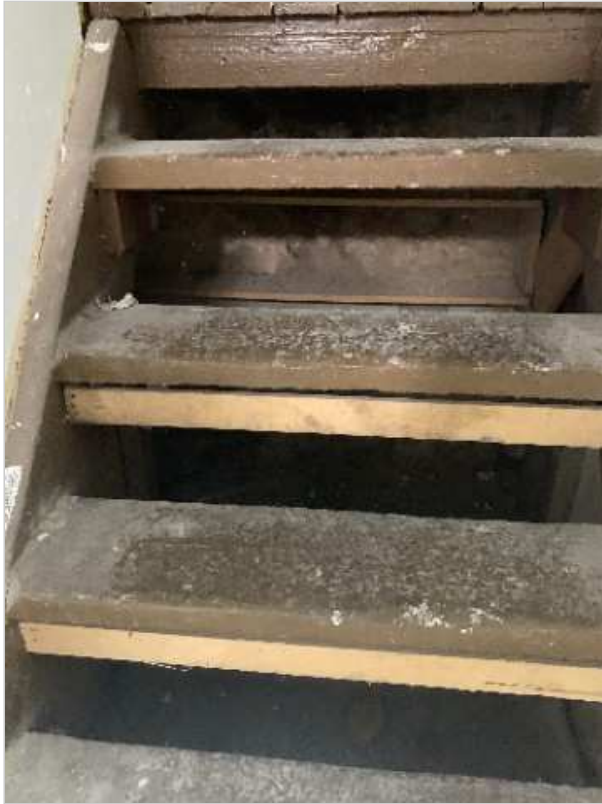
second set of stairs to basement are narrow and have no back plate recommend contractor evaluate

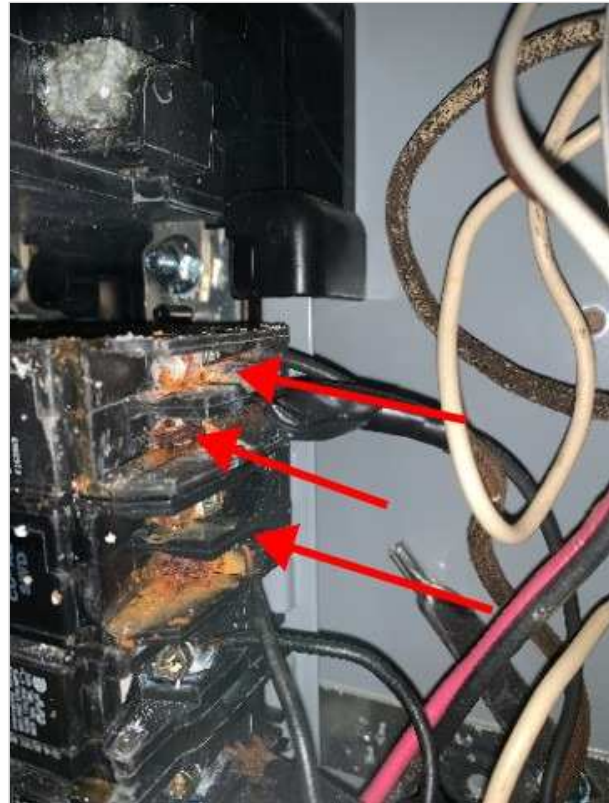
24. Electrical Service - Panel Cover(s) Removed

inside panel shows moisture recommend electrician evaluate

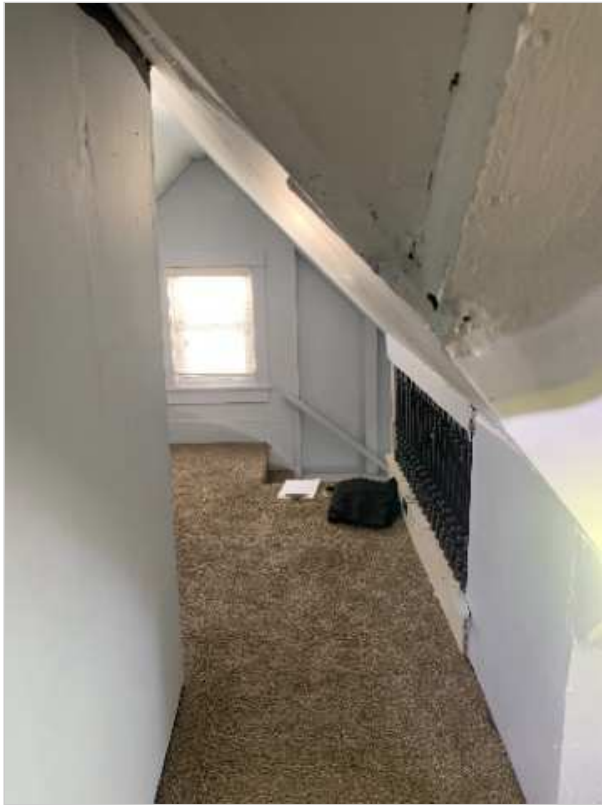
basement attic

no heat in finished attic

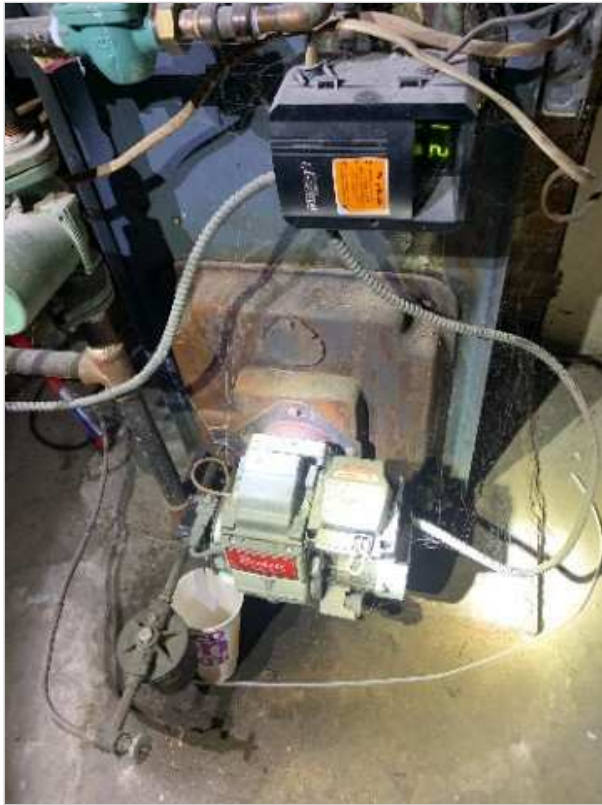
28. Heating System - Service Notes/Filter Size

There does not appear to be any visible posted service notes attached to heating unit. The inspector recommends questioning the seller to see if it has been serviced and if not then a qualified technician perform a service cleaning, tune-up, full unit evaluation and a review of the entire unit. Heating units need annual service and cleaning as a health and safety consideration. Service/evaluation s recommend evaluation for possible replacement

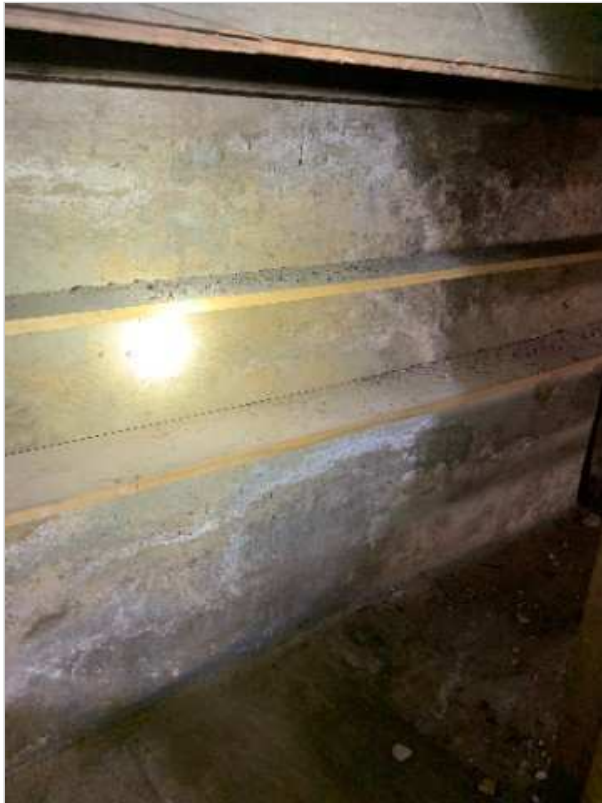
behind basement stairs

There was efflorescent visible along the perimeter foundation wall. Efflorescence is an indication of small amounts of moisture penetration through the concrete foundation. Correcting the grading, vegetation next to the foundation, redirecting any/all sprinklers away from the structure, and installing splash blocks at the downspouts will help in this area. Sealing the floor/walls with Drylock and adding a dehumidifier is also recommended. Also install a water sensor alarm. [Click for an alarm option](#) Monitoring this area during a heavy rainfall periods is recommended. Also recommend questioning the seller about any past issues.

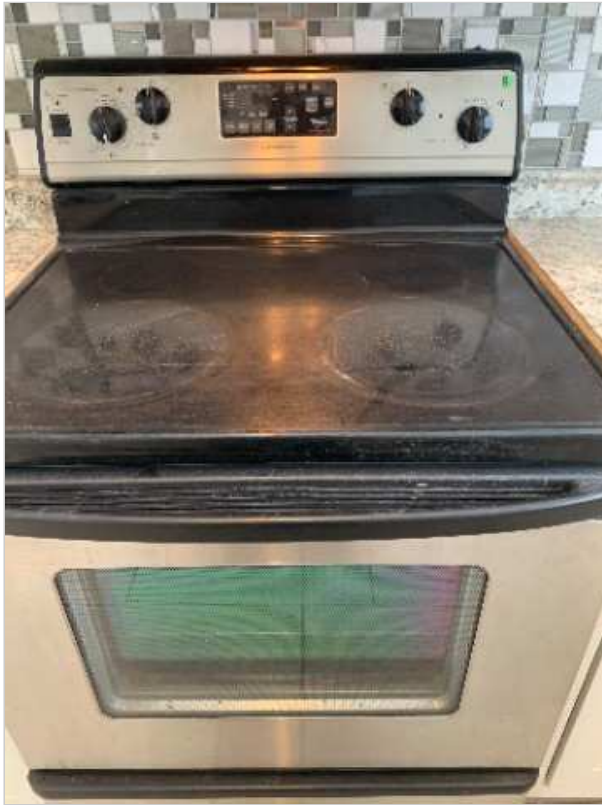
The unit was only operated as an on/off run. The stove top burners functioned oven could not be tested door was locked Recommend having repaired and obtaining the manufacturers manual on daily operations. This is not a guarantee/warranty on all settings.

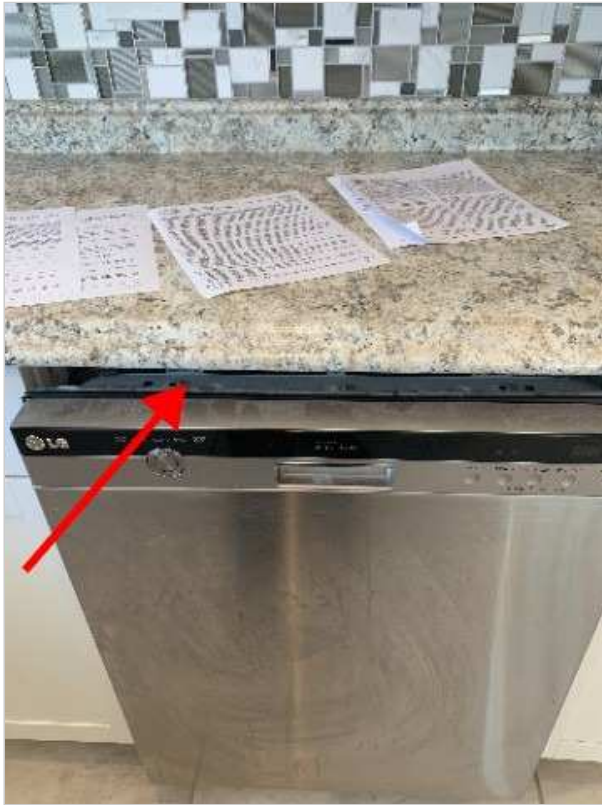
The dishwasher was not found to be functional at the time of inspection. Recommend having an appliance technician evaluate and repair/replace as needed.

not mounted

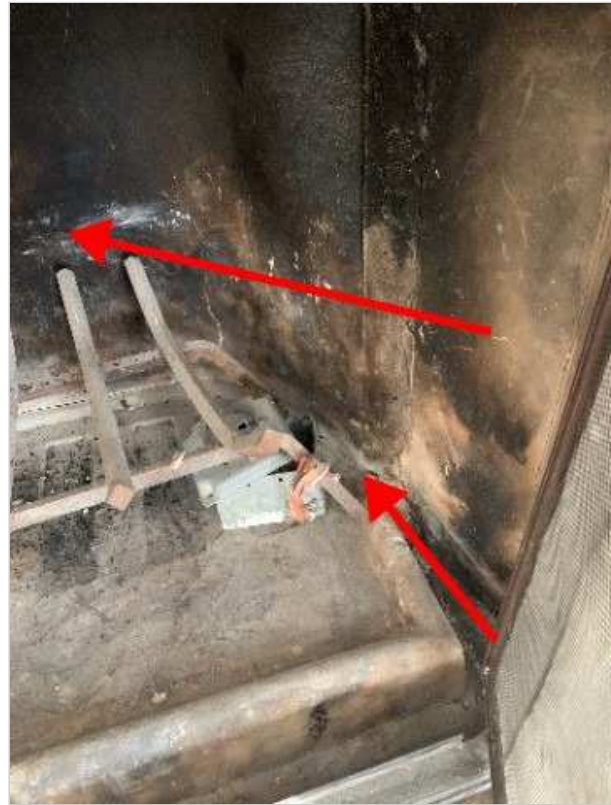
cracks along back

crack in fire box

The inspector recommends having the fireplace firebox system professionally evaluated and cleaned annually as a preventive maintenance/fire safety measure and prior to 1st use.

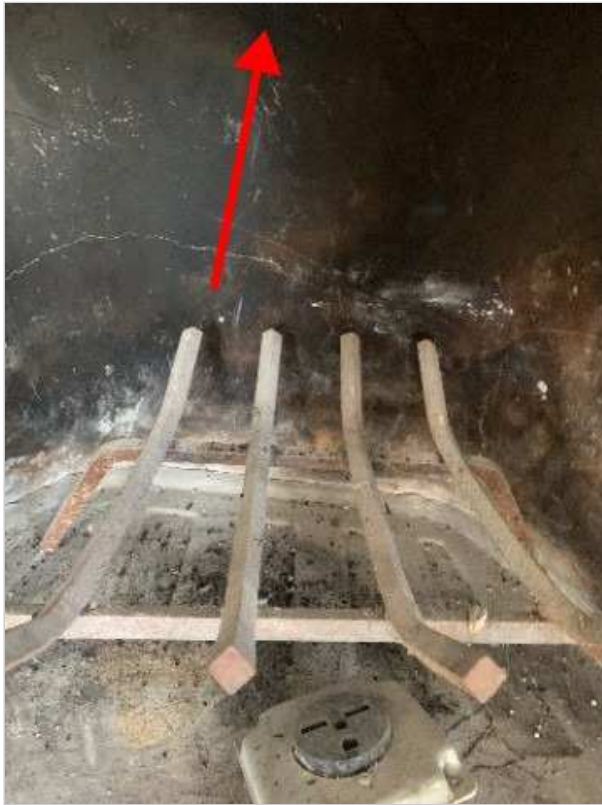
35. Fire Place/Wood Stove - Flue Dampers

no damper door visible Contact a chimney repair company.

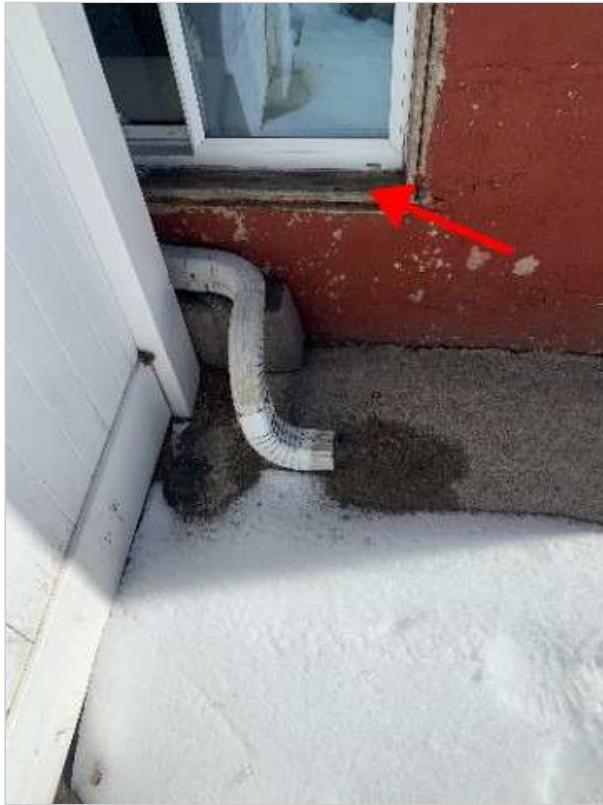
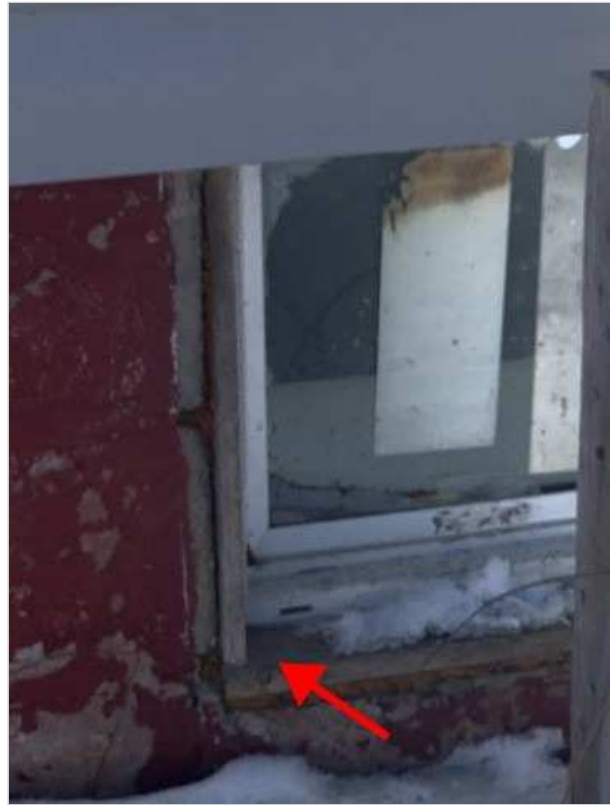
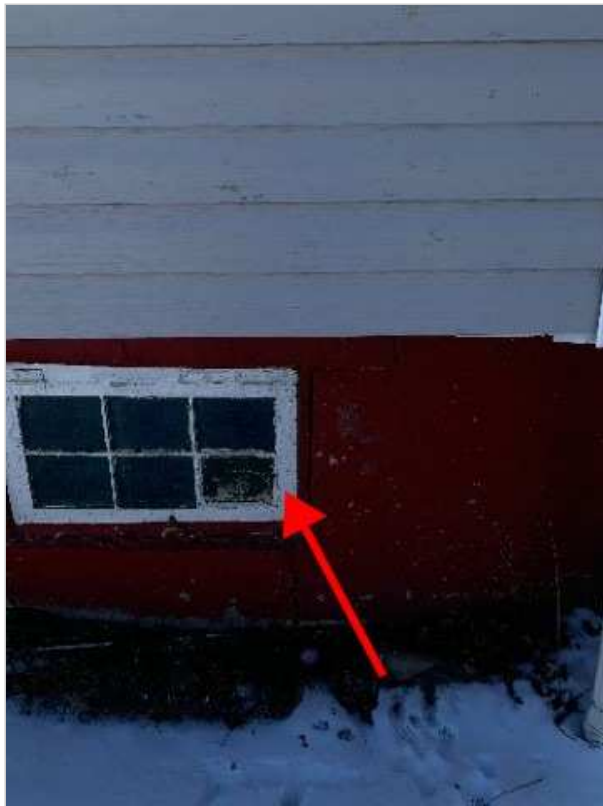
4. Caulking Structure

The structure caulking around the windows and trim is showing wear. Consideration should be given to caulking the exterior trim and siding in order to provide long term protection to the exterior surface material. Moisture can/may have entered which cause unforeseen damage. Recommend contractor evaluate/repair. An annual inspection of these areas is recommended as preventative maintenance.

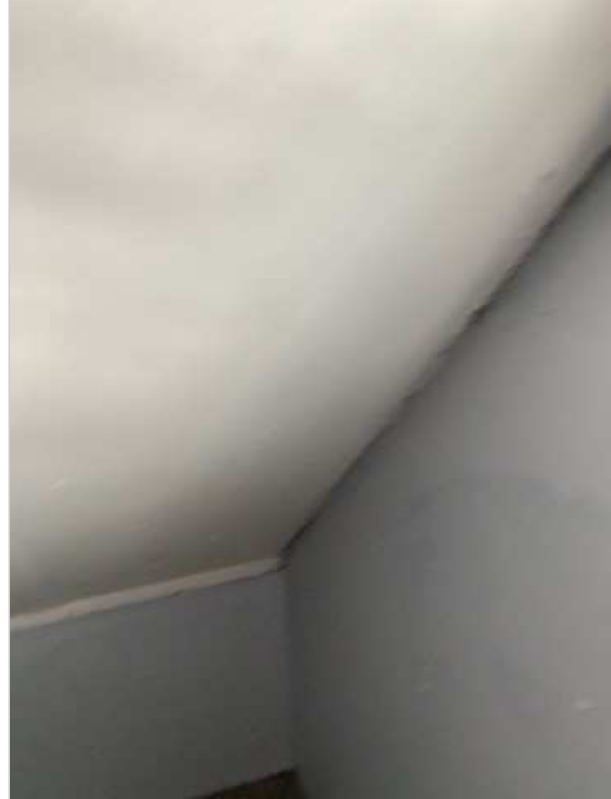
5. Repairs Evident

Various ceiling repairs visible in 3rd floor Recommend questioning the seller as to the extent of repair and why.

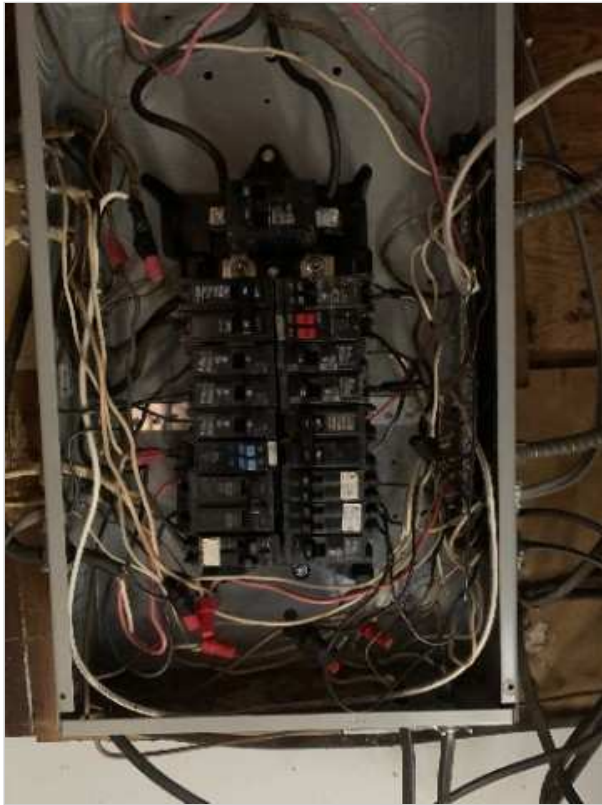
inside panel shows moisture recommend electrician evaluate

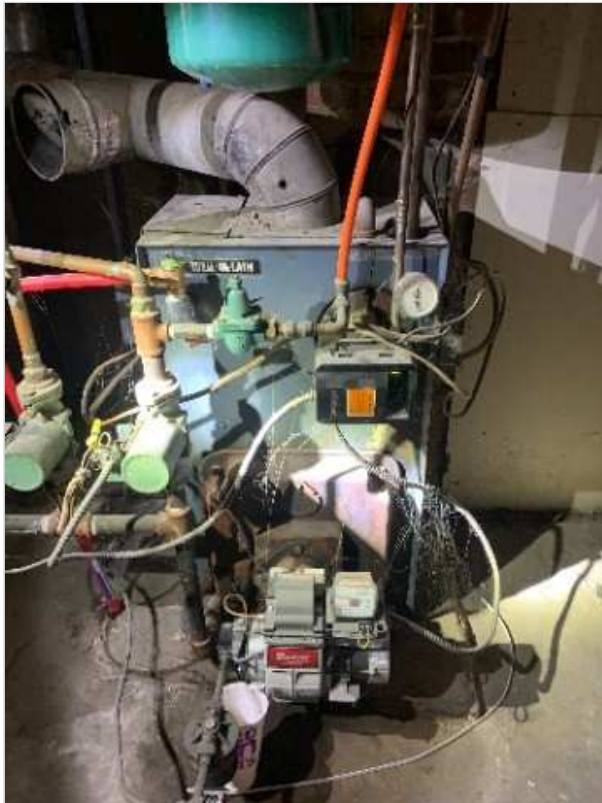
boiler shows hot area around casing recommend evaluated and serviced

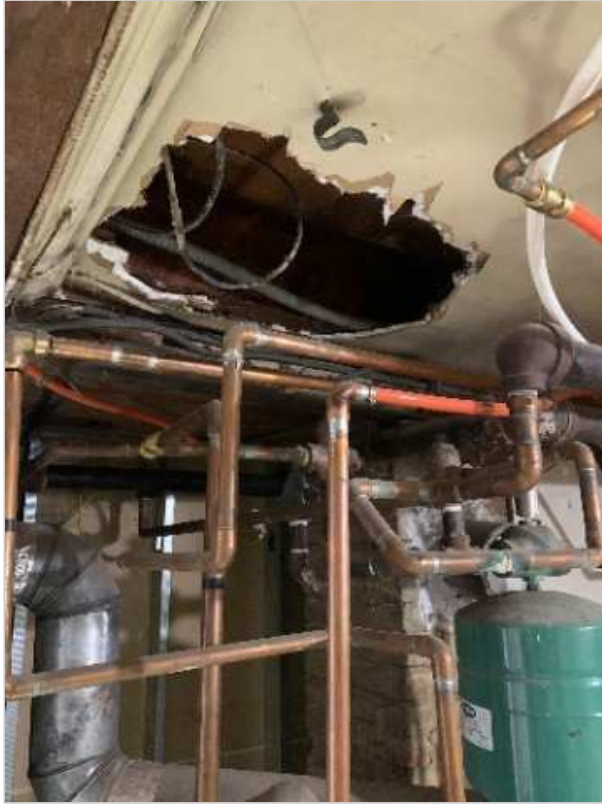
sheetrock need to be replaced over burner

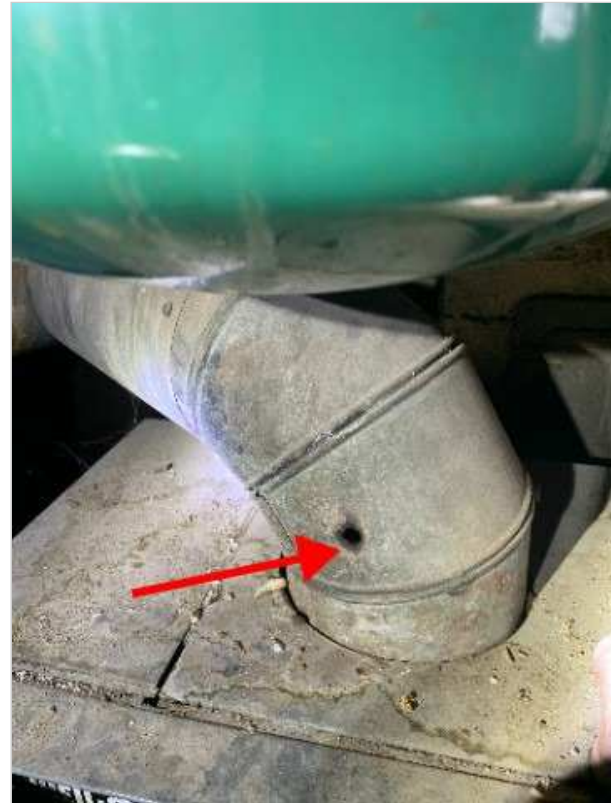
The entire inner flue was not visible at the time of inspection. The inspector recommends having the flues cleaned and inspected annually by a chimney cleaning company. Any and all joints should be sealed with a metal heat tape.

test hole for tech recommend silver tape to cover hole

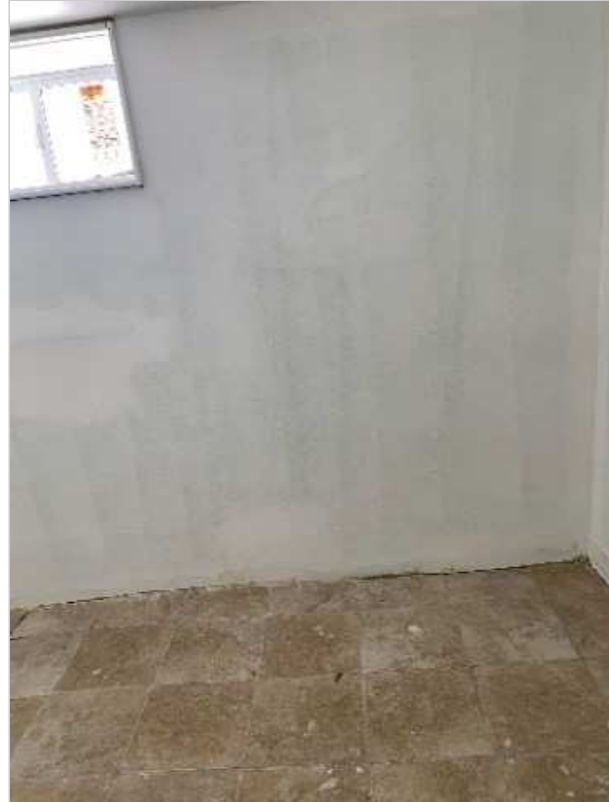
There was efflorescent visible along the perimeter foundation wall. Efflorescence is an indication of small amounts of moisture penetration through the concrete foundation. Correcting the grading, vegetation next to the foundation, redirecting any/all sprinklers away from the structure, and installing splash blocks at the downspouts will help in this area. Sealing the floor/walls with Drylock and adding a dehumidifier is also recommended. Also install a water sensor alarm. [Click for an alarm option](#) Monitoring this area during a heavy rainfall periods is recommended. Also recommend questioning the seller about any past issues.
