Property Address: 506 Madison Ave, Brentwood, NY 11717

Inspector: Santo Guinta
Company: Brookhaven Home Inspections, LLC
dba WIN Home Inspection Long Island
(631) 874-0011
wininspection.santo@gmail.com

Standard Full Home Inspection

Work Order Number: 022121SG

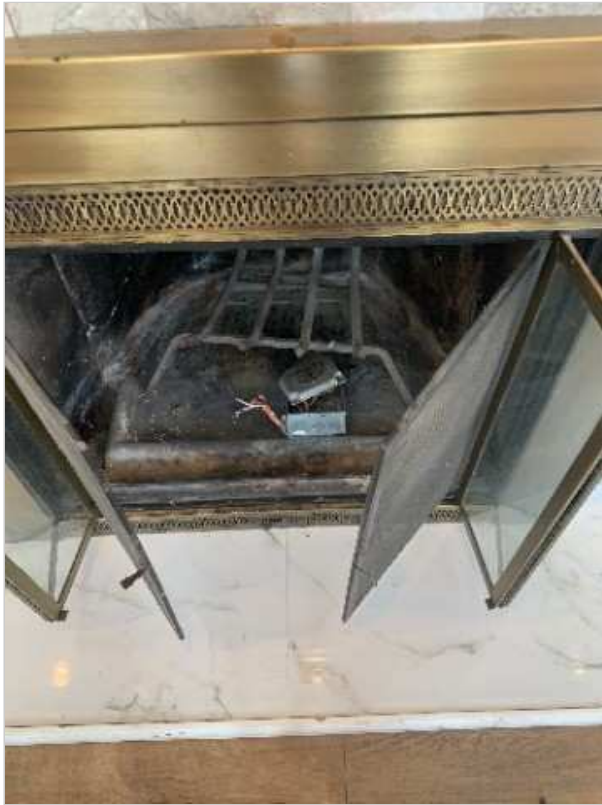
The chimney flue(s) was not visible. The inspector recommends having the fireplace system professionally evaluated and cleaned annually as a preventive maintenance/fire safety measure.
