**Property Address:** Avon, IN 46123

Extended Full Home Inspection  
Radon Testing, Pool Inspection

### Extended Full Home Inspection

**Service Date:** 7/11/2023

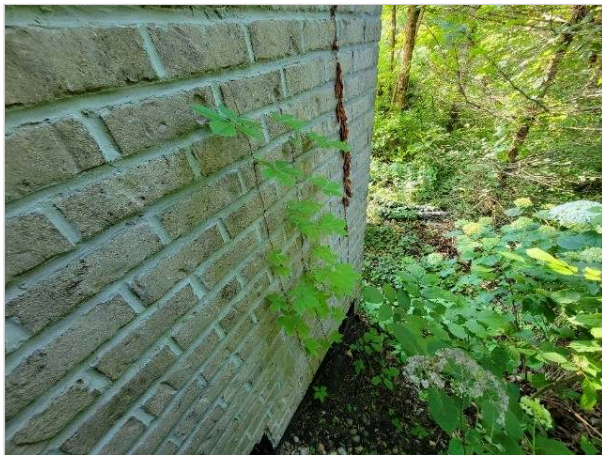
There is vegetation close to or in direct contact with the structure. All vegetation should be trimmed at least 6 - 12 inches away from the structure exterior to prevent damage and to eliminate a common avenue for pest infestation. Vegetation overgrowth may limit the view of the area for the inspector. An unknown condition may exist. Recommend repair by a qualified specialist.

Vines on South corner.

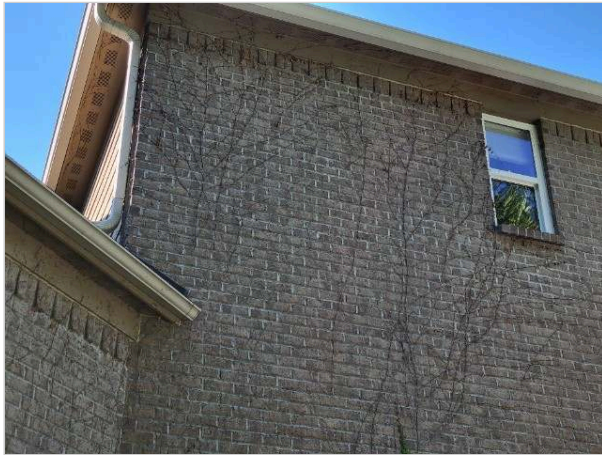
Remnants of dead vines on the structure. NW side.

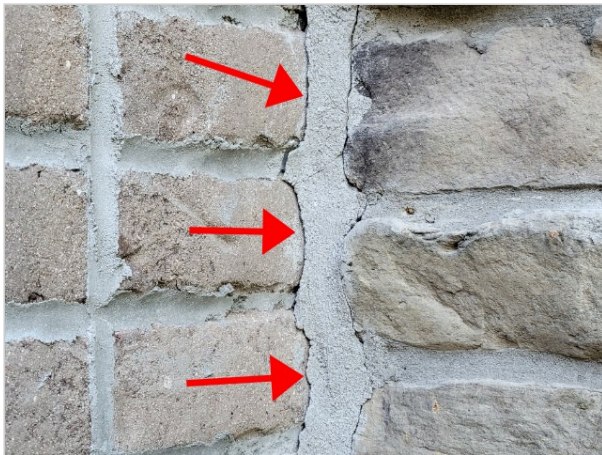
One or more areas of the exterior masonry mortar are cracked, damaged or missing. Repair is needed to prevent moisture penetration and further damage. Recommend evaluation and repair by a qualified masonry specialist.

Mortar cracked. Front porch area.

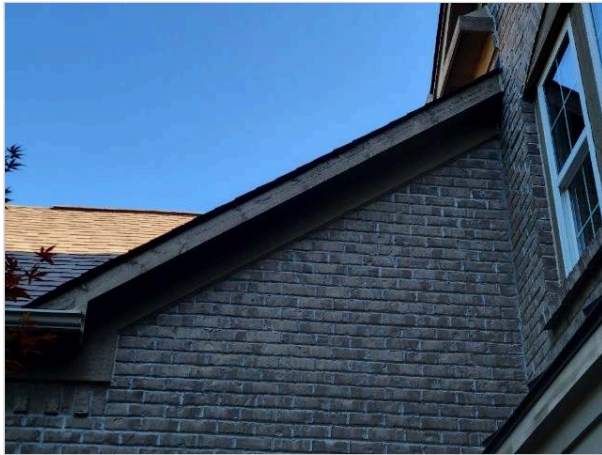
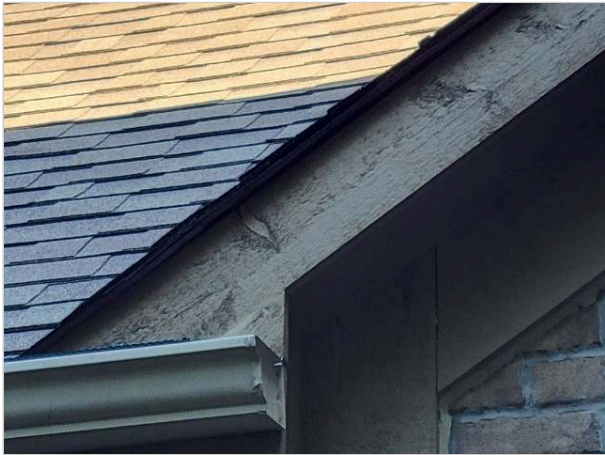
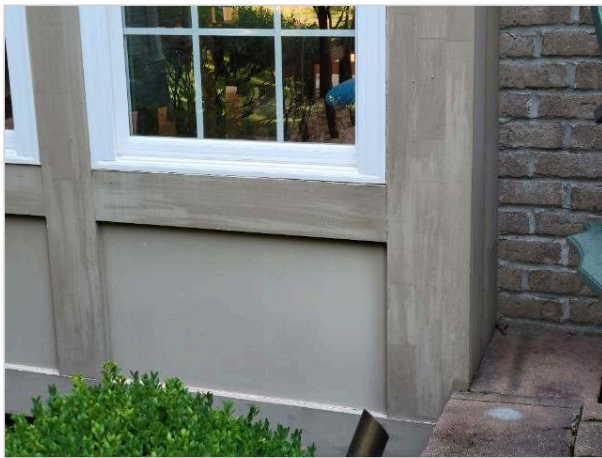
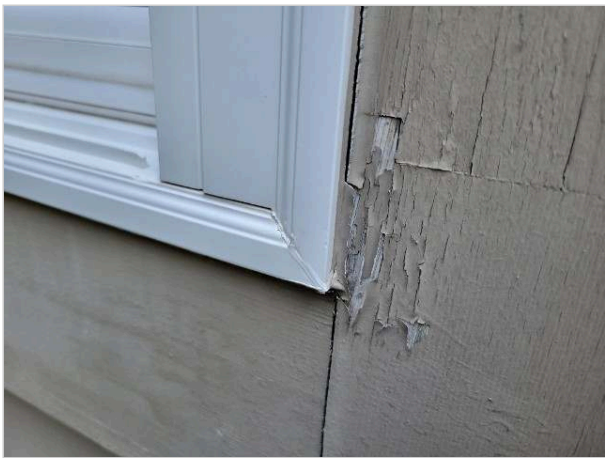
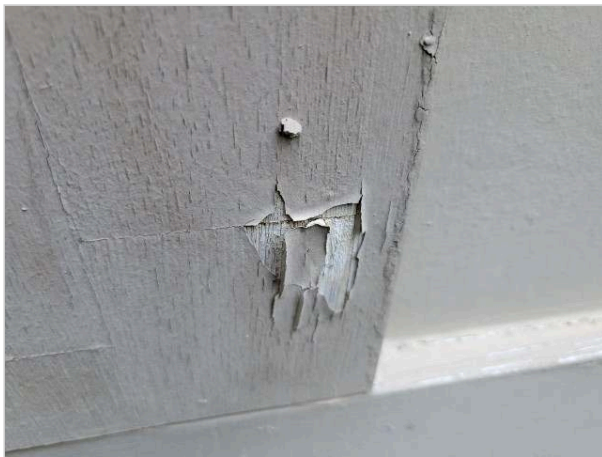
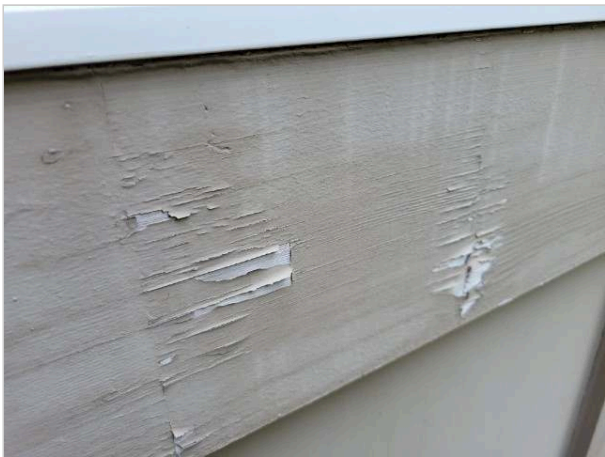
The exterior painted surfaces are showing deterioration and/or weathering. These areas are highly susceptible to the elements. Failure to maintain paint integrity may result in damaged trim and moisture penetration issues. Exterior paint has an average service life of 5-7 years. Recommend repair by a qualified specialist. *Note: The pictures below are samples. All affected areas are not shown.*

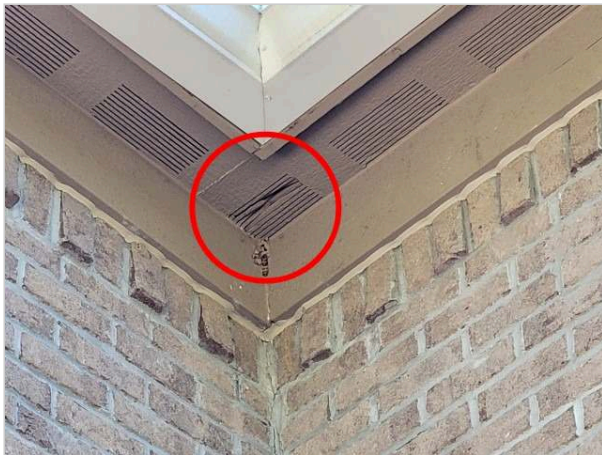
One or more areas of the soffit are damaged, loose, gaped or missing. Repairs are needed to prevent moisture penetration damage and pest intrusion. Recommend repair by a qualified specialist.

Soffit damaged. Above the garage.

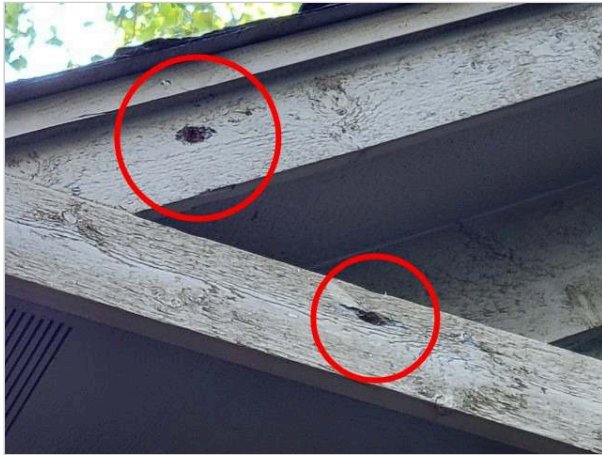
One or more areas of the trim are damaged, loose, gaped or missing. Repairs are needed to prevent moisture penetration damage and pest intrusion. These areas may be damage from carpenter bees. Recommend evaluation by a qualified exterminator and repair by a qualified contractor.

Front side trim.

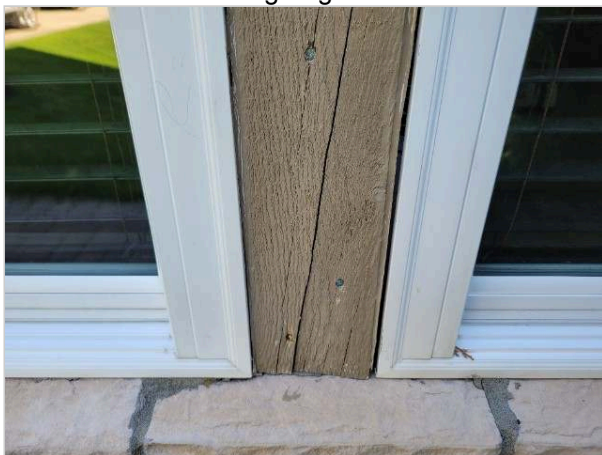
Trim split. Nail heads should be sealed. Front side, garage windows.

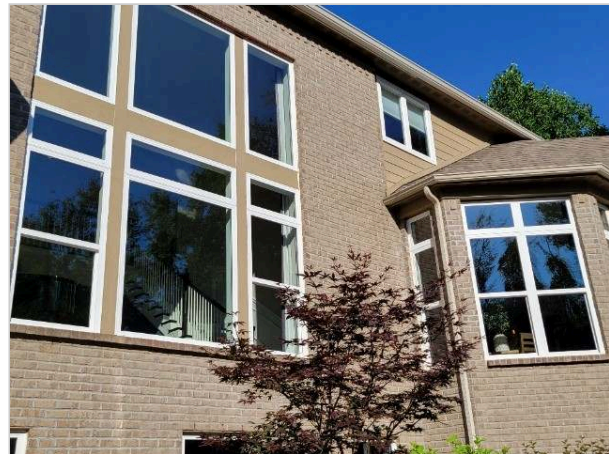
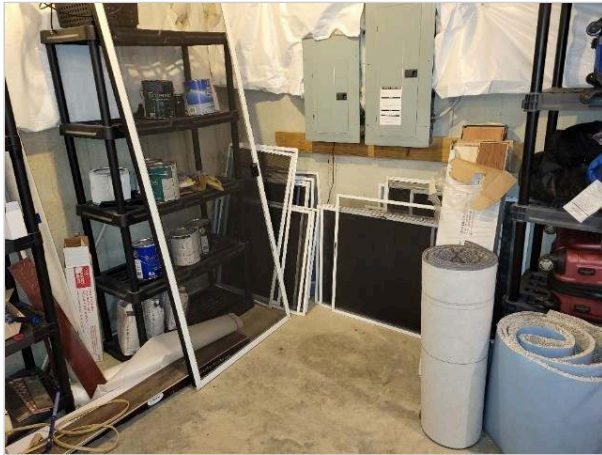
Most of the window screens are missing. Screens were found stored in the basement. Recommend installation or replacement for the desired service by a qualified specialist.

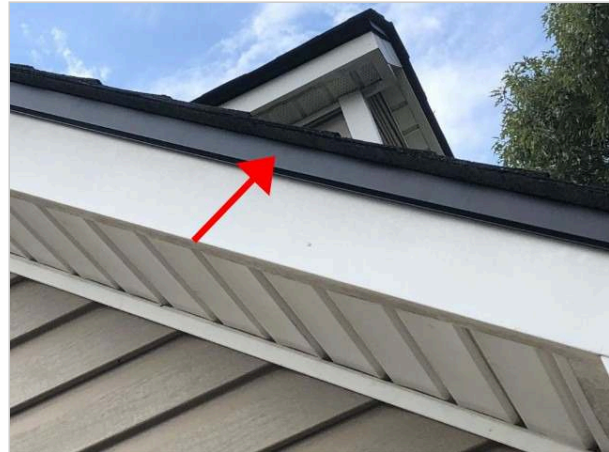
Example.

One or more areas of the drip edge is missing, damaged or installed improperly. Drip edge flashing supports the edges of the shingles, provides resistance to moisture from entering the attic and protects fascia and sheathing from damage. Most roofing cover manufacturers require a drip edge. Recommend repair or installation by a qualified roofing contractor.

No drip edge installed.

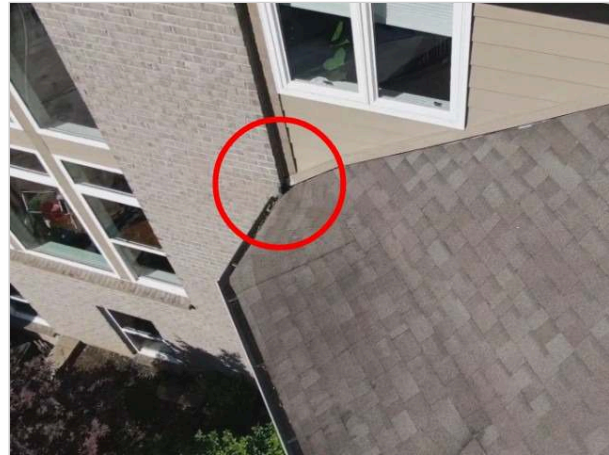
One or more areas of the roof is missing kickout flashing. Where a roof eave (end) meets a vertical wall, kickout flashing is required. Rain water coming down the roof may spill over the gutter onto the exterior wall. This may lead to staining, but can allow moisture to enter the wall behind the siding material, potentially causing extensive damage. Recommend evaluation and repair or installation by a qualified roofing contractor.

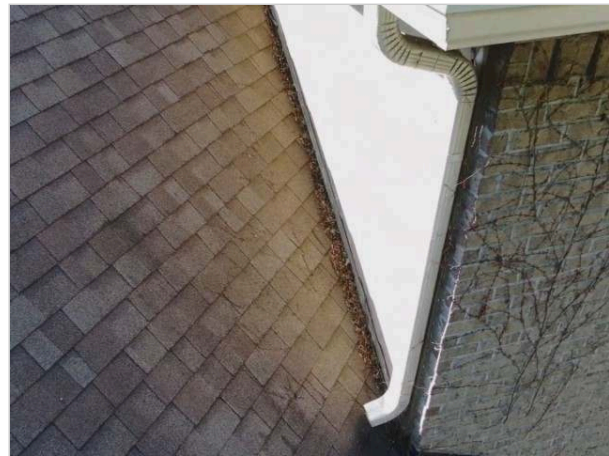
There was debris on the roof at the time of the inspection. Debris should be cleaned off the roof surface as a proper care and maintenance recommendation. Recommend removal and cleaning of debris from the roof by a qualified specialist.

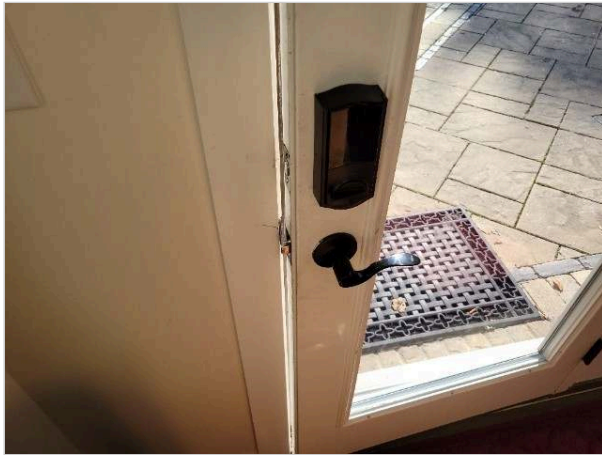
One or more doors needs fit adjustment for the desired service and ease of use. Recommend evaluation and repair by a qualified specialist.

Basement exterior door does not latch well.

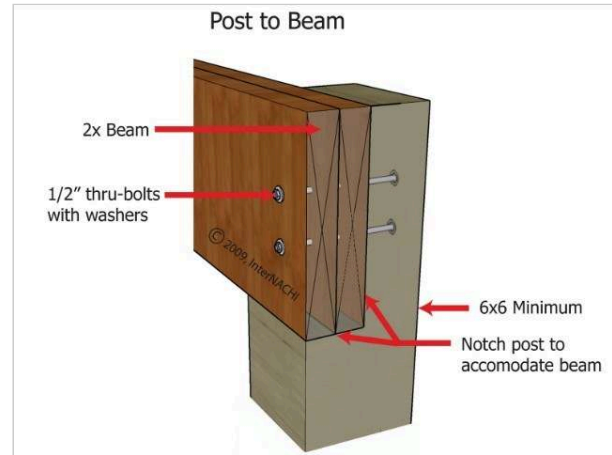
There is a large gap between one of the beams and a post. The beam should be resting on the post with no visible gap present. Recommend evaluation and correction by a qualified deck contractor.

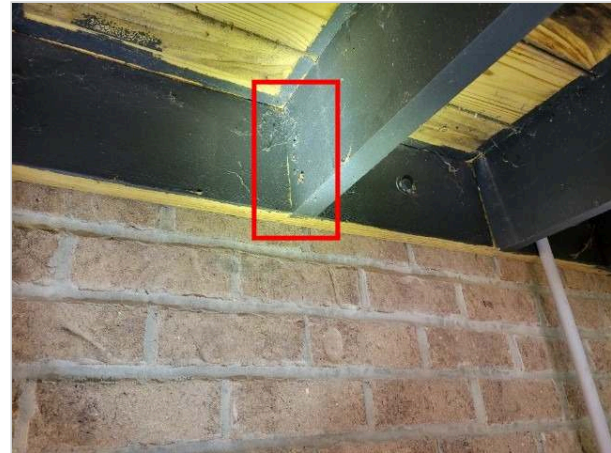
There are several joists that are missing a required joist hanger. Recommend repair by a qualified contractor.

Joist hangers missing.

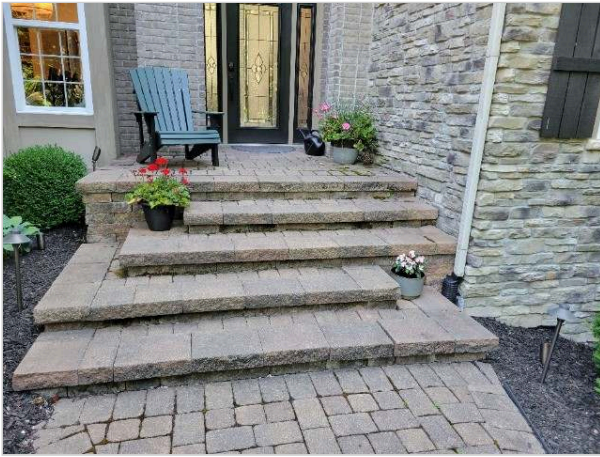
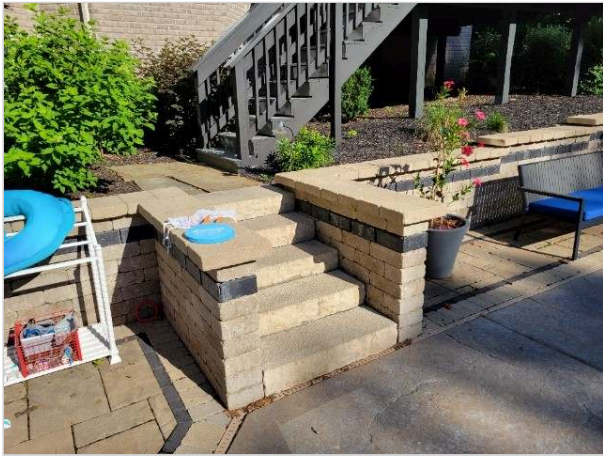
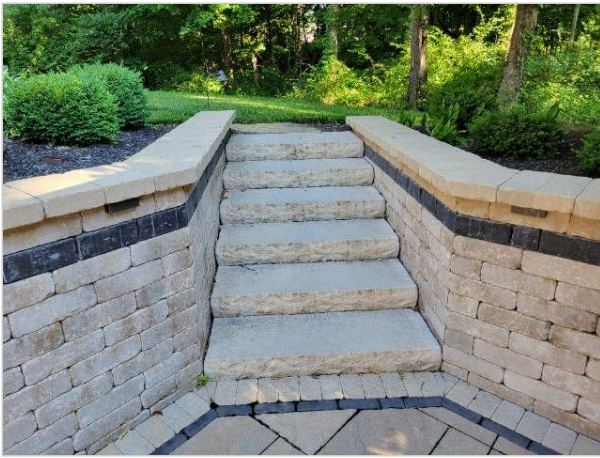
One or more areas do not have a required handrail. All stairways with four or more risers required a handrail. All railings should be secured on the side of all steps with four or more risers or platforms over 30" high. Recommend evaluation and installation of a railing system by a qualified specialist.

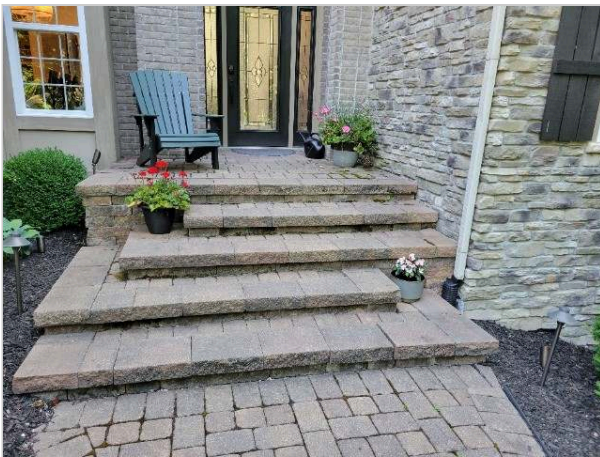
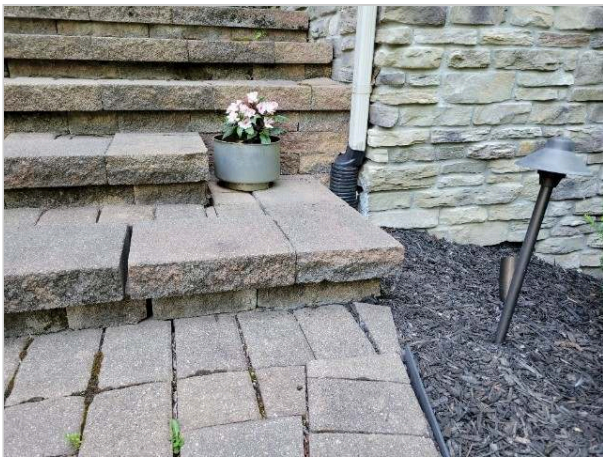
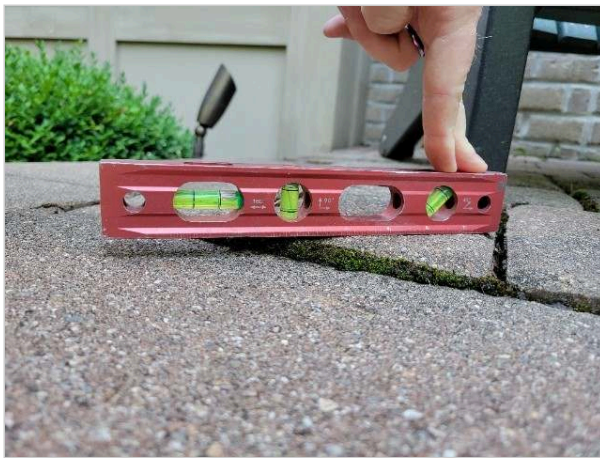
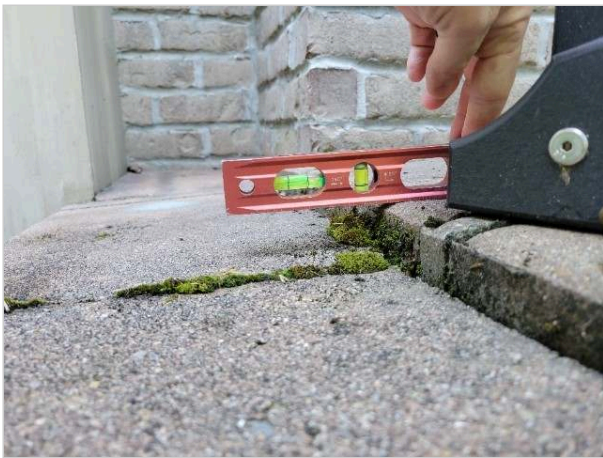
The front steps' pavers have areas that are not level and may pose a trip hazard. The bottom right side of the steps is sloping away to the right, which has created large gaps between the pavers. Removal and rebuilding of the steps may be required. Recommend evaluation and correction by a qualified contractor.

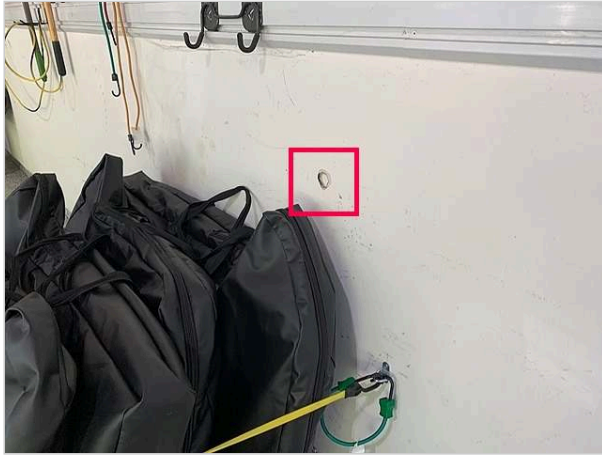
One or more areas of the interior walls and/or ceiling is damaged. Recommend evaluation and repair by a qualified specialist.

Damage to wall at garage.

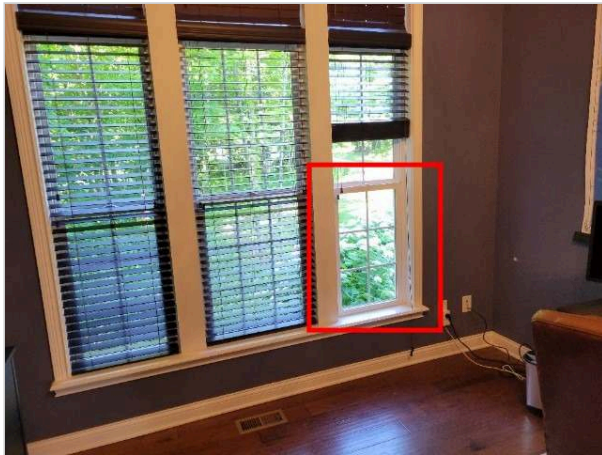
One or more windows were difficult to operate. Windows should be able to be opened and closed with relative ease for safety. Recommend evaluation of all the windows operation and repair by a qualified window specialist.

Office window difficult to operate. Too tight.

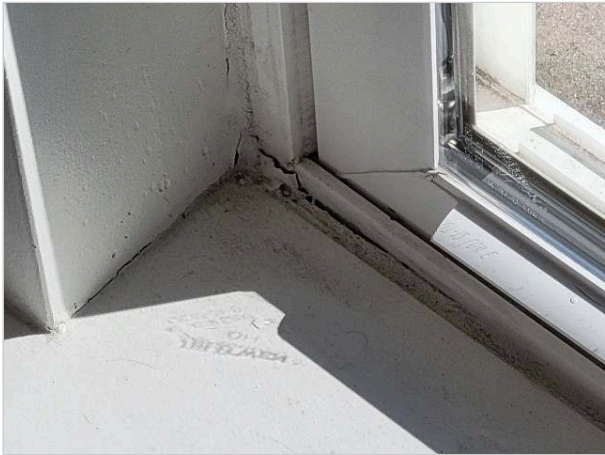
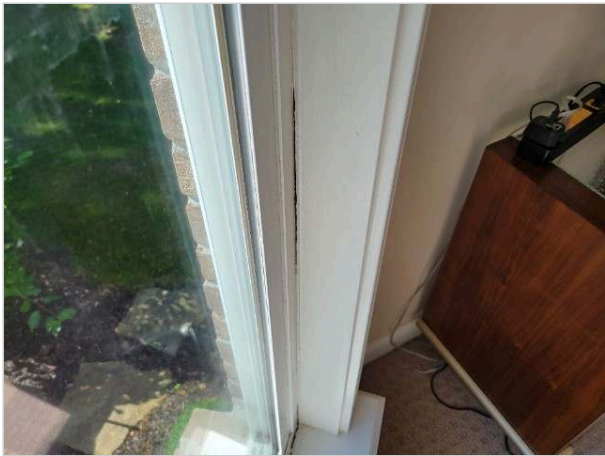
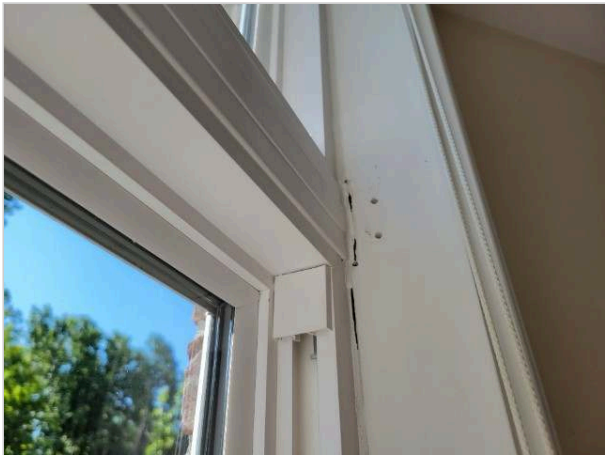
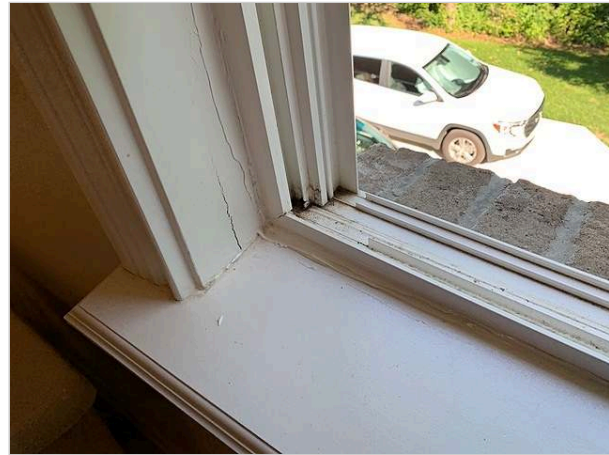
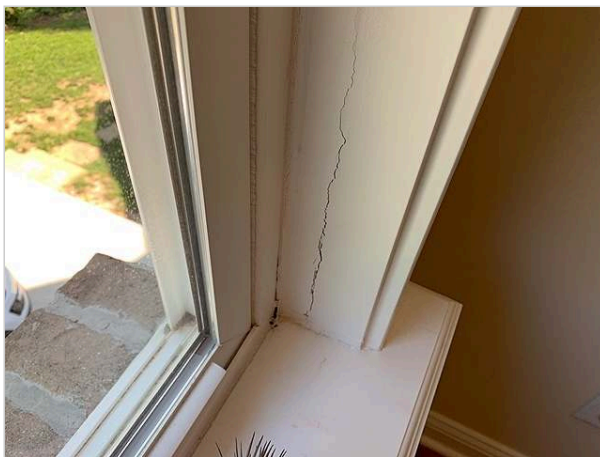
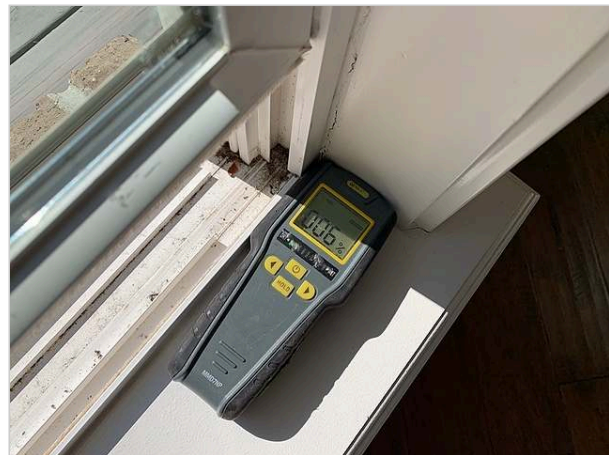
Several areas of the master bedroom window interior caulk has separated. The area was scanned with a moisture meter and no evidence of moisture penetration was observed. There were no moisture stains in the area. This is likely the result of fluctuating exterior temperatures. Recommend repair by a qualified specialist.

No elevated moisture found all locations.

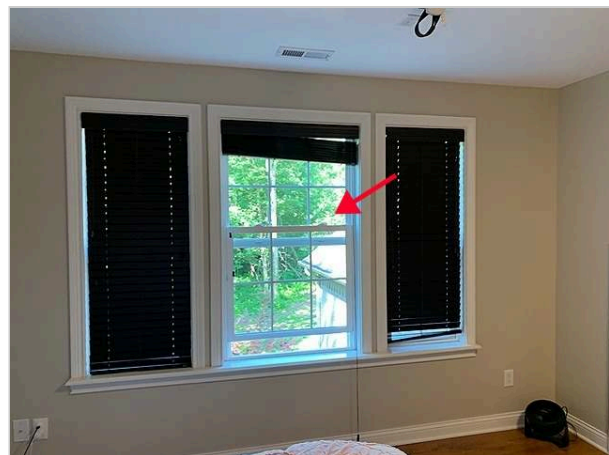
Affected window.

It appears the tilt latch, used to secure the window and tilt open the lower pane is damaged. Recommend evaluation and repair by a qualified specialist.

Tilt latch is damaged.

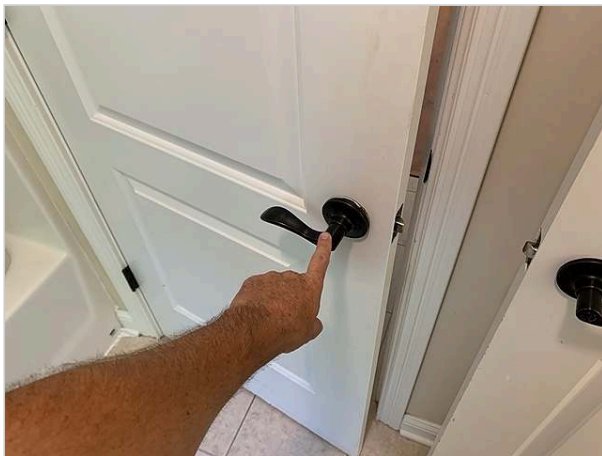
One or more doors have hardware that is loose, damaged or missing. Recommend repair by a qualified specialist.

Door handle is loose.

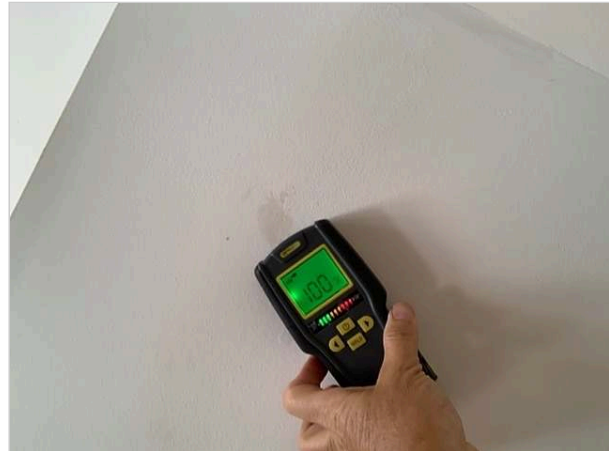
One or more areas of the interior walls or ceilings appears to have an active leak. The affected area was scanned with a moisture meter, which revealed the presence of active moisture. Corrective action should be taken immediately. Moisture leaks can cause extensive and costly damage to building materials. A home inspection is a visual-only, non-invasive inspection. Invasive inspection is required to determine the extent of damage. Recommend asking seller about this condition. Recommend further evaluation by a licensed plumber and/or qualified roofing contractor.

Elevated moisture 100%.

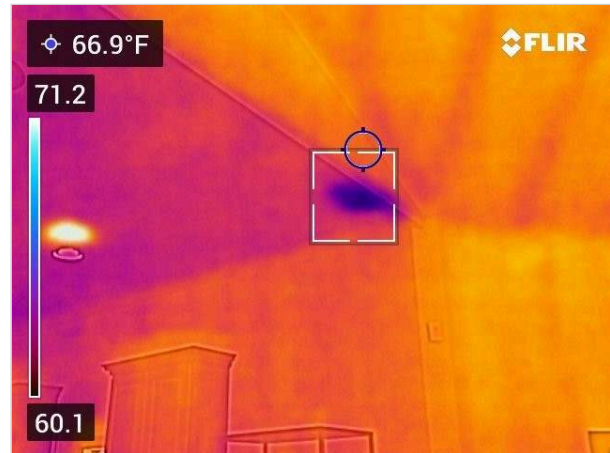
Thermal camera detects temperature drop in this area, moisture intrusion.

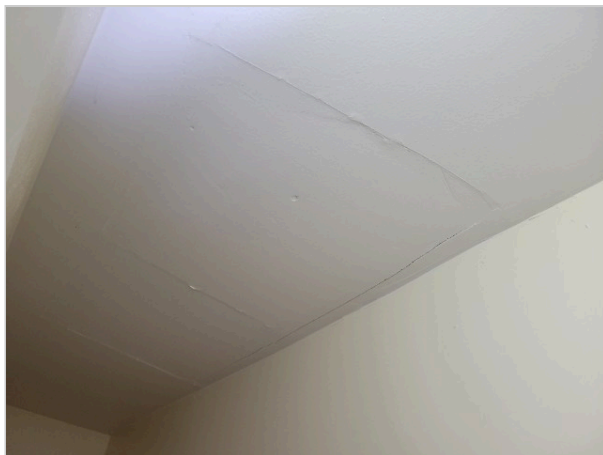
Basement bedroom closet ceiling.

One or more areas of the interior walls and/or ceilings appear to have been repaired in the past. These areas appear to be functional; however, it could not be determined what was repaired or what issue was corrected. The drywall finish is insufficient. Recommend asking seller about this condition. Recommend repair by a qualified specialist.

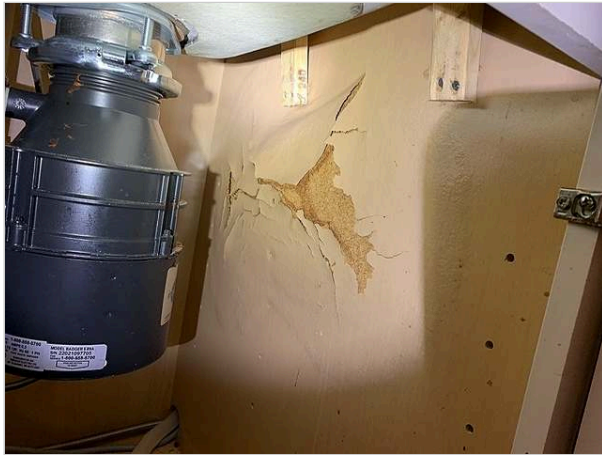
The bottom of the sink base cabinet is stained, warped, damaged or missing likely due to a current or past plumbing leak or cleaning chemical spill. There may be unseen or hidden damage. Invasive inspection may be required to determine the extent of damage. Recommend evaluation and repair or replacement by a qualified specialist.

Damage to wall at kitchen sink, no elevated moisture found.

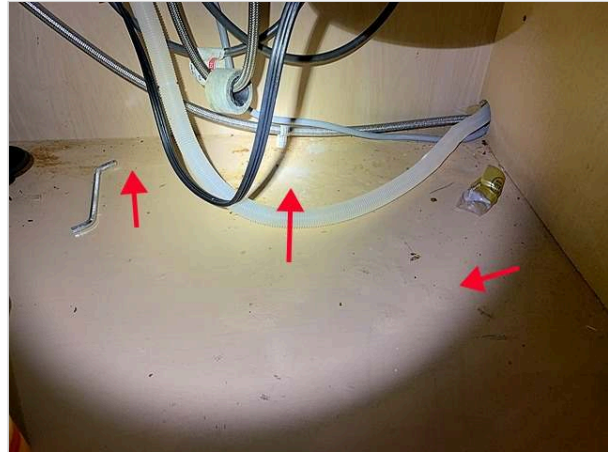
Base is stained + warped.

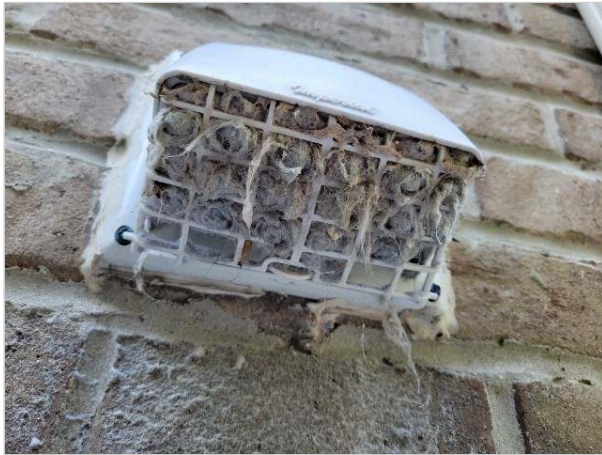
The vent system for the dryer exhaust has a significant build up of lint and debris. There is a grill or grate installed over the top of the dryer vent cover. This type of vent cover will clog rapidly and required frequent cleaning. The leading cause of fires from clothes dryers is excessive lint and other debris within the vent system. Corrective action should be taken as soon as possible to avoid a fire. This will also reduce the efficiency of the dryer. If additional methods are desired to prevent entry of animals, alternative vent cover designs exist that will prevent animal entry, but will not pose the same fire risk. Recommend professional cleaning of the dryer vent system.

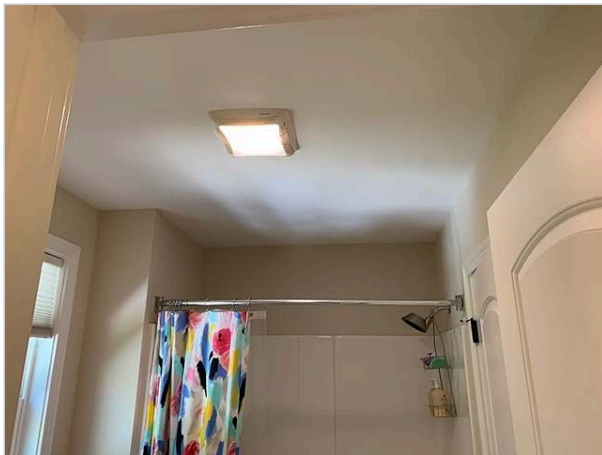
One or more bathroom ventilation fans makes an unusual or loud noise. There may be a defect or near future failure. Recommend repairing or replacing the fan by a qualified specialist.

Noisy vent fan.

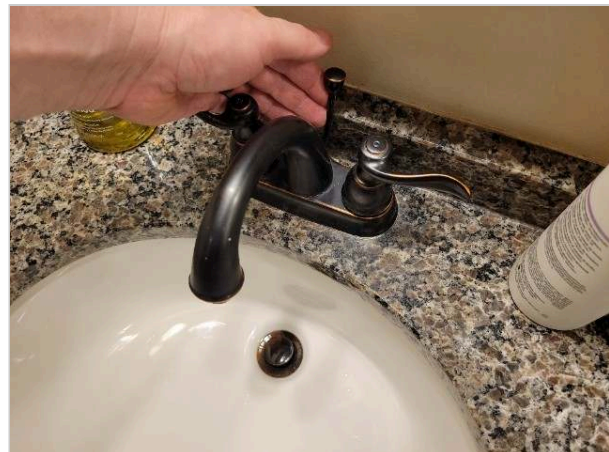
The master bathroom sink drain stoppers are difficult to operate. Recommend repair by a qualified specialist.

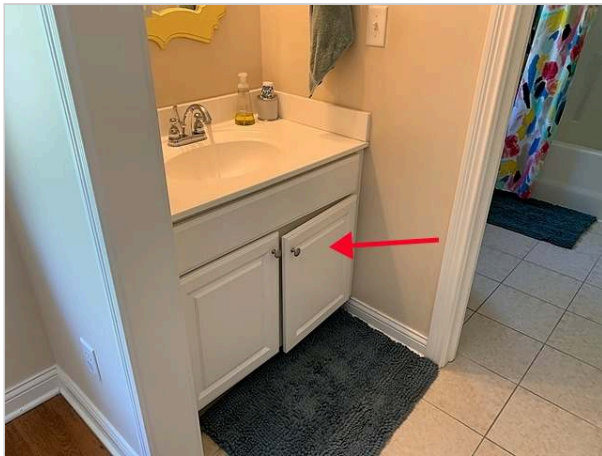
One or more of the cabinet drawers and/or doors are damaged, not installed or need adjustment. Recommend repair by a qualified specialist.

Loose cabinet at upper bath.

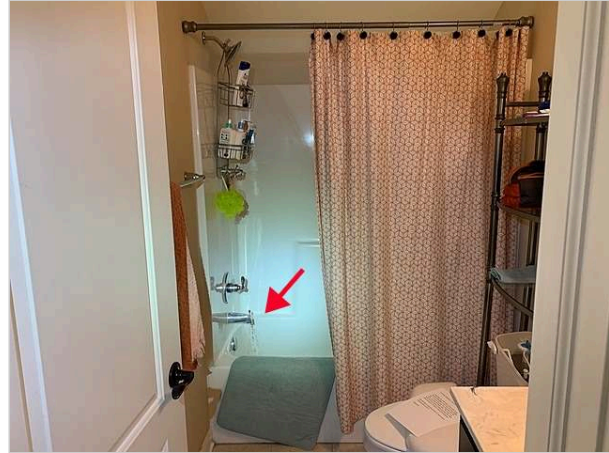
Affected bath.

One or more shower diverters appeared to be damaged. The shower diverter changes the direction of water flow from the tub faucet up to the shower head. When the shower head is active and water is still coming out of the tub faucet, the shower diverter is damaged and replacement is indicated. Moisture related damage may be hidden or otherwise undetectable by the inspector at the time of inspection. Invasive inspection may be required to determine the extent of damage. Recommend repair by a licensed plumber.

Damage to diverter.

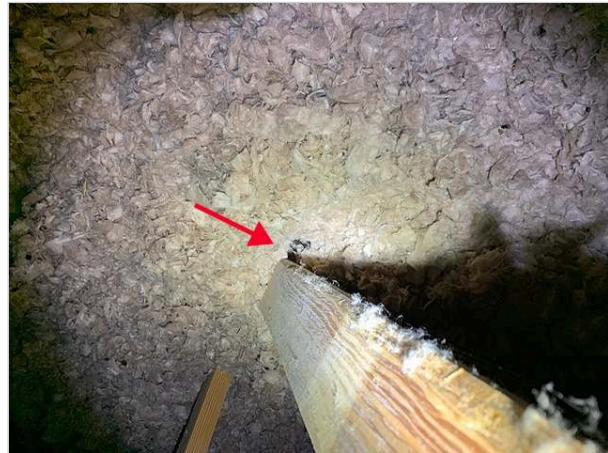
Multiple locations: There is evidence of vermin activity in one or more areas of the structure. Recommend implementation of preventative treatment methods and if needed further evaluation by a licensed exterminator.

Vermin tunnel at attic.

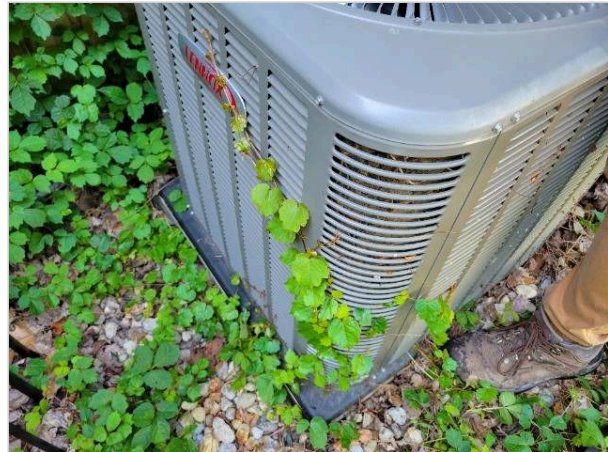
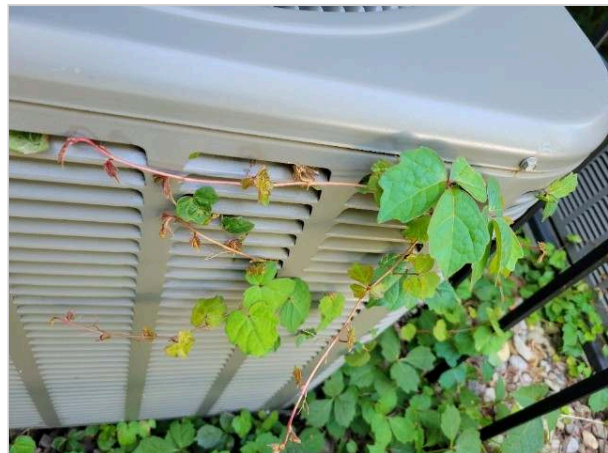
The outdoor portion of both air conditioners has insufficient clearance from nearby vegetation growth. There are vines growing inside the units. This can reduce the efficiency of the unit and may cause damage. A minimum of 12 inches of clearance is recommended. Recommend repair by a qualified specialist.

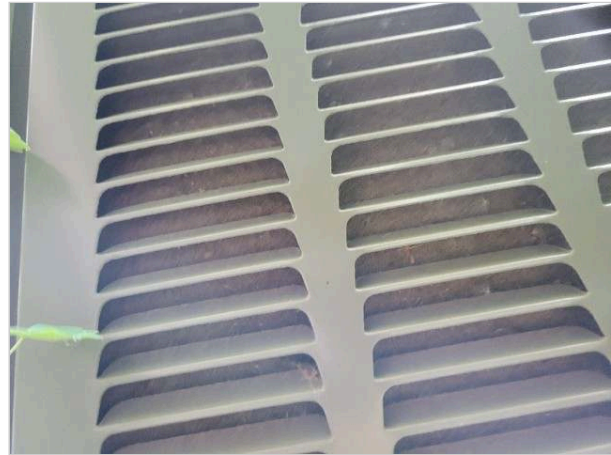
The condensing units are very dirty. Debris buildup can cause system malfunction, premature deterioration of the appliance and loss of energy efficiency. Recommend cleaning by a qualified HVAC technician.

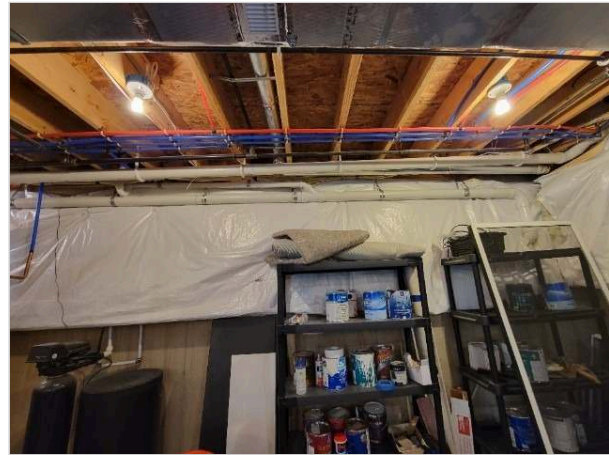
One or more areas of the PVC or plastic waste plumbing has metal straps. Metal or wire straps should not be used to secure plumbing waste drains. Straps may fail to resist upward thrust and lateral movement from water surge and expansion and contraction. The resulting movement may cut and damage the piping. Plastic straps should be used. Recommend replacement by a licensed plumber.

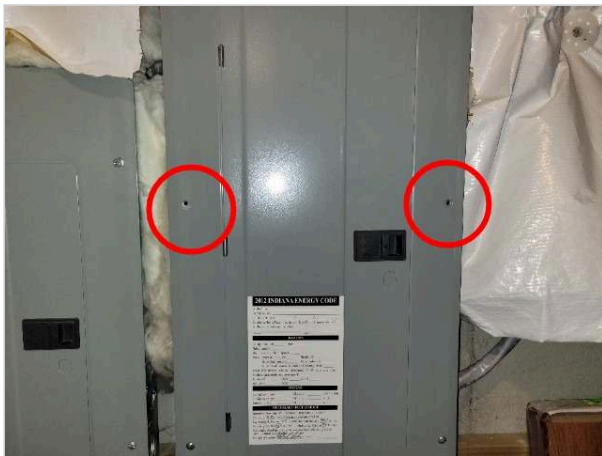
The electrical panel cover is missing one or more fasteners. Electrical panels should be secured in place with screws specifically for this application as a safety measure. Recommend repair by a qualified specialist.

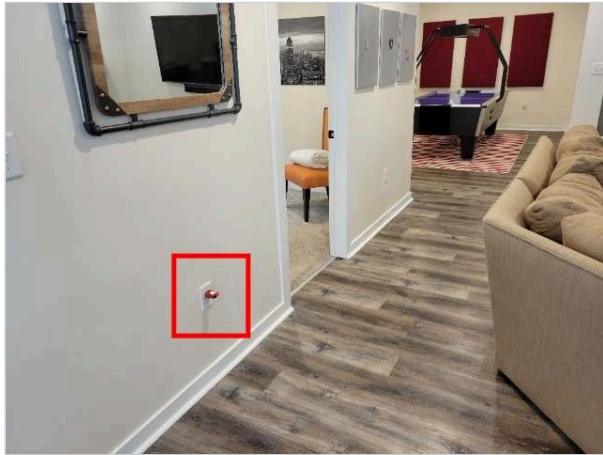
Outlet not secure. Basement.

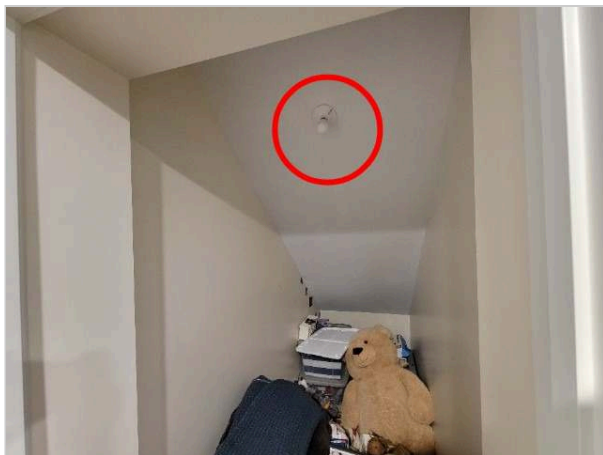
There is one or more bare bulbs installed in a closet. Exposed or partially exposed incandescent or LED bulbs are not allowed in closets. While utility light fixtures with bare bulbs in a socket were once common in closets and other storage areas, these are no longer allowed. All light bulbs must be fully enclosed in a globe or other housing. Recommend repair or replacement by a qualified electrician.

Basement storage closet. Under the stairs.

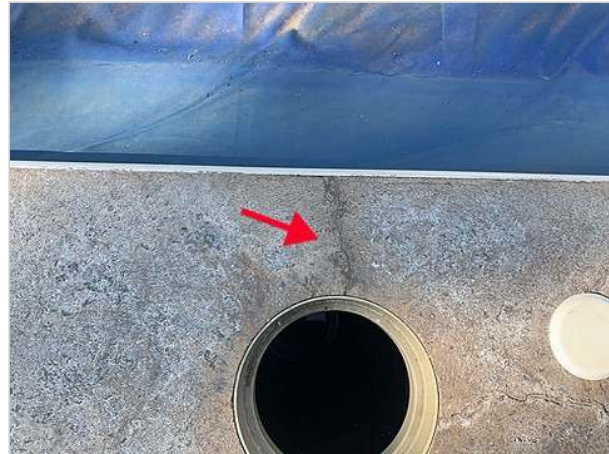
Picture 2.

Minor crack at pool sump pit.
