Property Address: 1111 Right Lane, Dublin, CA

Standard Full Home Inspection

Work Order Number: 112422RC

Service Date: 11/24/2022

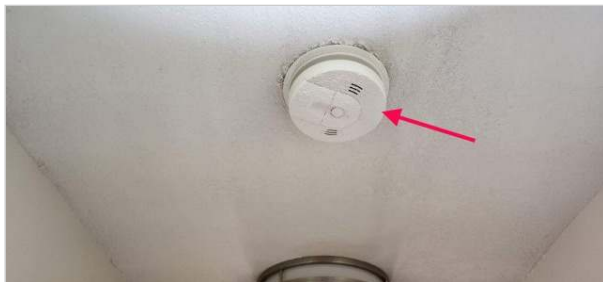
2. The hallway smoke detector has been painted over which may affect the functionality of the unit. Replacement is recommended.

Hallway - Smoke Detector painted over

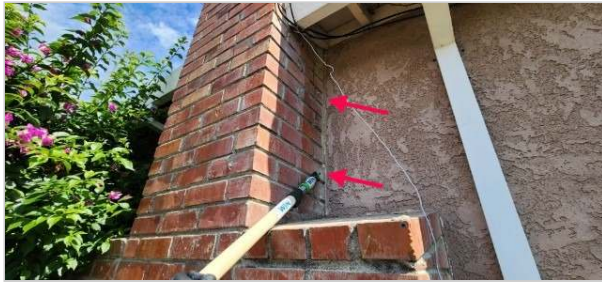
The mortar line between the chimney and exterior siding has deteriorated and should be sealed. A 10 oz. Quikrete mortar repair tube or similar product can be used. It is an acrylic formula specifically developed for sealing joints in concrete, brick and block surfaces. This will ensure no moisture penetrates between the brick and siding.

Chimney-Siding - Deteriorated caulking

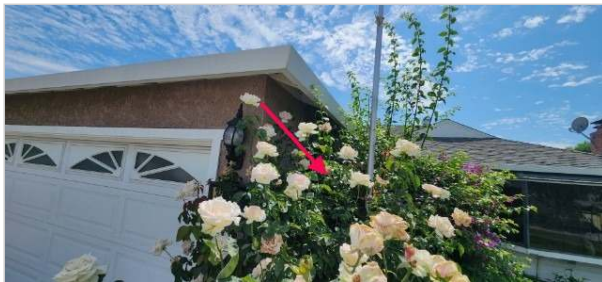
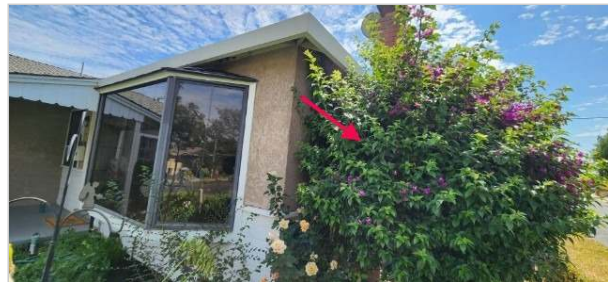
There is vegetation growing up against the exterior surface material. All vegetation should be trimmed at least 6-12 inches away from the structure to eliminate a common avenue for pest infestation and damage to the exterior structure material. Trees should not overhang the roof line and should be trimmed at least 3' from structure.

Vegetation growing against structure

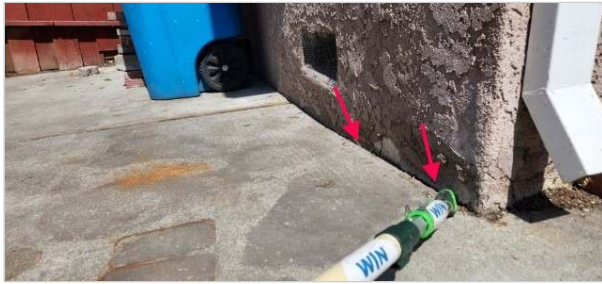
Stucco covering exterior walls of the home had inadequate clearance from grade. Stucco should terminate a minimum of 4 inches above grade. This condition may result in staining and deterioration of the lower portion of the wall stucco from moisture absorption.

Stucco - Inadequate clearance from grade

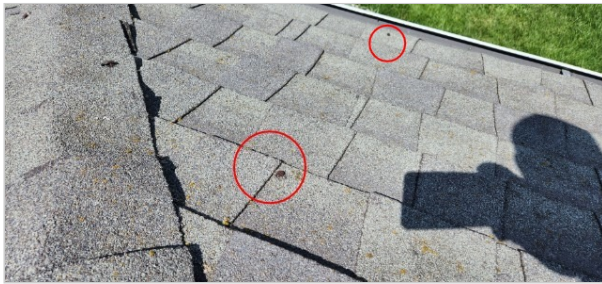
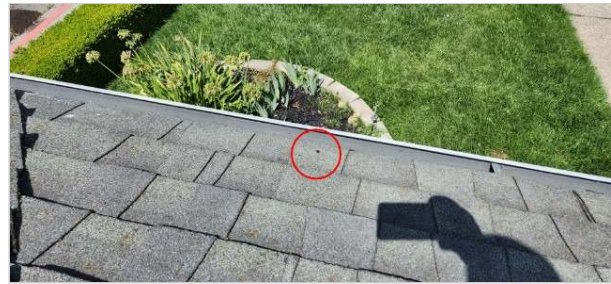
Some exposed nails were noted in several areas of the roof. It is recommended the protruding areas be repaired/ sealed to prevent moisture penetration.

Roof Shingles - Protruding Nails

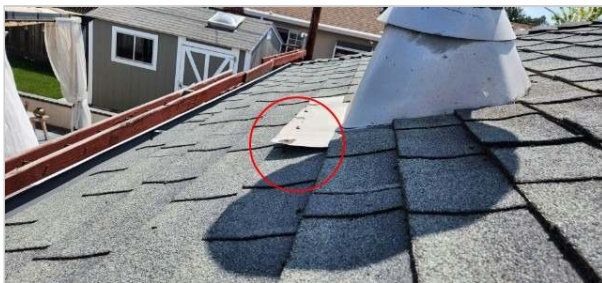
1. There are curled/lifted flashings that should be sealed to prevent moisture intrusion into the structure. Contact a qualified roofing expert to make the needed repairs.

Roof - Curled/Lifted Flashing

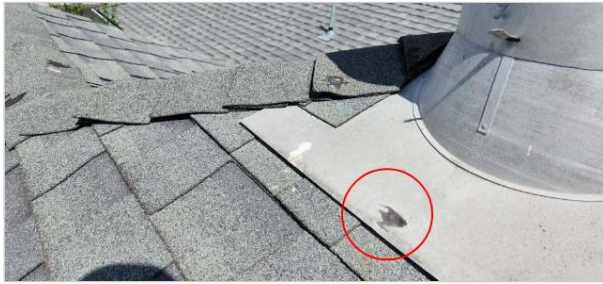
2. There are exposed nails on roof vent flashings that should be sealed to prevent moisture intrusion into the structure. Contact a qualified roofing expert to make the needed repairs.

Roof Vent Flashing - Exposed nails

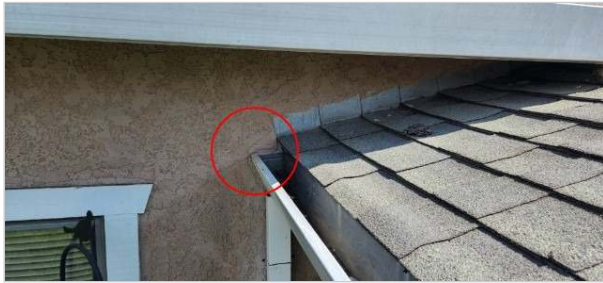
3. A wall section at the front edge of the roof had no kick-out flashing installed where a wall extended past the roof edge. This condition may allow moisture intrusion of the exterior wall covering. Moisture intrusion of the wall structure can damage home materials and encourage the growth of mold. Long term moisture intrusion can cause structural damage from wood decay. The Inspector recommends consulting with a qualified roofing contractor to gain an idea of options and costs for kickout flashing installation.

Roof - No Kick-out Flashing

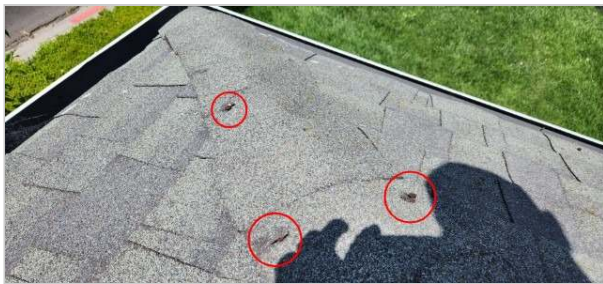
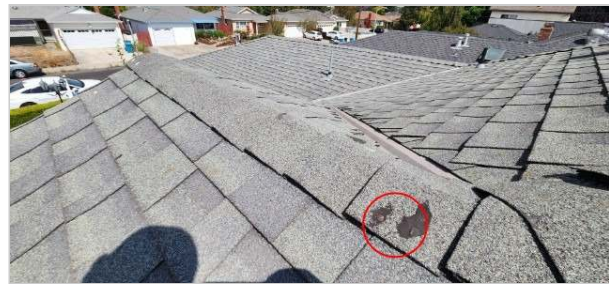
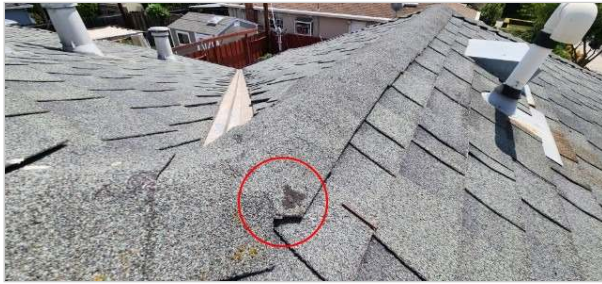
There are areas on the roof ridges with exposed nails that are missing sealant. Exposed nail heads should be limited to a few at the ridge caps and on overlapping flashing. None should be visible on valley flashing, or between the cutouts on the shingles. Exposed nails in acceptable locations should have a sealant. If left exposed too long, many nails will rust, leaving a hole and causing leaks

Roof Ridge - Exposed nails

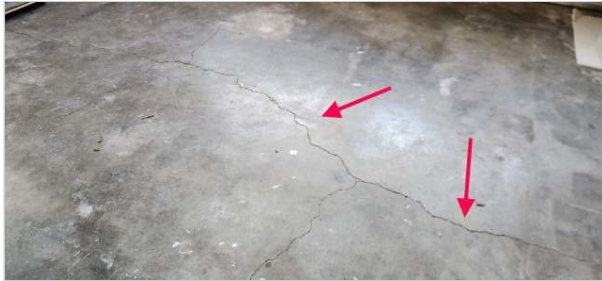
There are minor cracks on the garage floor. It is recommended that the cracks be sealed with a mortar patch or sealant designed for concrete to prevent moisture penetration in these areas. A qualified handyperson can make this repair.

Garage Floor - Minor cracks

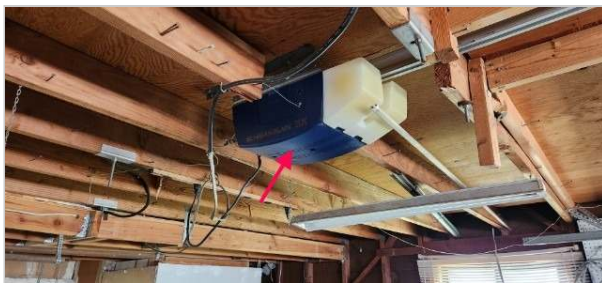
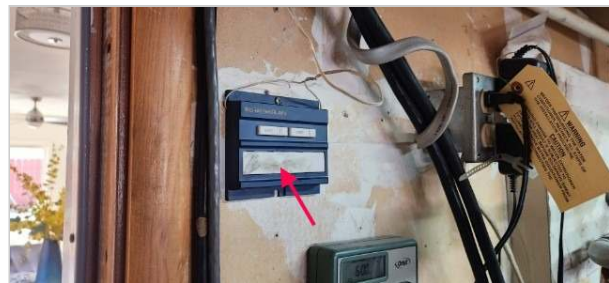
The automatic garage door was not tested. There was no power to the door opener unit at the time of the inspection. Re-inspection is recommended when functionality is restored.

Garage Door Opener - Not tested / no power

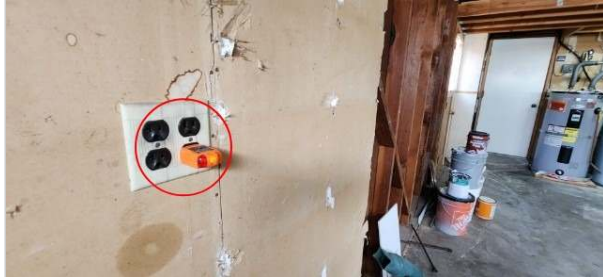
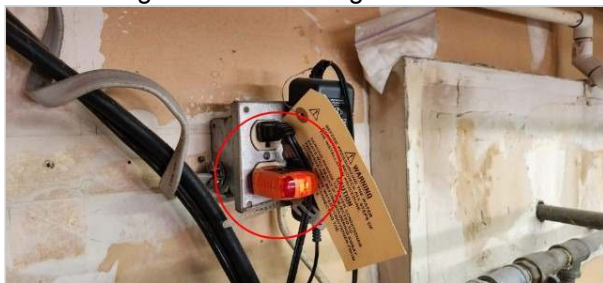
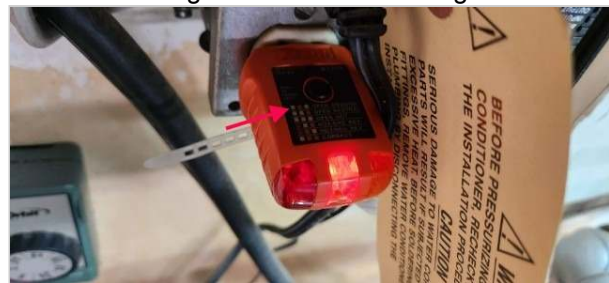
- Garage: Non-GFCI ungrounded outlet(s).
- Master Bathroom: Defective GFCI, No power to the receptacle.
- Hallway Bathroom: Defective GFCI, No power to the receptacle.

Garage - Non-GFCI ungrounded outlet

Ungrounded outlet reading

The inspector recommends receptacle repair or replacement as needed by a qualified electrical contractor.

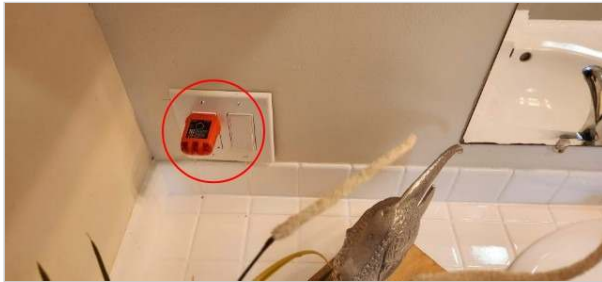
Master Bathroom - Defective GFCI, no power to outlet

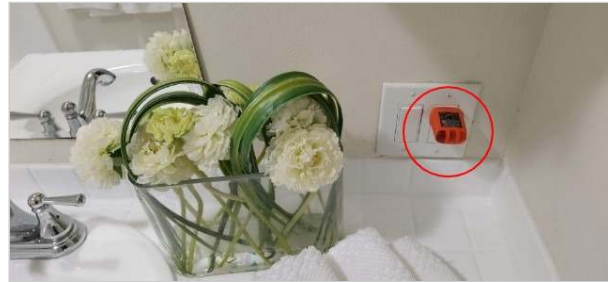
Hallway Bathroom - Defective GFCI, no power to outlet

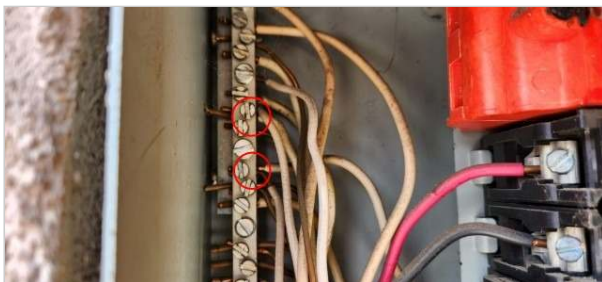
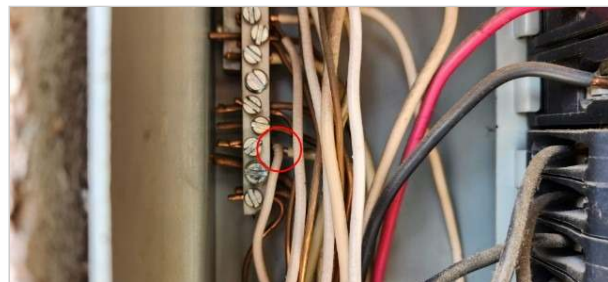
1. There are neutral wires that are double lugged to a same screw on the neutral bus bar. Double tapped neutrals can expand and contract enough to the point where the connection becomes loose. The loose connection could overheat and be a potential fire hazard. Contact a qualified electrician to perform repairs.

Sub-panel - Double lugged neutral wires

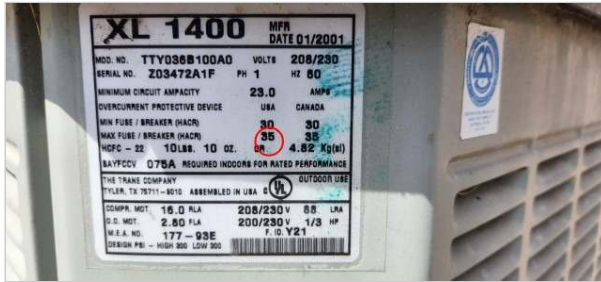
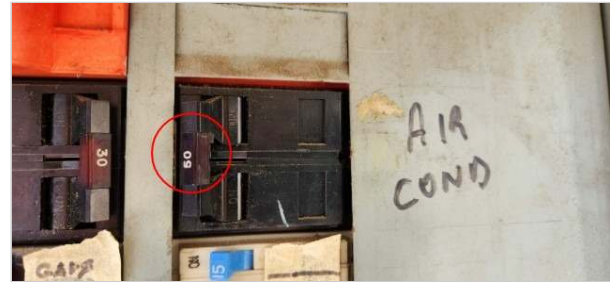
2. The amperage rating of the circuit breaker protecting the air-conditioner compressor exceeded the manufacturer recommended amperage rating. The maximum circuit breaker size noted on the A/C ratings plate is 35 amps. The inspector noted in the main service panel the breakers installed for the AC compressor was 50 amps.

A/C Ratings Plate - Max breaker amperage: 35 amps

Main Service Panel - Installed breaker amperage: 50 amps

Recommend replacing the circuit breakers with an amperage rating that does not exceed the stated size noted on the ratings plate. Contact a qualified electrical or HVAC contractor to perform the repairs.

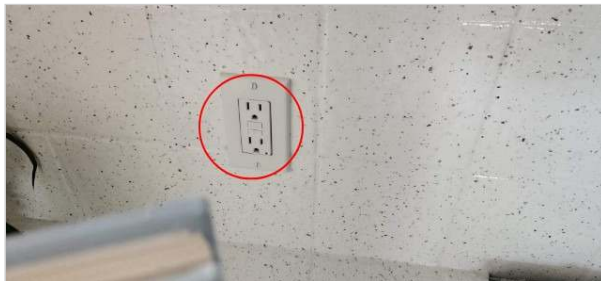
3. The kitchen stove/oven does not have its own dedicated circuit breaker. At the time of inspection, the stove/oven was plugged into an outlet that was wired to the circuit of an kitchen GFCI outlet. Recommend contacting a qualified electrician to install a new dedicated breaker for the stove/oven.

Kitchen - Stove Oven wired to GFCI outlet circuit.

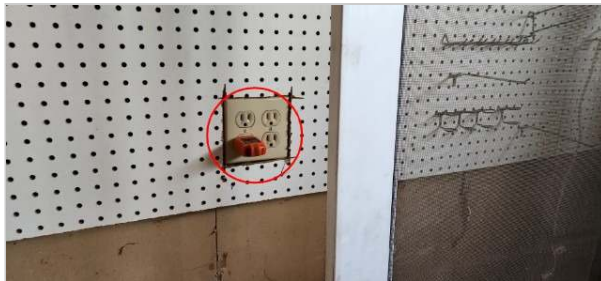
The inspector noted no power at an outlet in the garage. Questioning the seller on their operation is recommended. Consideration should be given to having a qualified handy person or electrician investigate the issue and provide repairs in order to establish functional service.

Garage - Defective outlet, no power

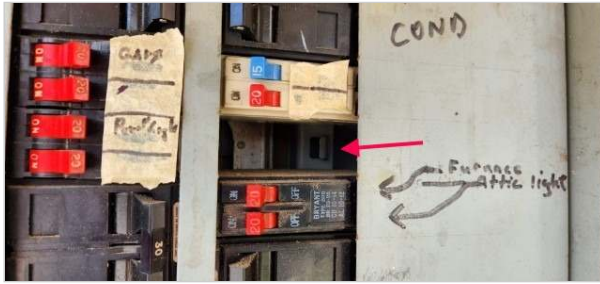
The inspector noted that there was a missing blank cover on the panel face. Installing a blank in the open slot is recommended as a preventive safety consideration. Blanks can be purchased at a home improvement center and installed by the homeowner.

Main Panel - Missing blank cover on unused breaker slot

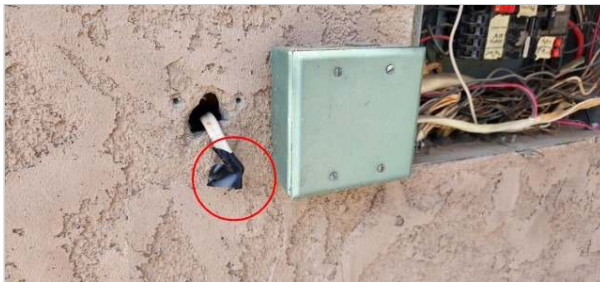
Improperly terminated wires noted near the electrical panel. The ends of spliced wires should be covered with a wire nut and electrical tape should be wrapped over the nut and onto the wires. Note, the inspector does not pull or track the source of terminated wires.

Main Service Panel - Improperly terminated wiring

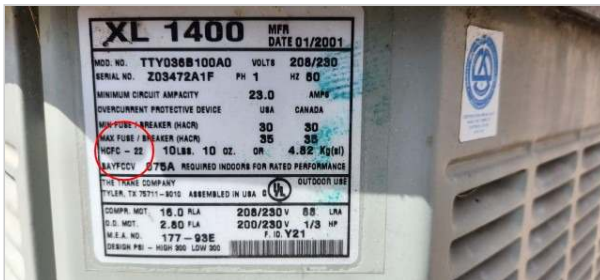
FYI - The air conditioner is an older unit which uses R22 refrigerant. The use of R22 was banned in the production of refrigeration and AC units by the EPA in 2010. This was replaced by the more environmentally-friendly R410a and other refrigerant blends. R22 refrigerant are not interchangeable with other refrigerant and recharging/repairing A/C units that use R22 can be prohibitively expensive. Replacement of the A/C unit is to be anticipated. For more information, please visit the EPA website (www.epa.gov).

Ratings Plate - R22 refrigerant

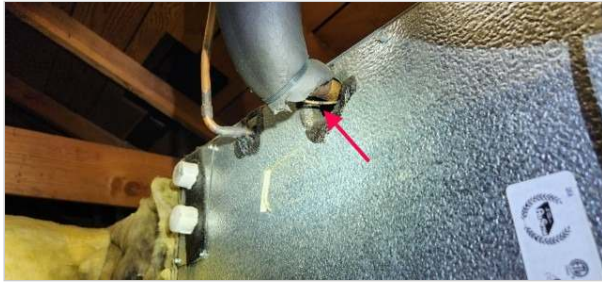
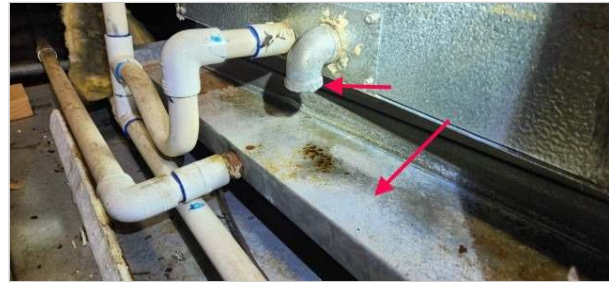
The condensate drain pan had excess water draining into the drain pan and there was visible water pooling which suggests there is a clogged or corroded condensate line. A clogged condensate line, a cracked condensate drain pan or a soggy furnace can lead to many unwanted issues. This includes: Microbiological growth, Safety hazards, low indoor air quality, unpleasant air odors, and water damage to the home. Contact a qualified HVAC technician to further evaluate and service the system.

Attic - Condensate Drain Line - Evidence of leak

Attic - Condensate Drain Pan - Excess Water / Water pooling

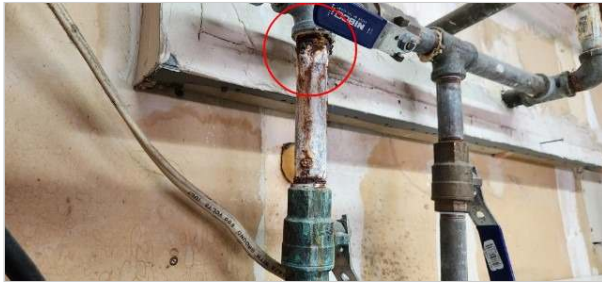
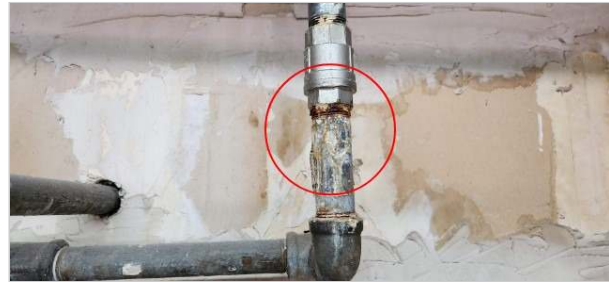
There are encrustations on the water connection(s) at the water supply pipes near the water heater. The condition is a result of a small amount of water seeping out along the threaded connections. It is recommended that the connections be removed and cleaned to remove any rust or corrosion and then taped with plumbers tape and reconnected. Contact a qualified repair person to perform this maintenance.

Water Heater - Encrustation on water connection

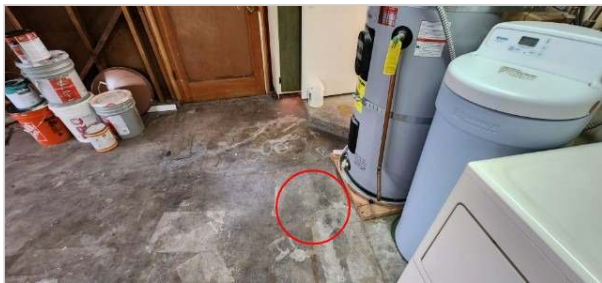
There was no protective barrier installed in front of the water heater. For safety and to protect against vehicular damage, adequate barriers must be installed (e.g. 4" diameter steel pipe filled with concrete installed in a footing measuring 12" in diameter and 3' deep and extending a minimum of 2'9" above the finished floor).

Water Heater - Protective barrier not installed

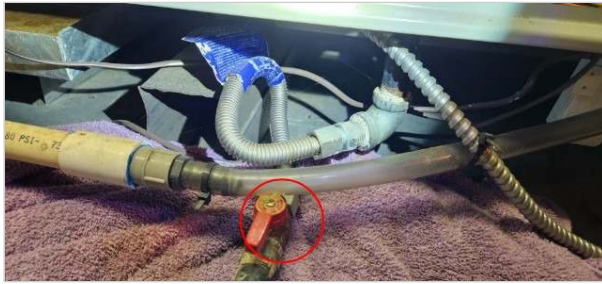
No sediment trap was installed at the furnace. Sediment traps are installed to keep particulates and moisture out of the gas valve and to prevent interference with the unit's burner operation. The Inspector recommends installation of a sediment trap by a qualified HVAC contractor. Check with your local jurisdiction for installation requirements.

Furnace - No Sediment Trap

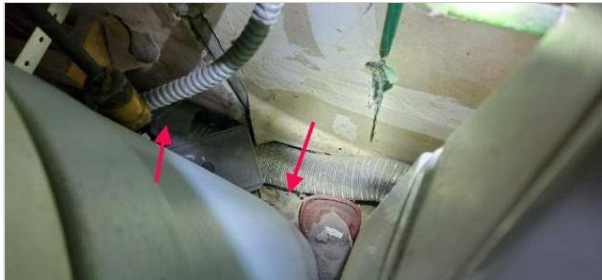
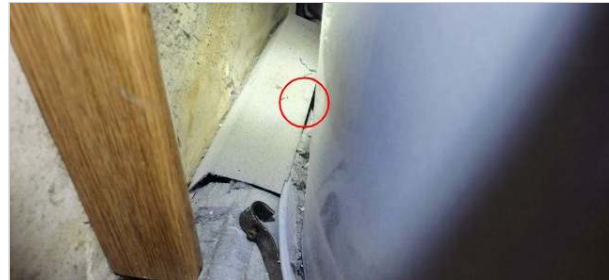
The dryer vent duct is disconnected which may inhibit proper ventilation and is allowing lint to accumulate behind the dryer. Dryer lint is very flammable. According to the National Fire Protection Association (NFPA), improper dryer ventilation leads to approx. 14,000 fires per year. Re-securing the vent duct and cleaning any accumulated lint debris is recommended.

Dryer Ventilation - Lint debris

Dryer Ventilation - Disconnected vent duct

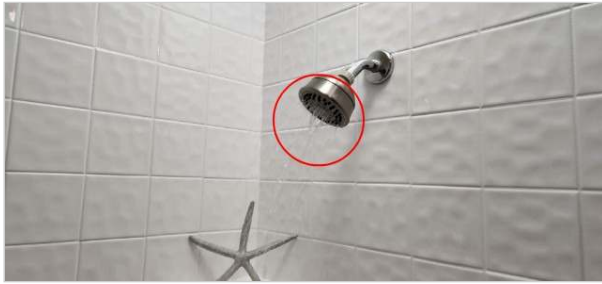
Hallway Bath - The shower fixture exhibited low water pressure. This condition could be excess calcium build-up in the shower head. Recommend contacting a qualified plumber for further evaluation and to recommend repairs.

Hallway Bathroom - Low water pressure

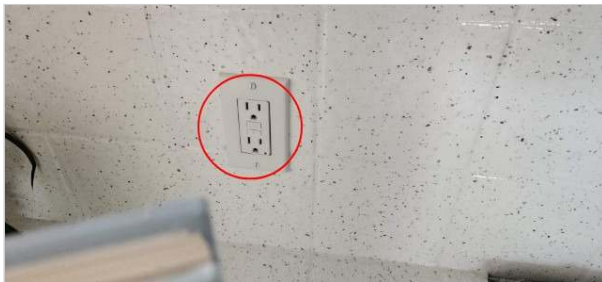
Stove Oven - The stove is plugged into an outlet that is wired to the same circuit as a kitchen GFCI outlet. This condition is improper and as a result, the GFCI trips when the oven is turned on. The inspector was unable to test the oven due to this condition. Recommend contacting a qualified electrician to install a new outlet for the stove.

Stove Oven - GFCI outlet trips when oven is turned on

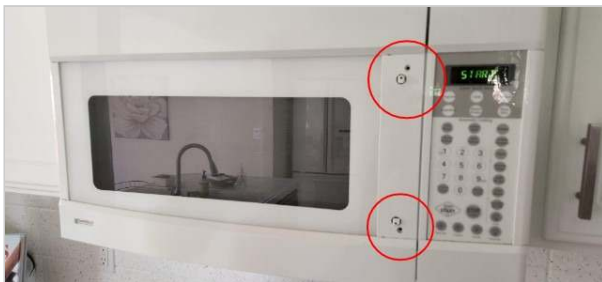
There is no handle for the microwave door. Repair is recommended in order to provide intended service.

Microwave - Handle missing

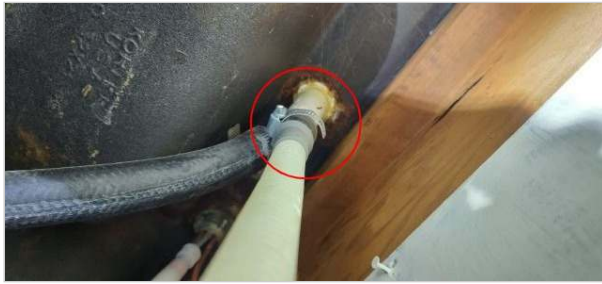
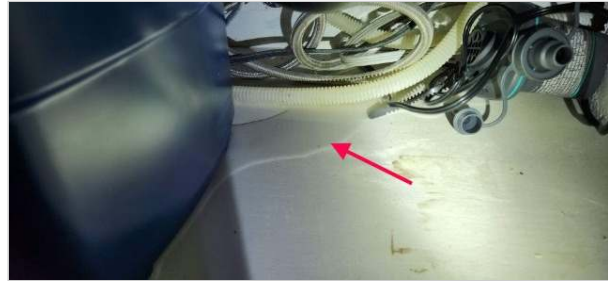
There is a minor leak at the drain line connection to the air gap when the dishwasher drains, indicating that there is most likely debris in the drain system. It is recommended that a qualified plumber be contacted to make needed repairs.

Dishwasher Drain Line - Minor leak at air gap connection

Evidence of Leak

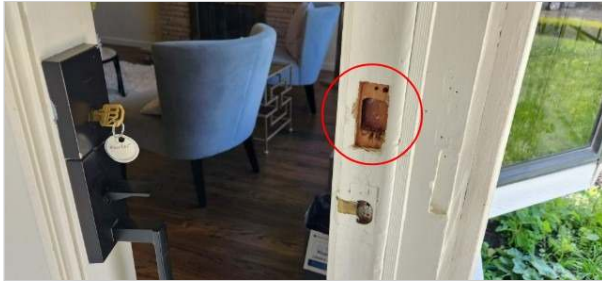
The main entry deadbolt lock is missing a strike plate. Installing the strike plate is recommended in order to protect the door jamb and allow the door to properly latch. Contact a qualified handyperson to make the repairs.

Main Entry Door - Missing strike plate

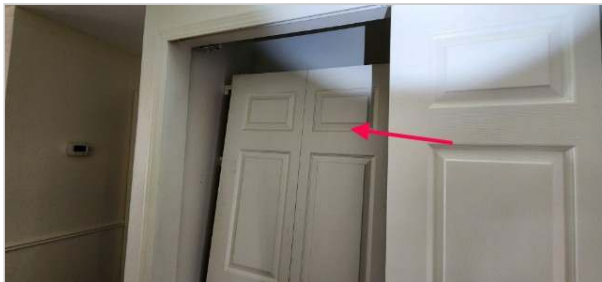
The hallway closet door is off its guides. Repair is recommended in order provide intended service. Contact a qualified handy person to make the repairs.

Hallway Closet - Closet door off guides

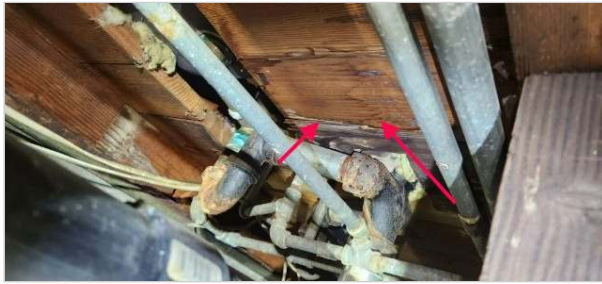
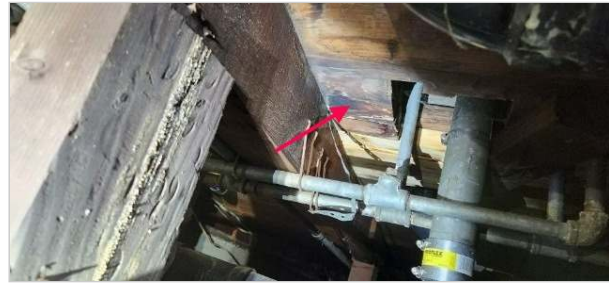
There are moisture stains visible under the master bath likely from past leak(s). There are no signs of wood deterioration and no evidence of an active leak. The stains in the area should be brushed and treated with chemicals such as "borates" which are well suited for both fungi and wood-destroying insects.

Crawlspace (Under Master Bathroom) - Moisture stains

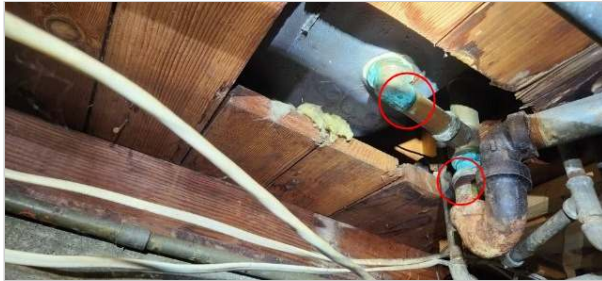
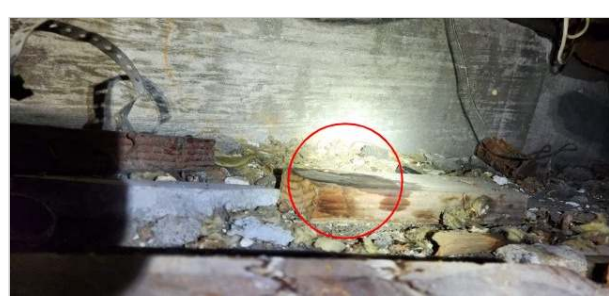
1. There is a minor drip/leak at the pipe fitting under the Master Bathroom tub. Recommended contacting a qualified plumber to evaluate and make the repairs.

Crawlspace (Under Master Bathroom Tub) - Leak at drain pipe fitting

Evidence of Leak

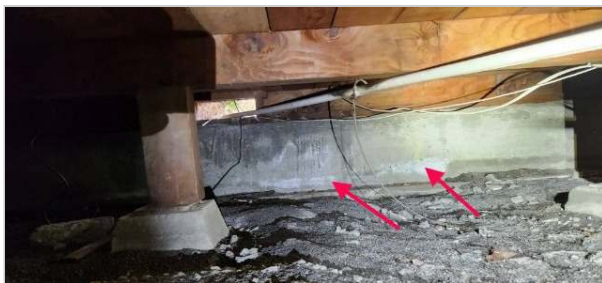
2. There is efflorescence (white chalky substance) on the inside of the concrete foundation walls in some areas that indicate a small amount of moisture has migrated from the outside through the concrete. This is common for structures of this age and does not necessarily indicate an excessive moisture condition that has allowed water to build up in the basement. There were no visible signs of water stains that would indicate excessive moisture build up has occurred in the recent past. Installing a concrete sealer on the inside of the foundation may help prevent future build up and reduce the build up of moisture.

Crawlspace - Efflorescence on stem walls

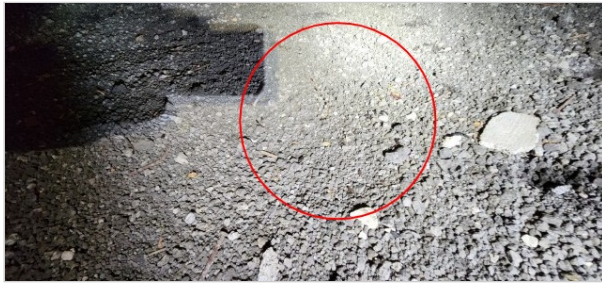
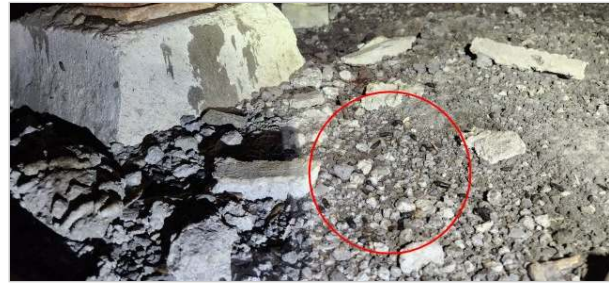
- There is evidence of past animal activity in the crawlspace area. Cleaning the area and sealing entry points is recommended to prevent small animals and rodents from entering the crawlspace. Contact a qualified professional for further evaluation and estimates

Crawlspace - Evidence of past rodent activity

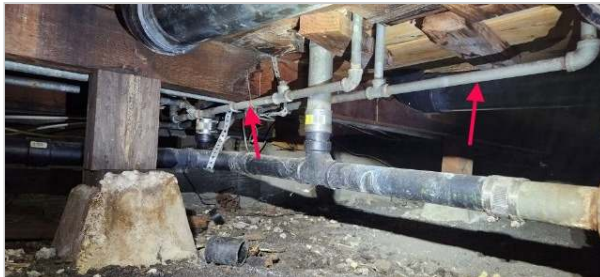
Galvanized steel piping has an average life expectancy of fifty to seventy years. When the pipes wear out, rust accumulates inside the pipe and restricts the diameter of the pipe, resulting in reduced water pressure and flow. Cleaning debris out of shower heads, faucet strainers and valves may improve flow for the short term. Replacing the supply piping in sections is a common practice for the readily accessible sections of piping in basements or crawl spaces. Consideration will need to be given to upgrading the galvanized supply water pipes when the flow is reduced to a level that does not provide the intended service.

Galvanized Steel
