**Property Address:** 3456 Anywhere Ave., Tucson, AZ 85000

Standard Full Home Inspection

## WIN Home Inspection

### Standard Full Home Inspection

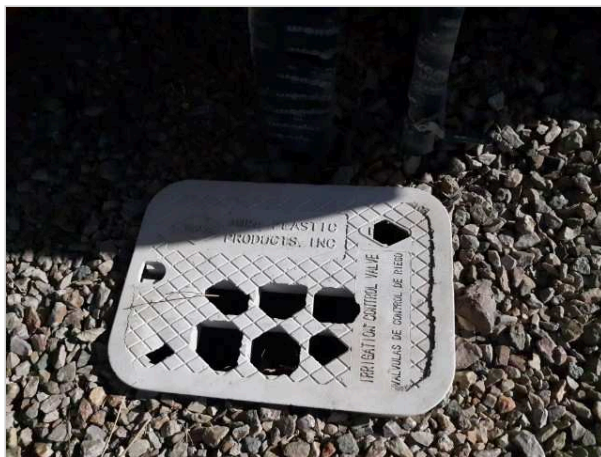
The property is equipped with an automatic watering system which adds a positive aspect to the property. Testing the system is not within the scope of the inspection. The cover for the irrigation control box is damaged and inside it appears to have been full of water at some point. The water is currently shut off and should be further evaluated by a qualified irrigation professional.

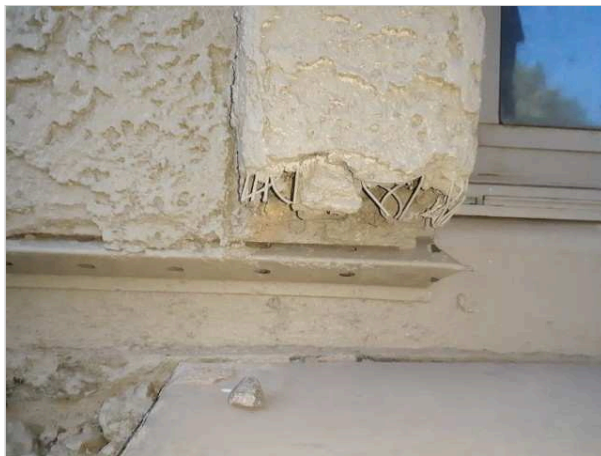
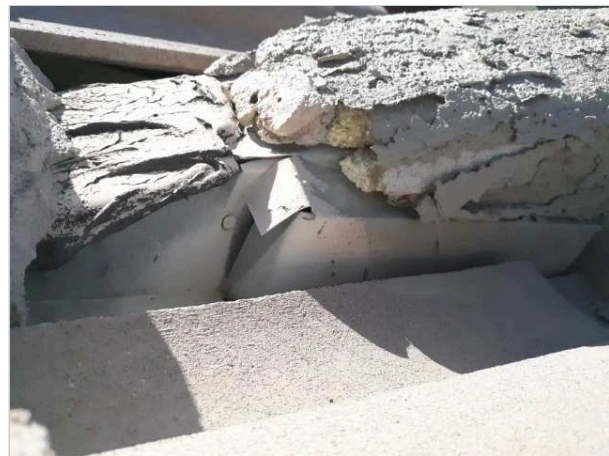
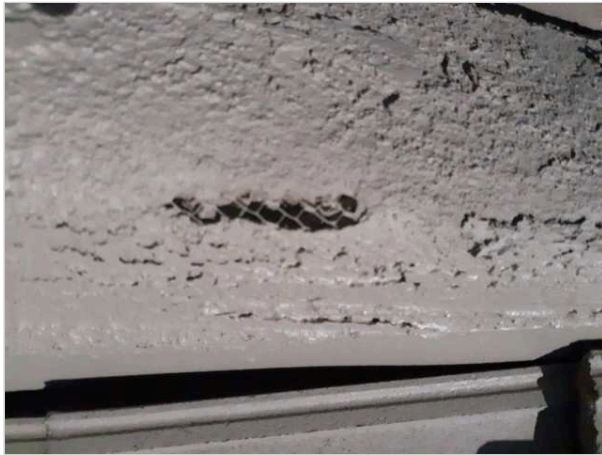
## 2. Exterior Structure - Siding Condition

Stucco damage has occurred at the back of the home around the exterior door as well poor stucco coverage in places on the parapets and the transition between the home and the roof is in poor condition. A qualified stucco contractor make the needed repairs.

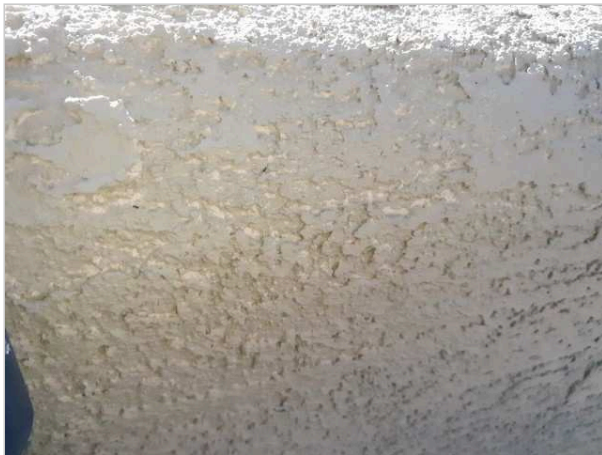
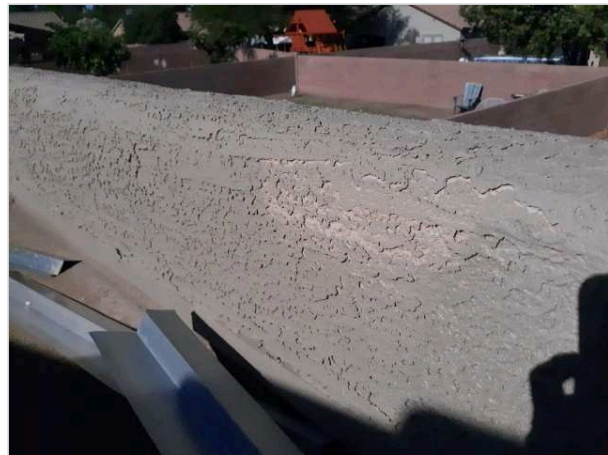
### 3. Exterior Structure - Painted Surfaces

The paint on the exterior of the home was not installed properly. Parpet paint has not covered properly. A qualified painter needs to correct this.

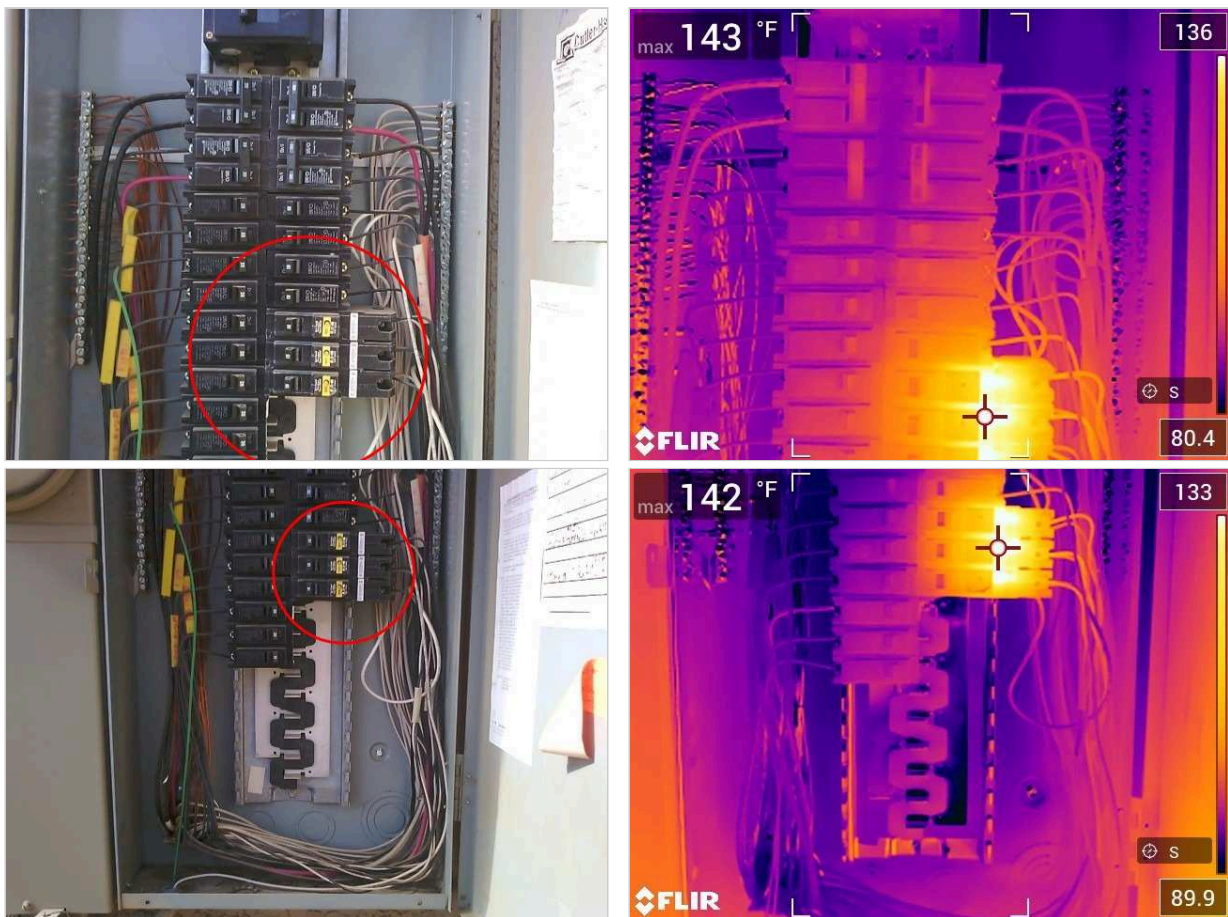
The electrical panel cover(s) are removed to provide access to the interior of the panel for inspection. An IR Thermal image of the panel indicates the arc fault breakers are approximately 143 degrees which is an indication of a potential issue and should be fully evaluated by licensed electrician.

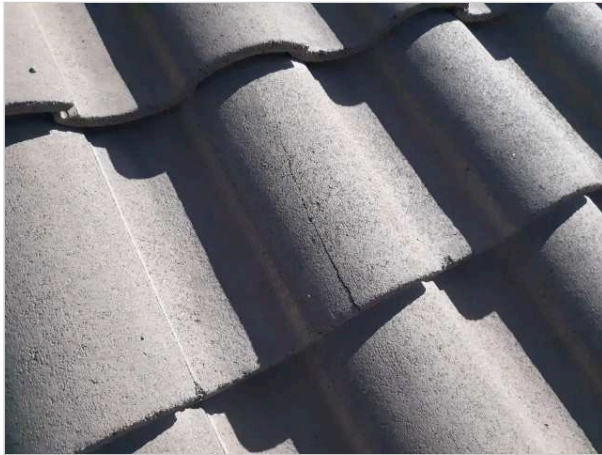
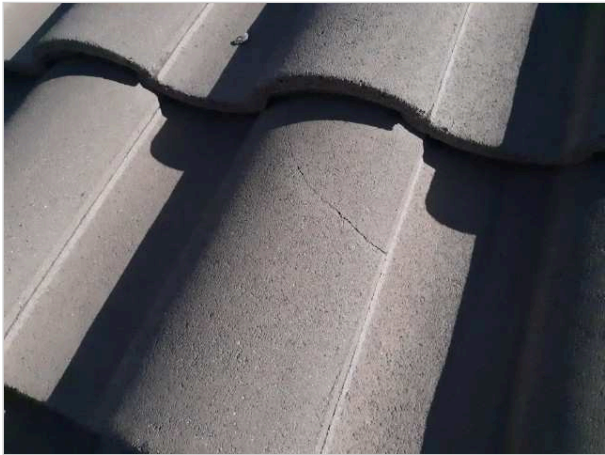
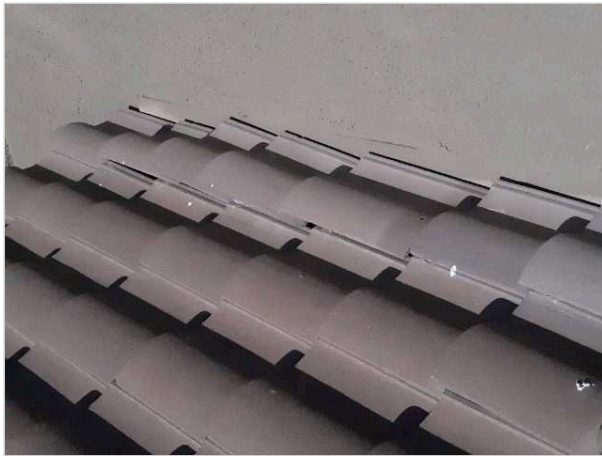
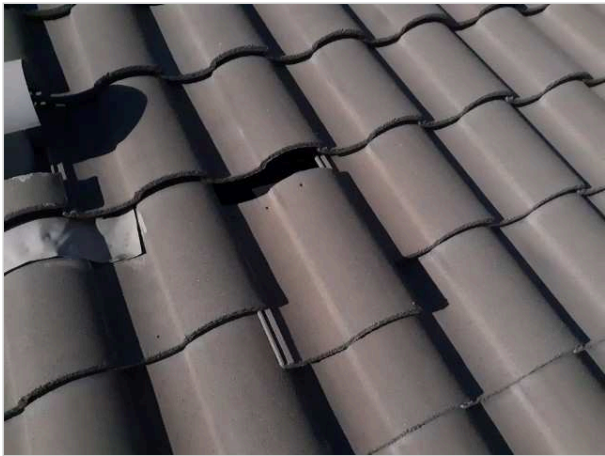
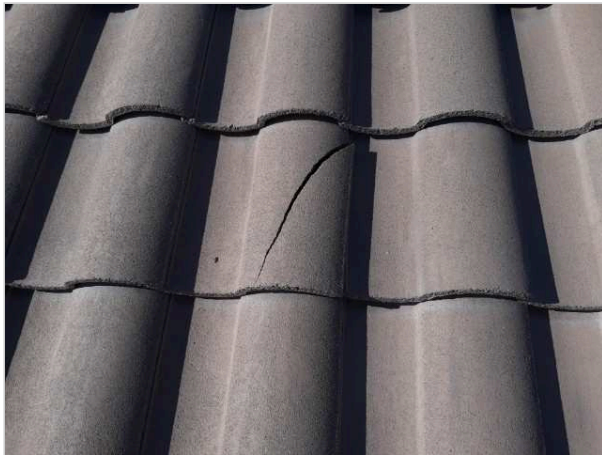
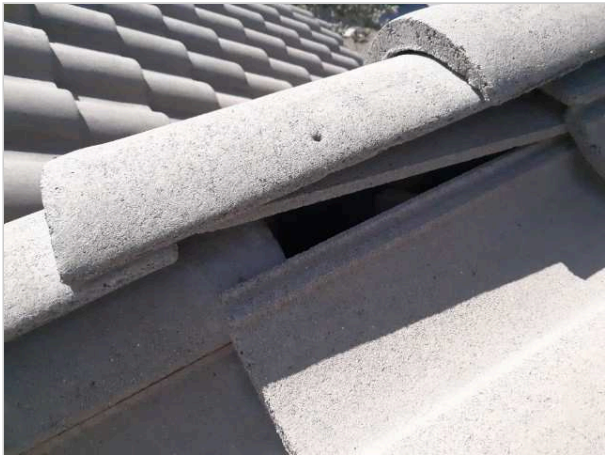
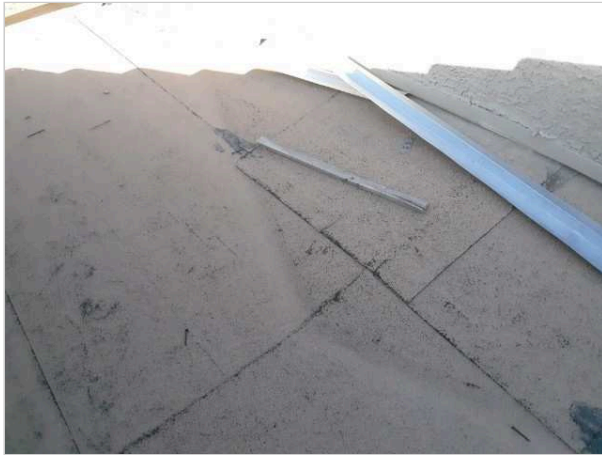
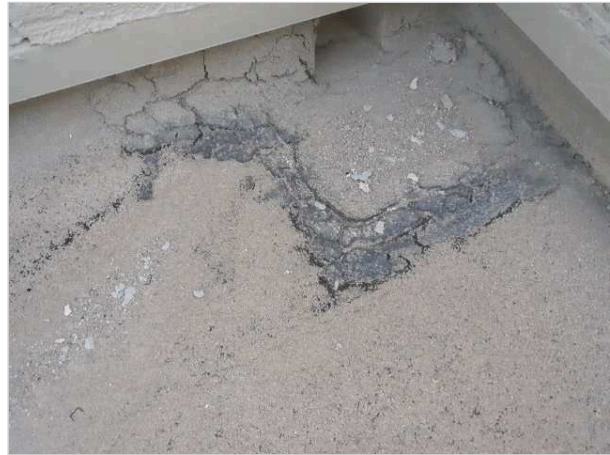
## 6. Roof - Cover Material Condition

The inspector found tile that were broken or cracked on the roof surface as well slipping tile. On the back porch there is debris that needs to be removed and allegatoring at the roof drains that need to be repaired. A licensed roofer can provide these repairs.

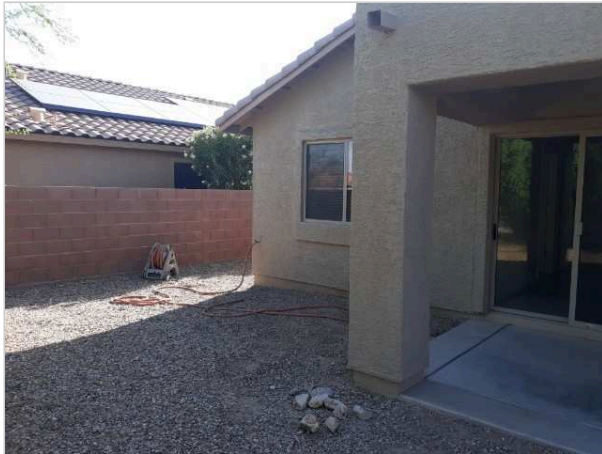
## 7. Roof - Drains/Splash Blocks

There are roof drains at the home that are emptying next to the structure perimeter. Roof drains that empty along the foundation wall are the most common cause of water penetration and settlement around the foundation of a home. Erosion is occurring due to this. Directing runoff a minimum of 4-6' away from the perimeter of the foundation is needed. Using extended gutters, splash blocks or installing drain rock with rock swales to direct drainage away from the foundation to natural drainage away from the home is recommended.

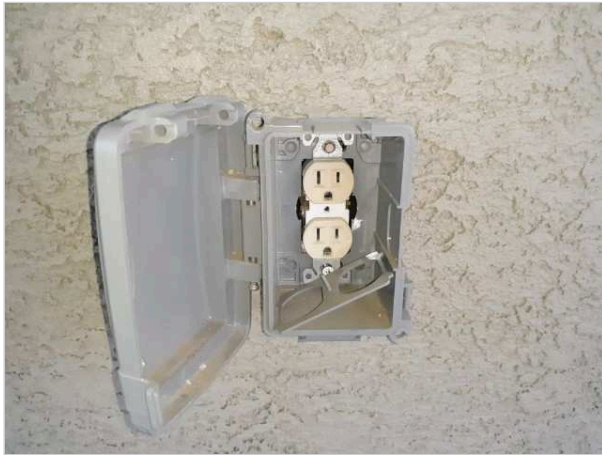
## 8. Patios/Decking/Porches - Electrical Service

The electrical receptacle on the porch has been taken partially apart and needs to be repaired by a qualified handyman or electrician.

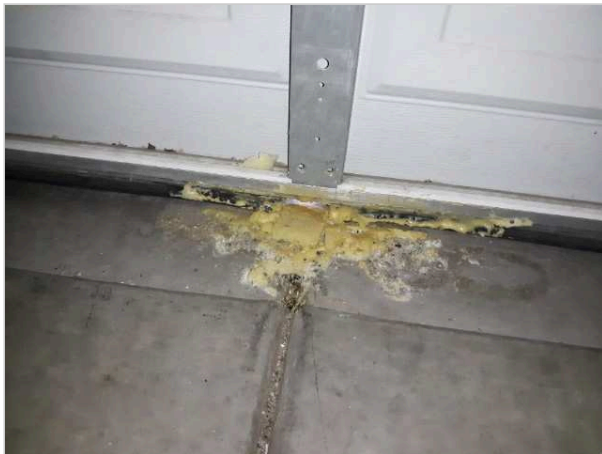
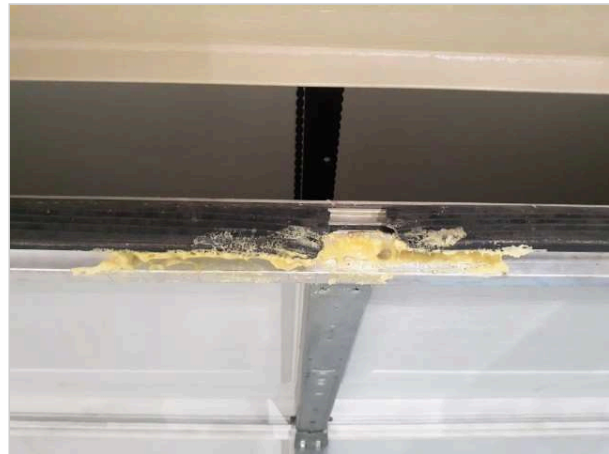
The seal along the bottom of the garage door is damaged. Spray foam has incorrectly been applied to this area and needs to be removed and the seal replaced by a qualified garage door tech.

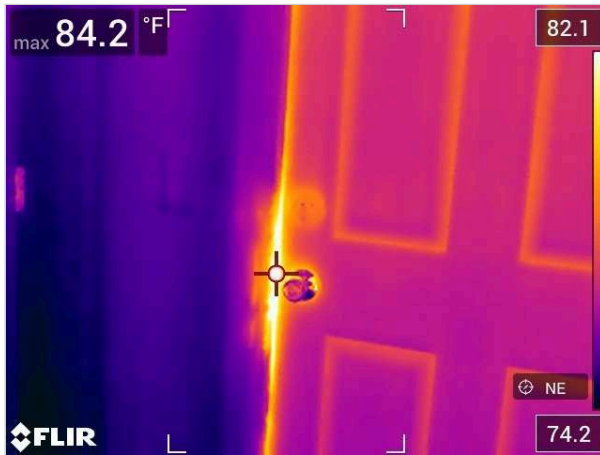
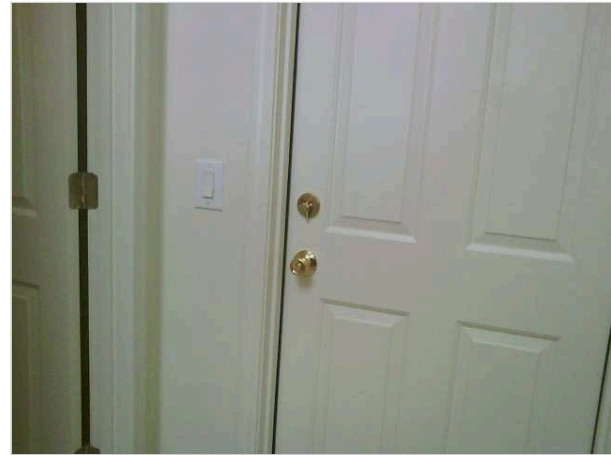
## 11. Attached Garage - Door(s), Garage - Building

The passage door between the home and garage should self close and have a fume/weather seal installed to help prevent losing conditioned air from the home and maintain protection from car exhaust etc. The door seal is not functioning properly as noted in the IR Thermal image of heat passing from the garage into the home. Adjustment/repair is required for functional service. A qualified handyman or contractor can perform this maintenance.

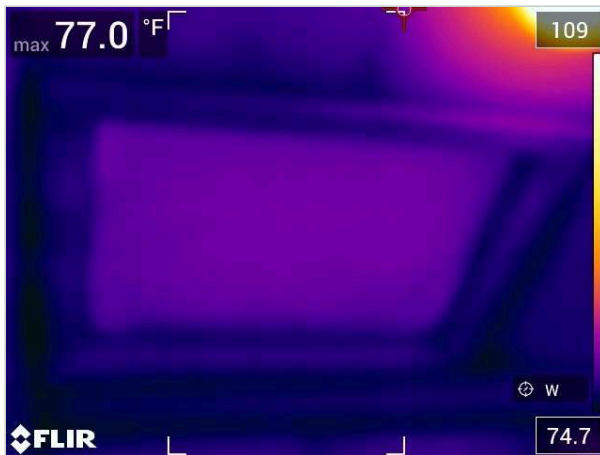
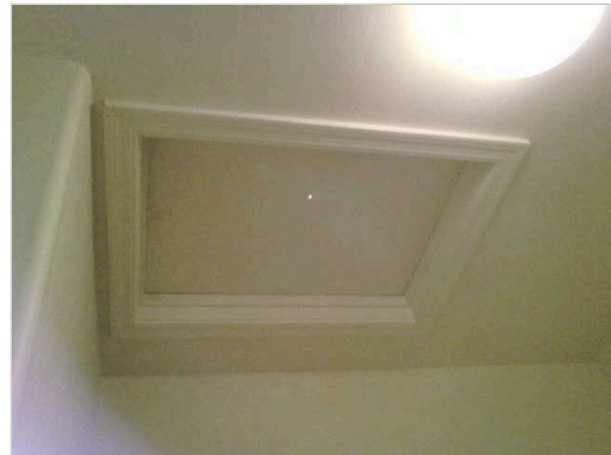
## 12. Attic - Access

Access to the attic was satisfactory. The attic access cover however is not insulated which was determined with an IR Thermal image and confirmed in the attic. The cover needs to have a piece of fiberglass batt insulation installed and glued to the cover.

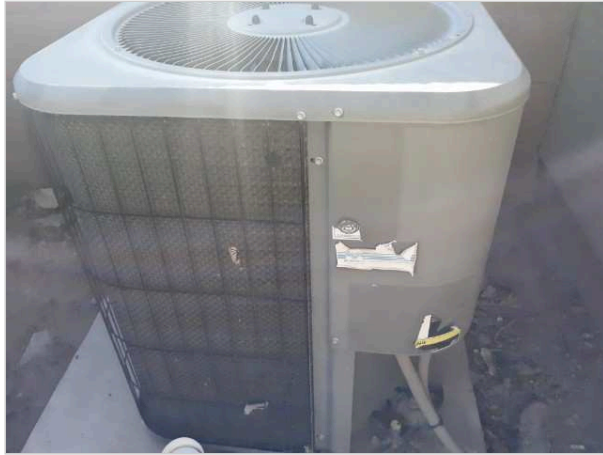
The inspector was not able to determine the capacity of the HVAC unit. The information tag has been non typically removed. A licensed HVAC tech can provide further information.

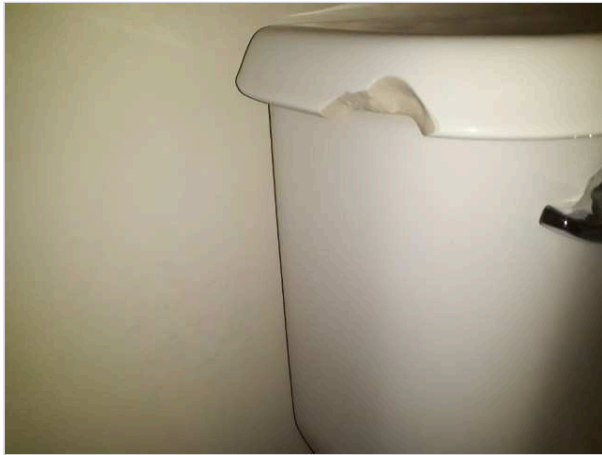
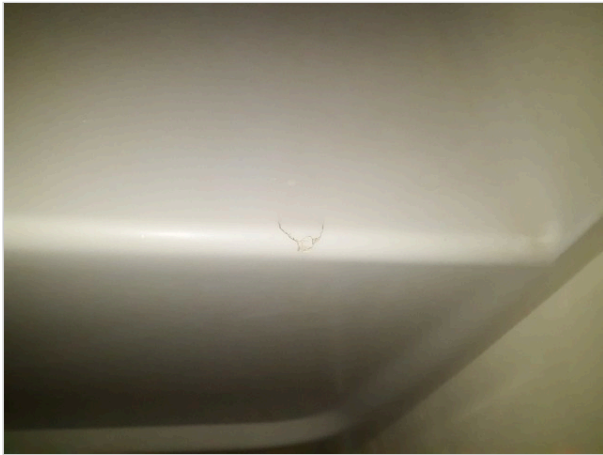
The master bathroom toilet is fully loose and the hall toilet rocking . These need to be properly secured to the floor/repared as needed by a licensed and qualified plumber.

Additionally the tank lid is broken and by its appearance had fallen off the tank and landed on the tub edge as the fiberglass tub is also damaged. The tank lid should be replaced and the tub repaired by a qualifed contractor.

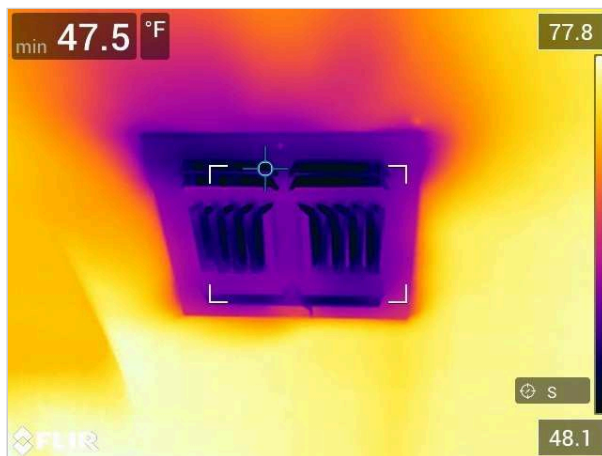
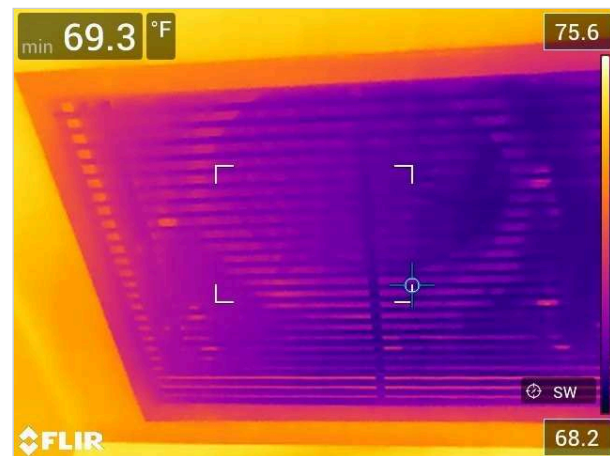
Temperature Split(s) 69/47

Temperature splits refer to the ambient temperature taken in the home near the air return and the contrasting temperature coming from the registers in the home. This provides a differential value by subtracting the temperatures which indicates if the A/C system is operating within a normal conditioned air temperature range. The inspector is looking for a temperature value that is within 15-20 degrees. Based on that and other information obtained a recommendation is made in the "On/Off Check" comment below. This is designated by split temps with location information as necessary such as: (70-50)N This indicates 70 degrees ambient, 50 degrees(average) at registers in the north portion of the home if there are more than one system in the home otherwise in single system homes (70-50) would be the numbers used.
