Service: Condo Inspection

Prepared for: Sample Report

WIN Inspector

Damien Devine

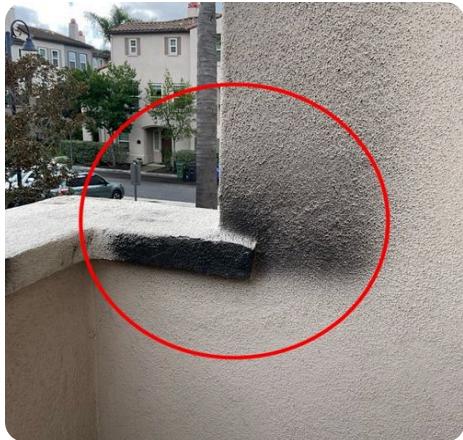
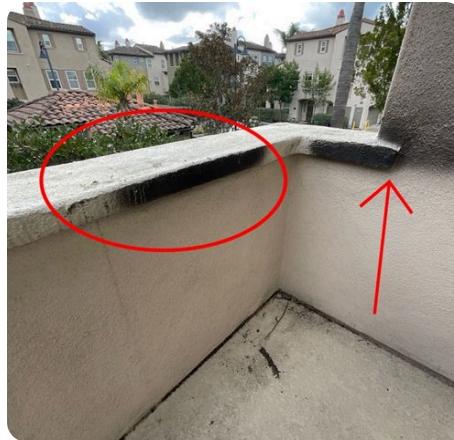
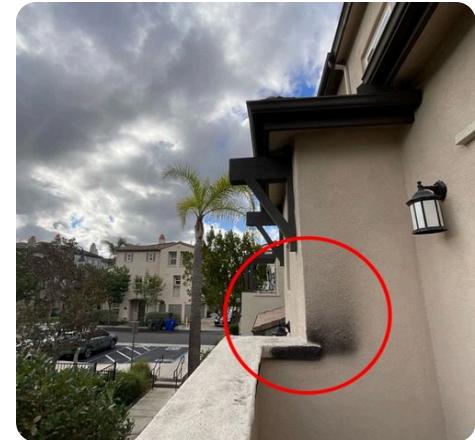
1 Stucco Burn Marks From Barbecue**Repairs Recommended****Location: Front Deck**

The burn marks on the stucco at the balcony from the barbecue could indicate potential fire hazards and structural damage. It is recommended to evaluate the extent of the damage and repair as necessary to ensure safety and prevent further deterioration. A licensed contractor or stucco repair specialist should be consulted for appropriate repair options. Contact the HOA for evaluation and painting or repairs.

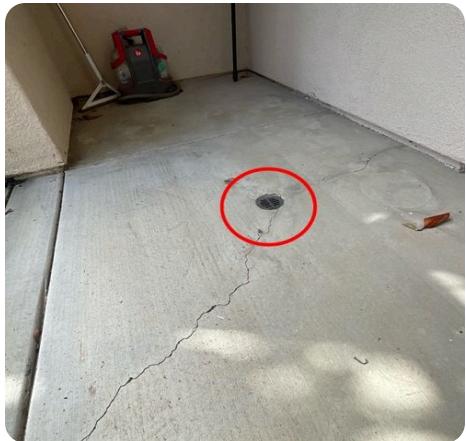
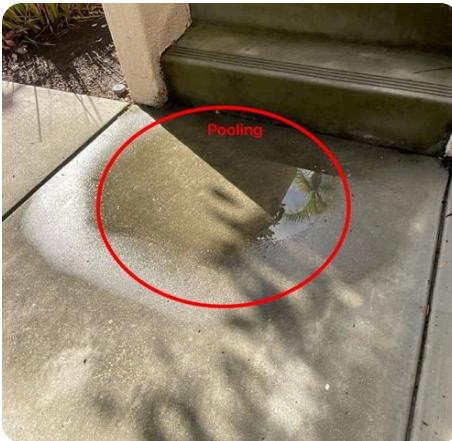
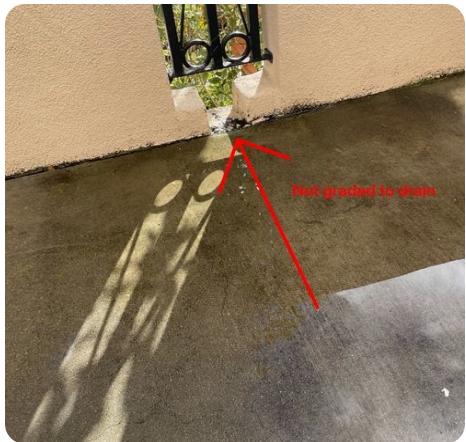
**2 Grading Recommendations****Repairs Recommended****Location: Front Porch**

The grading around the perimeter of the foundation should be maintained to adequately drain excessive surface and roof runoff water away from the structure. Due to the soil type and/or amount of water from surrounding areas, even flat lots may hold water. It is recommended that the grade slope away from the structure at least 6" for the first 6'-10' away from the foundation.

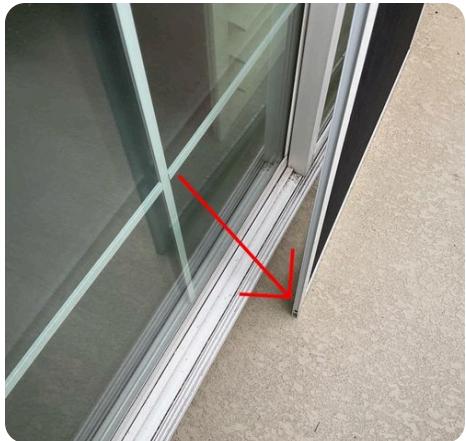
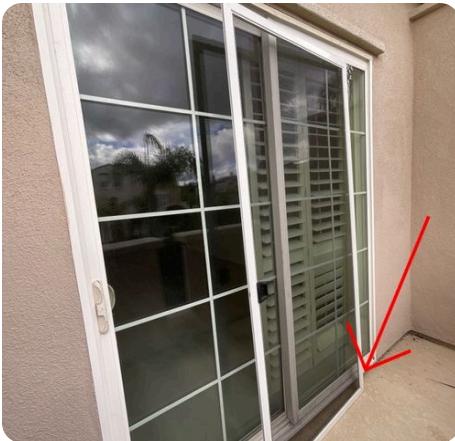
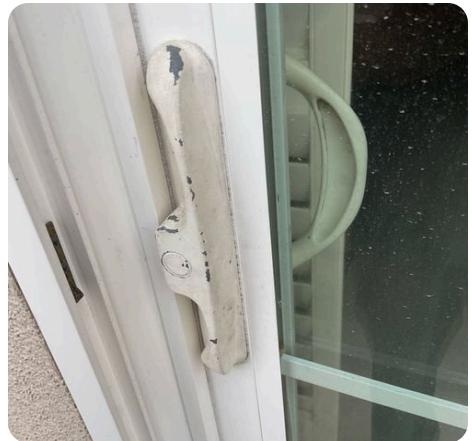
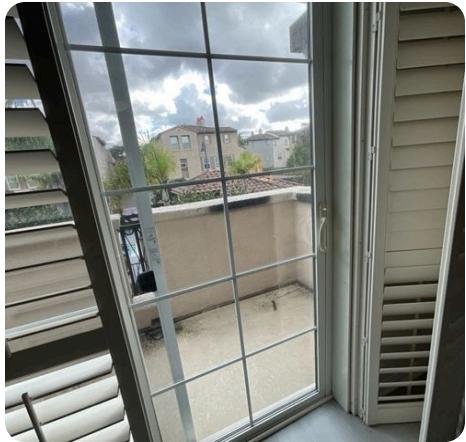
3 Sliding Screen Door Is Off Track

Location: Front Deck, Living Room

The sliding screen door at the exterior is off track. It is essential to fix this issue to ensure proper functionality of the door and to prevent any damage or inconvenience. It is recommended to contact a qualified repair person or a door repair specialist to evaluate and repair the sliding screen door.

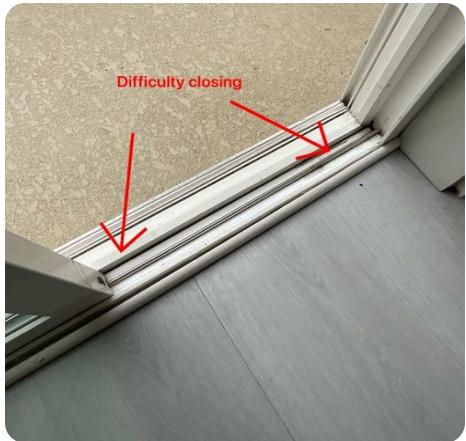
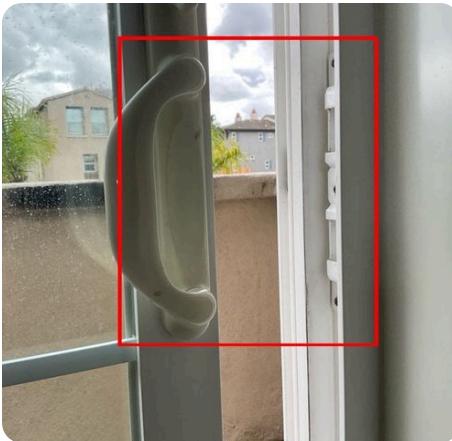
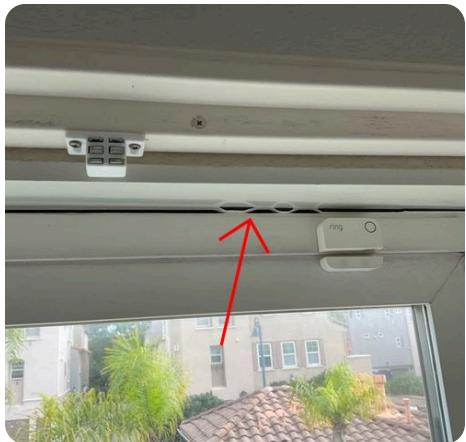
4 Stiff Sliding Glass Door

Location: Front Deck, Living Room

The sliding glass door at the exterior does not slide smoothly, which could pose inconvenience and potential security risks. It is recommended to have a qualified window and door company or a trade professional evaluate and repair the sliding glass door to ensure proper functionality.

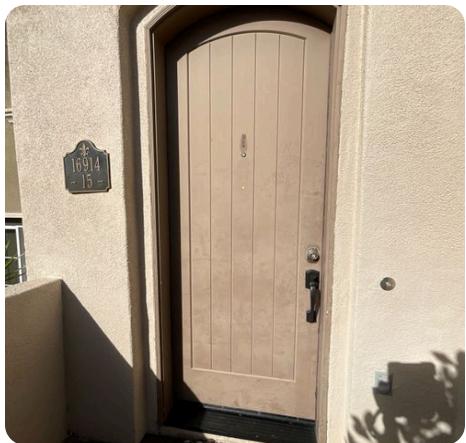
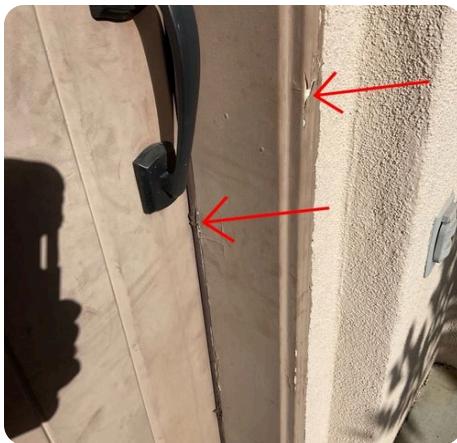
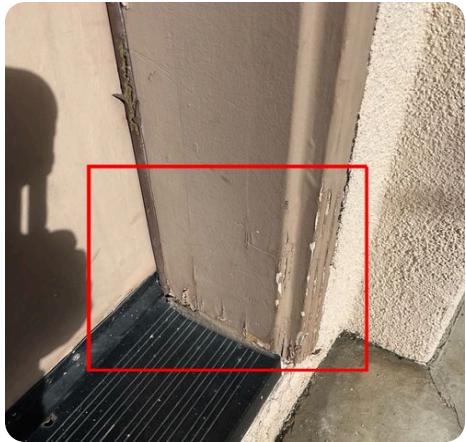
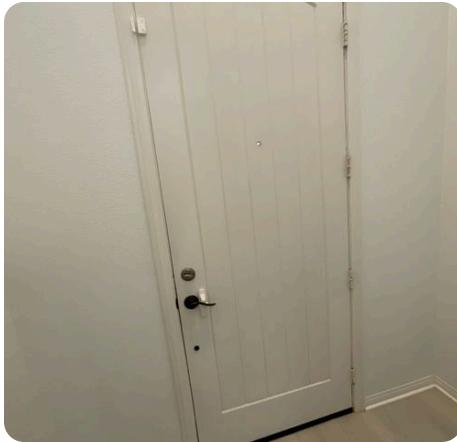
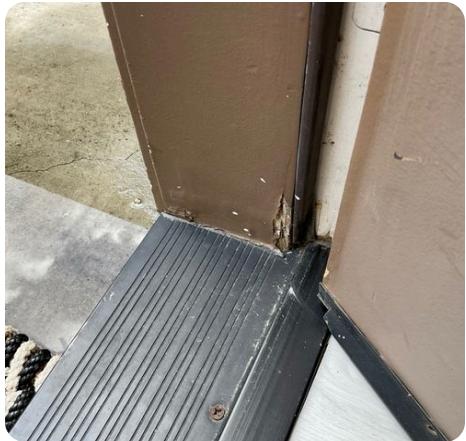
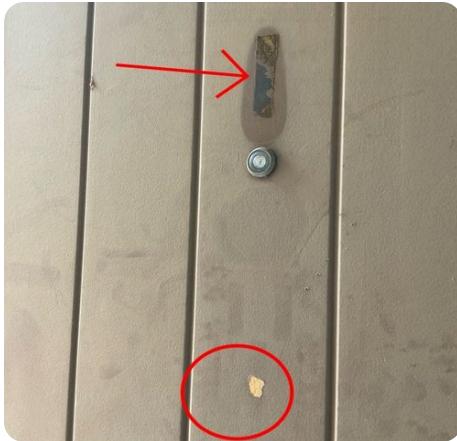
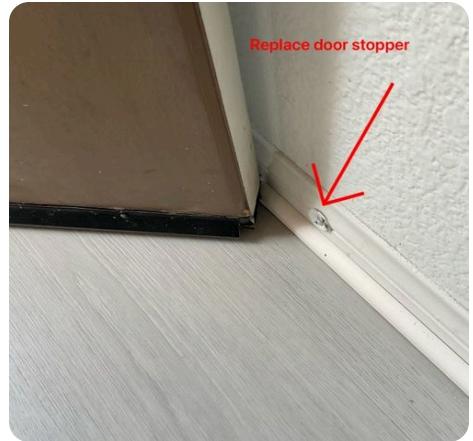
5 Repainting, Weather Stripping, And Door Stopper Replacement

Location: Main Entry Door

The exterior door shows signs of wear, especially on the paint which helps protect the door from elements. Repair or repaint any areas of concern to prevent deterioration. Additionally, check and replace the weather stripping as needed to improve energy efficiency and weather protection. Lastly, consider replacing the door stopper to prevent interior damage and ensure proper functionality.

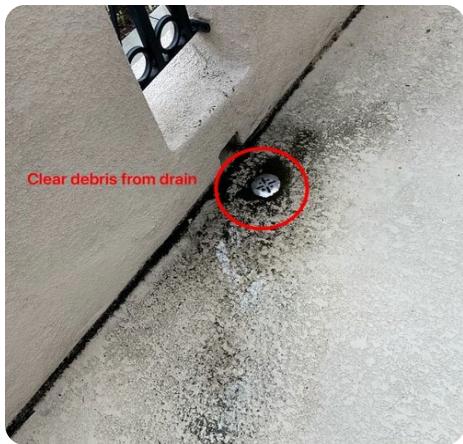
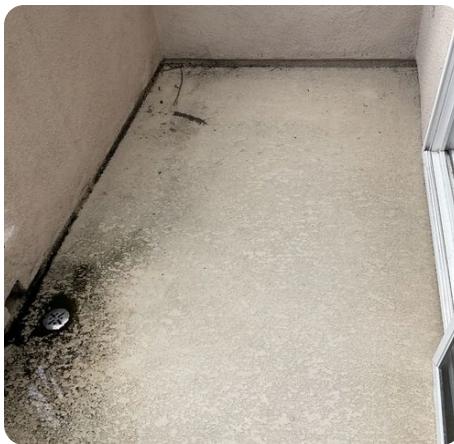
6 Sub Framing Not Visible

The foundation, or underside, is not visible due to the type of installation or low clearance. Issues may exist that are not visible. If examination is needed, contact a qualified professional for further assessment.

The drain requires cleaning to prevent flooding.

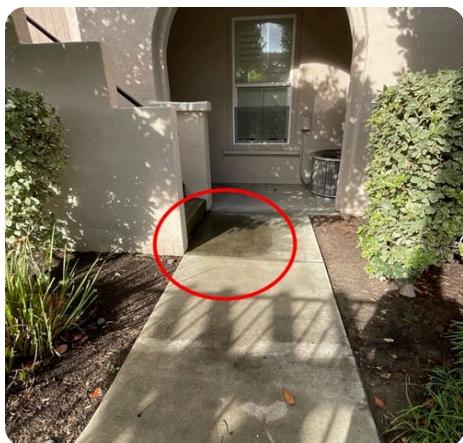
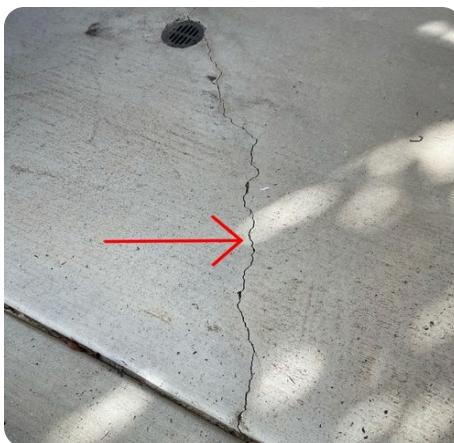
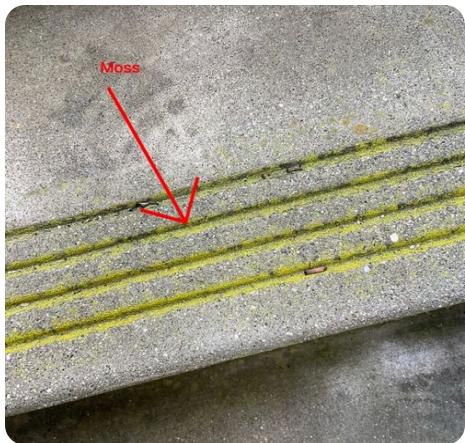
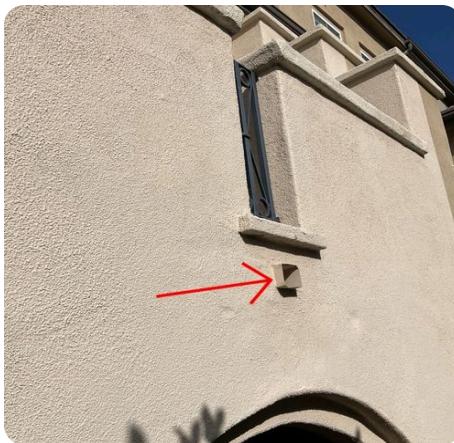
7 Pooling Water At Stairs

📍 Location: Front of Home, Front Porch

Pooling of water at the top and bottom of the stairs is observed. This could lead to safety hazards and potential water damage to the structure over time. It is recommended to evaluate the drainage in these areas and make necessary repairs to prevent water accumulation.

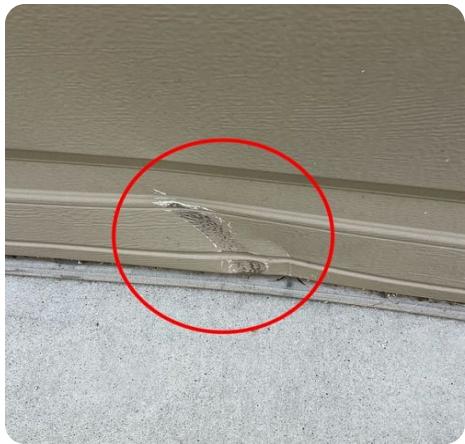
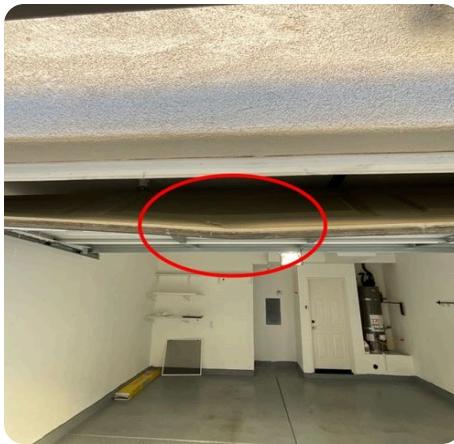
8 Garage Door Panel Damage**⚠ Repairs Recommended****📍 Location: Garage**

The garage door panel has minor damage. It is recommended to evaluate and repair the damaged panel to prevent further issues and maintain the door's functionality. A qualified garage door repair professional can assess the extent of the damage and provide repair options.

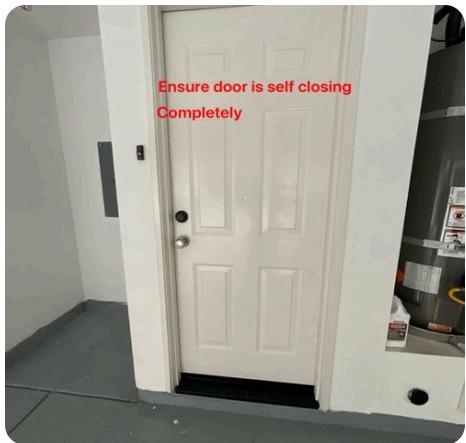
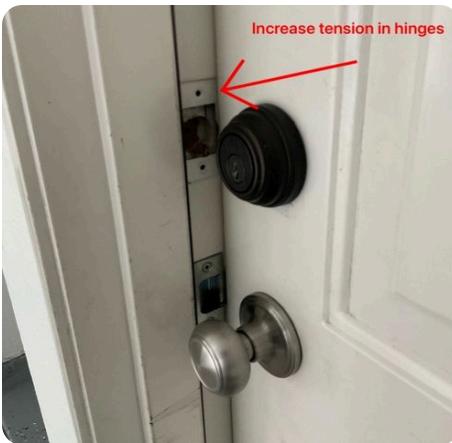
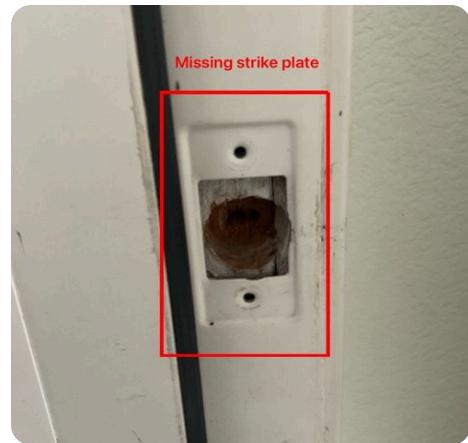
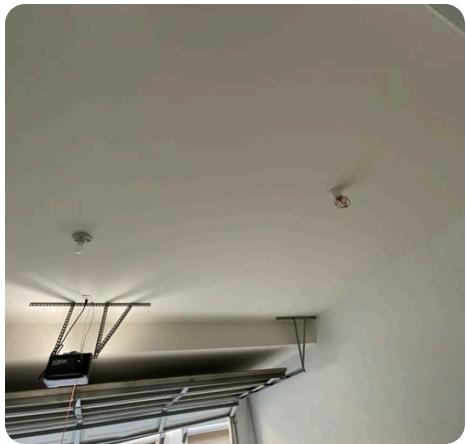
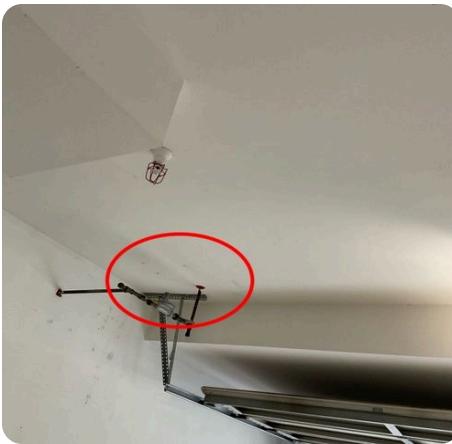
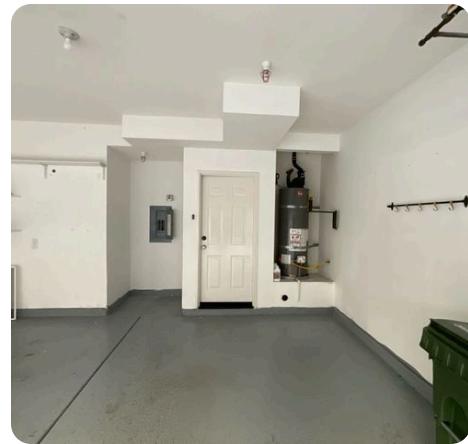
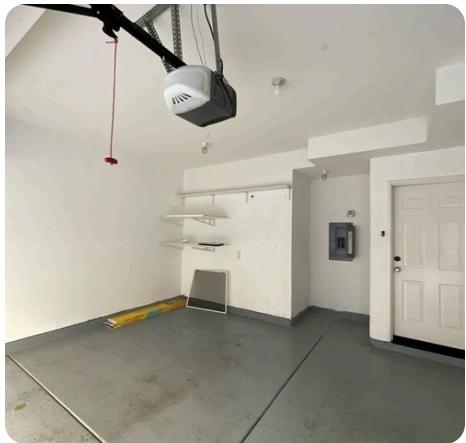
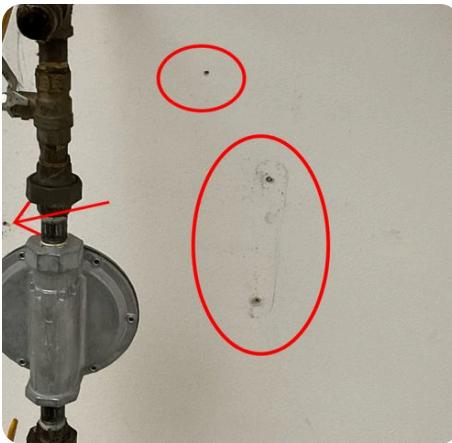
**9 Firewall Protection****⚠ Action Required****📍 Location: Garage**

All openings of more than 1/8" are recommended to be sealed to maintain a proper firewall barrier. Increase tension in self closing hinges to ensure the fire door closes completely. The strike plate is missing.

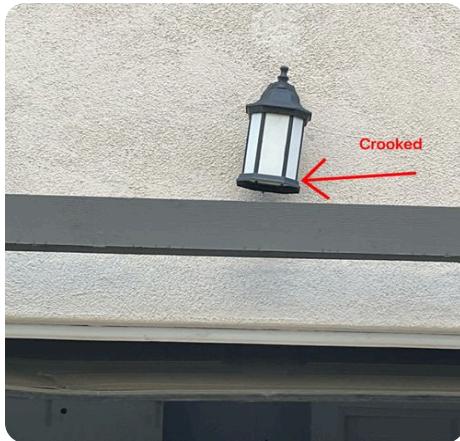
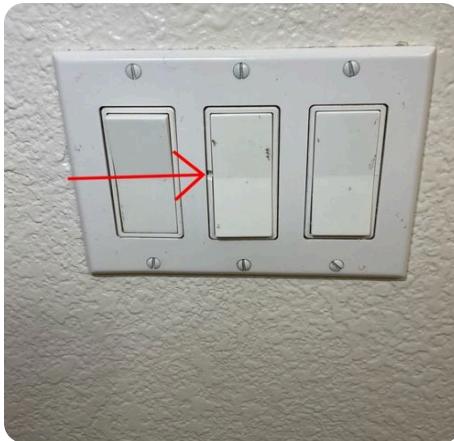
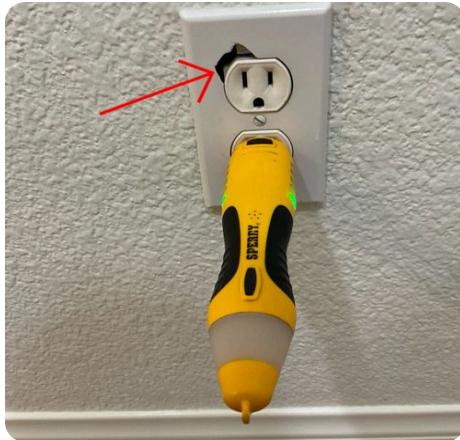
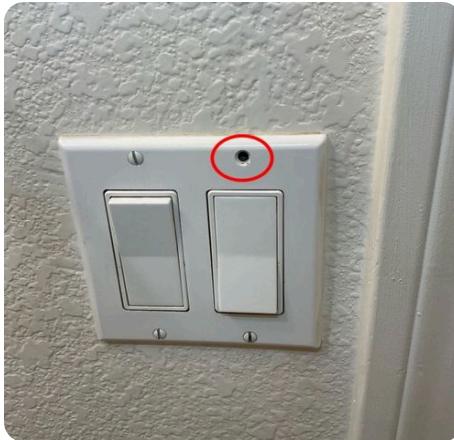
The condition of the outlets, switches, and junction boxes that were visible and accessible at the time of the inspection, were evaluated. Electrical outlets are recommended to be replaced if cracked/damaged to prevent arcs which might be caused by a worn outlet. Occupied homes often have furniture and stored items covering electrical outlets, switches, and junction boxes that limit their accessibility.

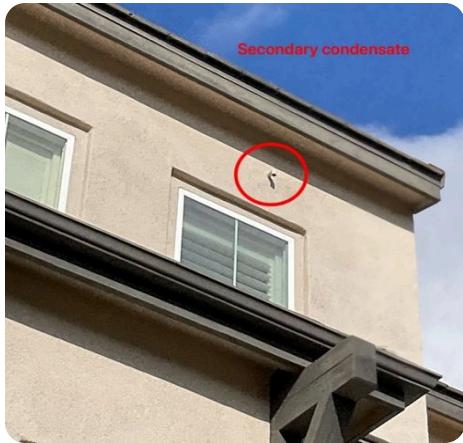
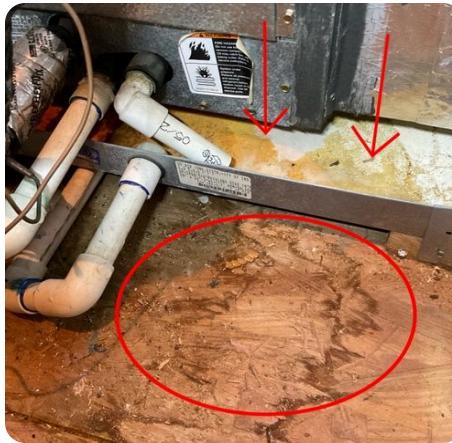
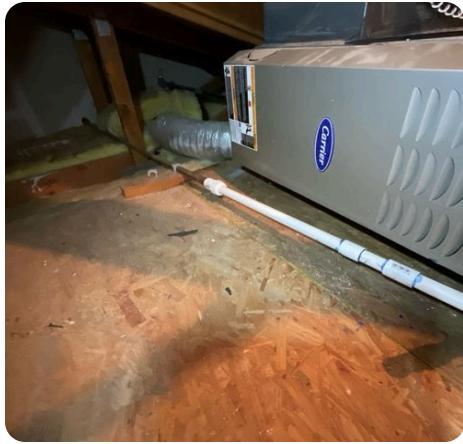
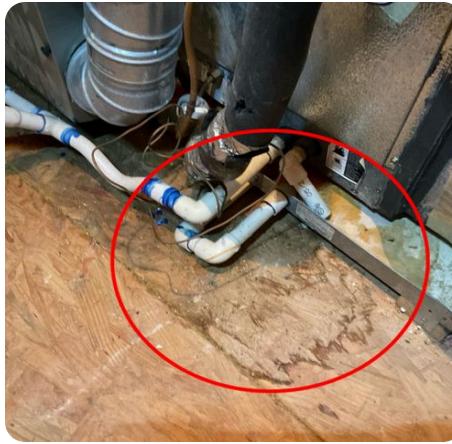
11 Condensate System Evaluated (Moisture Stains)

Moisture stains noted in and around the drain tray in the attic. Contact a qualified HVAC company for flushing the condensation lines and adding a safety switch to prevent flooding.

The condensate system is a critical component of your HVAC system, responsible for removing condensation produced by the evaporator cooler. Ensuring the condensate system is functioning properly helps prevent moisture damage. If you notice any leaks, blockages, or unusual noises, it is advised to have a qualified HVAC technician evaluate and repair the condensate system.

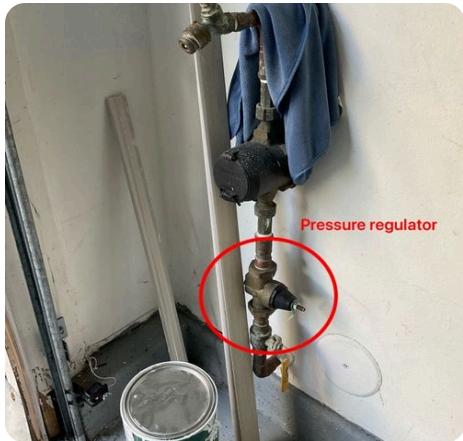
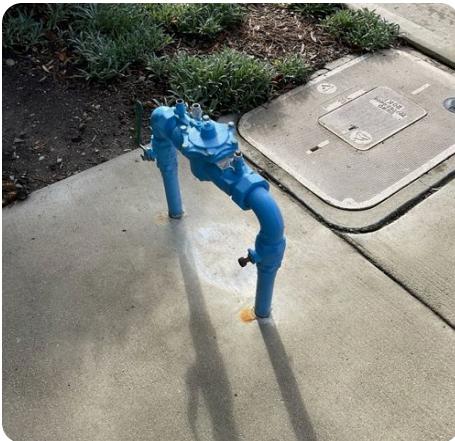
12 Water Pressure

The water pressure at the exterior faucets is approximately 100 +- psi. Recommended water pressure is between 40 and 70 psi. We suggest a pressure regulator be installed, adjusted or replaced if the pressure exceeds 80 psi. Note: The excessive water pressure can reduce the life expectancy of the plumbing lines, void warranties of certain appliances, and cause premature leaks in fittings, landscape irrigation and faucets.

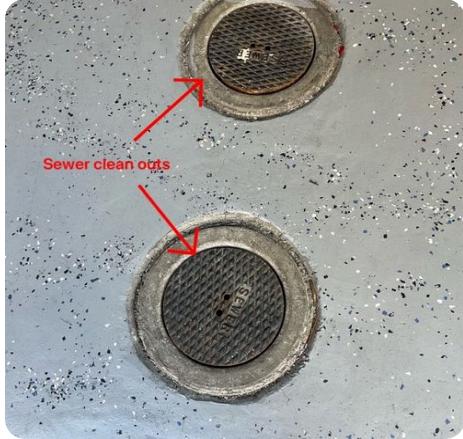
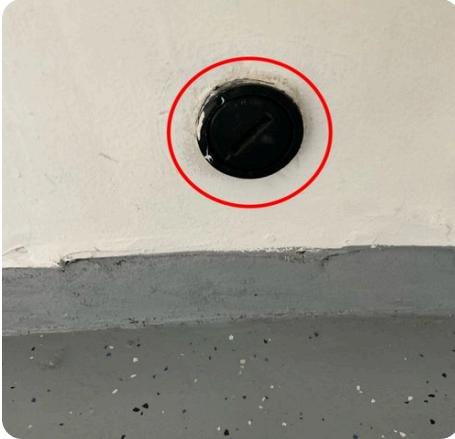
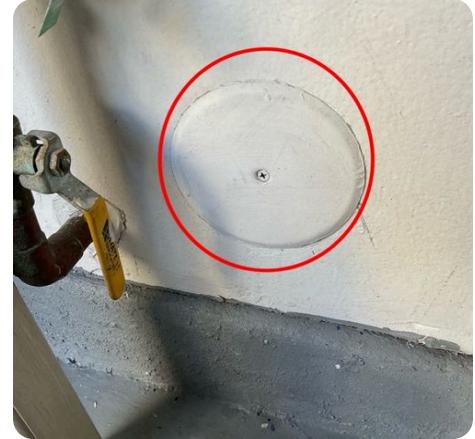
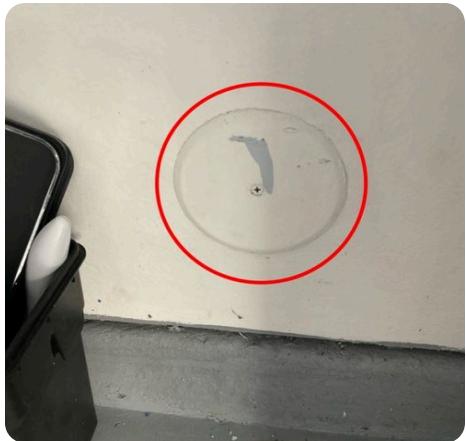
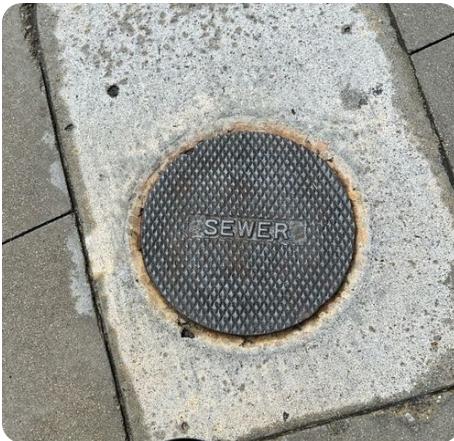
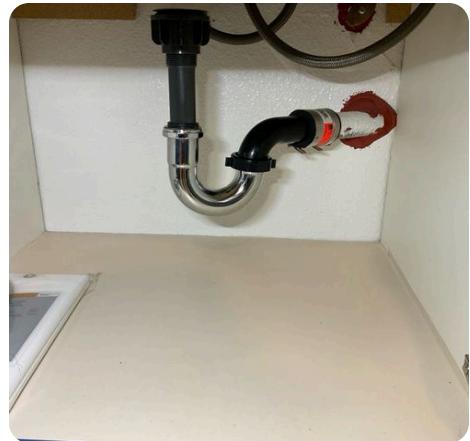
**13 Visual Inspection Of Drain Pipes****Preventive Measure**

This is a visual examination of the exterior piping. We recommend questioning the seller regarding their knowledge of any slow draining or other plumbing-related issues. Also, a video examination of your waste system is recommended to determine if any obstructions exist inside the waste lines.

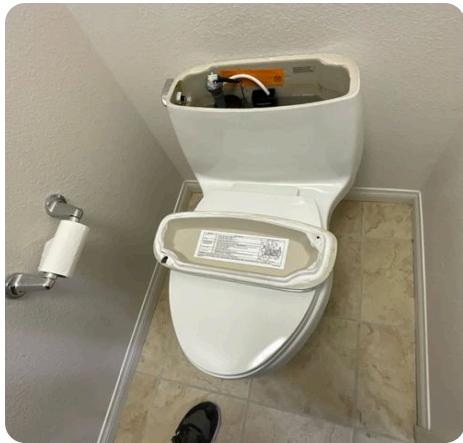
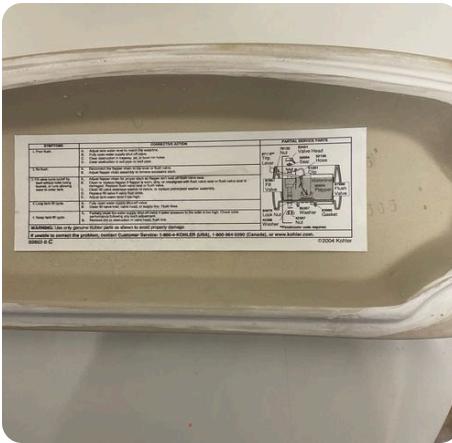
14 Inadequate Flush

The toilet is not flushing properly due to an issue with the flushing mechanism. Maintaining a fully functioning toilet is crucial for proper sanitation. It is recommended to have a qualified plumber evaluate and repair the toilet for a proper flush.

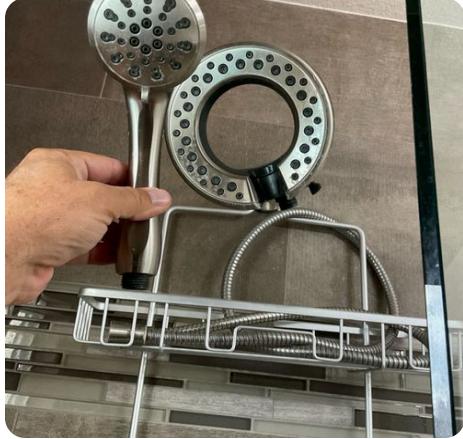
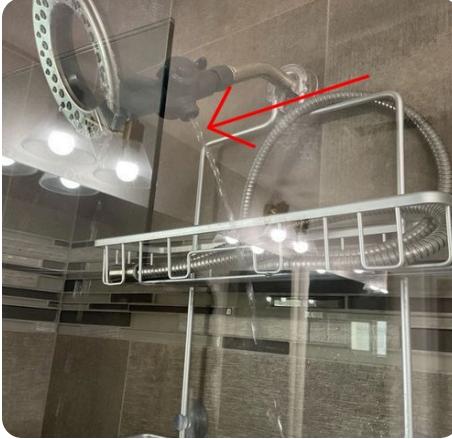
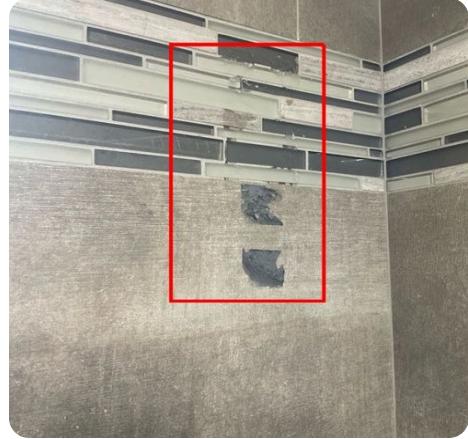
**15 Disconnected Shower Head****⚠ Repairs Recommended****📍 Location: Primary Bathroom**

The shower head is disconnected. This issue can result in water leakage and affect the water pressure during showers. We recommend reattaching the shower head securely to prevent any water damage and ensure proper functionality. If needed, a licensed plumber can assist with the reattachment to avoid any further issues.

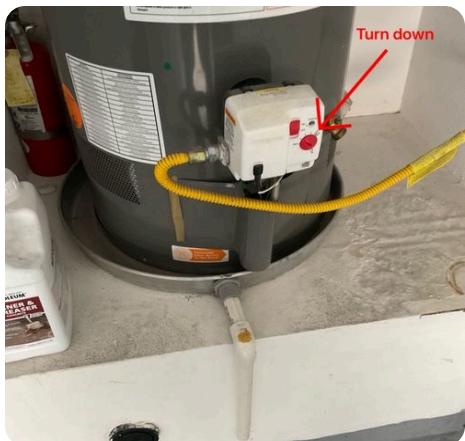
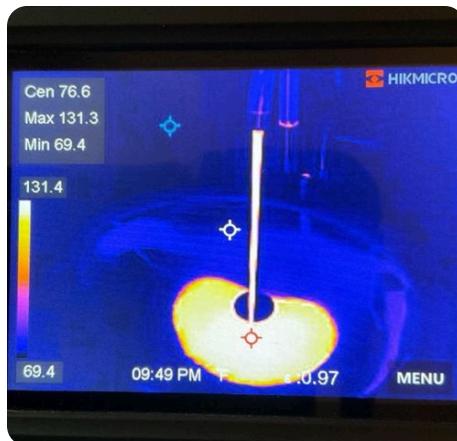
**Water Heating Equipment****16 Caution! Water Too Hot****⚠ Repairs Recommended****📍 Location: Garage**

The water temperature at the faucet was too hot. Lowering the setting is recommended. Temperature settings on water heaters should be set so that the temperature of the water at the faucets is 120°F or lower. This will provide the most efficient operation and also reduce the danger of potential burns from scalding. Temperature adjustment can be made at the dial on the water heater.

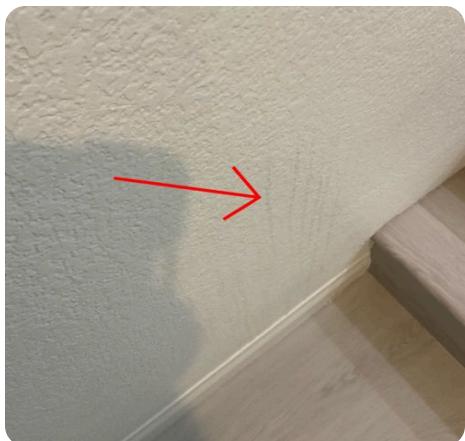
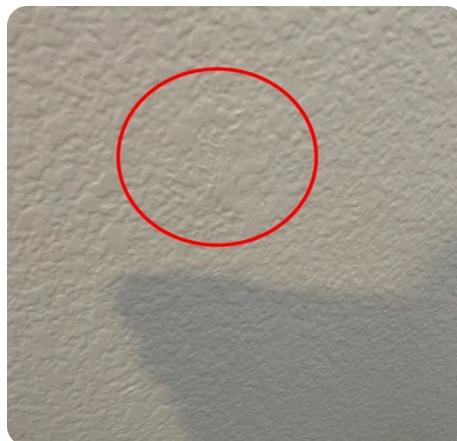
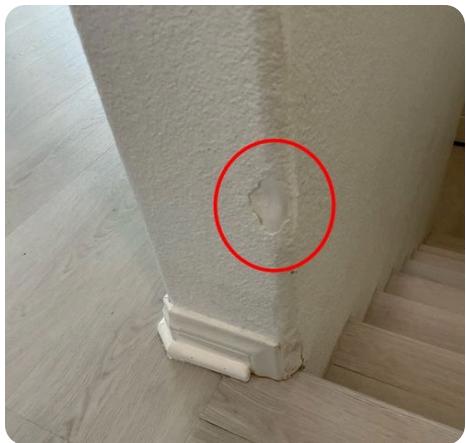
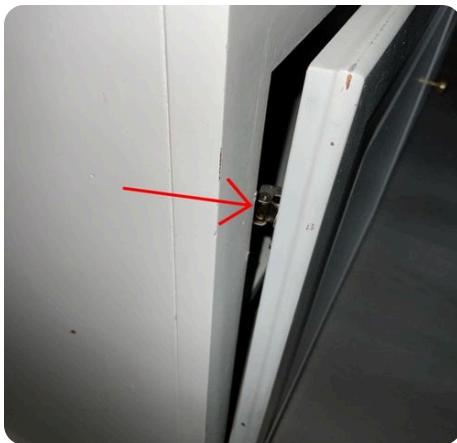
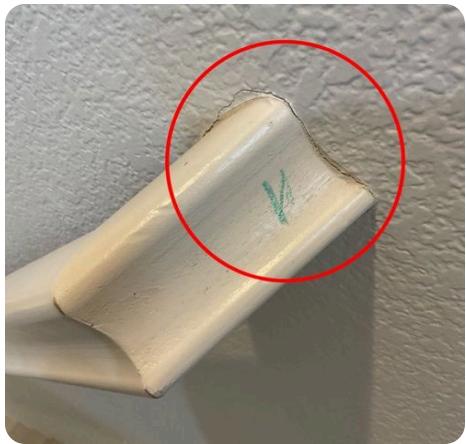
17 General Cosmetic Damage

The floors, walls, and ceilings exhibit some general cosmetic damage, which is typically superficial and does not impact the structural integrity of the property. It is recommended to assess and address these cosmetic issues for aesthetic reasons. Depending on the extent of the damage, options may include patching or replacing affected areas, repainting or refinishing surfaces, or seeking assistance from a professional contractor for more substantial damages.

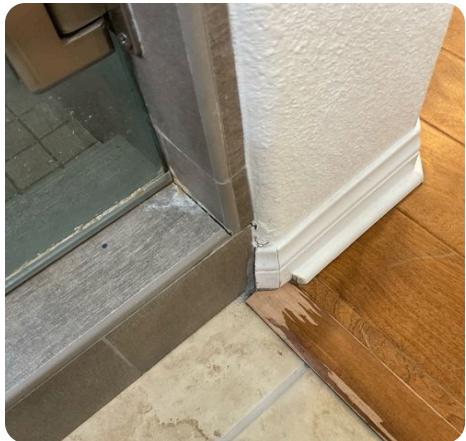
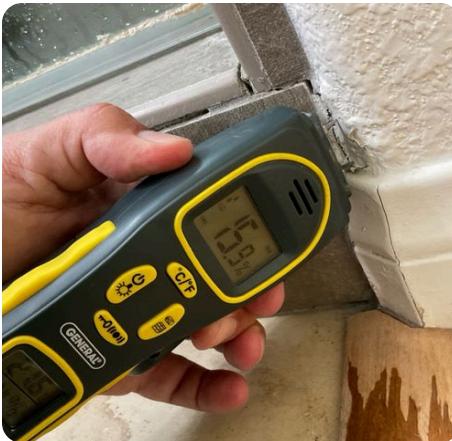
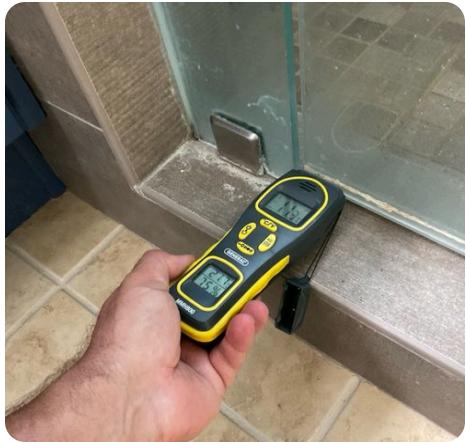
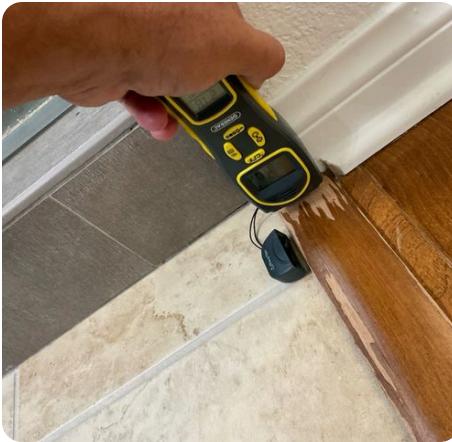
18 Moisture Issue Outside Of Shower

The presence of moisture outside of the shower area is a common issue that can lead to mold growth and water damage. It is recommended to properly seal any cracks or gaps in the shower enclosure to prevent water seepage. Additionally, ensuring that the shower door is properly sealed and that the ventilation fan is functioning effectively can help mitigate moisture buildup.

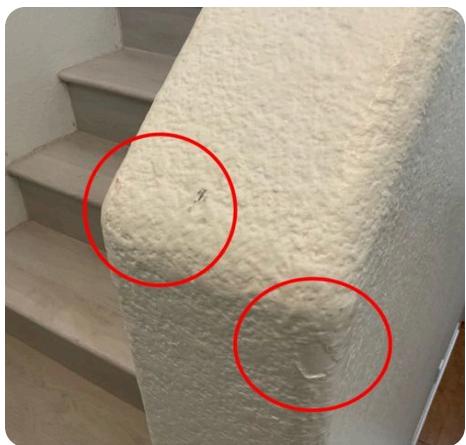
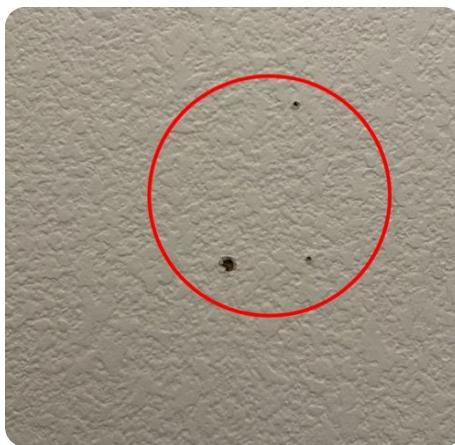
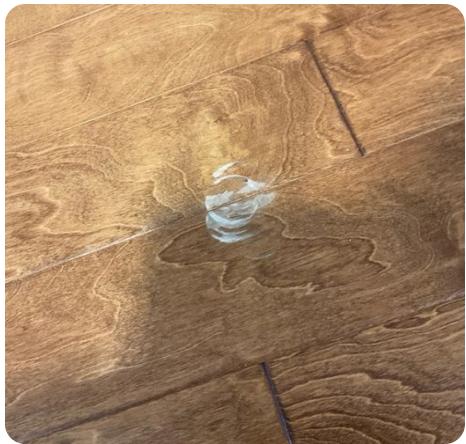
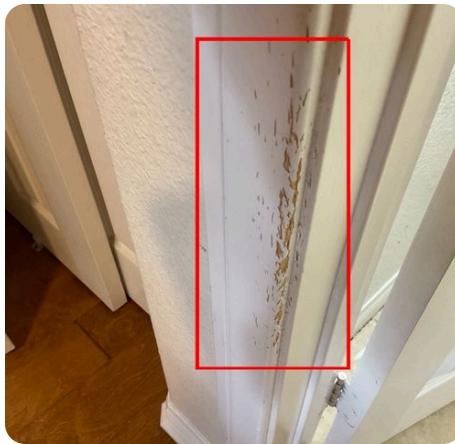
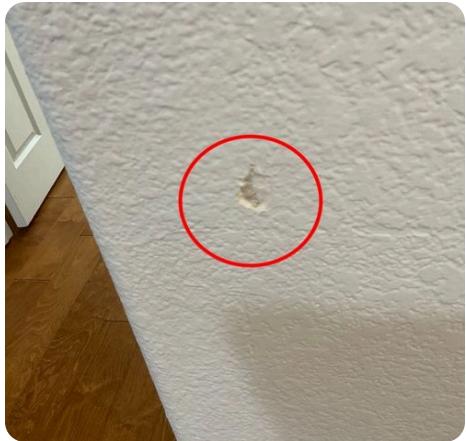
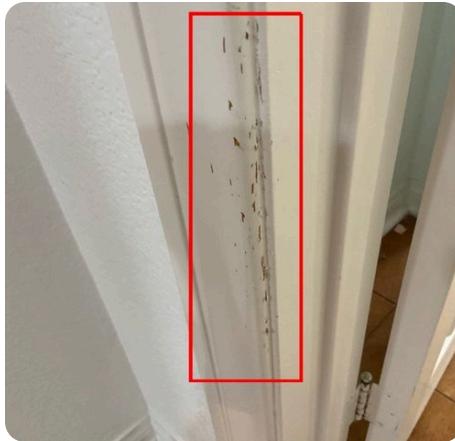
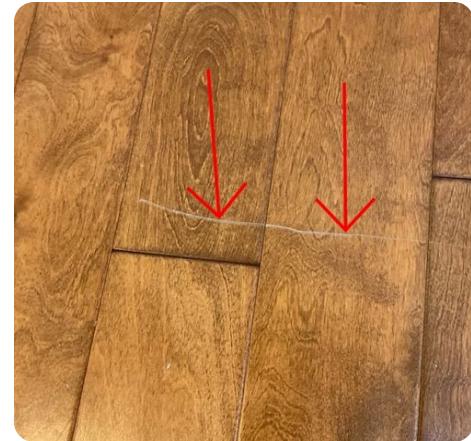
19 General Cosmetic Damage

The floors, walls, and ceilings exhibit some general cosmetic damage, which is typically superficial and does not impact the structural integrity of the property. It is recommended to assess and address these cosmetic issues for aesthetic reasons. Depending on the extent of the damage, options may include patching or replacing affected areas, repainting or refinishing surfaces, or seeking assistance from a professional contractor for more substantial damages.

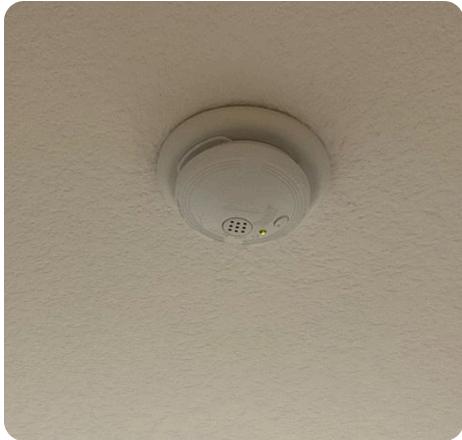
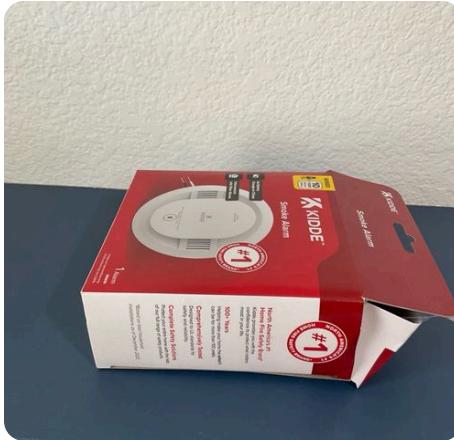
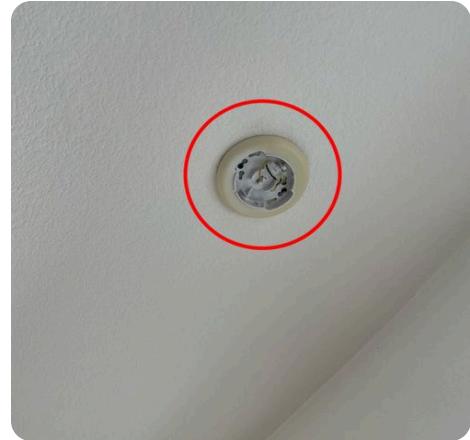
20 Missing Smoke Alarms**Action Required**

One or more smoke alarms is missing. Smoke alarms are required on all levels and outside all sleeping areas. Recommend further evaluation and installation of a functional smoke alarm for safety.

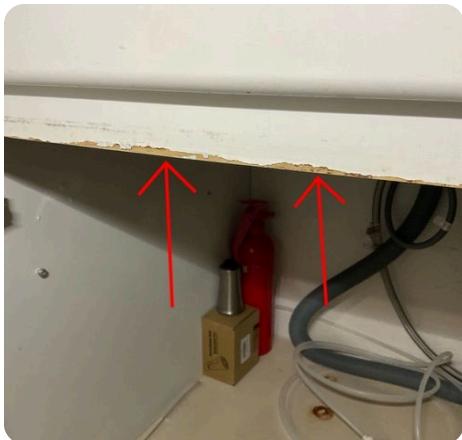
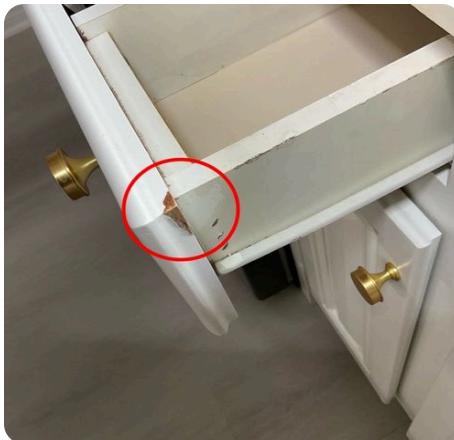
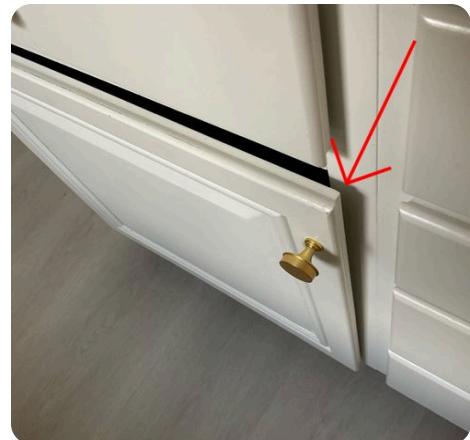
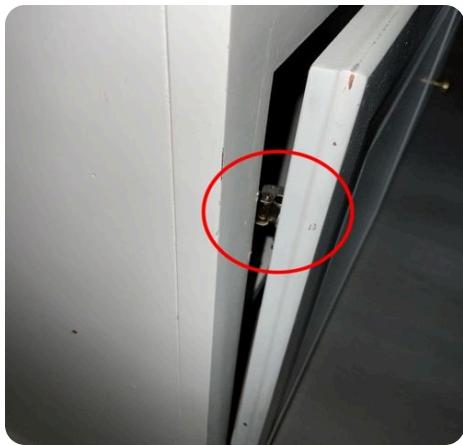
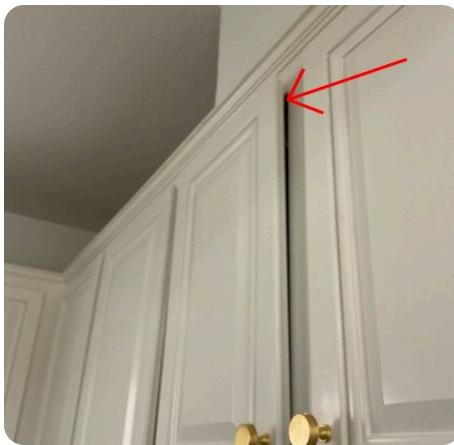
**21 Cosmetic Damage On Cabinet****Repairs Recommended**

Cosmetic damage was observed on the front surface of the cabinet. While this does not impact the cabinet's functionality, it could be a concern for aesthetics. Assessing the extent of the damage and exploring repair or replacement options is advisable. Contacting a qualified cabinet professional might provide useful guidance in resolving this matter.

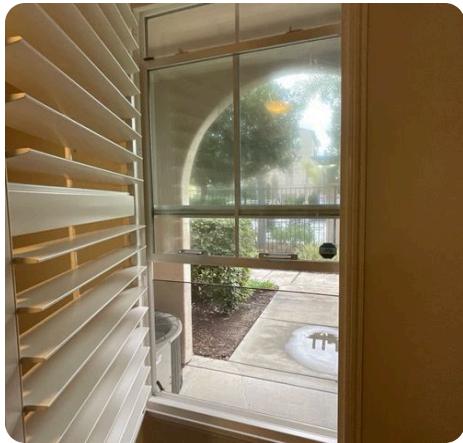
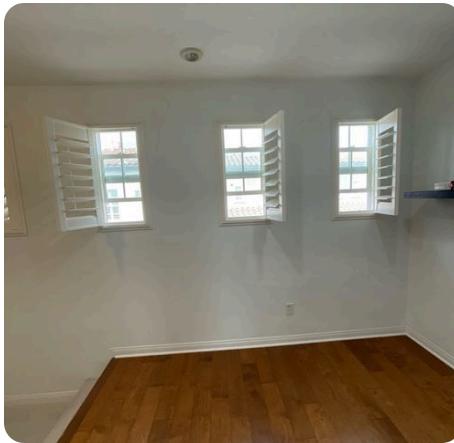
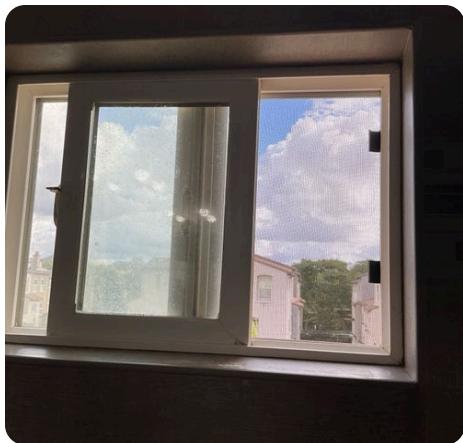
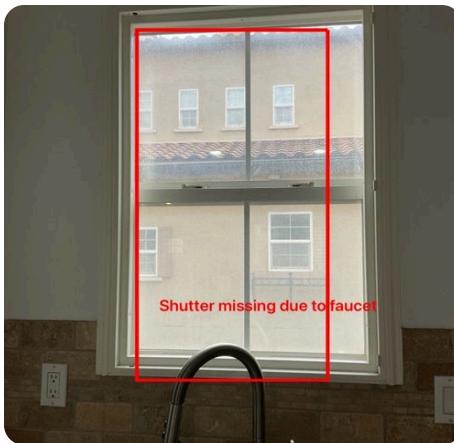
22 Window Seals

The kitchen window shutter was found in the garage. This was likely removed due to the height of the faucet blocking the window covering from opening. Consider a lower faucet or a different type of window covering.

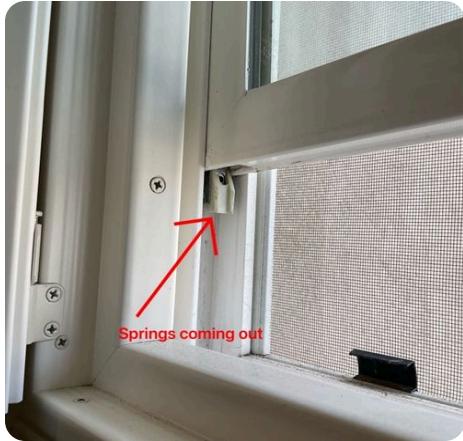
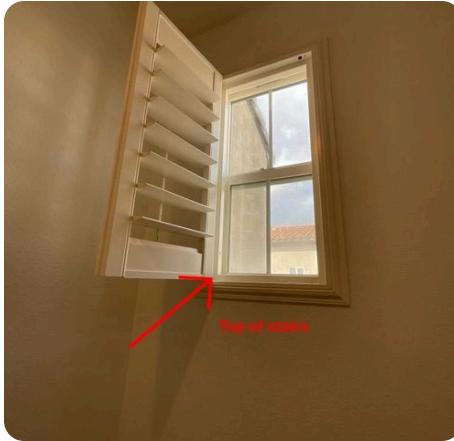
**23 Window Springs Damaged****☒ Repairs Recommended****📍 Location: Den, Main Stairway**

The window spring on one side is not functioning properly. This can compromise the function of the window. It is recommended to have a qualified locksmith or window repair specialist evaluate and repair.

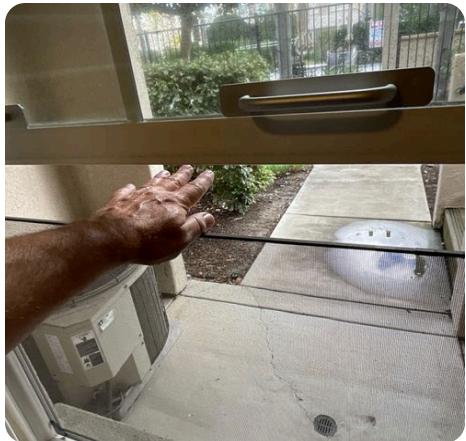
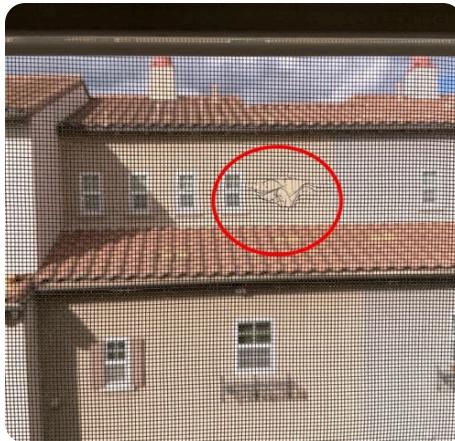
**24 Missing Window Screen****☒ Repairs Recommended****📍 Location: Den, Rear of Home, Guest Bedroom, Front of Home**

Isolated windows in the home were missing screens. Asking the seller for the location of any additional screens placed in storage is recommended in addition to confirming that one screen is available for every window. Slight damage was noted on a rear windows. Contact a qualified window or screen company for evaluation and repair.

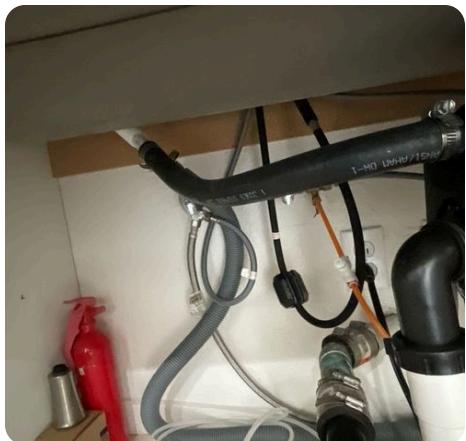
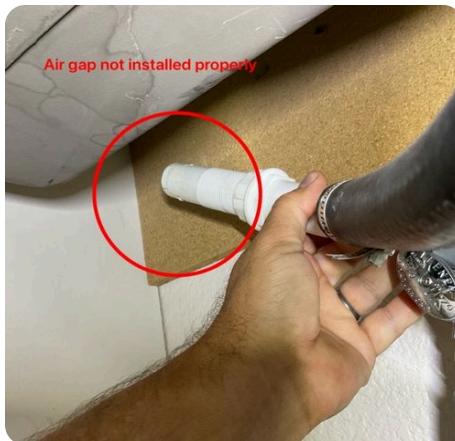
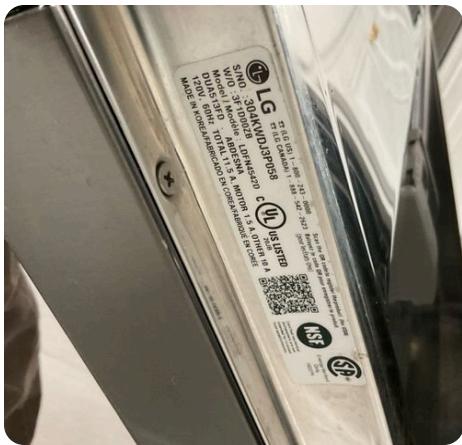
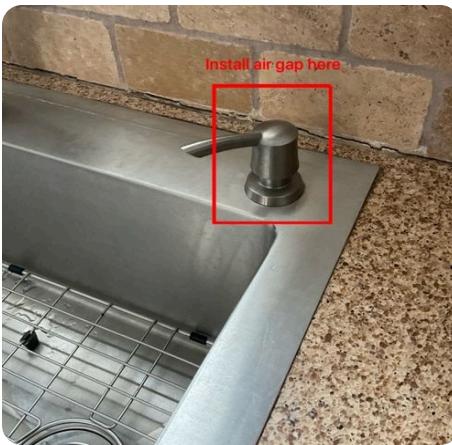
25 Inadequate Air Gap Installation In Dishwasher

The dishwasher is in working condition but the air gap is not properly installed, which could lead to water leakage into the cabinetry and walls. It is recommended to remove the soap dispenser and reconnect the air gap correctly to ensure proper drainage into the sink. A qualified plumber should be contacted for further evaluation and repair.
