Service: Condo Inspection

Prepared for: Sample Report

WIN Inspector

Damien Devine

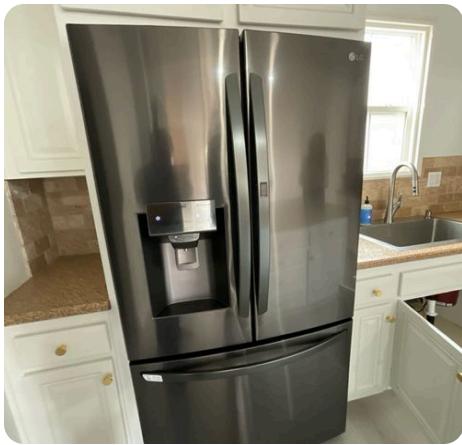
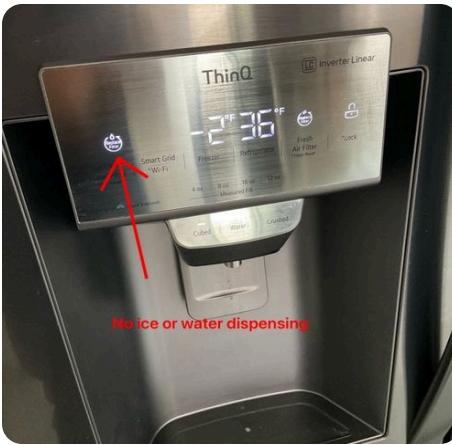
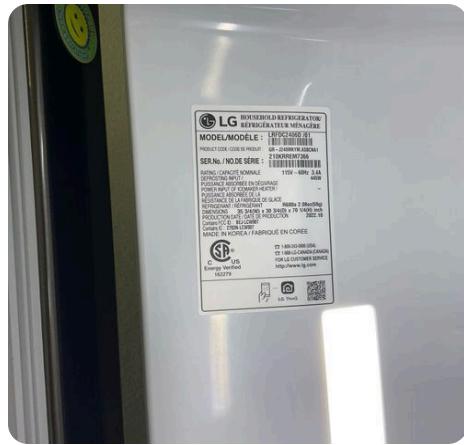
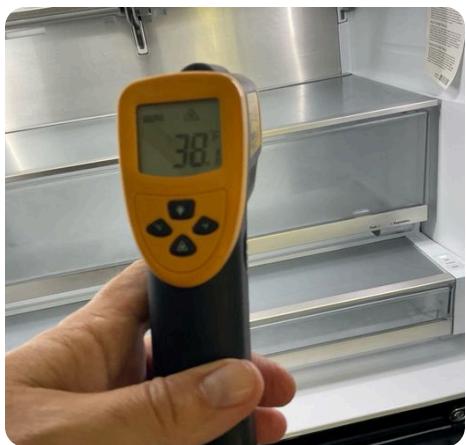
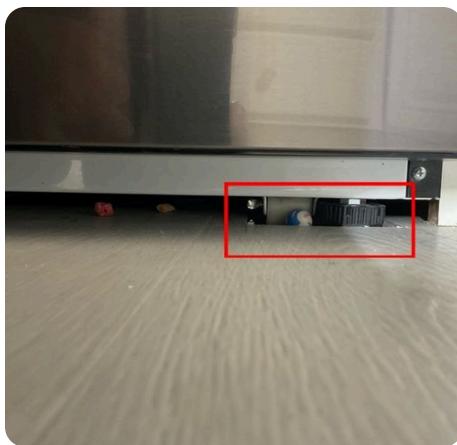
26 Refrigerator Functionality

The refrigerator was functional at the time of inspection, however the water connection was not visible due to the wheels being below the flooring. The ice and water functions were not operating. Ensure there is a water connection and it is connected.

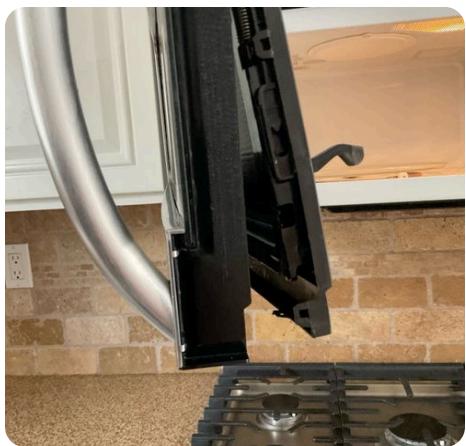
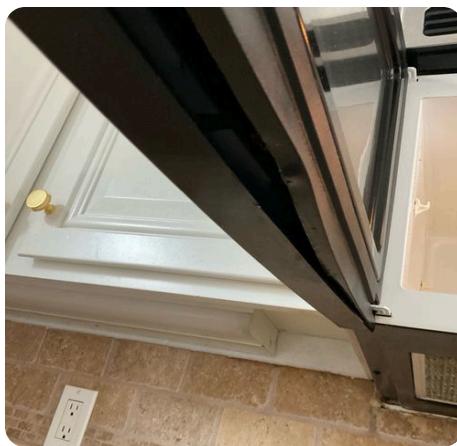
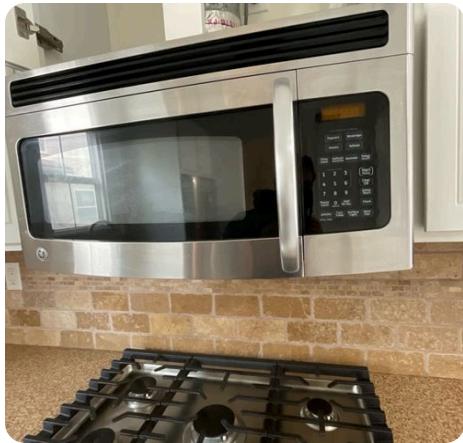
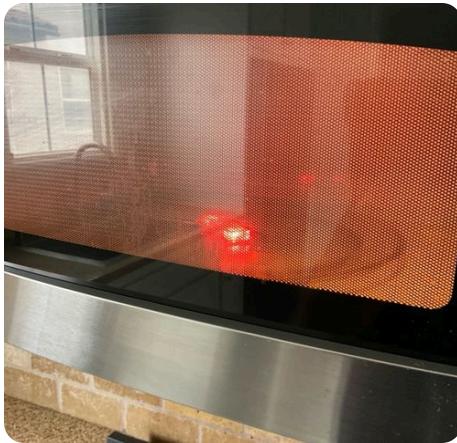
27 Not Functional

The microwave oven was not functional. The door panel is melted and falling off. This can cause exposure to microwaves which is known to have negative health impacts. It is recommended to have replacement done by a qualified professional and verify functionality before closing of escrow.

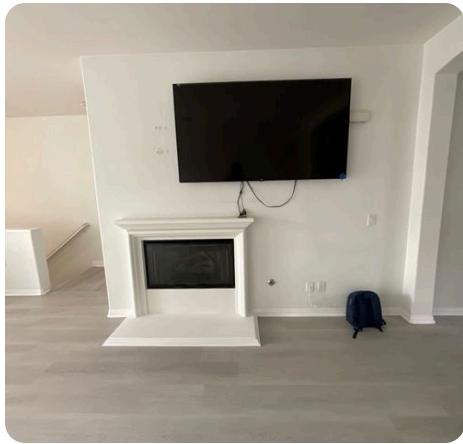
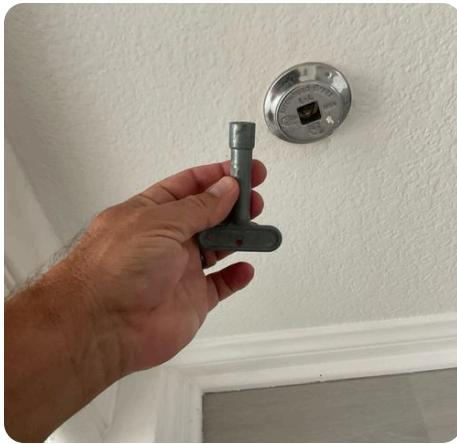
28

The gas for the fireplace was off at the time of inspection and was tested. The gas may be shut off, as it did not ignite. It is recommended having a fireplace technician evaluate, ignite, and test the unit to ensure proper functionality and safety.

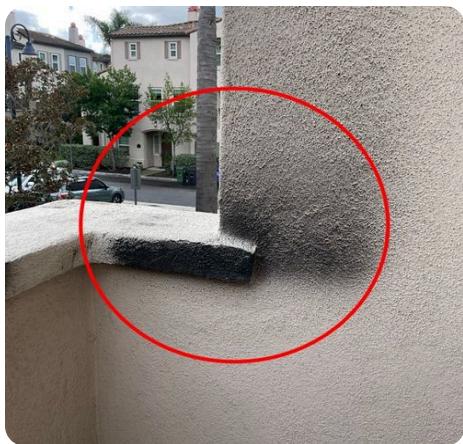
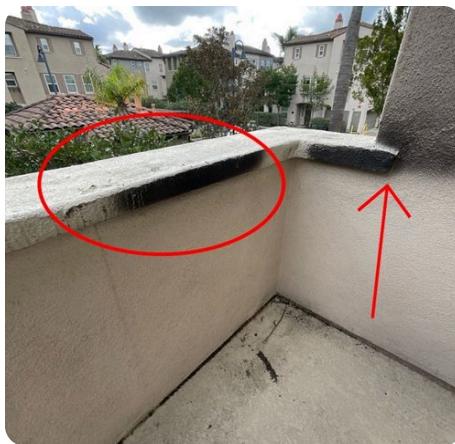
Stucco Burn Marks From Barbecue

The burn marks on the stucco at the balcony from the barbecue could indicate potential fire hazards and structural damage. It is recommended to evaluate the extent of the damage and repair as necessary to ensure safety and prevent further deterioration. A licensed contractor or stucco repair specialist should be consulted for appropriate repair options. Contact the HOA for evaluation and painting or repairs.

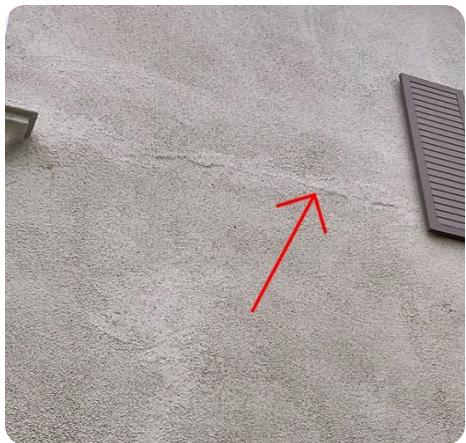
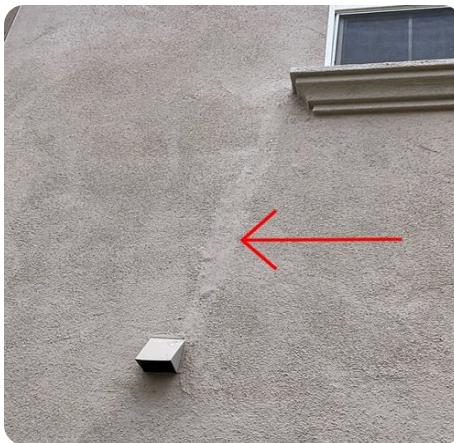
Stucco Cracks

The exterior siding includes stucco with some small cracks. It is recommended to evaluate and repair the cracks in the stucco to prevent water intrusion and further damage. A qualified stucco contractor should be contacted for repair, which may involve filling and sealing the cracks with appropriate materials to maintain the integrity of the siding.

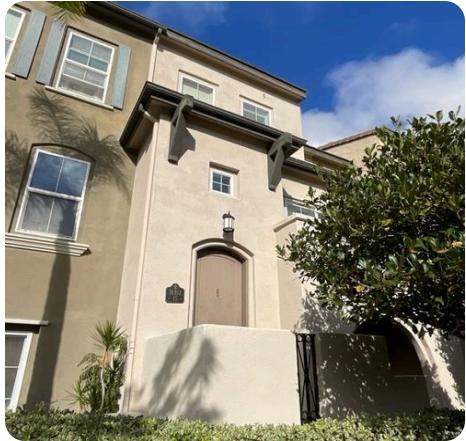
Siding And Trim Evaluation

It is important to proactively maintain these materials in order to preserve the integrity, weather protection and aesthetics of your home. Regular cleaning, re-painting, and periodic inspections can help prevent damage and ensure the longevity of the exterior surfaces.

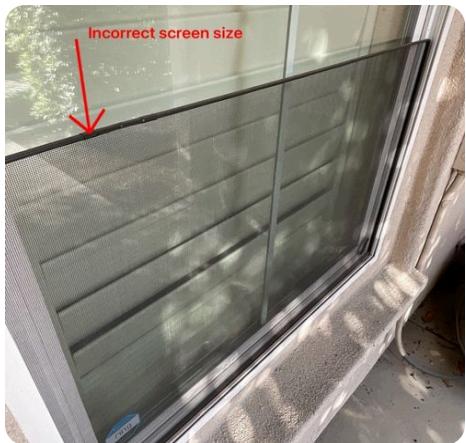
The exterior window frames and glazing were inspected for any signs of damage or wear. All windows were found to be serviceable.

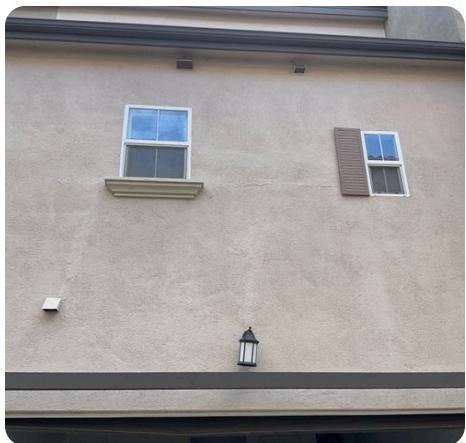
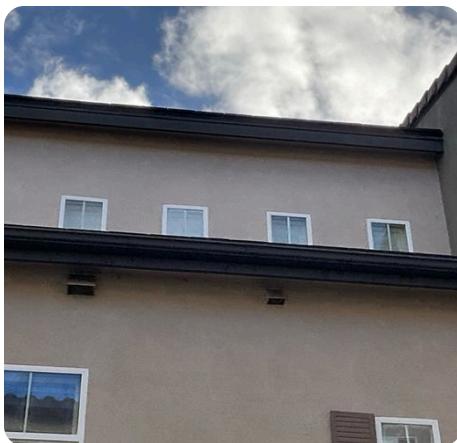
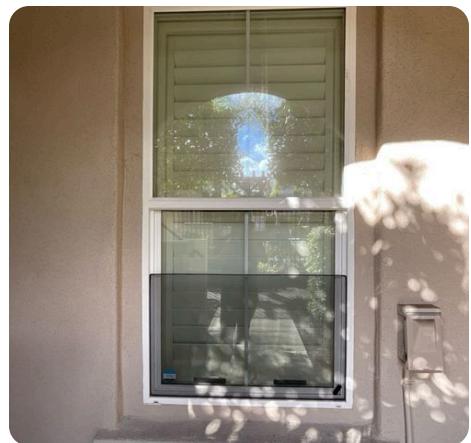
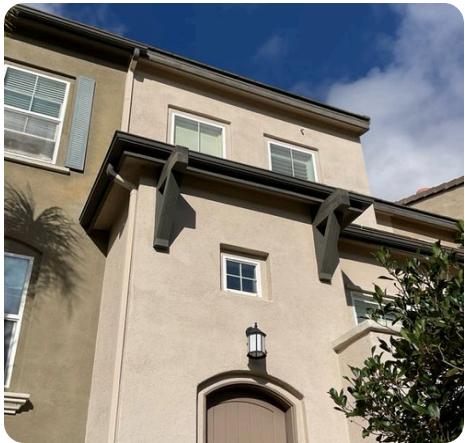
**Windows Evaluated***Informational*Location: **Exterior**

The visual inspection of the windows may not disclose seals that have lost their seal in between the panes of glass, or other deficiencies with the windows or UV coatings or films. The deficiency is sometimes only visible under certain climatic conditions. It is not always possible to see all windows or seals during a home inspection due to furnishings, obstructions, film, or debris on the glass. If concerned, we suggest all windows be cleaned and/or re-inspected.

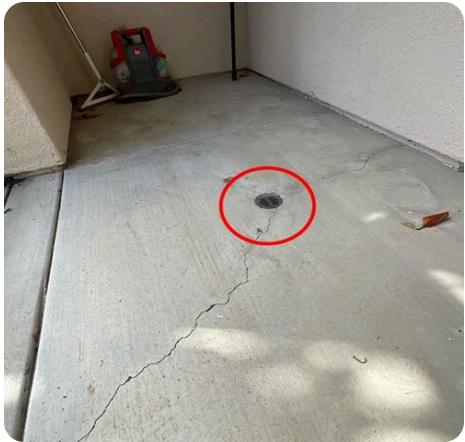
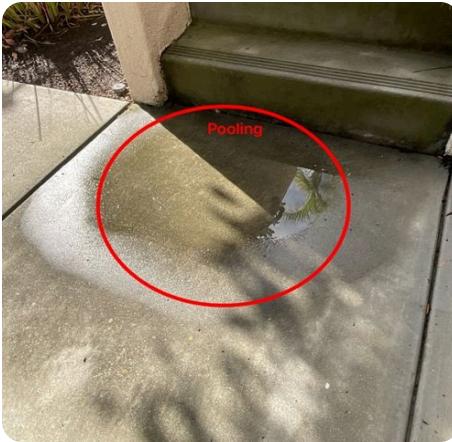
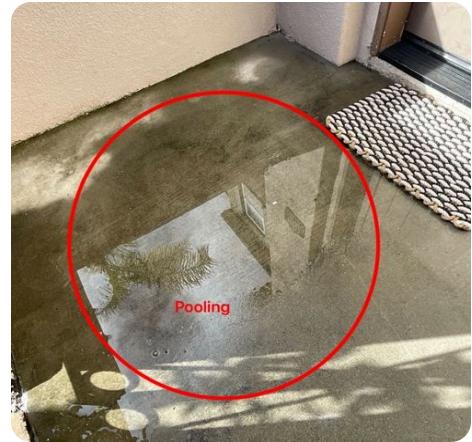
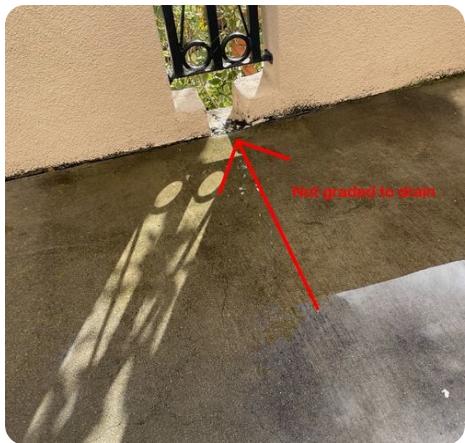
Grading Recommendations

The grading around the perimeter of the foundation should be maintained to adequately drain excessive surface and roof runoff water away from the structure. Due to the soil type and/or amount of water from surrounding areas, even flat lots may hold water. It is recommended that the grade slope away from the structure at least 6" for the first 6'-10' away from the foundation.

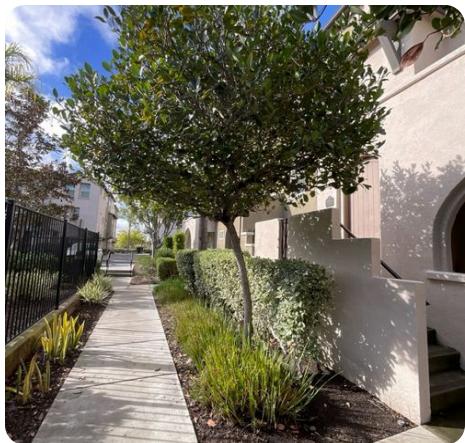
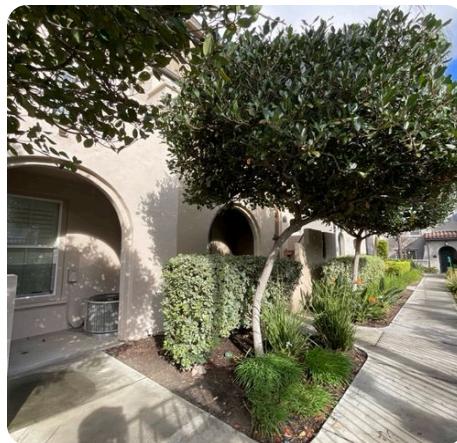
**Vegetation Recommendations** **Informational**

All vegetation should be kept trimmed 12 inches away from the structure to eliminate a common avenue for pest infestation and damage to the exterior structure material. Maintenance of overhanging trees, vines and other plant material is recommended.

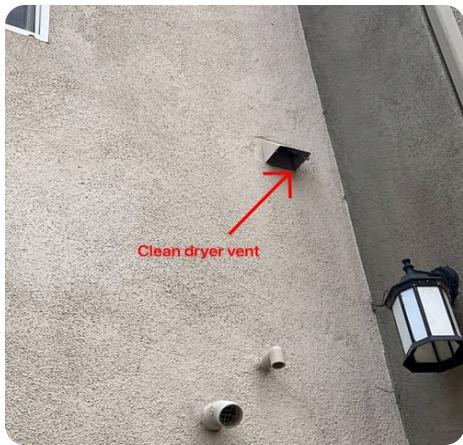
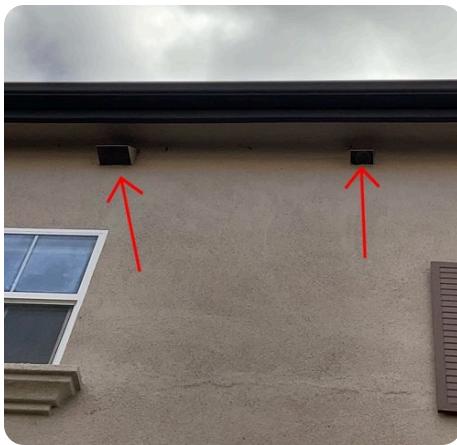
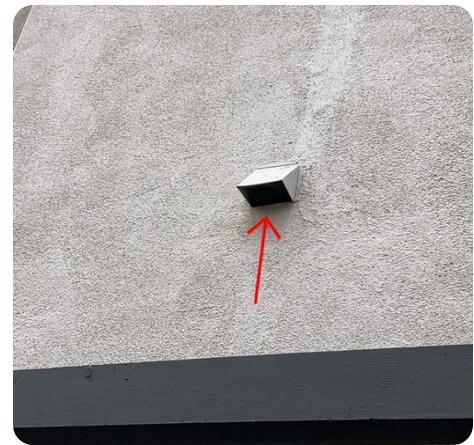
**1.4 Exterior > Exhaust Hoods, Vents, and Other Penetrations****Exterior Vents And Penetrations Evaluated** **Functional**

The exterior vents and siding penetrations appeared to be in functional condition at the time of the inspection. It is recommended to routinely check and maintain these areas to ensure proper functionality, prevent blockages, damage, and optimize ventilation. Regular visual checks and cleaning can help maintain efficiency and avoid potential issues.

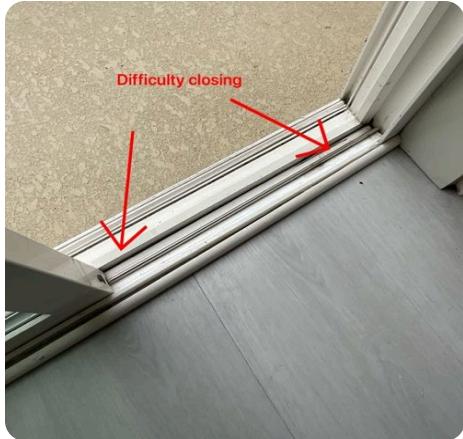
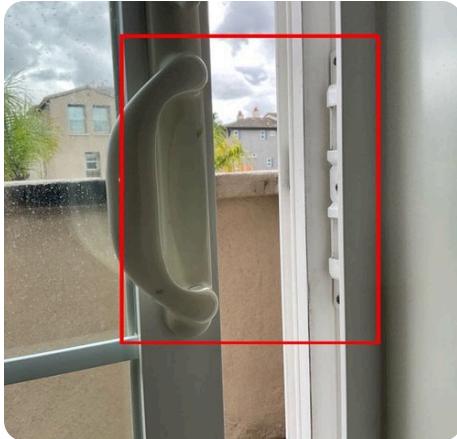
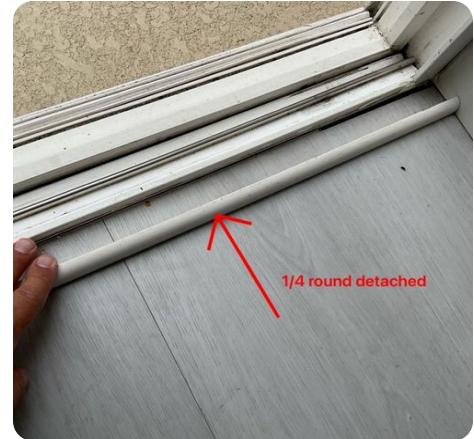
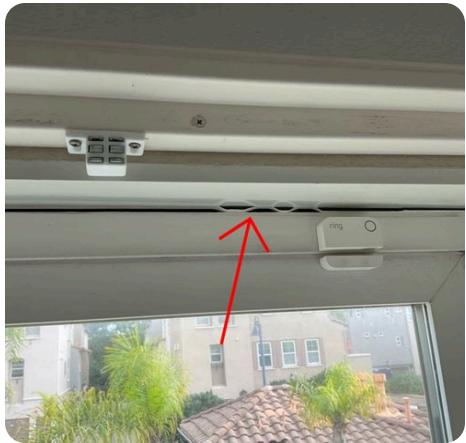
Stiff Sliding Glass Door

The sliding glass door at the exterior does not slide smoothly, which could pose inconvenience and potential security risks. It is recommended to have a qualified window and door company or a trade professional evaluate and repair the sliding glass door to ensure proper functionality.

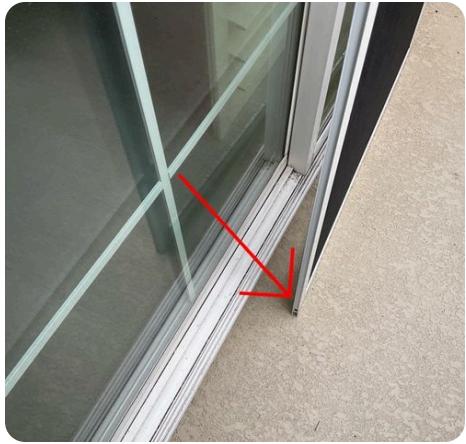
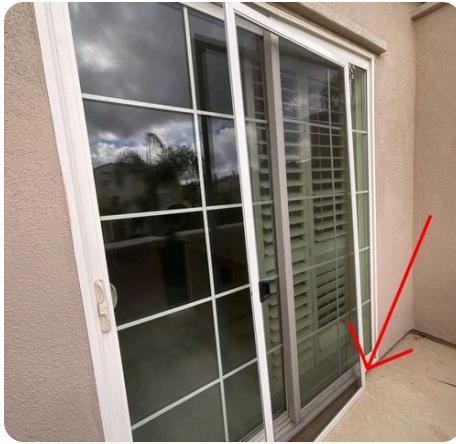
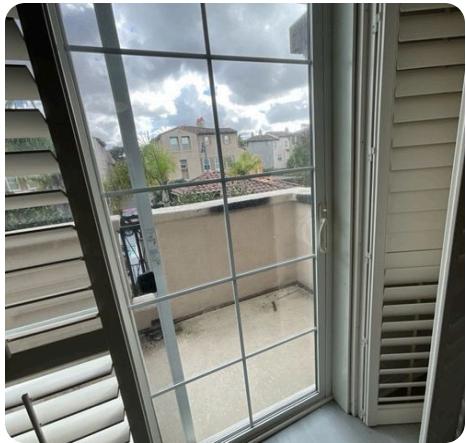
**Sliding Screen Door Is Off Track**

The sliding screen door at the exterior is off track. It is essential to fix this issue to ensure proper functionality of the door and to prevent any damage or inconvenience. It is recommended to contact a qualified repair person or a door repair specialist to evaluate and repair the sliding screen door.

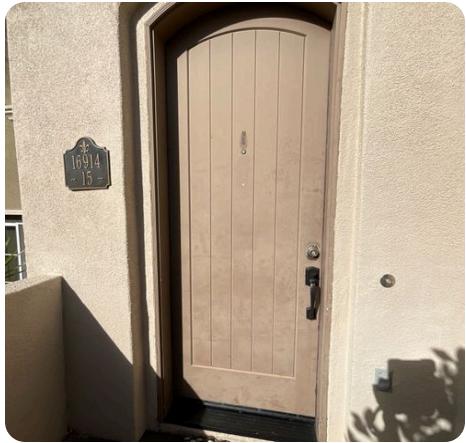
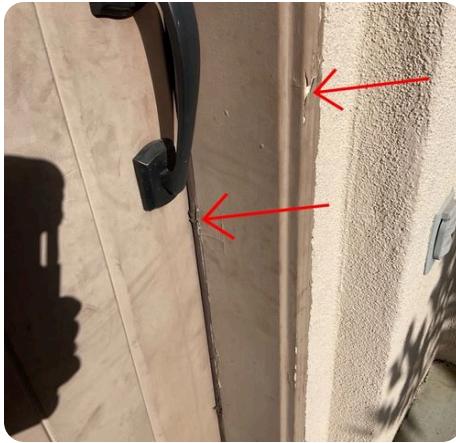
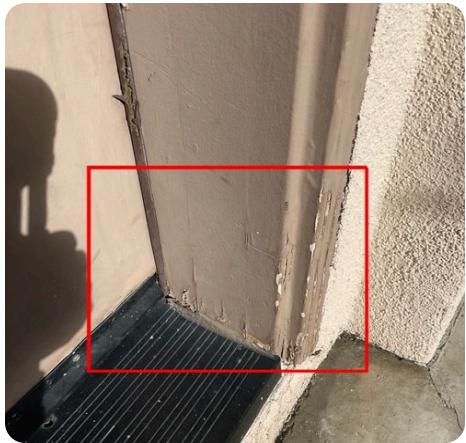
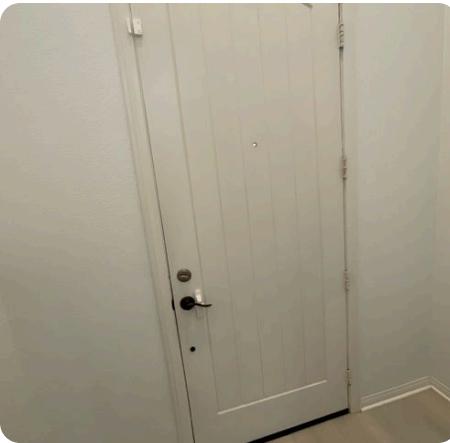
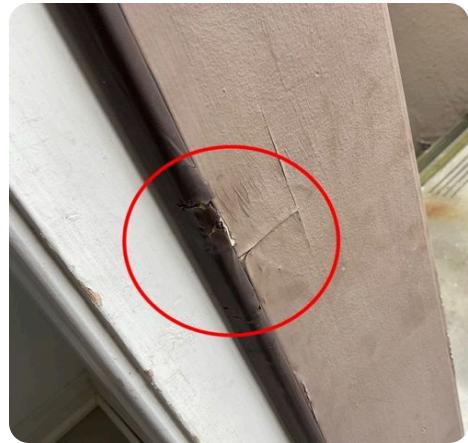
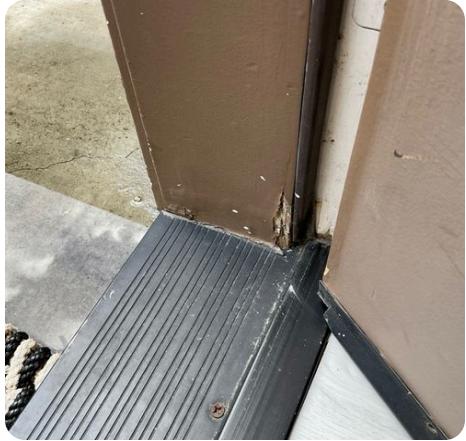
**Repainting, Weather Stripping, And Door Stopper Replacement**

The exterior door shows signs of wear, especially on the paint which helps protect the door from elements. Repair or repaint any areas of concern to prevent deterioration. Additionally, check and replace the weather stripping as needed to improve energy efficiency and weather protection. Lastly, consider replacing the door stopper to prevent interior damage and ensure proper functionality.

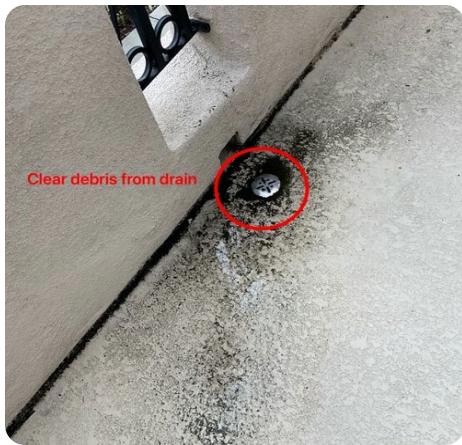
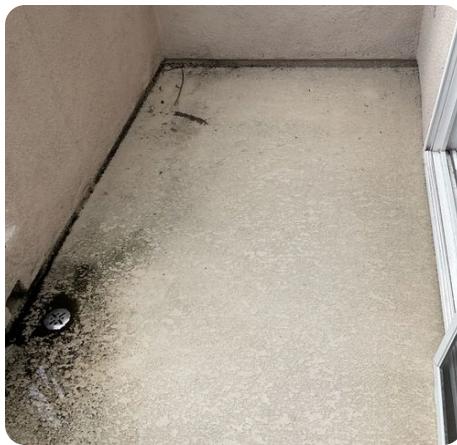
Sub Framing Not Visible

The foundation, or underside, is not visible due to the type of installation or low clearance. Issues may exist that are not visible. If examination is needed, contact a qualified professional for further assessment.

The drain requires cleaning to prevent flooding.

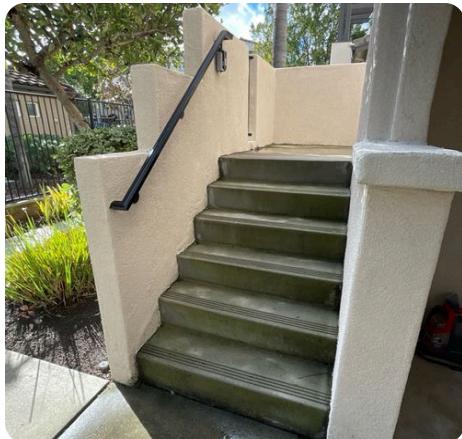
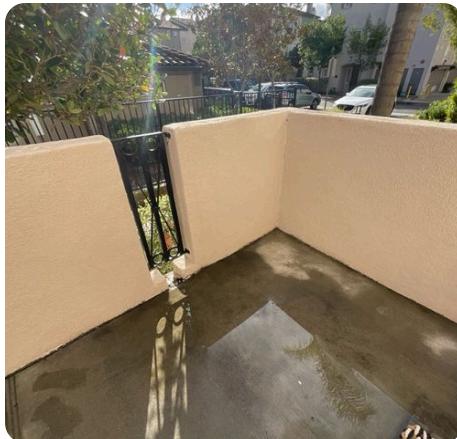
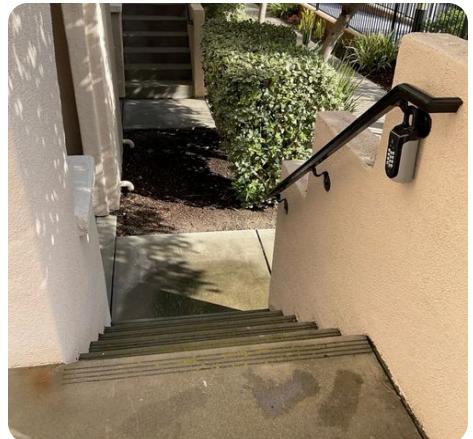
Railings, Guardrails, Steps Evaluated

The railings, guardrails, and/or steps were evaluated to assess their safety and condition. This included verifying that the railings are at appropriate heights and that all steps are even and free of hazards. Periodic inspections of these items are recommended to ensure long-term safe use as components will wear and settle over time.

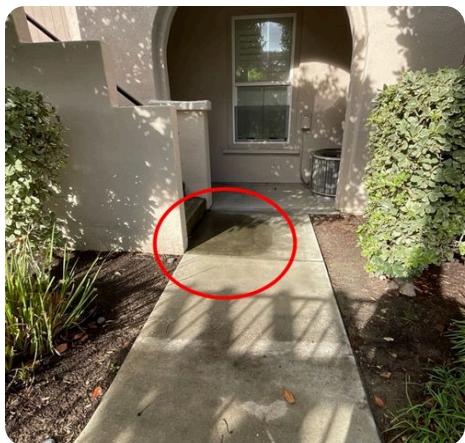
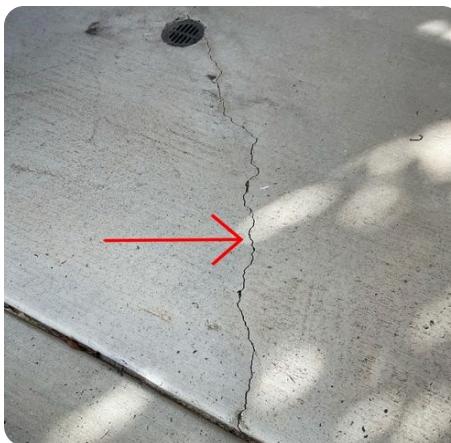
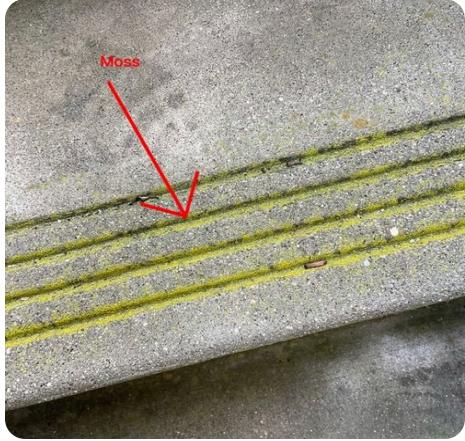
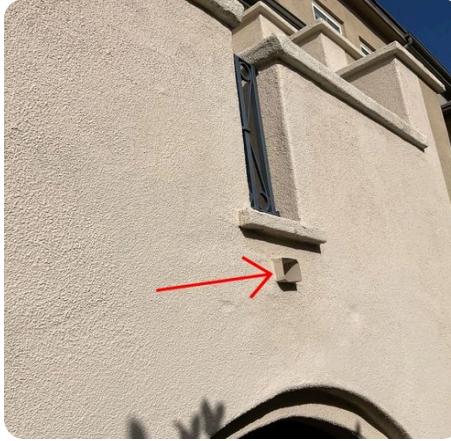
Location: Front of Home, Front Porch

Pooling of water at the top and bottom of the stairs is observed. This could lead to safety hazards and potential water damage to the structure over time. It is recommended to evaluate the drainage in these areas and make necessary repairs to prevent water accumulation.

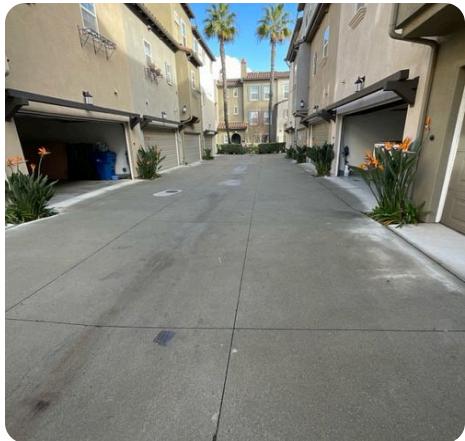
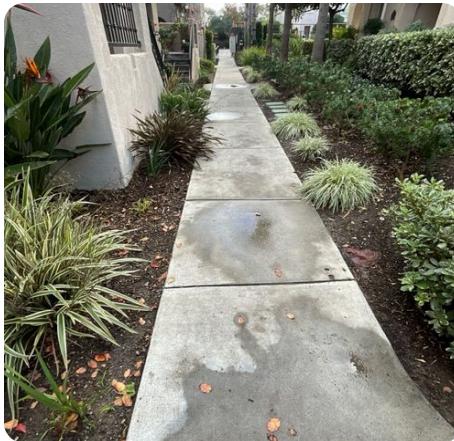
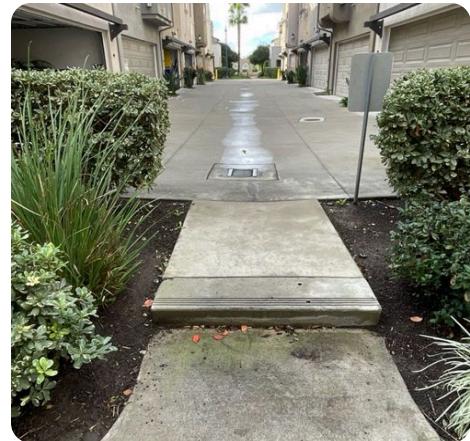
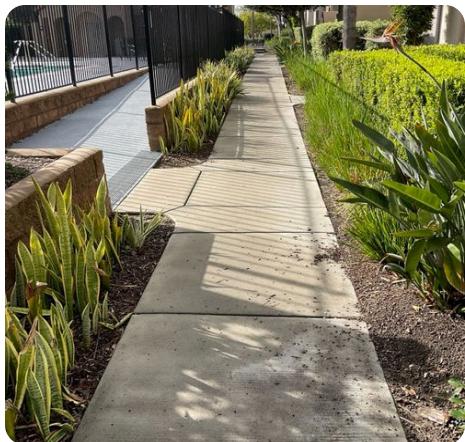
Location: Exterior

The inspection of the walkways and driveway included checking for cracks, uneven surfaces, and proper drainage to prevent standing water. Both the walkways and the driveway were found to be in serviceable condition.

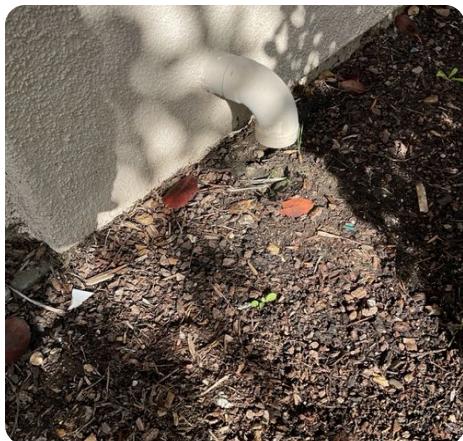
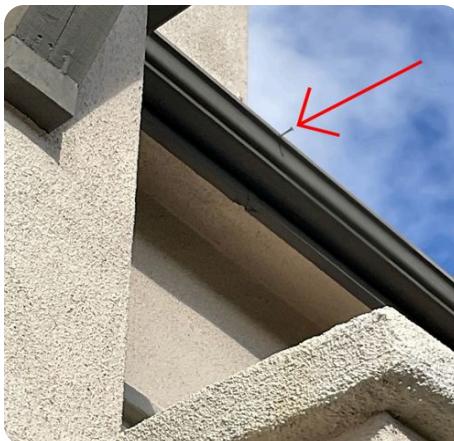
📍 Location: Front of Home

It is recommended to inspect and clean the gutter system and roof surface on an annual basis. Typically, gutters have a life span of approximately 20-25 years, depending on the type of material. If the current gutter system is approaching or over this life span, budgeting for replacement is recommended. Also, if overhanging trees are present, there are gutter screen materials that help keep leaves and other debris out of the gutter system to prevent clogging of the gutters, downspouts, and drain system.

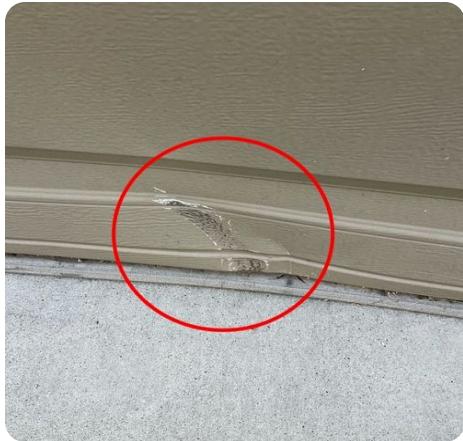
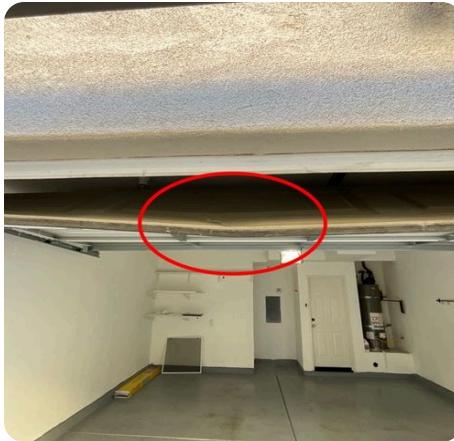
Location: Garage

Garage Door Panel Damage

The garage door panel has minor damage. It is recommended to evaluate and repair the damaged panel to prevent further issues and maintain the door's functionality. A qualified garage door repair professional can assess the extent of the damage and provide repair options.

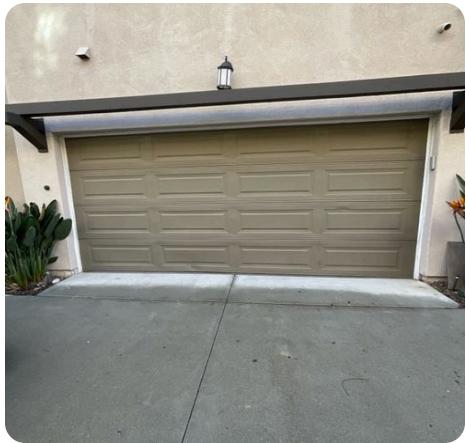
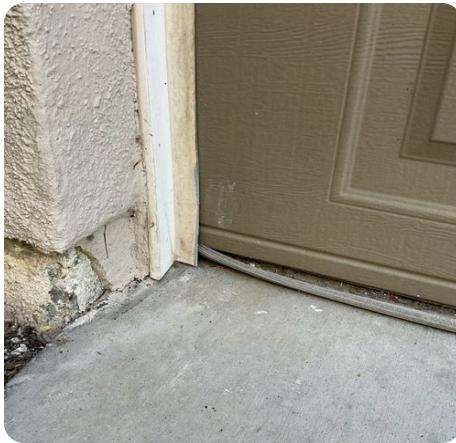
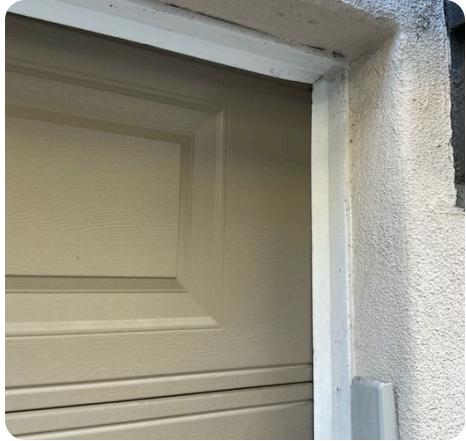
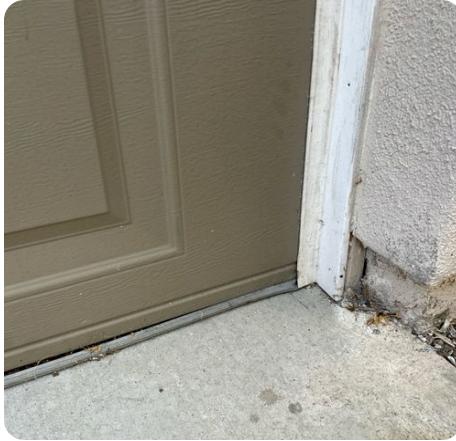
Location: Garage

**Garage Vehicle Door Evaluated**

Functional

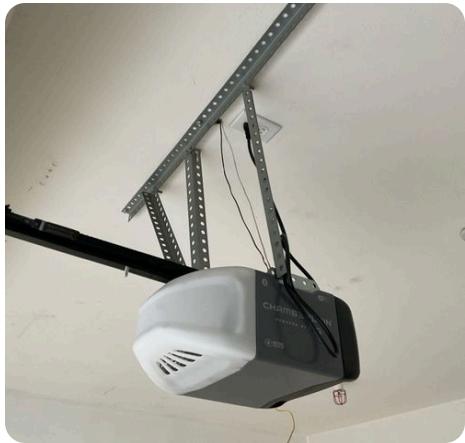
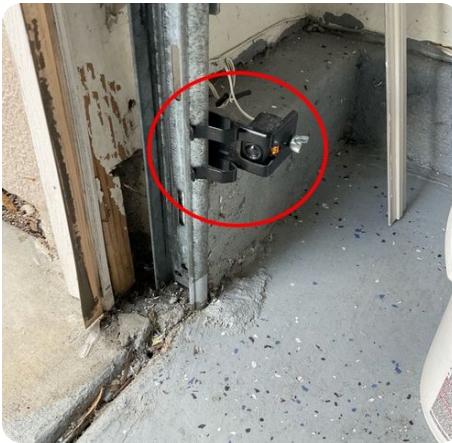
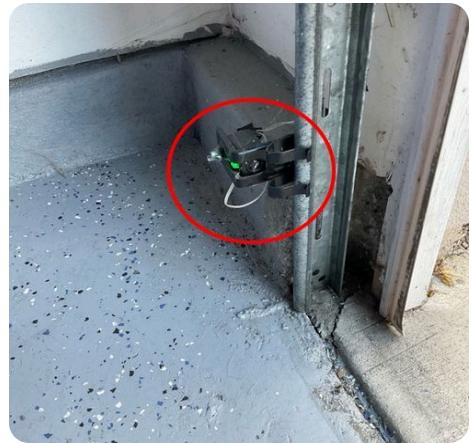
📍 Location: Garage

Periodic inspections, greasing, adjustments, and tightening of brackets are suggested as part of normal preventative maintenance. We recommend contacting the manufacturer or an overhead door company for proper installation and maintenance questions.

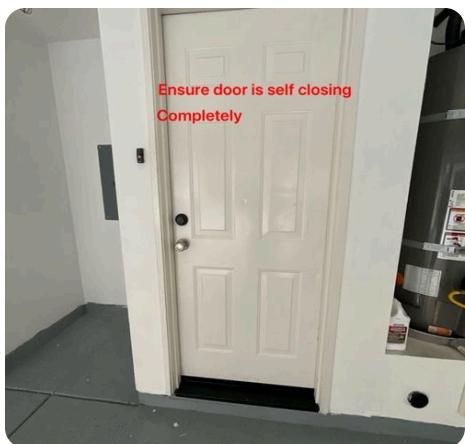
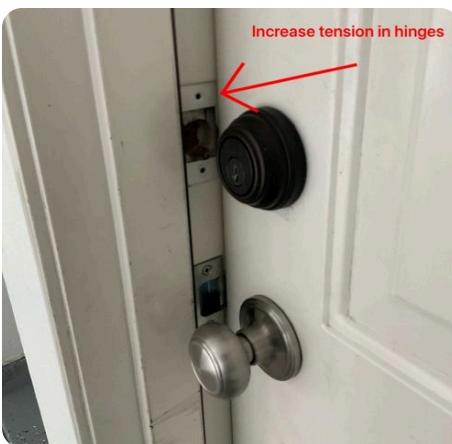
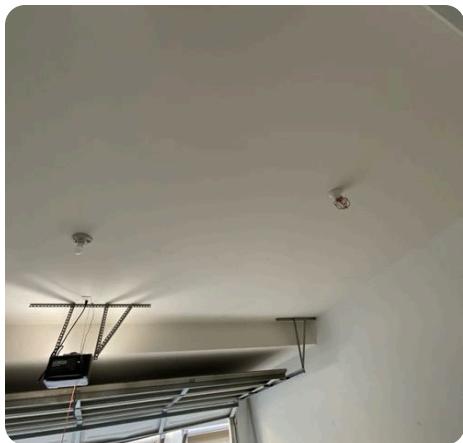
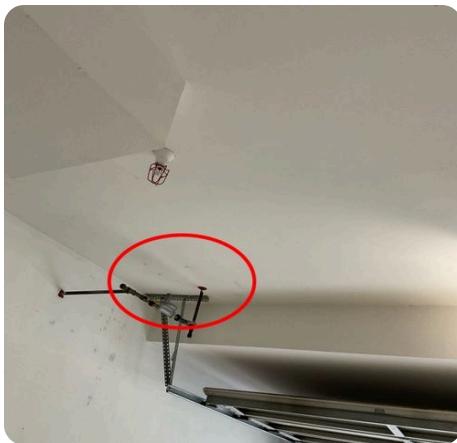
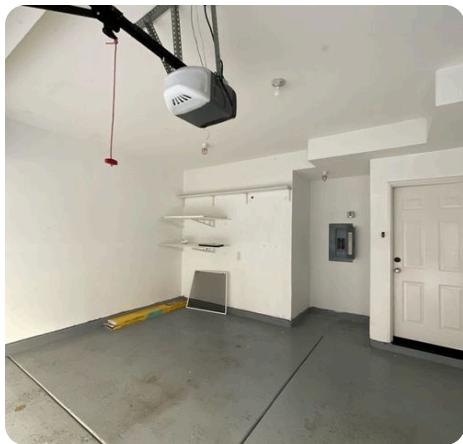
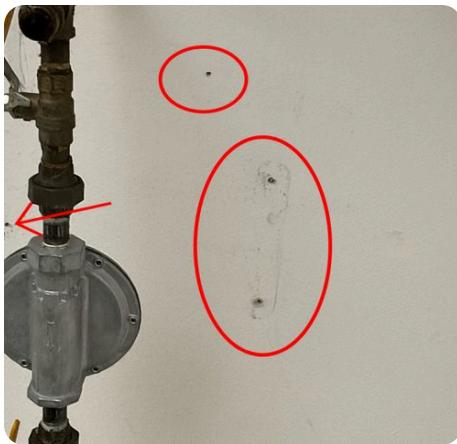
Location: Garage

All openings of more than 1/8" are recommended to be sealed to maintain a proper firewall barrier. Increase tension in self closing hinges to ensure the fire door closes completely. The strike plate is missing.

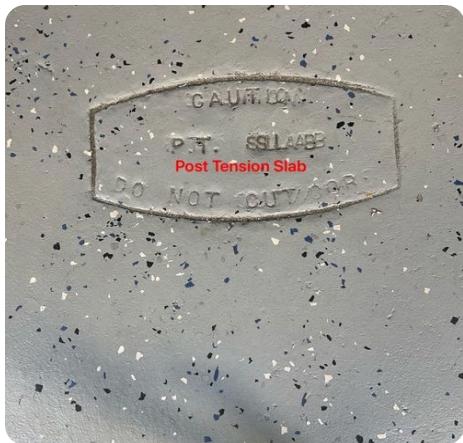
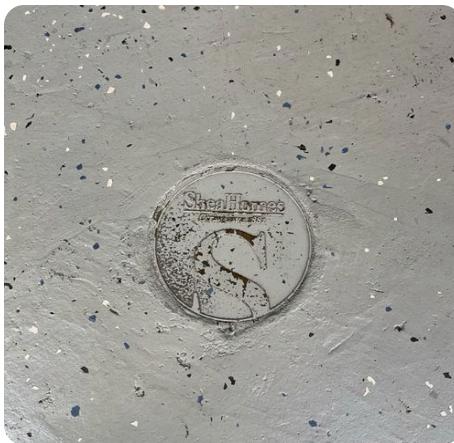
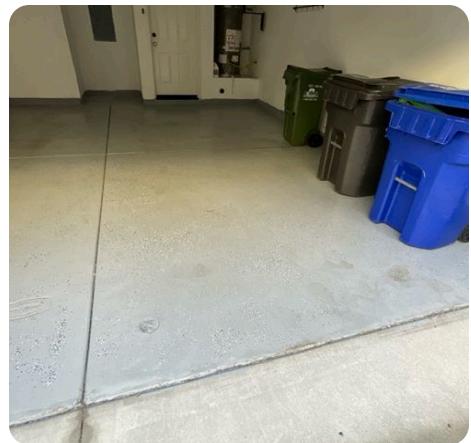
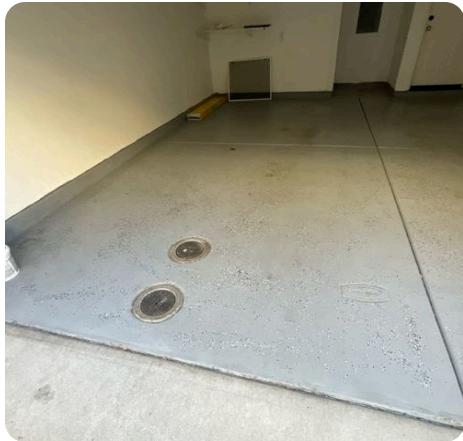
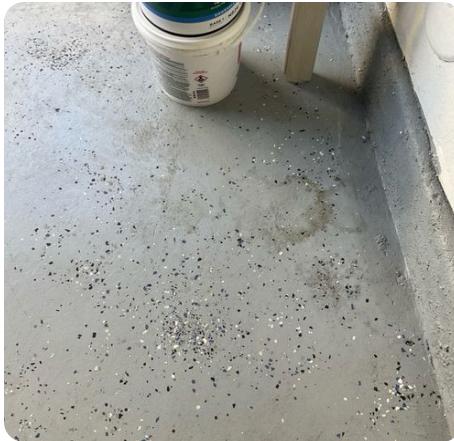
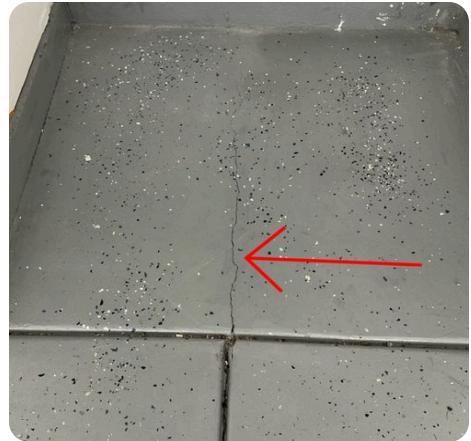
Location: Garage

The property has a post-tension slab. It is recommended to avoid drilling into or cutting the slab without consulting a qualified structural engineer, as it may compromise the structural integrity of the foundation. Any repairs or modifications to a post-tension slab should be carried out by a licensed professional experienced in working with post-tension systems to prevent potential damage.

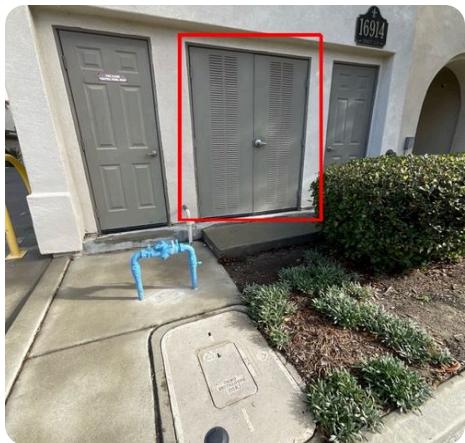
Location: Utility Closet, Exterior, South Side

The meter, service entrance, and system grounding could not be verified by the inspector due to their location behind locked doors in this condominium building. Questions regarding these systems should be raised with building maintenance.

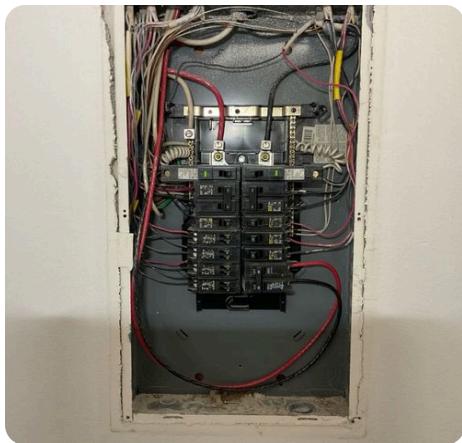
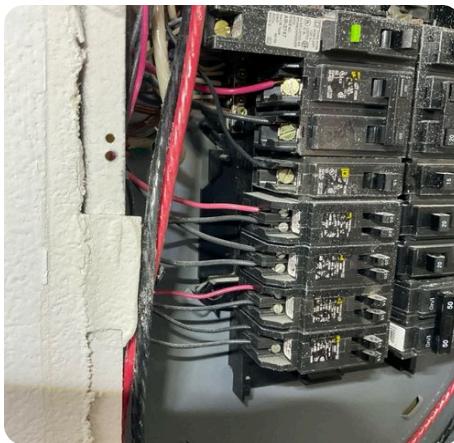
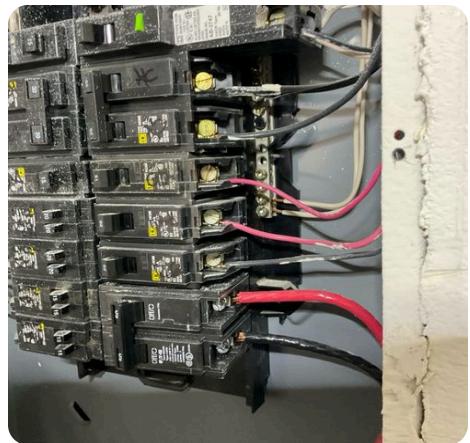
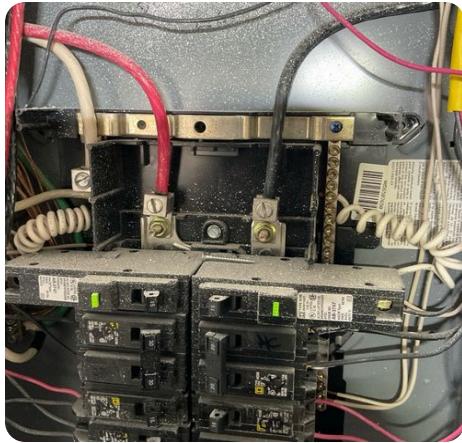
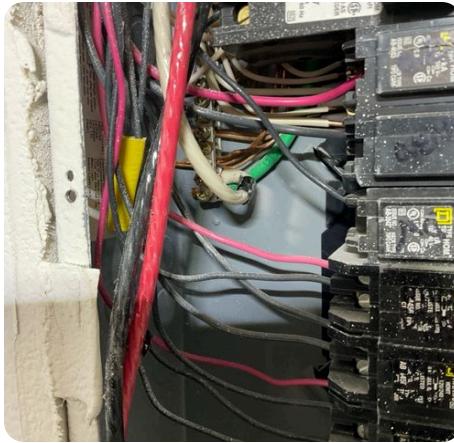
Interior Components Evaluated Functional Location: Garage

The interior components of the service panels were evaluated during the inspection, and they were found to be in working condition. It is always recommended to conduct regular maintenance and/or evaluation on the electrical panels to ensure continued performance.

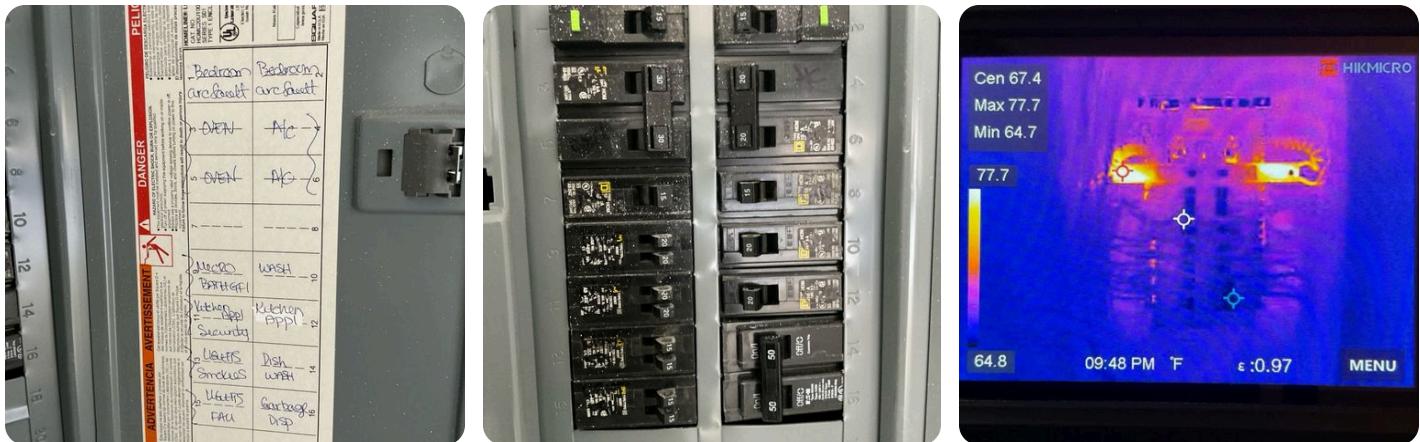
Breakers Evaluated Functional Location: Garage

The breakers in the electrical panels were evaluated and in satisfactory condition at the time of the inspection. It is essential to ensure these devices are kept in serviceable working condition to protect the electrical system from overloads and short circuits. Note: The inspector does not operate or physically test any of the breakers during this visual examination.

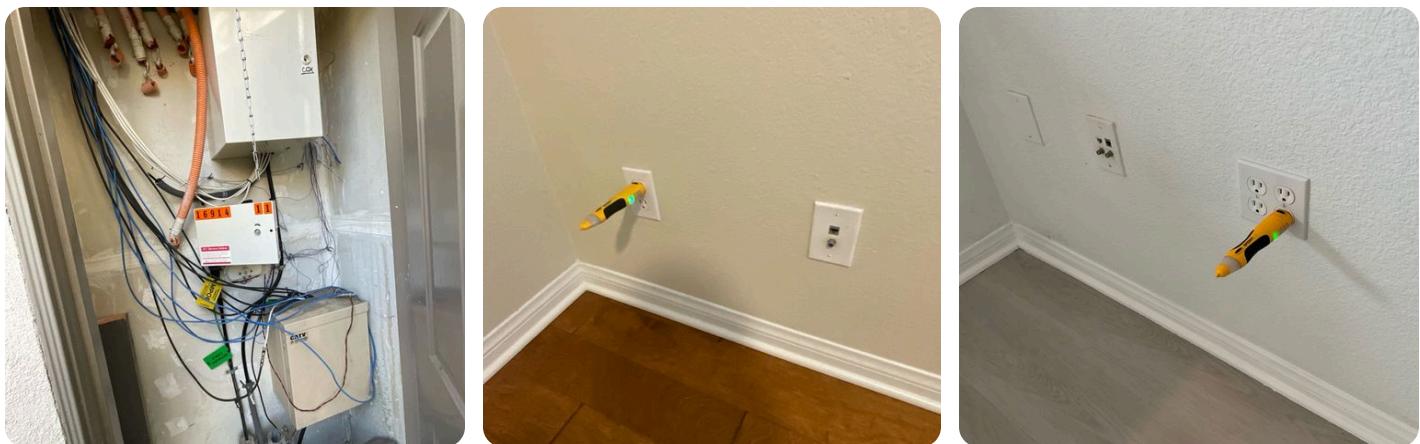
Location: Throughout the Home

The visible and accessible electrical wiring was evaluated. Properly maintained wiring is crucial for the safety and functionality of the home's electrical system. Much of the wiring in the home is enclosed behind walls or ceilings, and is not visible to inspect. It is recommended to conduct regular inspections to ensure the system is compliant with electrical safety standards.

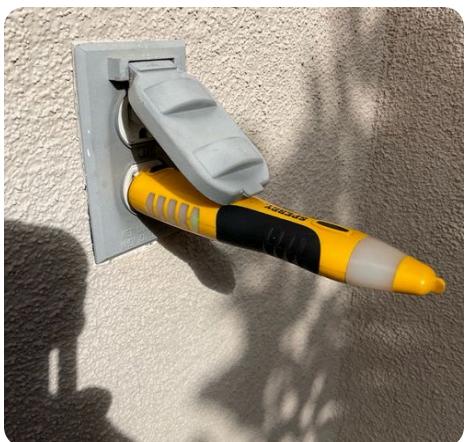
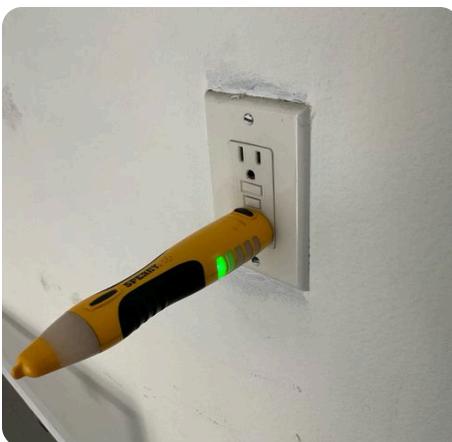
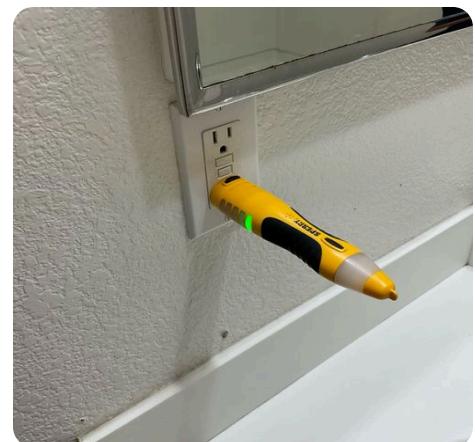
5.6 Electrical > GFCIs

Location: Kitchen, Garage, Exterior, All Bathrooms

Ground Fault Circuit Interrupter (GFCI) is a protection feature that allows a circuit or receptacle to "trip" or "shut off" if as little as a 5 milliamp differential is detected between the "hot" and "neutral" conductors. This protection is recommended for receptacles within 6 feet of the edge of a sink or where something plugged into a receptacle could come into contact with water, including bathrooms, kitchens, on the exterior, in garages, laundry rooms, and basements and crawl spaces. Although GFCI protection may not have been required in some or all of these areas when the home was built, their installation is highly recommended and is typically inexpensive. GFCI protection is only tested for if the circuit is protected by a visible receptacle containing a "Test" and "Reset" button, or a GFCI breaker in the electrical panel, as the UL (underwriters laboratory) only recognizes testing this protection by depressing the "Test" button on the receptacle or breaker and not by the use of a polarity tester. As well, testing with a polarity tester can trip a hidden GFCI leaving the circuit inoperable. Please see above for area(s) that were not able to be tested or confirmed for GFCI protection, and these area(s) are recommended to be tested for GFCI protection when personal belongings have been removed from the home.

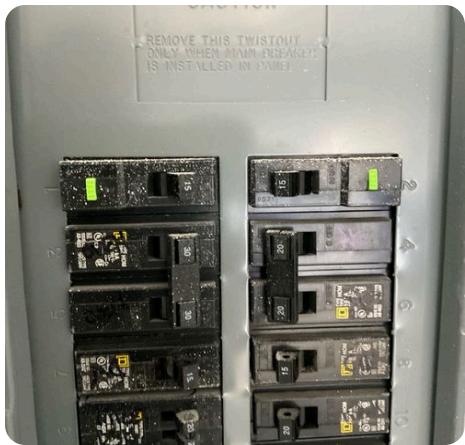
5.7 Electrical > AFCIs

Location: Garage

The inspector noted that the structure is equipped with AFCI breakers and protected outlets. Arc Fault Circuit Interrupter (AFCI) is a residential circuit breaker with an integrated processor that recognizes the unique current and/or voltage signatures associated with arcing faults and acts to interrupt the circuit to reduce the likelihood of an electrical fire. Testing these devices is outside the scope of a home inspection.
