Service: Condo Inspection

Prepared for: Sample Report

WIN Inspector

Damien Devine

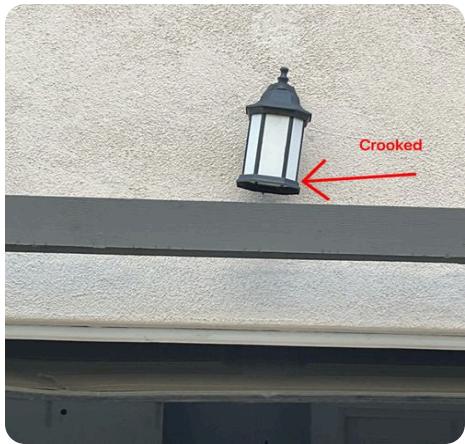
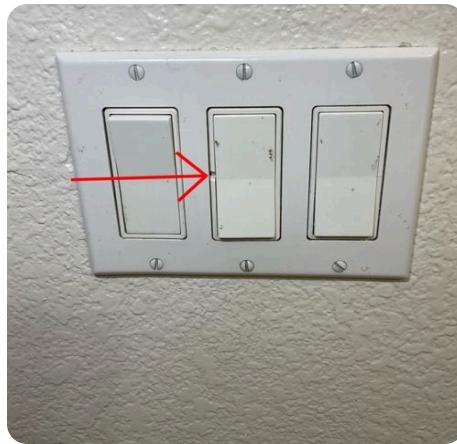
5.8 Electrical > Fixtures, Switches, and Receptacles

Repairs Recommended

📍 Location: Rear of Home, Living Room, Den

The condition of the outlets, switches, and junction boxes that were visible and accessible at the time of the inspection, were evaluated. Electrical outlets are recommended to be replaced if cracked/damaged to prevent arcs which might be caused by a worn outlet. Occupied homes often have furniture and stored items covering electrical outlets, switches, and junction boxes that limit their accessibility.

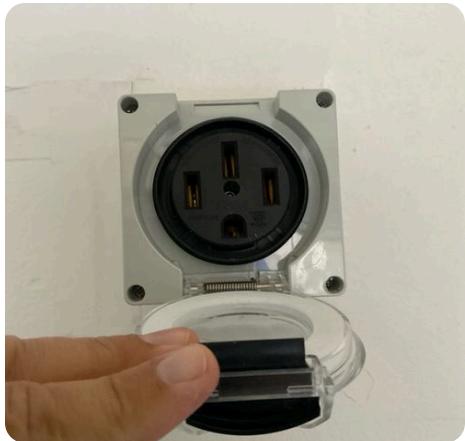
5.9 Electrical > Additional Information

Location: Garage

A car charger outlet is installed in the garage. Assessing the proper installation and function of a device is outside the scope of this inspection. We recommend contacting a reputable licensed electrician for further assessment.

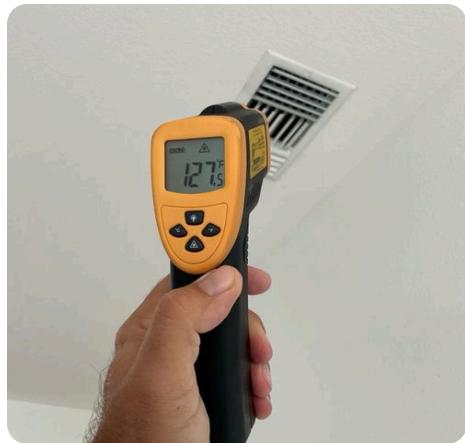
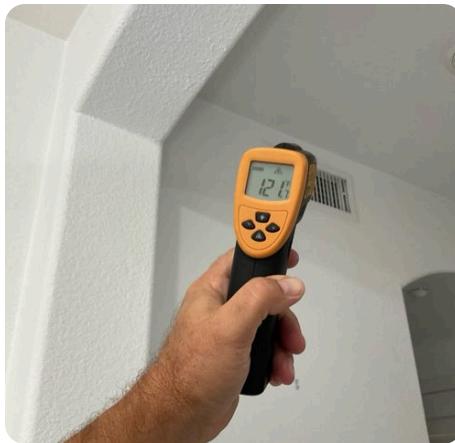
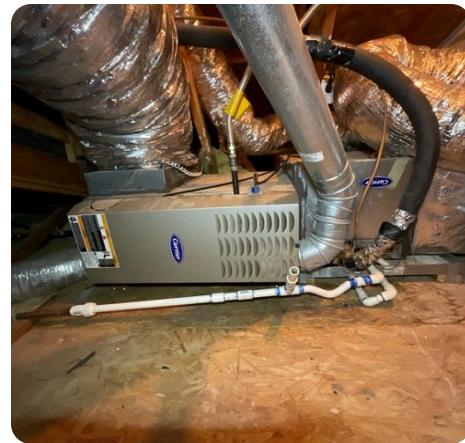
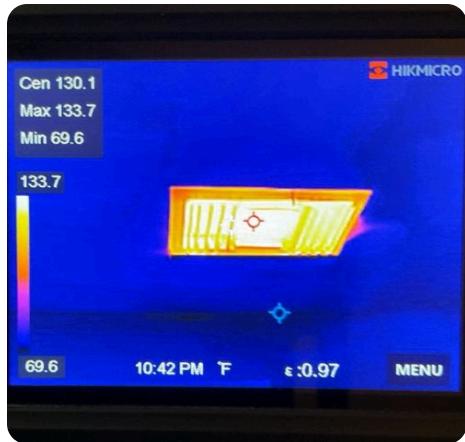
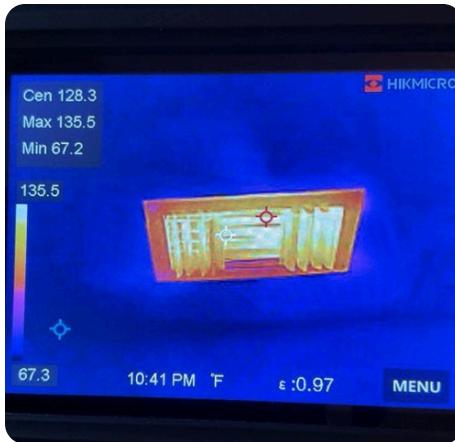
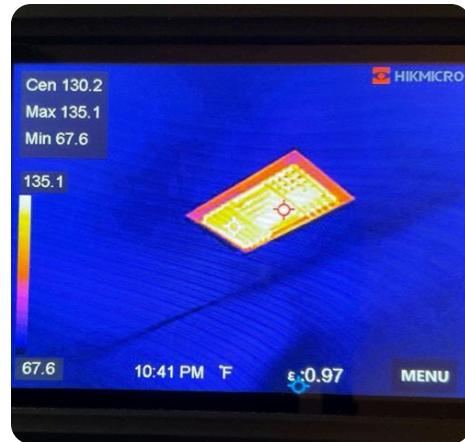
6.1 HVAC > Heating Equipment**About the Heating Equipment**

Location: Attic

The average life expectancy of a heating system is approximately 15-25 years depending on the type and maintenance of the system. If the system is near or over this life span, consideration into saving for a replacement or a more efficient model, should be considered. The inspector is not required to remove flame guards or view/identify the condition of the heat exchanger. This inspection checks on the general function of the heating system and in no way guarantees any mechanical components for useful life, serviceability, or efficiency. It is also recommended you contact an HVAC company annually, or as needed, to perform servicing and maintenance on the unit.

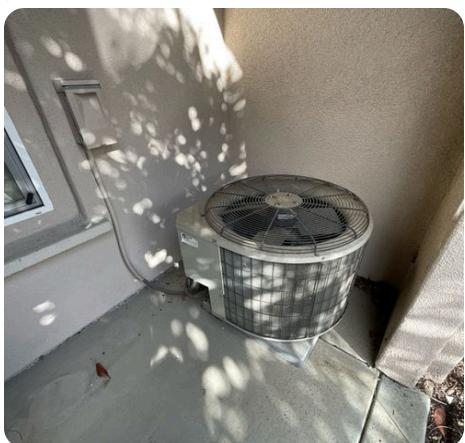
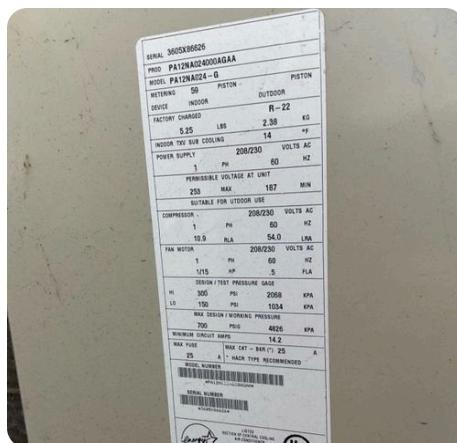
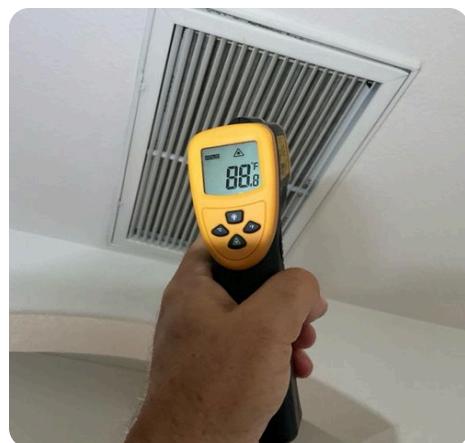
6.2 HVAC > Cooling Equipment

📍 Location: Exterior, Attic, Front Porch

The recommended temperature differential is typically between 15-22 degrees. The temperature differential is the difference of the air temperature in the return air grill, and air temperature out of the registers in the structure. If the unit does not fall within these recommendations, service by a qualified HVAC technician is recommended.

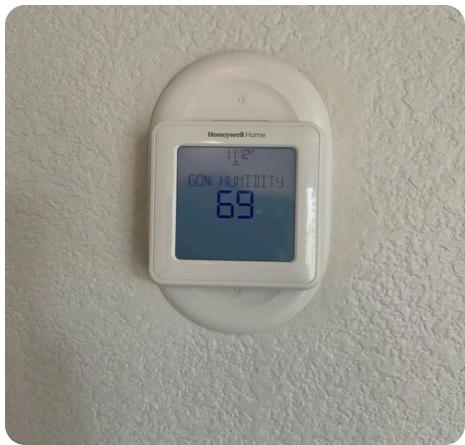
6.3 HVAC > Thermostats and Controls

Location: Living Room

The thermostats in the home were evaluated during the inspection and found to be in working condition. Properly functioning thermostats are essential for maintaining a comfortable temperature in the house and can help save energy costs. It is recommended to continue regular maintenance and setting appropriate temperatures for optimal performance.

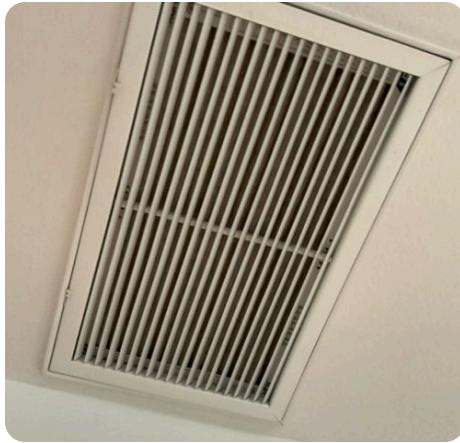
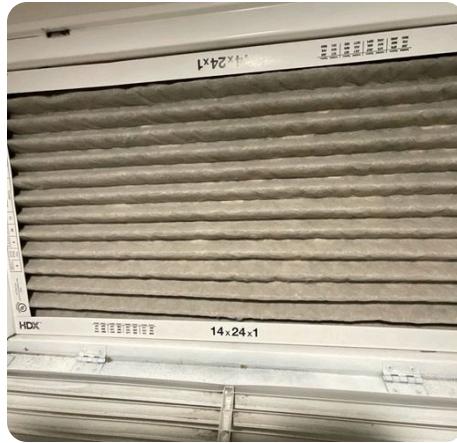
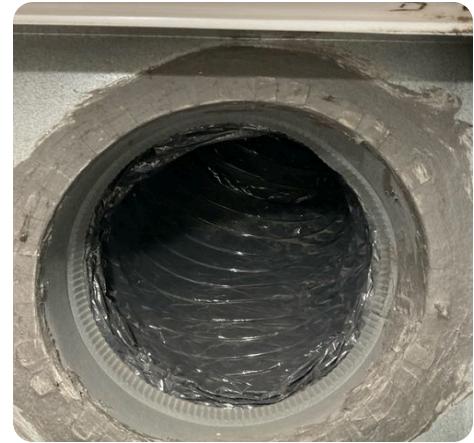
6.4 HVAC > Distribution/Return Ducts and Systems

Location: Attic, Throughout the Home

The visible portions of the ducts/returns appear to be in satisfactory condition. Dust and debris can reside inside air ducts, if the occupants have allergies or other breathing-related issues, a duct cleaning may be warranted by a qualified contractor.

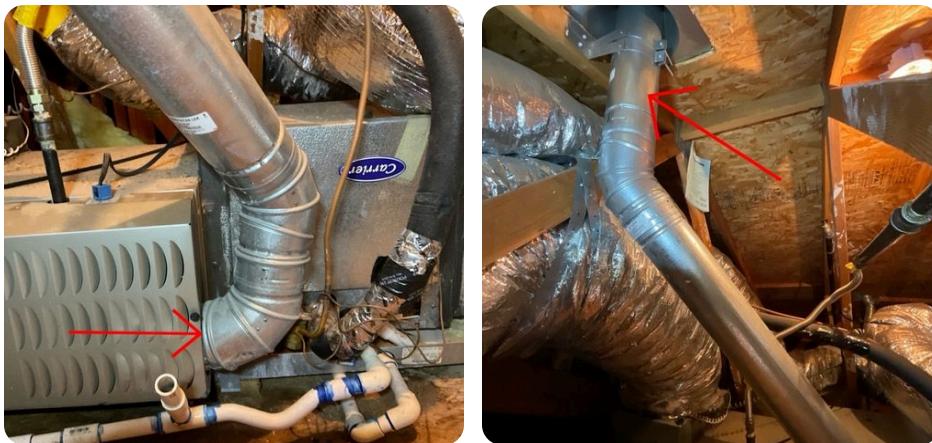
Location: Attic

Vents And Flues Evaluated

The homes vents and flues were evaluated during the inspection and were found to be in working condition. Proper functioning vents and flues are crucial for the efficient operation of the heating system, ensuring the safety and comfort of the occupants. To ensure continued performance and reliability, regular maintenance and inspections are strongly recommended

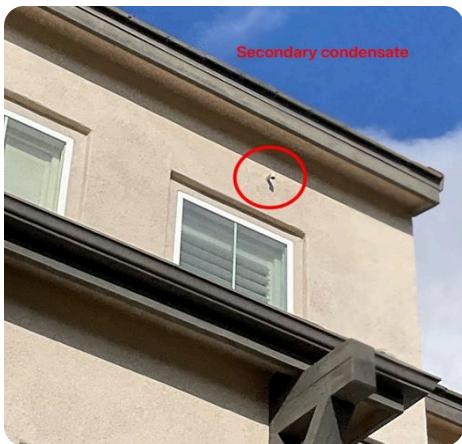
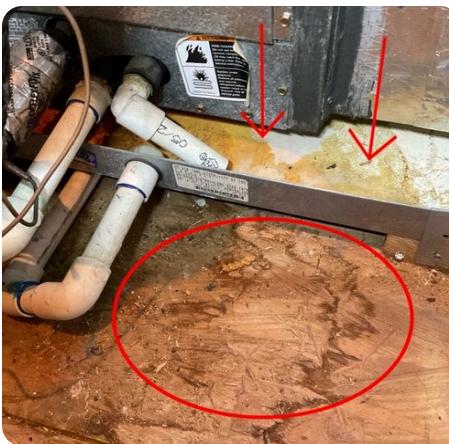
Condensate System Evaluated (Moisture Stains)

Moisture stains noted in and around the drain tray in the attic. Contact a qualified HVAC company for flushing the condensation lines and adding a safety switch to prevent flooding.

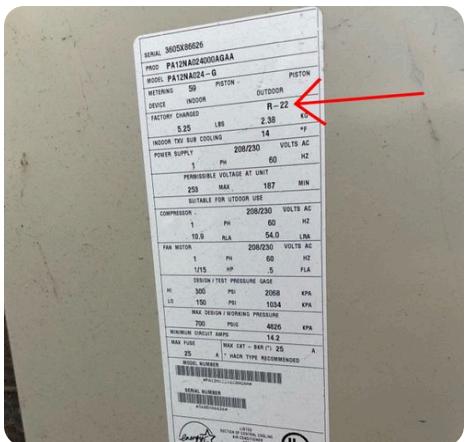
Location: Exterior, Attic, Front Porch

R – 22 Refrigerant

This unit requires R-22 refrigerant. Beginning in 2020, R-22 refrigerant is no longer manufactured and supplies will become limited. It is recommended that a qualified trades person be contacted to evaluate and service the unit and to provide information and options for upgrade of the refrigerant/unit when this unit is no longer functional.

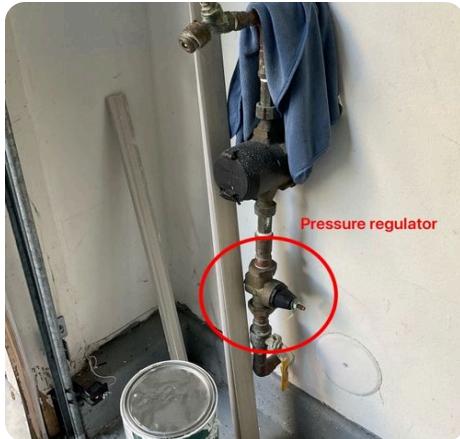
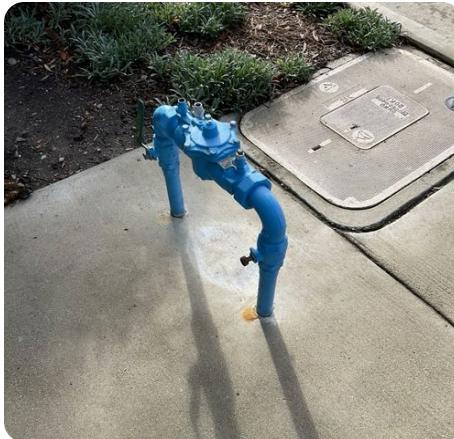
Water Pressure (Included in Summary)⚠ Action Required📍 Location: Garage

The water pressure at the exterior faucets is approximately 100 +- psi. Recommended water pressure is between 40 and 70 psi. We suggest a pressure regulator be installed, adjusted or replaced if the pressure exceeds 80 psi. Note: The excessive water pressure can reduce the life expectancy of the plumbing lines, void warranties of certain appliances, and cause premature leaks in fittings, landscape irrigation and faucets.

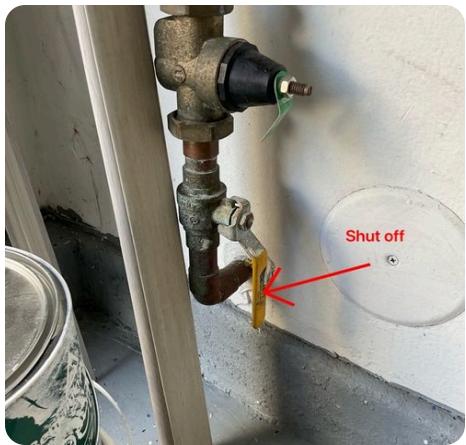
Water Main Shut-Off✓ Functional📍 Location: Garage

The water main shut-off valve was located and was functional. It is important to know the location and condition of the shut-off valve in case of emergencies or repairs. We recommend testing the shut-off valve periodically to ensure functionality.

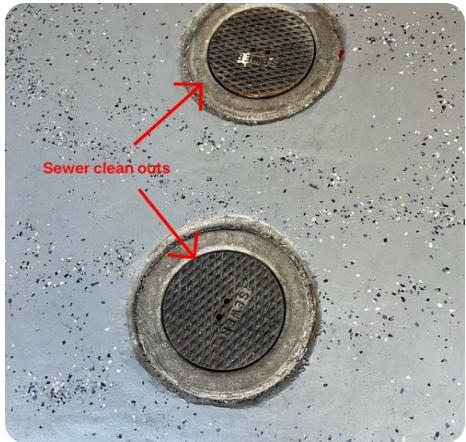
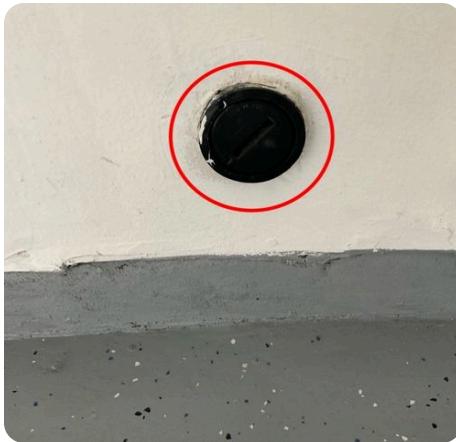
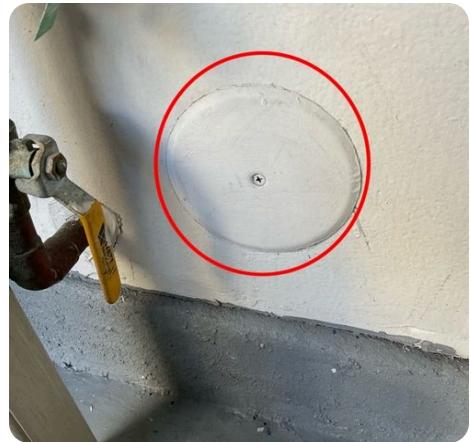
📍 **Location:** Kitchen, Garage, All Bathrooms

This is a visual examination of the exterior piping. We recommend questioning the seller regarding their knowledge of any slow draining or other plumbing-related issues. Also, a video examination of your waste system is recommended to determine if any obstructions exist inside the waste lines.

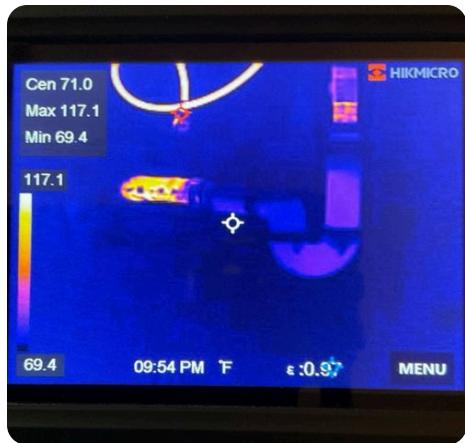
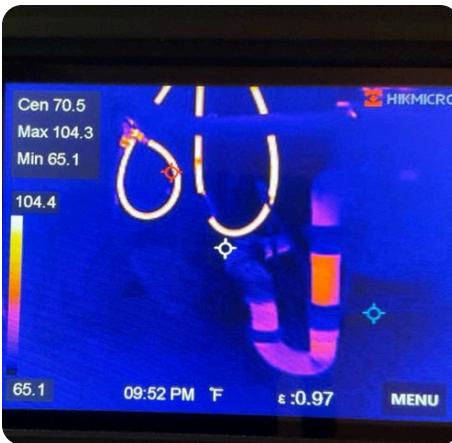
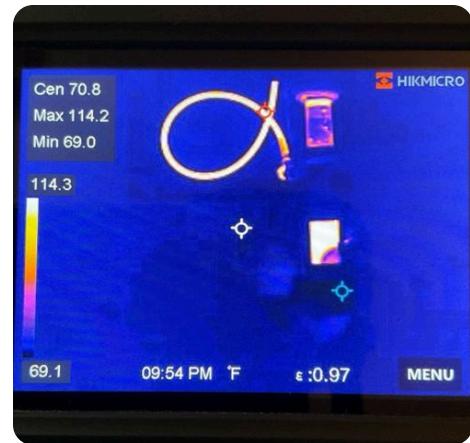
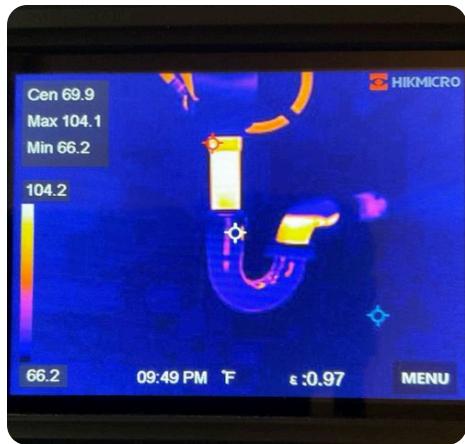
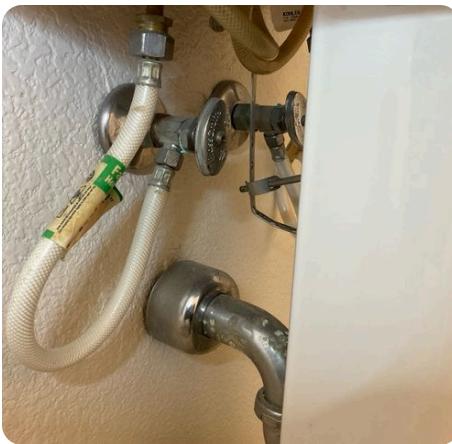
📍 Location: Kitchen, All Bathrooms

Visual Inspection Of Drain Pipes

This is a visual examination of the exterior piping. We recommend questioning the seller regarding their knowledge of any slow draining or other plumbing-related issues.

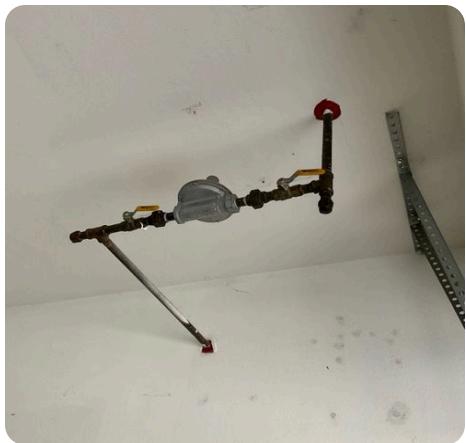
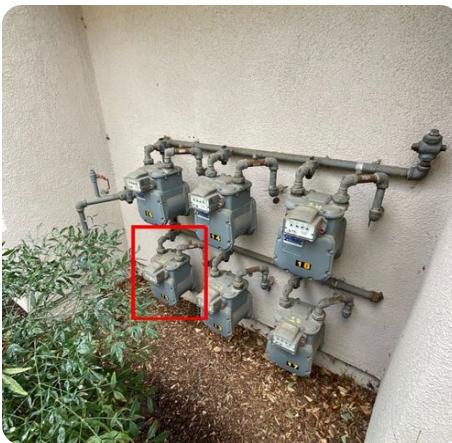
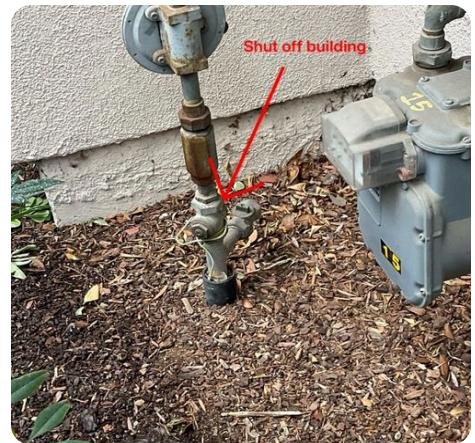
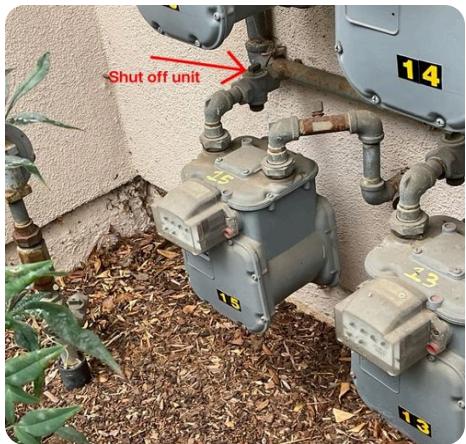
Location: Garage, North Side, Exterior

The gas plumbing system was evaluated during the home inspection and was found to be in functional working condition. No issues were identified with the gas plumbing system, assuring its functionality and safety for the occupants. Regular maintenance and inspection are recommended to ensure continued optimal performance.

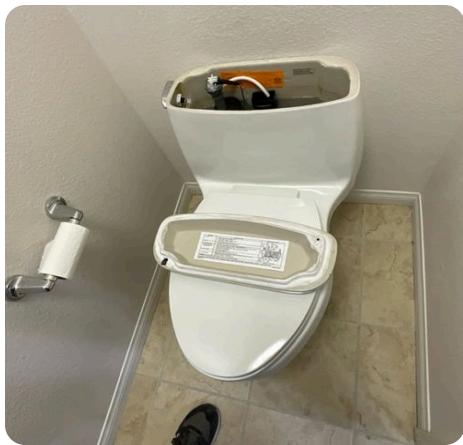
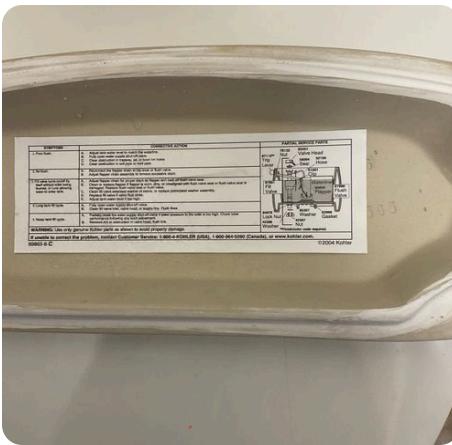
Location: Primary Bathroom

Inadequate Flush

The toilet is not flushing properly due to an issue with the flushing mechanism. Maintaining a fully functioning toilet is crucial for proper sanitation. It is recommended to have a qualified plumber evaluate and repair the toilet for a proper flush.

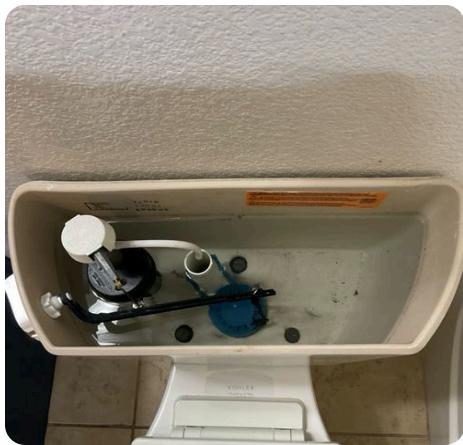
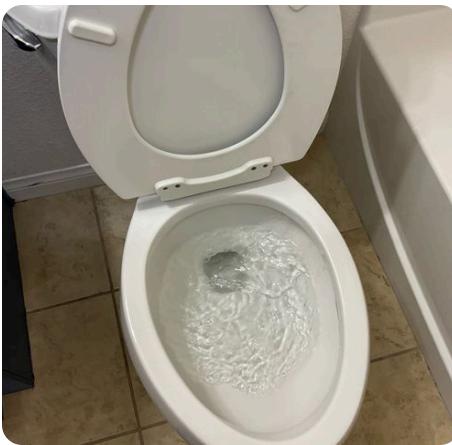
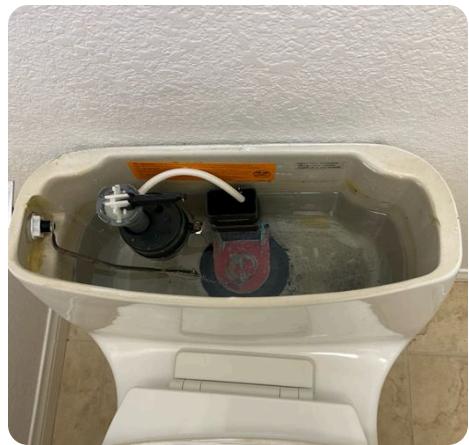
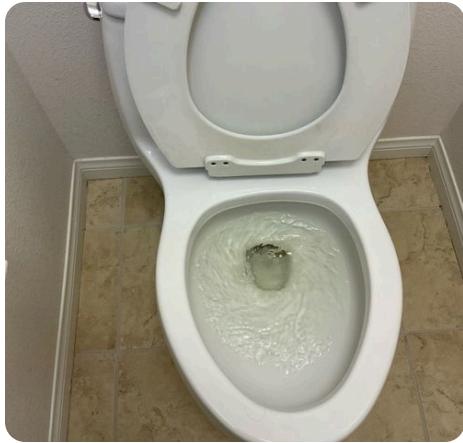
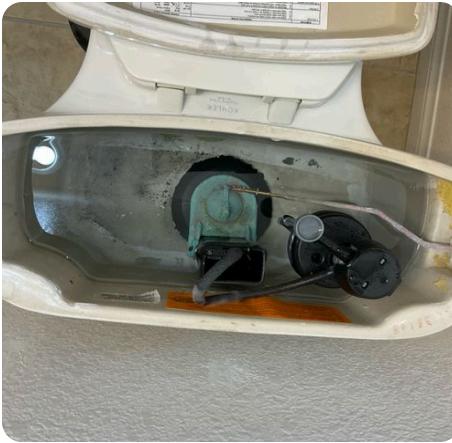
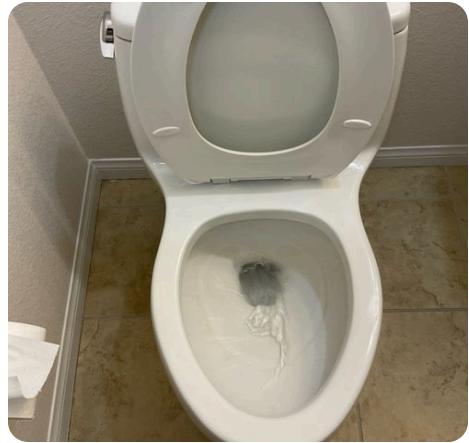
The toilets were flushed and inspected for cracks, leaks, and serviceability. The toilets should be inspected periodically for indications of cracking in the toilet bowl, tank, or base. Also, periodic replacement of flapper valves and water towers should be expected as typical homeowner maintenance.

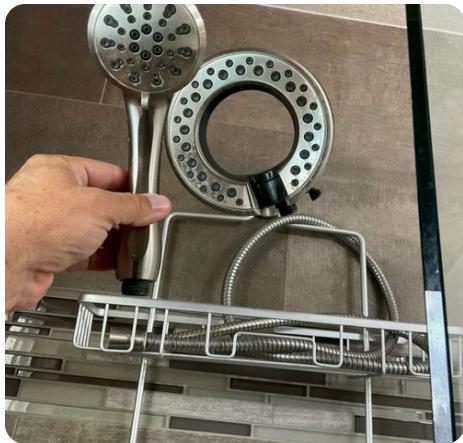
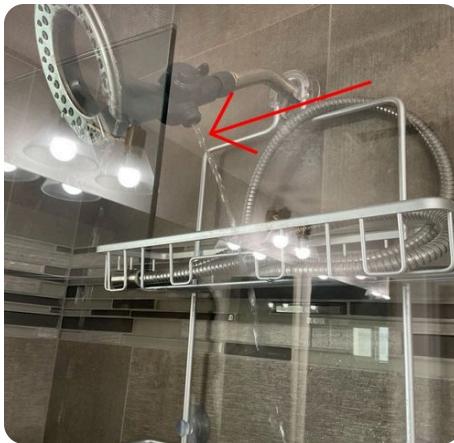
7.6 Plumbing > Tubs, Showers, and Fixtures

Disconnected Shower Head

📍 Location: Primary Bathroom

The shower head is disconnected. This issue can result in water leakage and affect the water pressure during showers. We recommend reattaching the shower head securely to prevent any water damage and ensure proper functionality. If needed, a licensed plumber can assist with the reattachment to avoid any further issues.

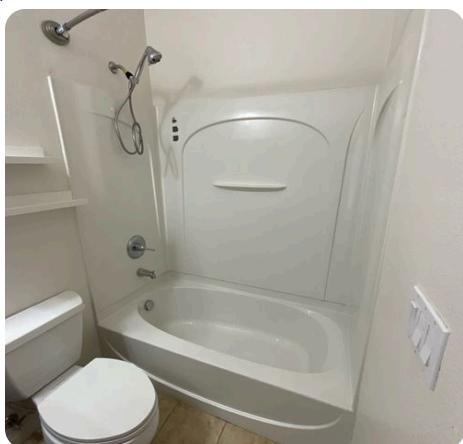
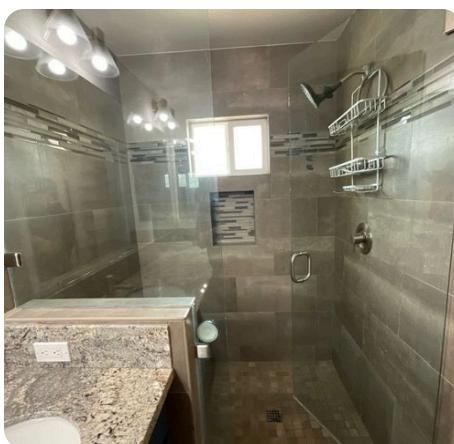
Water Exposed Areas

📍 Location: All Bathrooms

Routine preventive maintenance should include applying and maintaining caulking in and around tubs and shower surrounds to prevent moisture penetration behind tub and shower wall/floor cover materials.

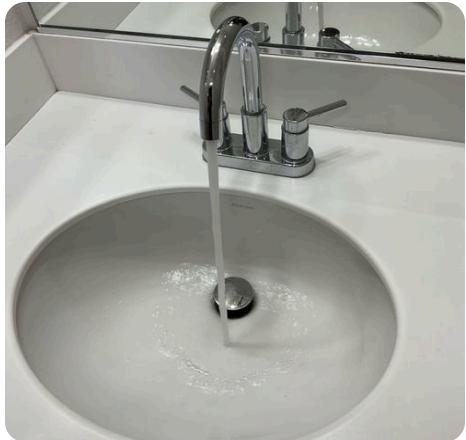
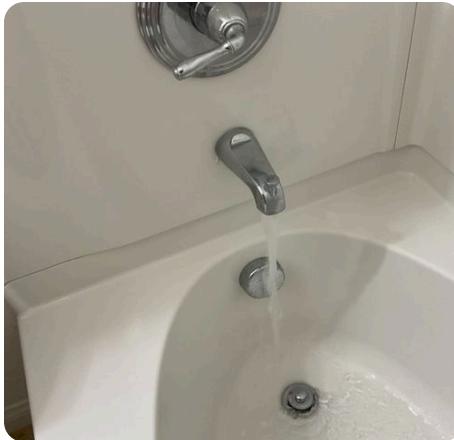
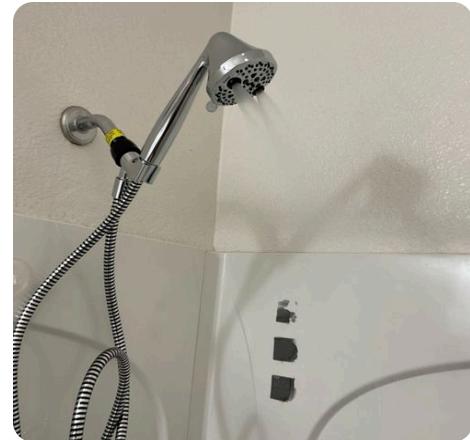
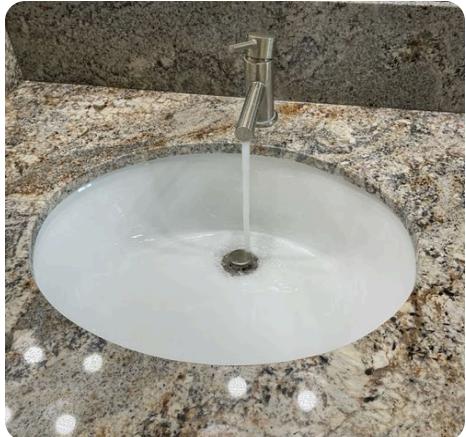
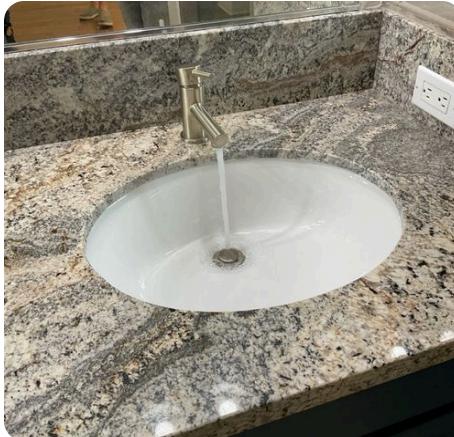
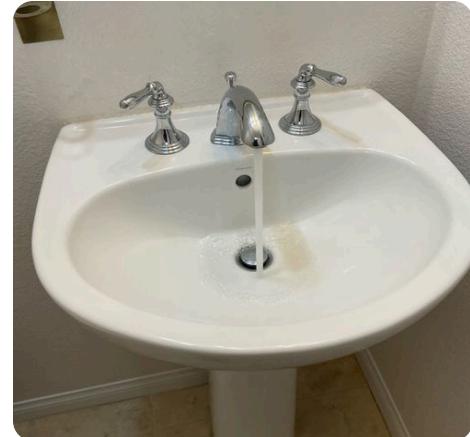
Plumbing Fixtures Maintenance Information**Preventive Measure**

📍 Location: All Bathrooms, Kitchen

Routine preventive maintenance and/or replacement of fixtures is needed periodically. Faucets and valves have a typical life expectancy of 5-15 years. General wear, depending on the quality of fixture, is expected. Preventative measures, such as the installation of a soft water or water conditioning unit is recommended.

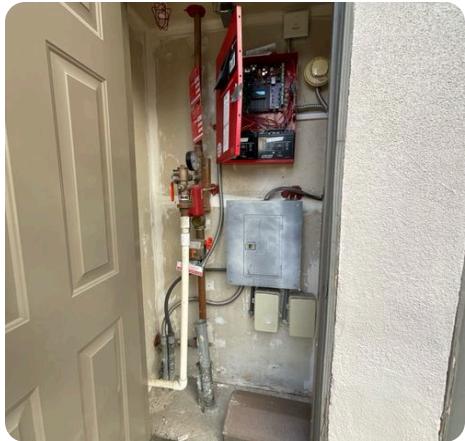
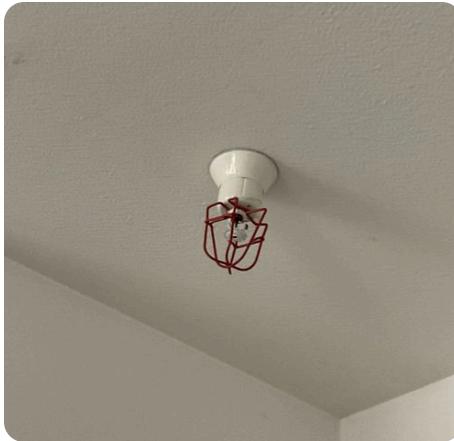
The home is equipped with a fire sprinkler system. Testing and evaluation of the fire sprinkler system is not included within the scope of this inspection.

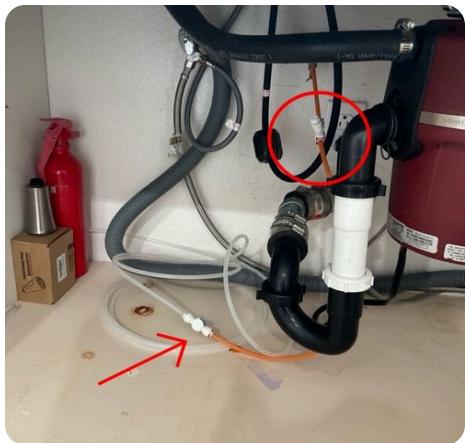
Removed Water Filter System

Location: Kitchen

The water filter system has been removed. It is recommended to evaluate installing a new water filter system to maintain water quality and ensure clean drinking water for the household. The refrigerator has the capability to pour water as long as it is properly connected to a water line.

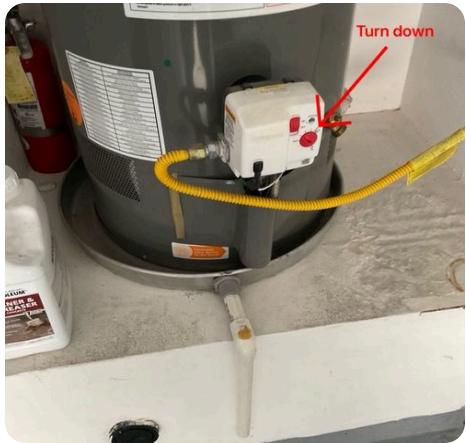
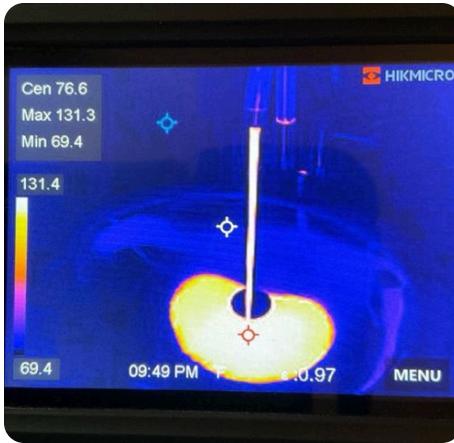
📍 Location: Garage

The water temperature at the faucet was too hot. Lowering the setting is recommended. Temperature settings on water heaters should be set so that the temperature of the water at the faucets is 120°F or lower. This will provide the most efficient operation and also reduce the danger of potential burns from scalding. Temperature adjustment can be made at the dial on the water heater.

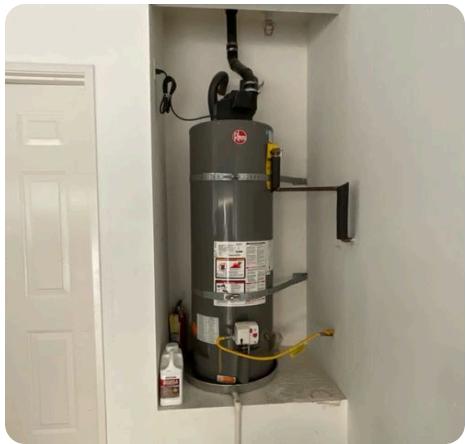
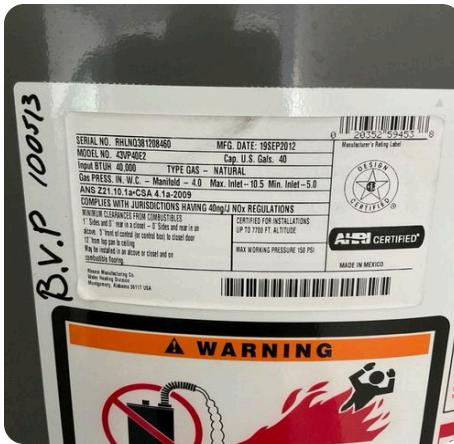
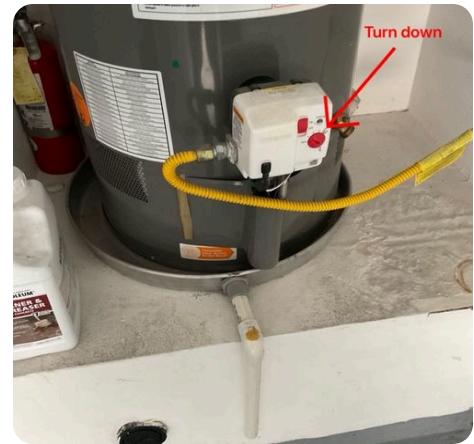
Water Heater

The water heater was visually inspected. The life expectancy of a water heater is typically 8-12 years from the date of installation, although there are exceptions on both sides. As a preventative maintenance recommendation, the water heater should be drained periodically to remove sediment buildup in the tank. The recommended setting for a residential water heater is under 120 degrees Fahrenheit. For safety.

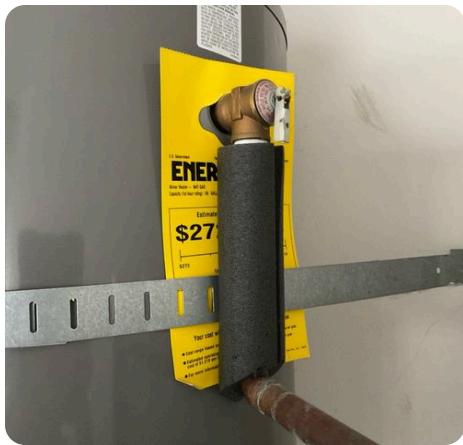
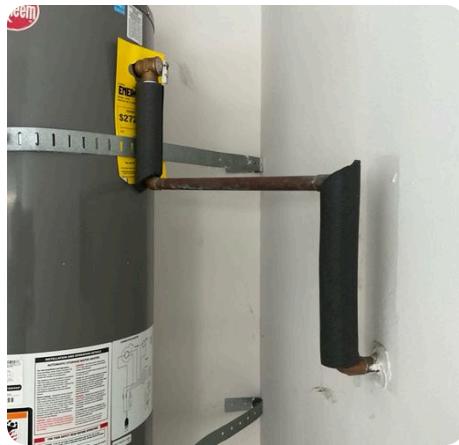
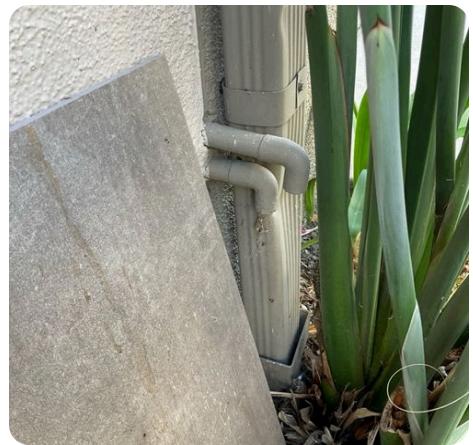
8.2 Water Heating Equipment > TPR Valve/Discharge Pipe

The water heater's temperature/pressure relief valve is equipped with an approved discharge pipe. The pipe serves the purpose of preventing someone from being sprayed with scalding water in the event that the valve were to discharge. These components were in satisfactory condition at the time of the inspection.

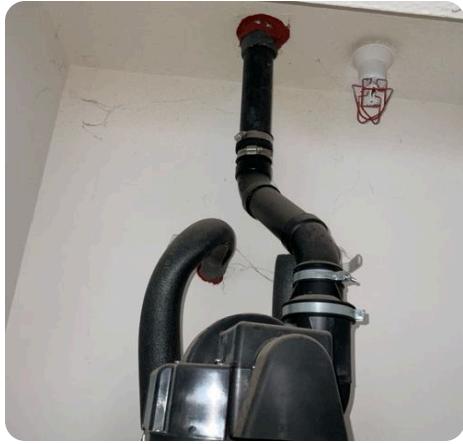
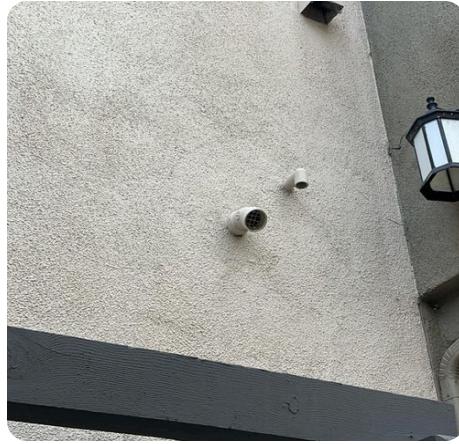
8.3 Water Heating Equipment > Exhaust Flue Piping

The exhaust flue piping of the water heater was visually examined to ensure it was properly installed. The piping appeared secure, free from obstruction, and correctly venting exhaust gases outside.

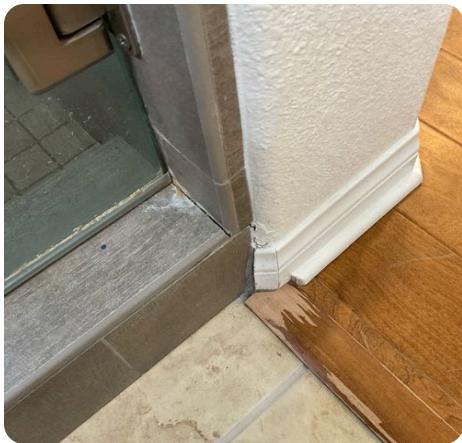
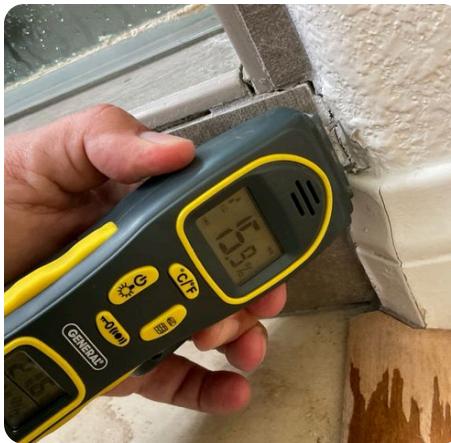
Moisture Issue Outside Of Shower

Location: Primary Bathroom

The presence of moisture outside of the shower area is a common issue that can lead to mold growth and water damage. It is recommended to properly seal any cracks or gaps in the shower enclosure to prevent water seepage. Additionally, ensuring that the shower door is properly sealed and that the ventilation fan is functioning effectively can help mitigate moisture buildup.

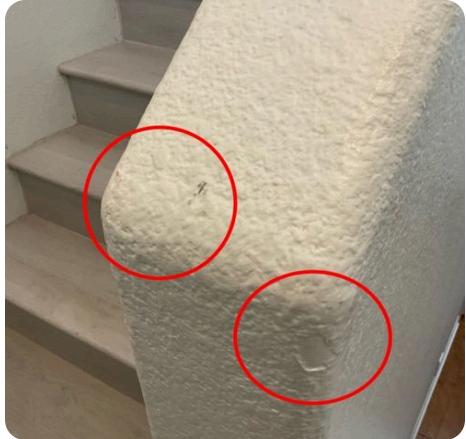
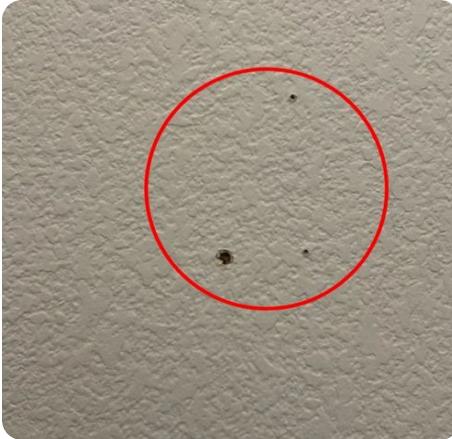
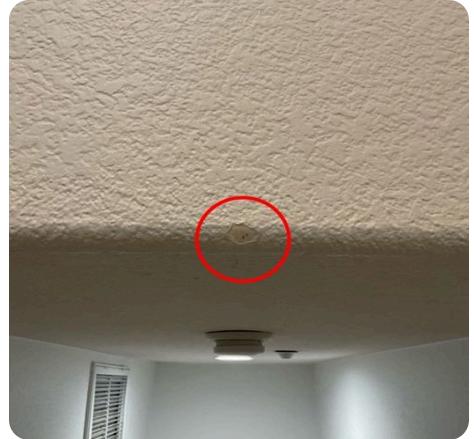
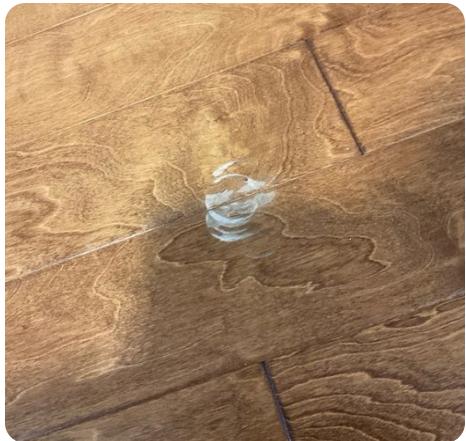
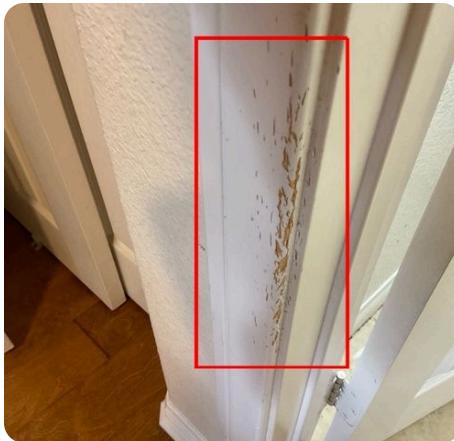
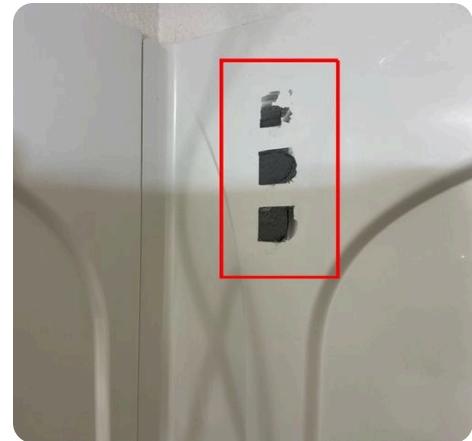
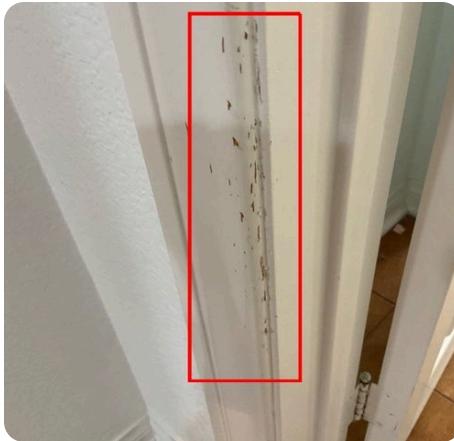
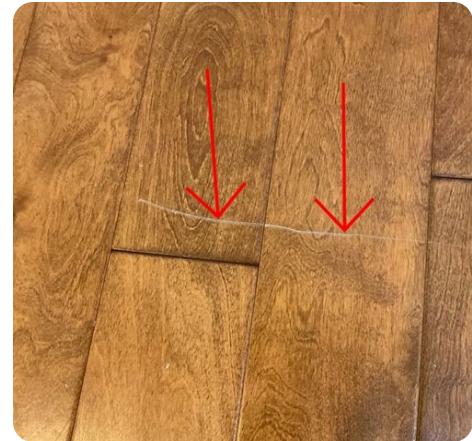
Location: Throughout the Home

General Cosmetic Damage

The floors, walls, and ceilings exhibit some general cosmetic damage, which is typically superficial and does not impact the structural integrity of the property. It is recommended to assess and address these cosmetic issues for aesthetic reasons. Depending on the extent of the damage, options may include patching or replacing affected areas, repainting or refinishing surfaces, or seeking assistance from a professional contractor for more substantial damages.

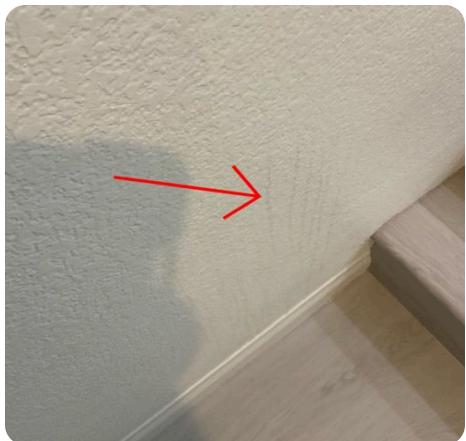
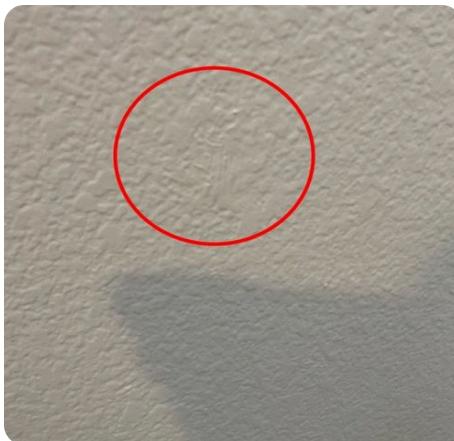
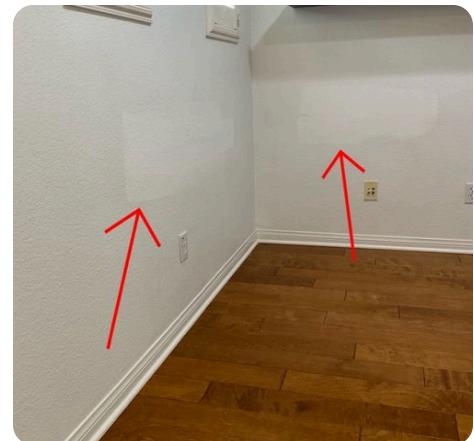
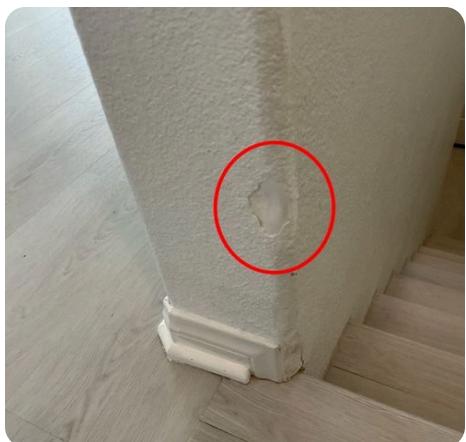
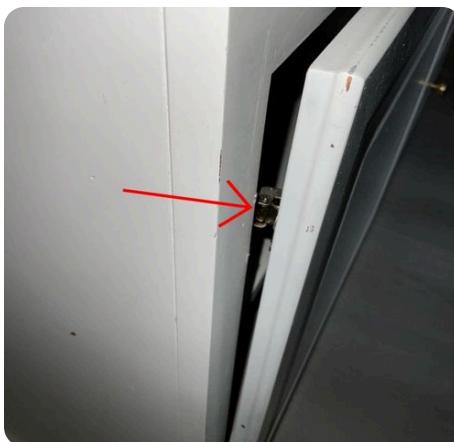
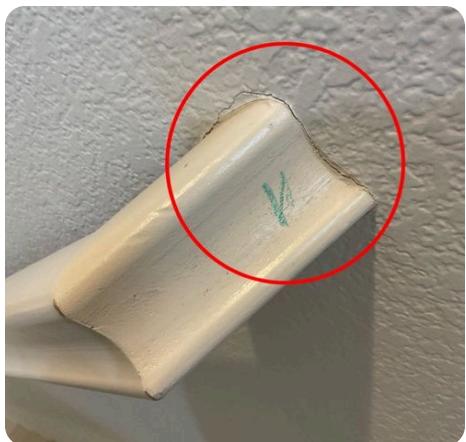
📍 Location: Throughout the Home

General Cosmetic Damage

The floors, walls, and ceilings exhibit some general cosmetic damage, which is typically superficial and does not impact the structural integrity of the property. It is recommended to assess and address these cosmetic issues for aesthetic reasons. Depending on the extent of the damage, options may include patching or replacing affected areas, repainting or refinishing surfaces, or seeking assistance from a professional contractor for more substantial damages.

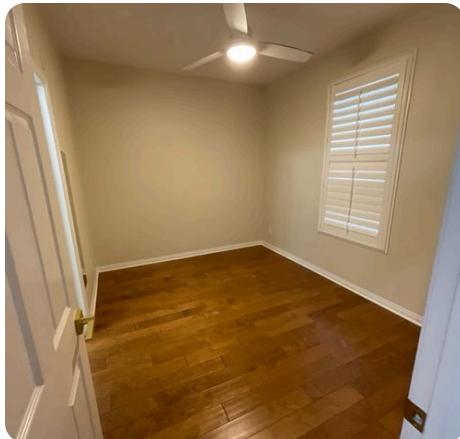
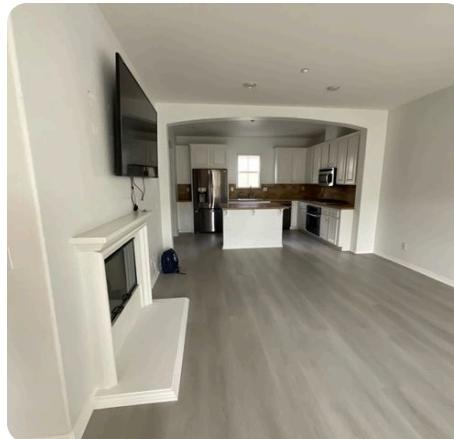
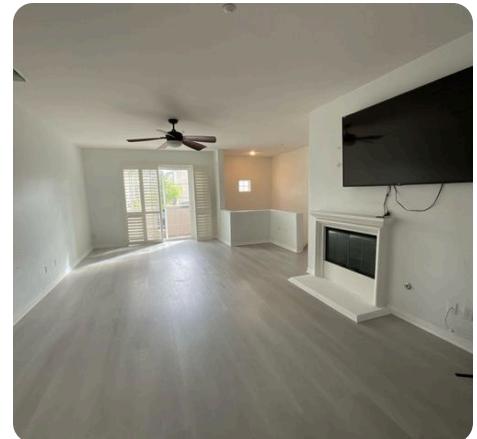
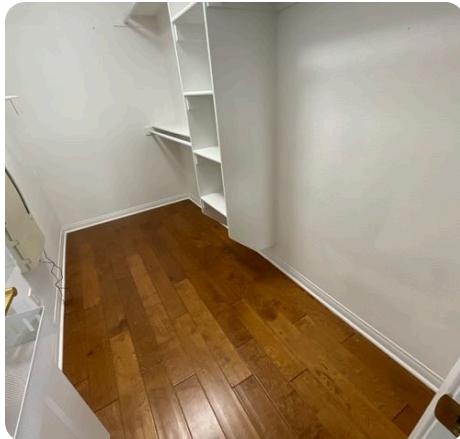
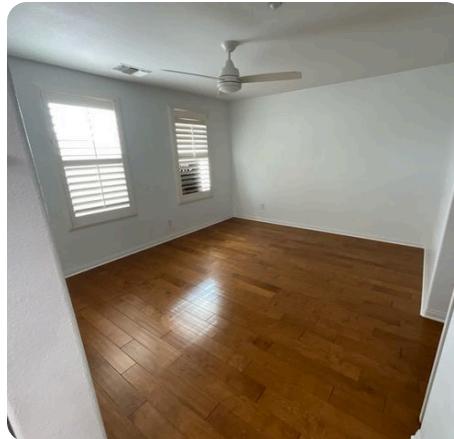
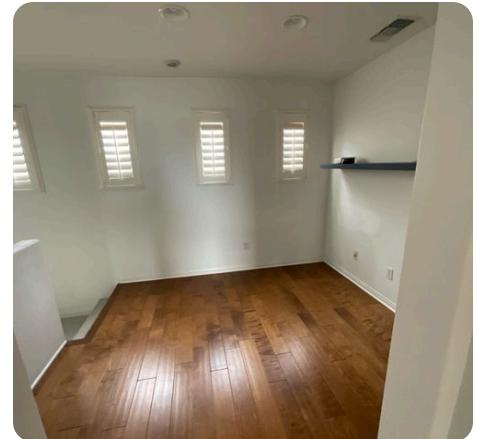
Location: Interior

Interior Walls Functional

The interior walls, ceiling, and flooring were inspected and there did not appear to be any major deficiencies. There may be areas of minor cracking of drywall seams and nail pops at the wall/ceiling junctions that are not of structural concern. Caulking and repainting to address these conditions is recommended. Contact a qualified professional to perform this maintenance. This reporting does not comment on whether interior finishes are square, straight, level, or plumb.

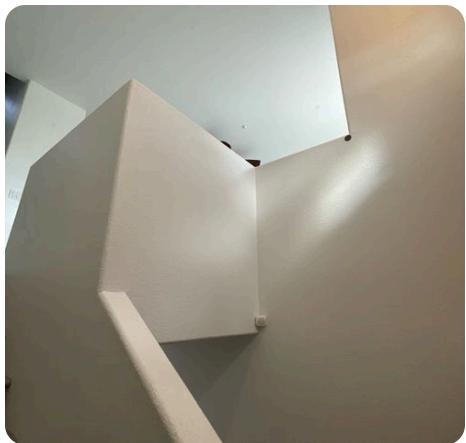
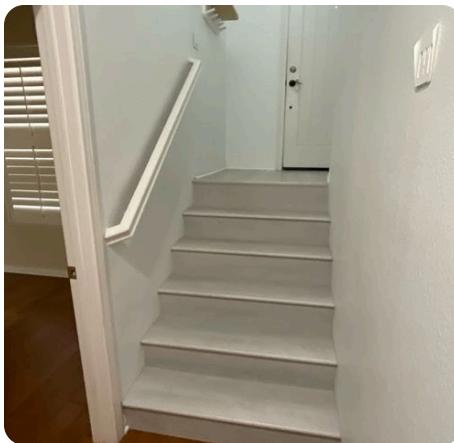
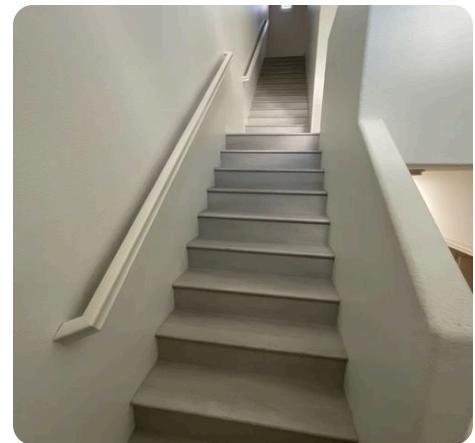
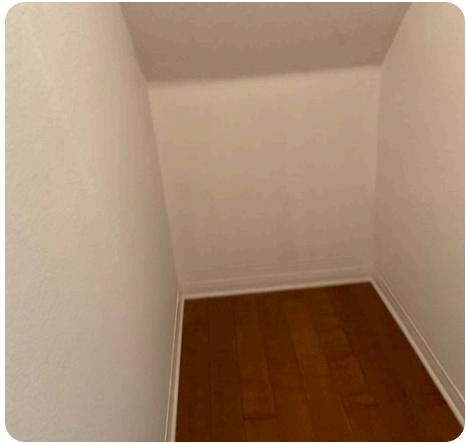
Location: Main Stairway

Interior Stairways, And Components Evaluated

The interior stairway and its associated components were found to be in satisfactory condition at the time of inspection. All steps, handrails, and railings were secure and functional, with no signs of significant wear or damage.
