Service: Condo Inspection

Prepared for: Sample Report

WIN Inspector

Damien Devine

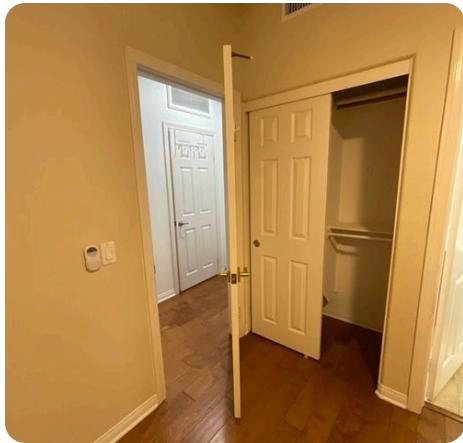
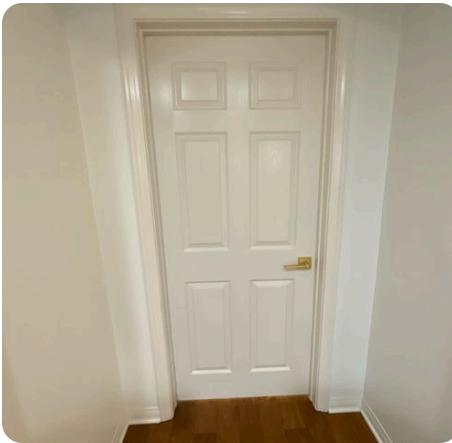
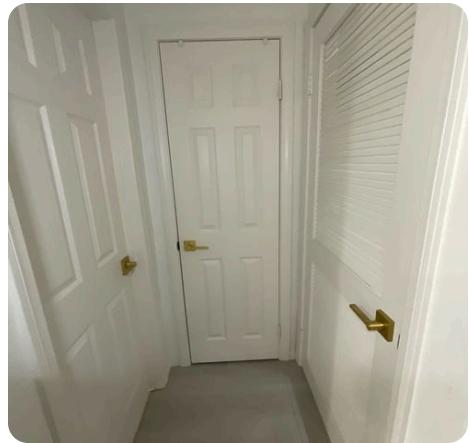
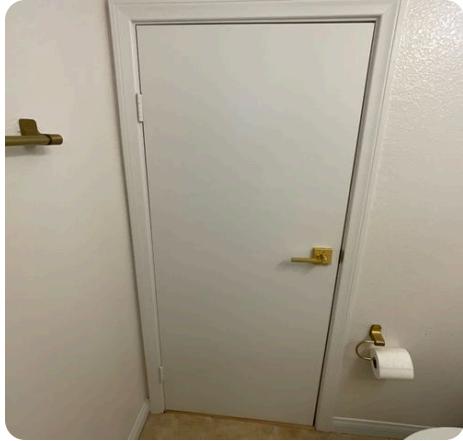
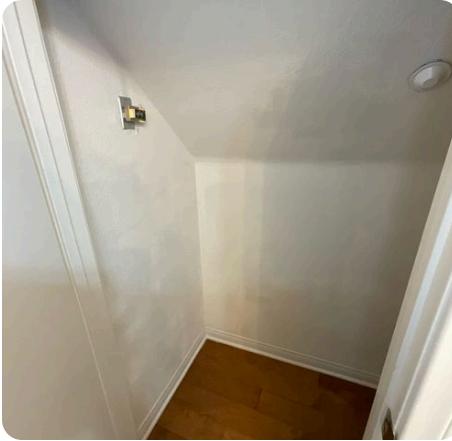
Location: Interior

Interior Doors - Functional

All accessible doors were inspected to ensure proper alignment, secure fitting, and smooth operation. No functional defects or issues were observed during the inspection, and the doors were found to be in satisfactory working condition.

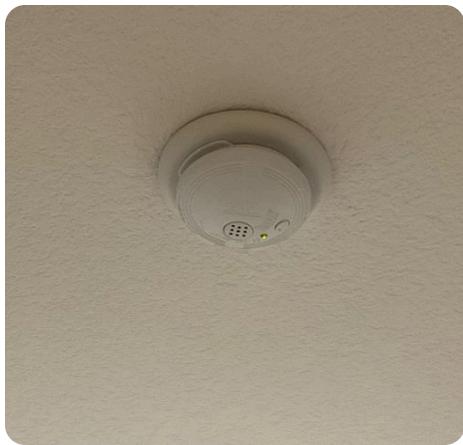
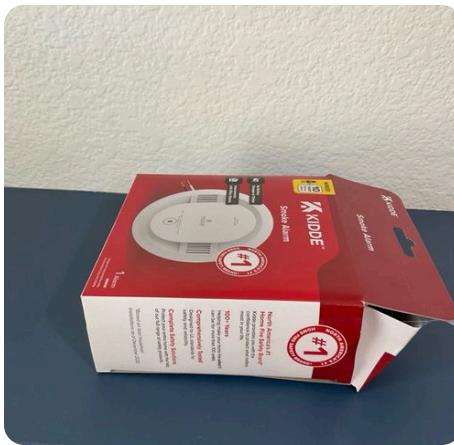
Location: Upstairs Hallway, Den

Missing Smoke Alarms

One or more smoke alarms is missing. Smoke alarms are required on all levels and outside all sleeping areas. Recommend further evaluation and installation of a functional smoke alarm for safety.

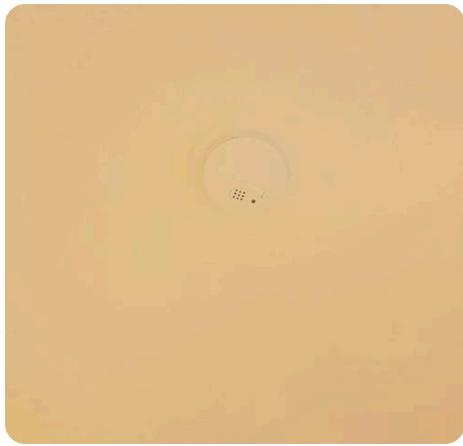
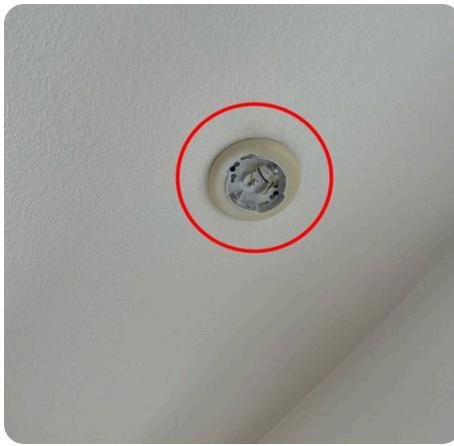
📍 Location: Main Stairway, All Bedrooms, Upstairs Hallway, Bathroom

**Smoke Alarm Information****Preventive Measure**

Determining the functionality of smoke detectors is outside the scope of this inspection as the units should be checked monthly. Any unit greater than 10 years of age should be replaced as they are considered to be at the end of their service life. Functional smoke/fire detectors are recommended inside and outside each sleeping area for increased safety awareness.

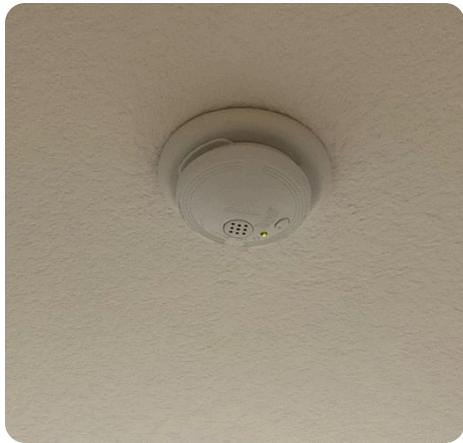
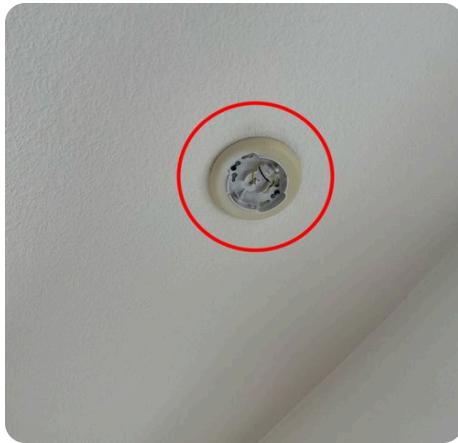
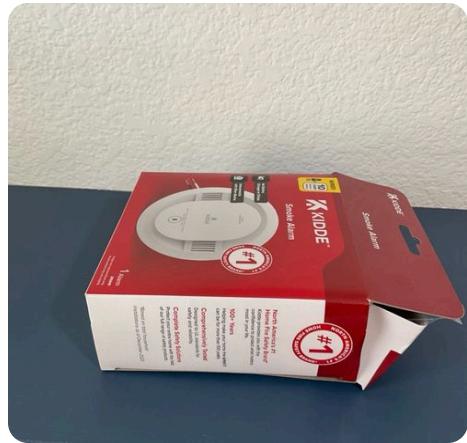
📍 Location: Den, Upstairs Hallway, Main Stairway

**9.5 Interior > Carbon Monoxide Alarms****Carbon Monoxide Alarms Evaluated****Preventive Measure**

Carbon monoxide (CO) alarms were located in the home. The inspector does not test these alarms; however, verifies that they are installed near sleeping areas and on each level of the home. For continued protection, regular manual testing and battery maintenance are recommended.

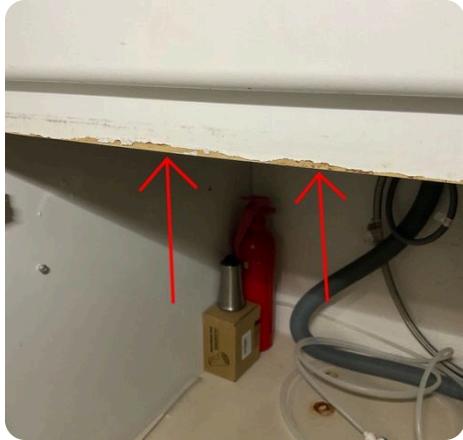
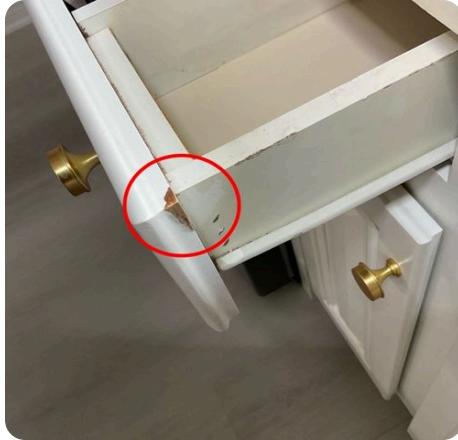
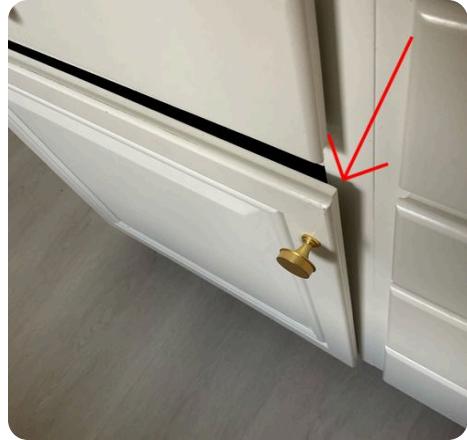
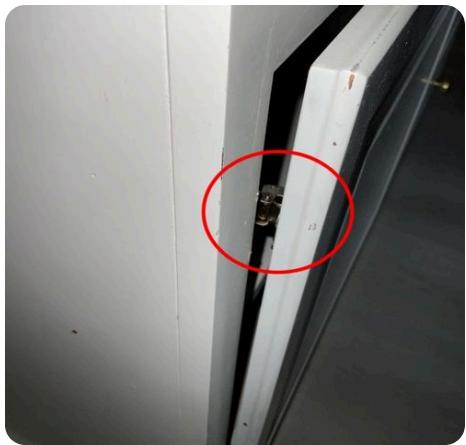
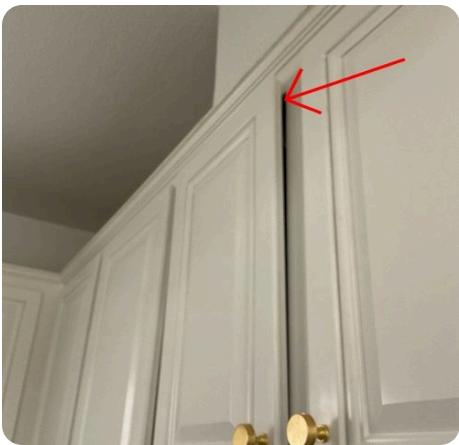
Cosmetic Damage On Cabinet

Location: Kitchen

Cosmetic damage was observed on the front surface of the cabinet. While this does not impact the cabinet's functionality, it could be a concern for aesthetics. Assessing the extent of the damage and exploring repair or replacement options is advisable. Contacting a qualified cabinet professional might provide useful guidance in resolving this matter.

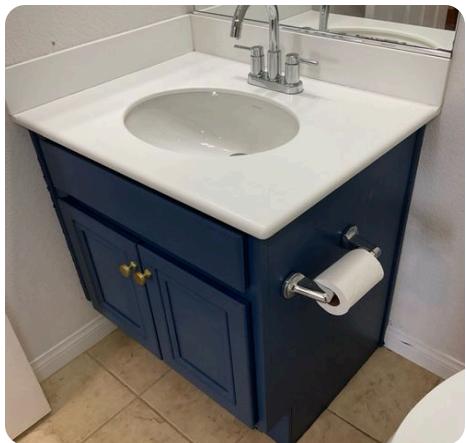
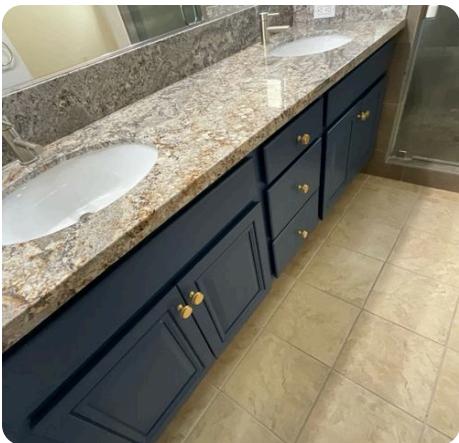
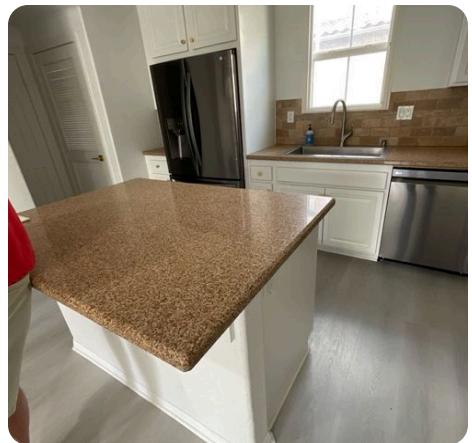
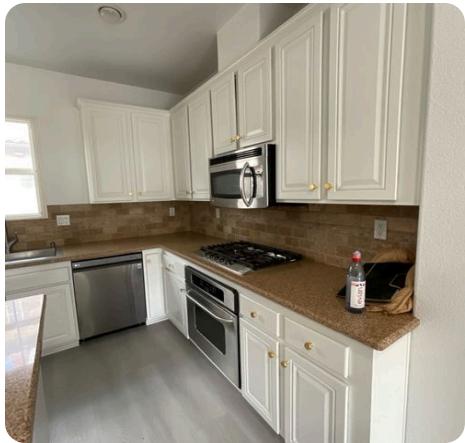
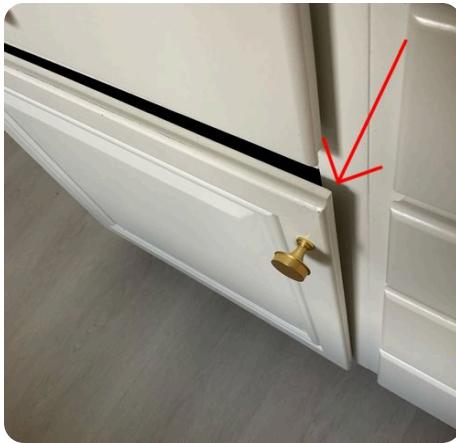
Countertops And Cabinets Evaluated

Location: All Bathrooms, Kitchen

The accessible countertops and installed cabinets were evaluated to assess their stability, surface condition and functionality. No significant signs of wear or damage were observed on the inspected components, confirming their suitability for continued use at the time of the inspection.

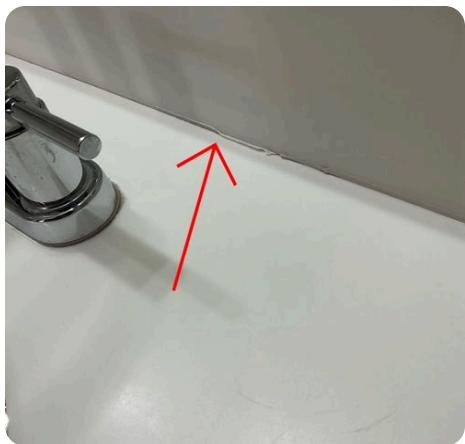
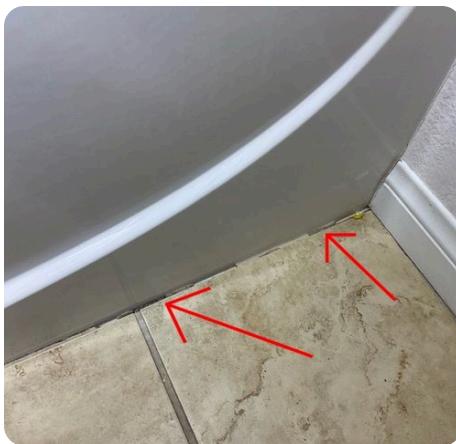
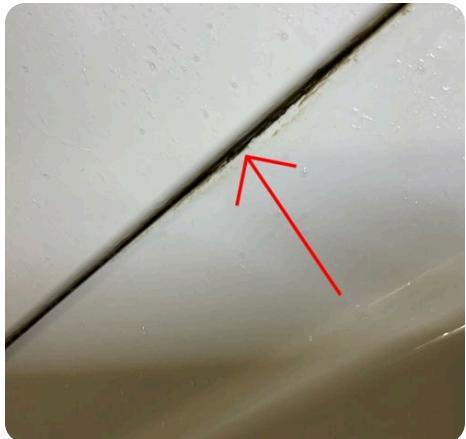
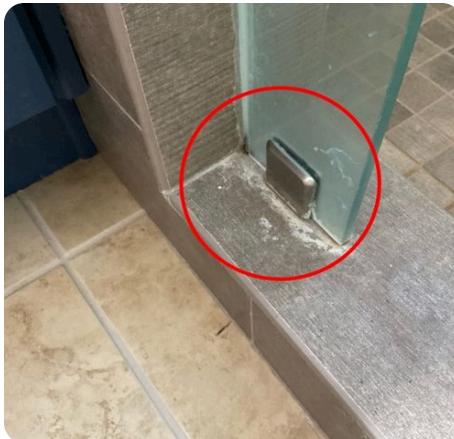
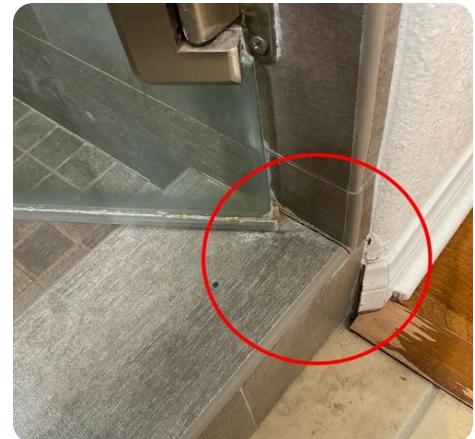
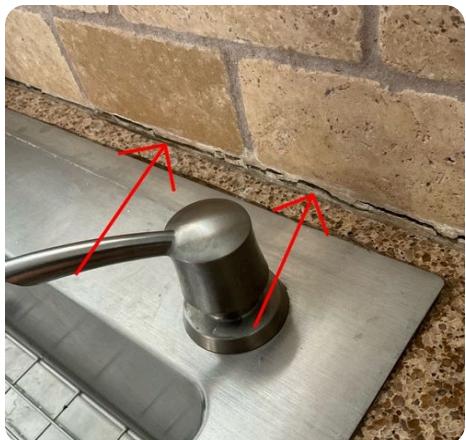
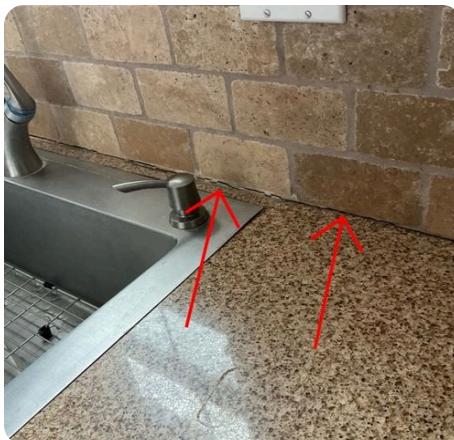
Recaulking Recommendation For Interior Caulking

Location: All Bathrooms, Kitchen

The caulking in the interior areas such as around the bathtub, shower, or sink is showing signs of wear and tear. It is recommended to recaulk these areas to prevent water seepage and maintain the integrity of the surfaces. A qualified handyman or plumber can evaluate and repair this caulking to ensure proper sealing and prevent any potential water damage.

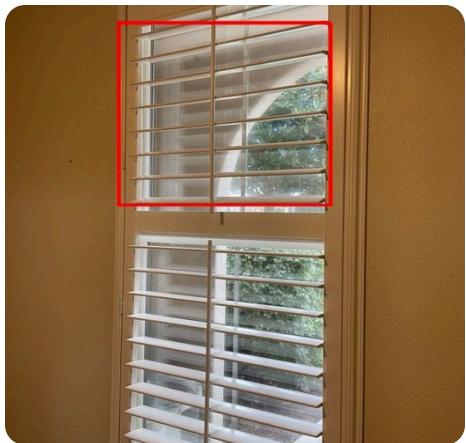
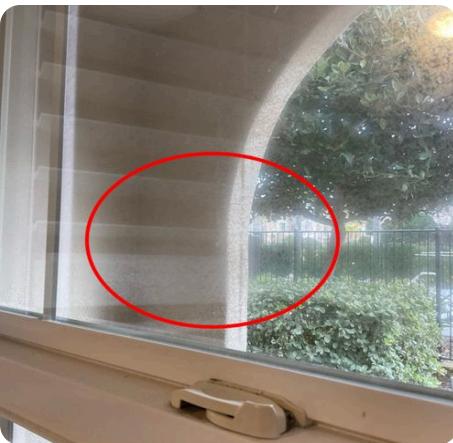
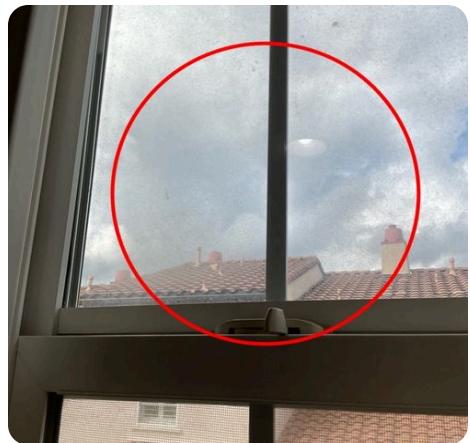
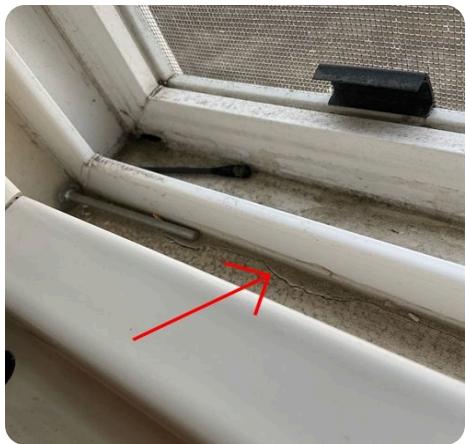
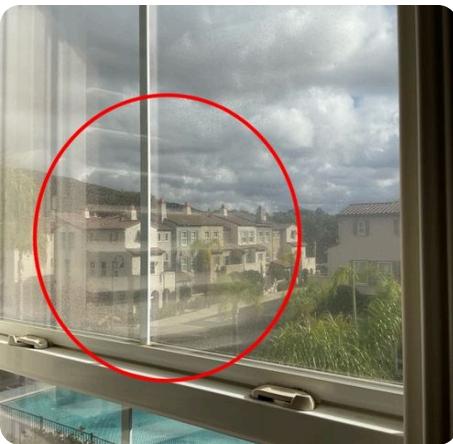
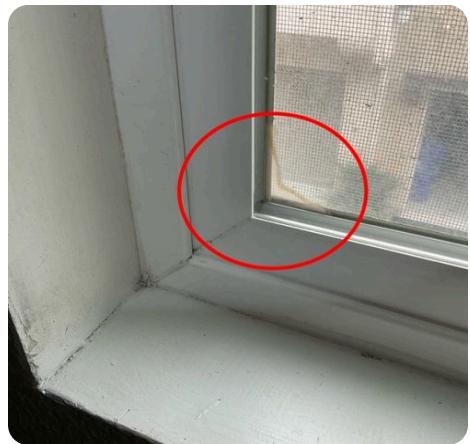
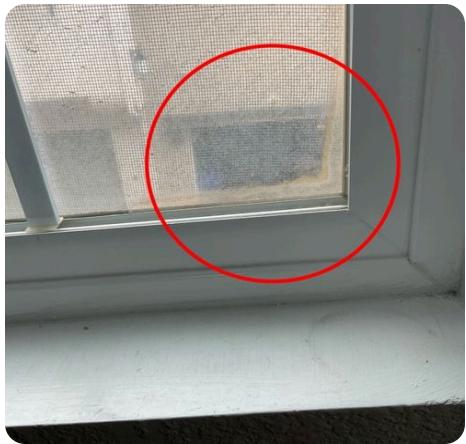
Broken Seal On Window

Location: Throughout the Home

The window has a broken seal, which can result in energy loss and reduced insulation. It is recommended to evaluate and repair the broken seal to prevent further energy inefficiency. A qualified window repair specialist can address this issue by resealing or replacing the window.

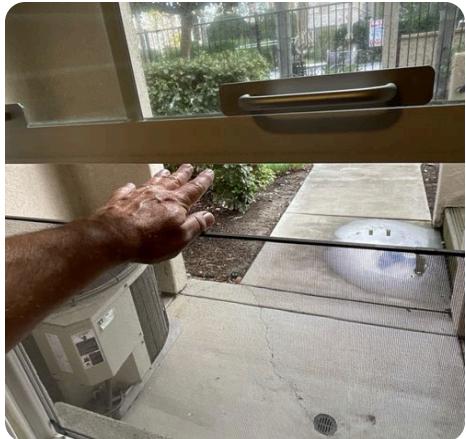
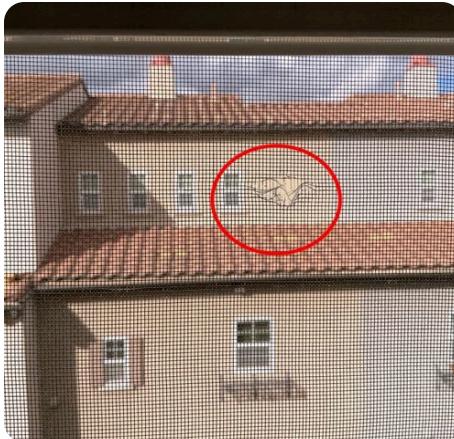
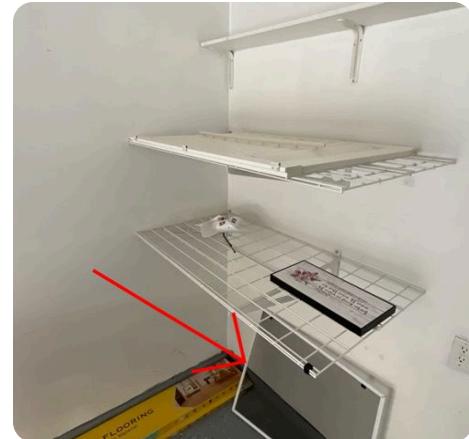
Missing Window Screen

Location: Den, Rear of Home, Guest Bedroom, Front of Home

Isolated windows in the home were missing screens. Asking the seller for the location of any additional screens placed in storage is recommended in addition to confirming that one screen is available for every window. Slight damage was noted on a rear windows. Contact a qualified window or screen company for evaluation and repair.

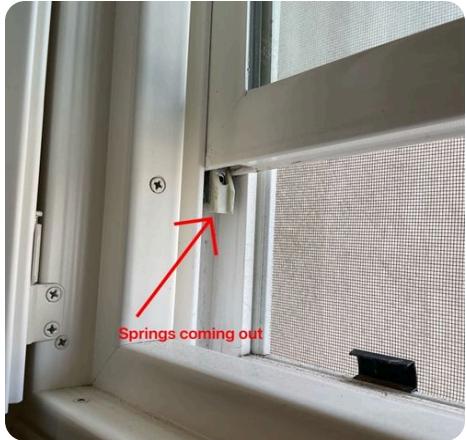
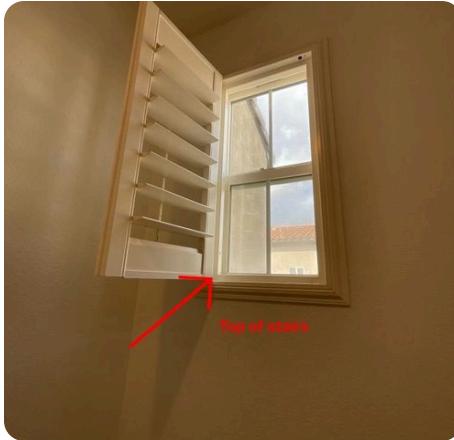
**Window Springs Damaged**

Location: Den, Main Stairway

The window spring on one side is not functioning properly. This can compromise the function of the window. It is recommended to have a qualified locksmith or window repair specialist evaluate and repair.

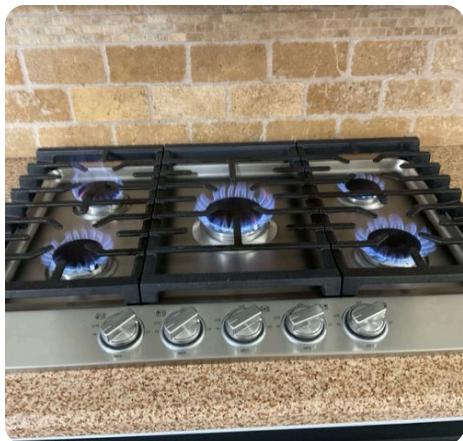
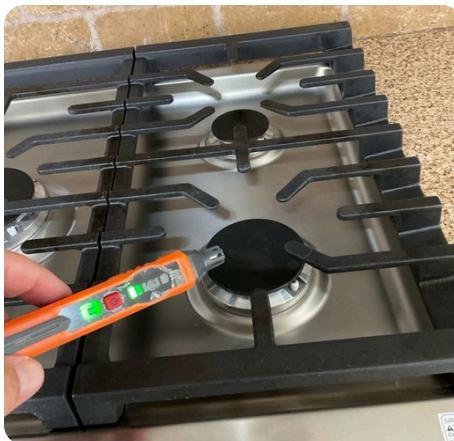
An on / off test was performed to determine if the cooktop was functioning. Periodic cleaning and maintenance is recommended for continued use.

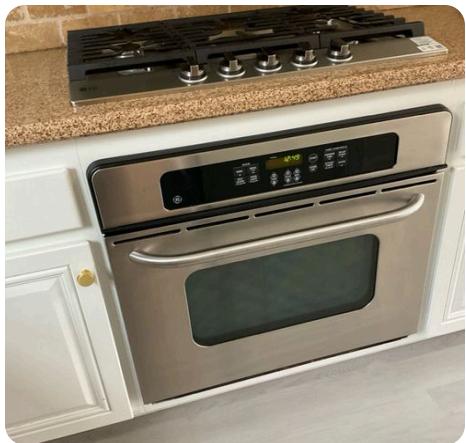
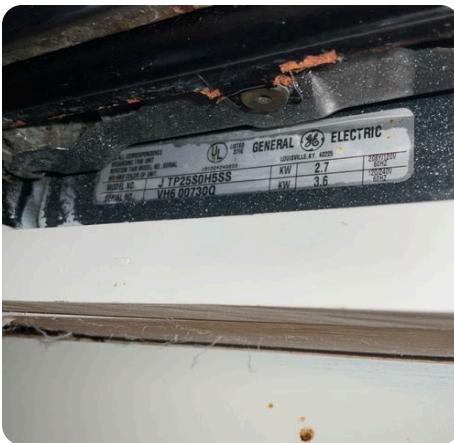
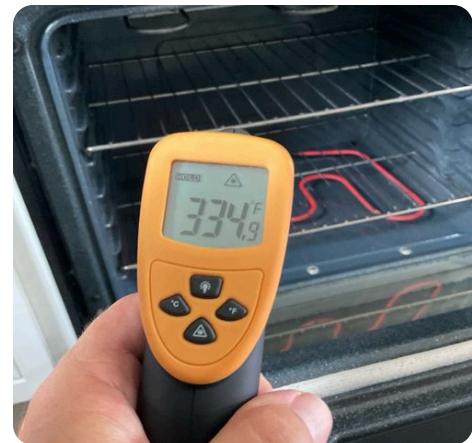
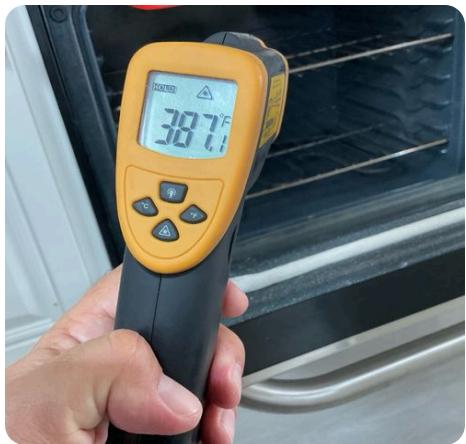
The oven functioned normally when tested in a limited fashion at both the bake and broil settings. The tests are designed to determine basic functionality and should not be considered a verification of actual temperatures achieved.

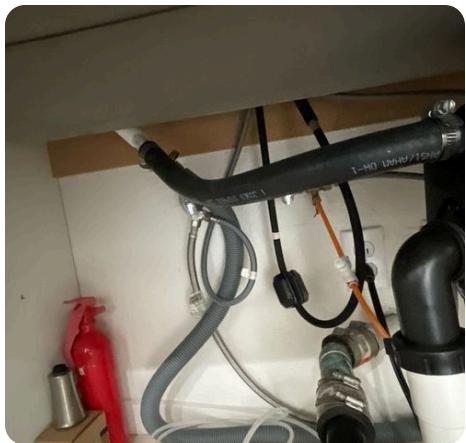
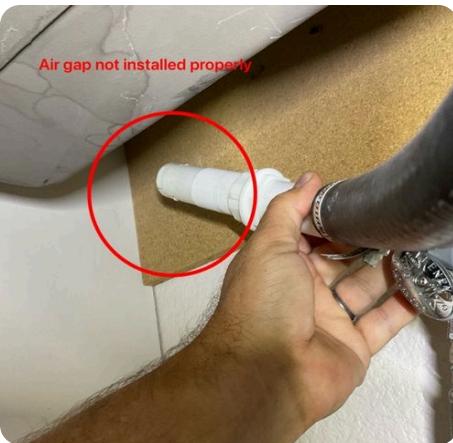
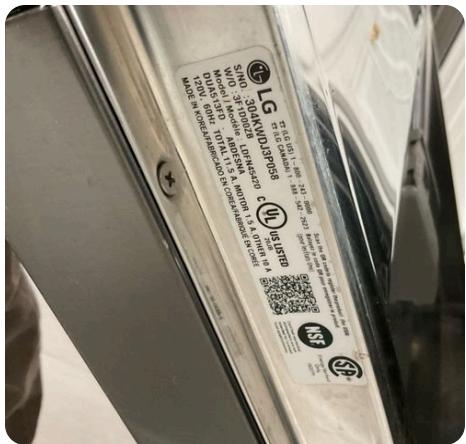
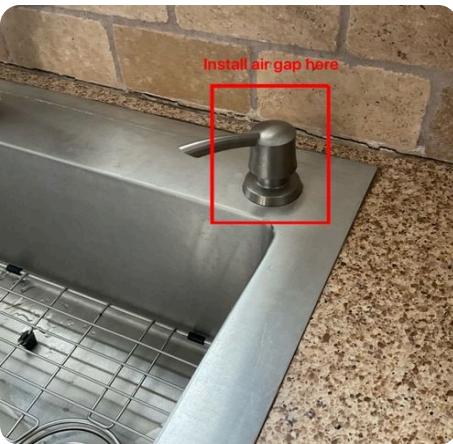
📍 Location: Kitchen

Inadequate Air Gap Installation In Dishwasher

The dishwasher is in working condition but the air gap is not properly installed, which could lead to water leakage into the cabinetry and walls. It is recommended to remove the soap dispenser and reconnect the air gap correctly to ensure proper drainage into the sink. A qualified plumber should be contacted for further evaluation and repair.

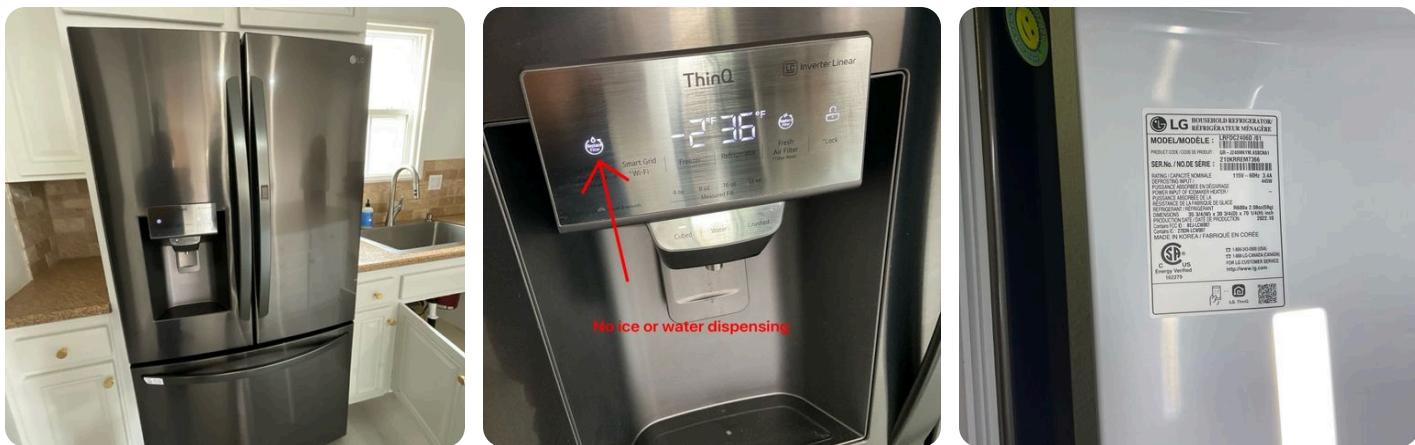
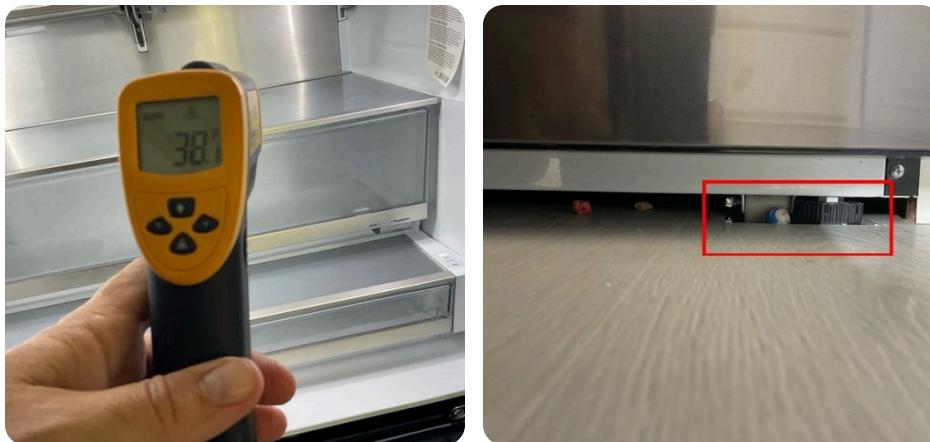
Location: Kitchen

Refrigerator Functionality

The refrigerator was functional at the time of inspection, however the water connection was not visible due to the wheels being below the flooring. The ice and water functions were not operating. Ensure there is a water connection and it is connected.

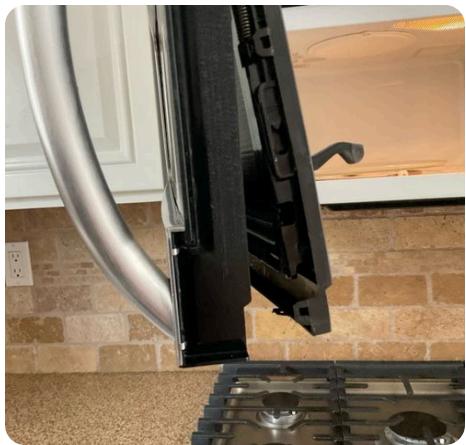
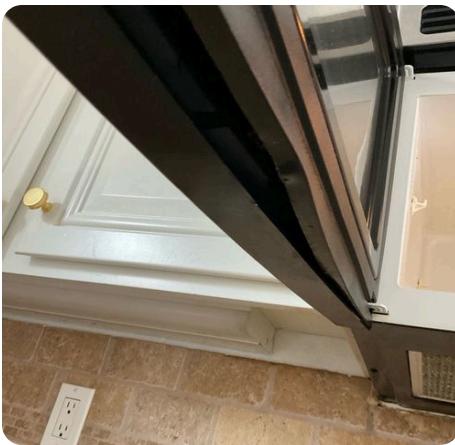
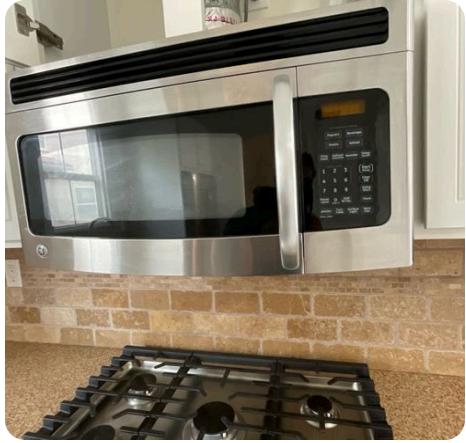
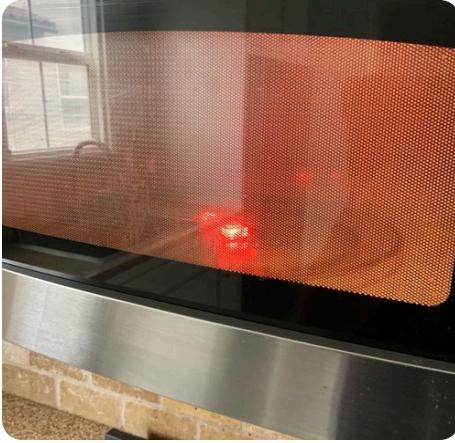
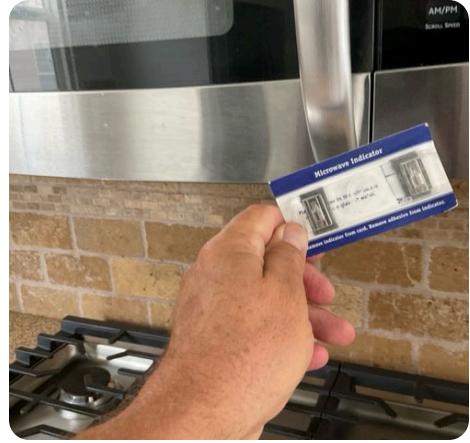
📍 Location: Kitchen

Not Functional

The microwave oven was not functional. The door panel is melted and falling off. This can cause exposure to microwaves which is known to have negative health impacts. It is recommended to have replacement done by a qualified professional and verify functionality before closing of escrow.

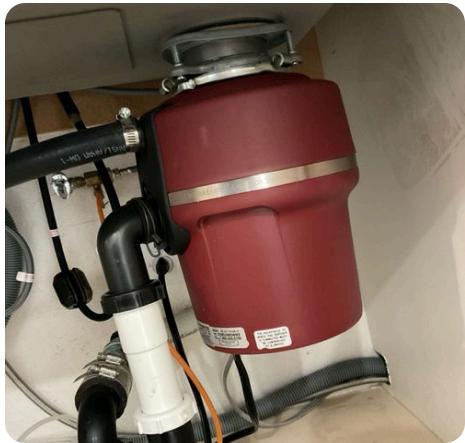
The garbage disposal was on/off tested and found functional. The unit was not tested to determine if it could grind food. The typical life expectancy of a garbage disposal is 7-15 years.

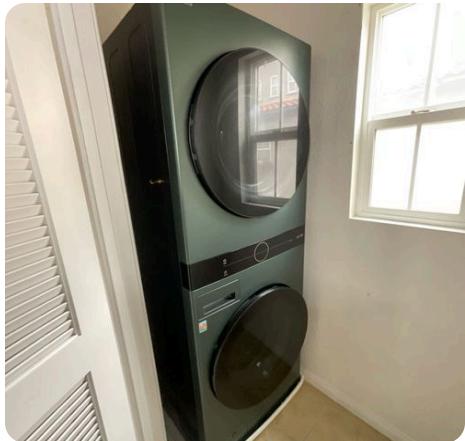
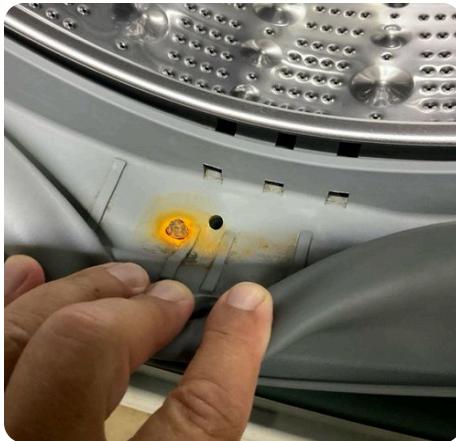
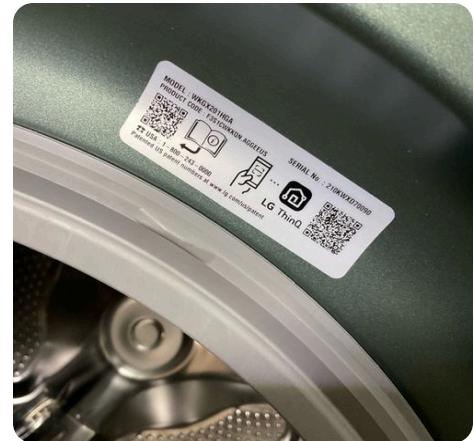
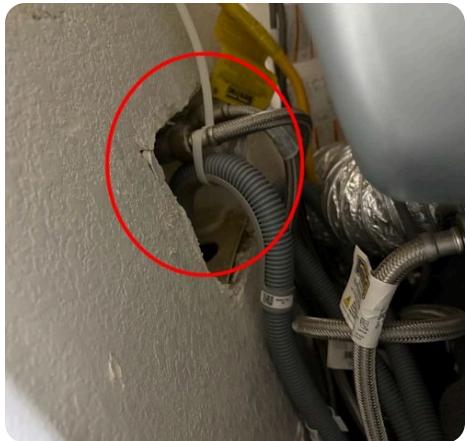
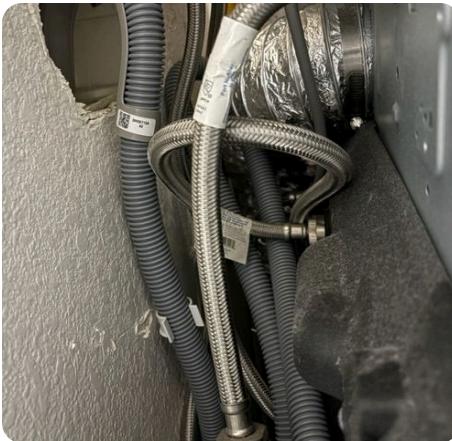
The washing machine was spot tested. The inspector does not run the clothes washer or drain water. We recommend you ask the current owner if the drain is working properly, or if any past or present issues exist.

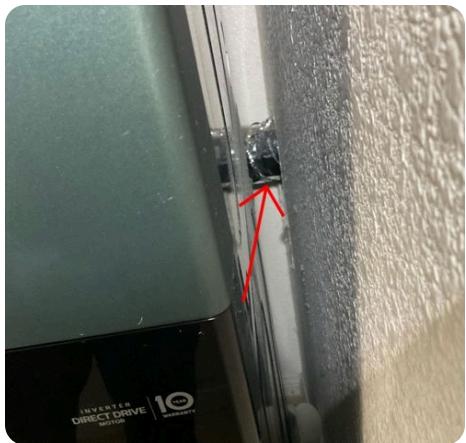
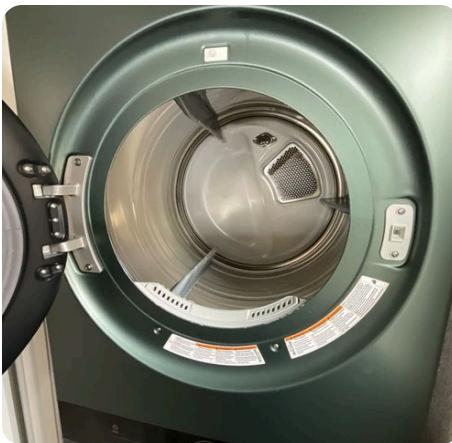
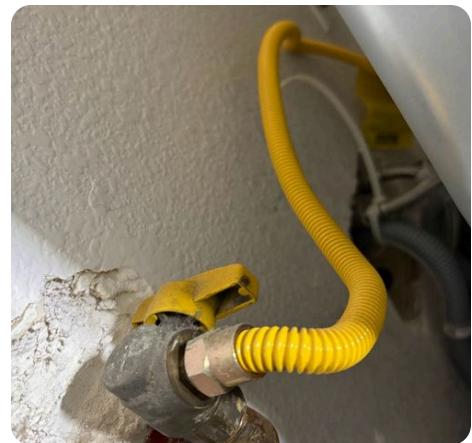
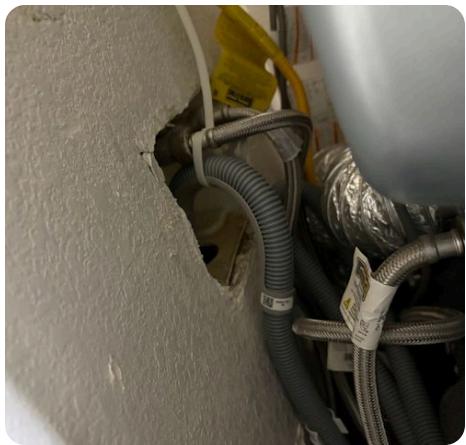
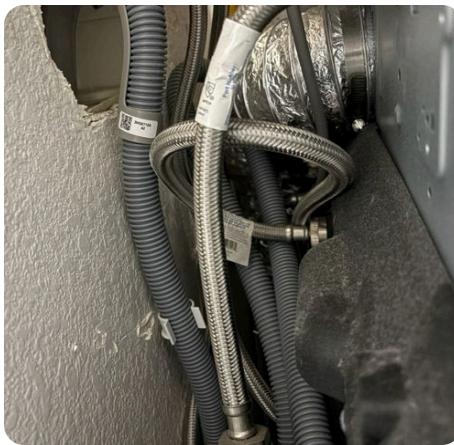
Location: Laundry Room

An on/off test was performed on the clothes dryer if present. Inspection of the dryer outlet and visible portions of the dryer vent were conducted. It is noted that the vast majority of the dryer vent system is not visible. Due to the limitations of a visual home inspection, an unknown condition may exist in the vent system. Periodic cleaning of the dryer vent system by a qualified specialist is a part of normal home maintenance to prevent lint fires.

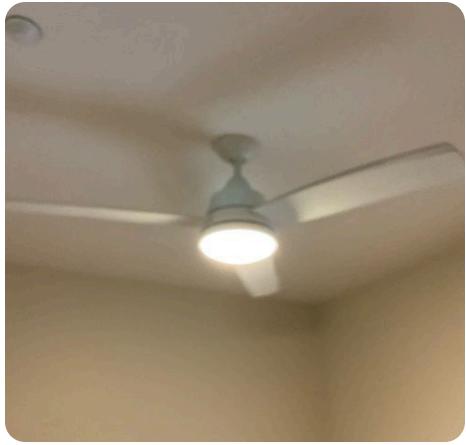
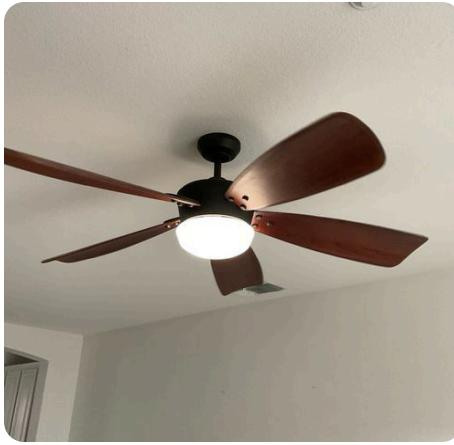
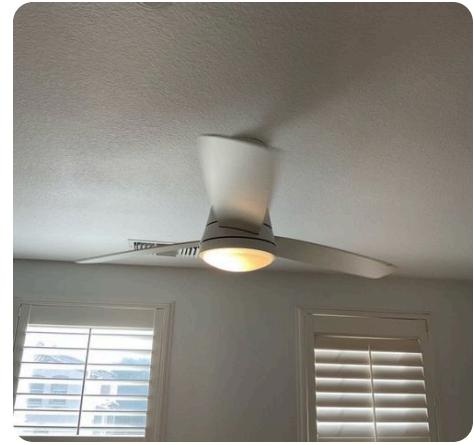
All ceiling fans were functional at the time of inspection.

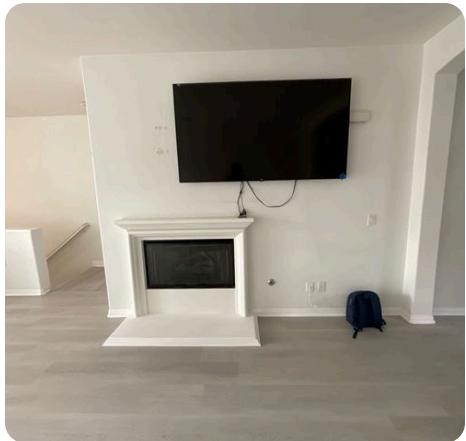
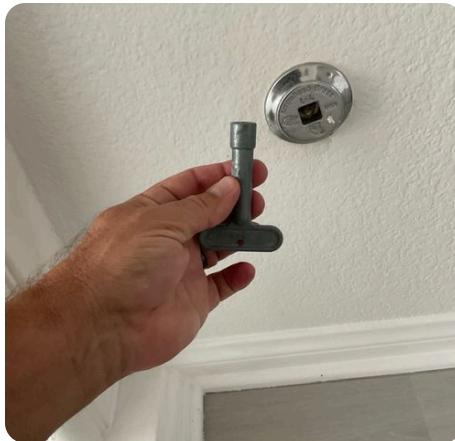
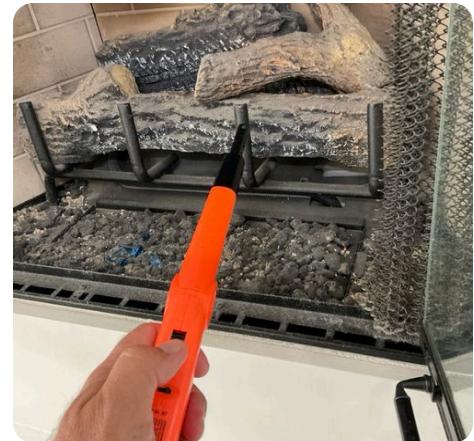
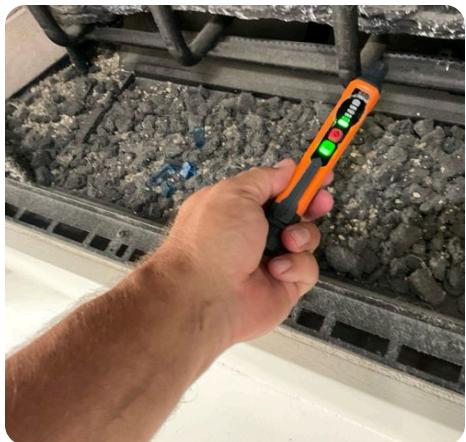
**11.1 Fireplace > Fuel-Burning Equipment****Gas Fireplace Evaluation** *(Included in Summary)* **Repairs Recommended** **Location: Fireplace Chimney, Living Room**

The gas for the fireplace was off at the time of inspection and was tested. The gas may be shut off, as it did not ignite. It is recommended having a fireplace technician evaluate, ignite, and test the unit to ensure proper functionality and safety.

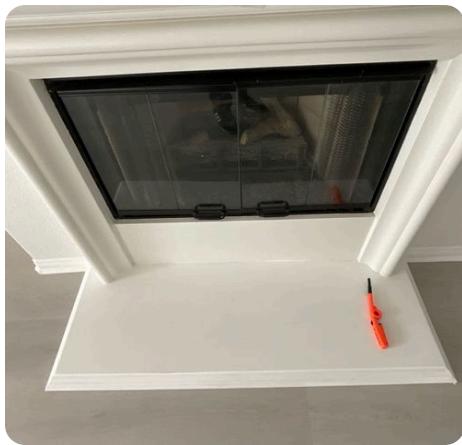
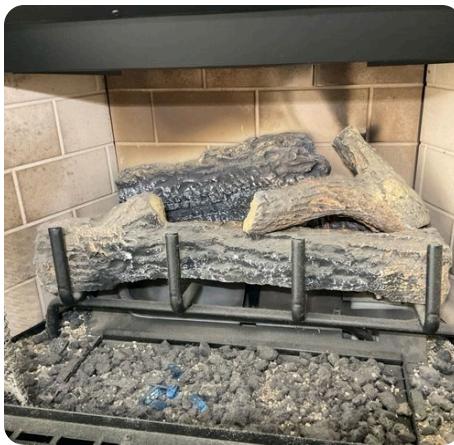
Location: Living Room, Fireplace Chimney

Gas Log Firebox Evaluated

The fireplace may require cleaning and evaluation to remove any soot, debris, or creosote buildup for proper airflow and to prevent potential fire hazards. It is important to have the fireplace professionally cleaned. A qualified chimney sweep should be contacted to thoroughly clean and inspect the chimney and fireplace, including assessing the condition of the chimney liner, damper, and firebox. Any necessary repairs or maintenance should be done. Regular cleaning and evaluation of the fireplace is essential for safe and efficient operation.

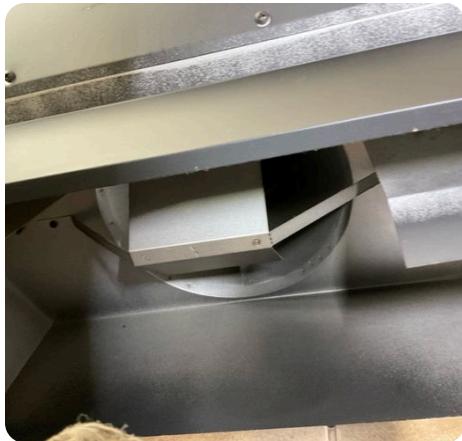
📍 Location: Fireplace Chimney

Only the firebox, damper, and visible portions of the chimney system are checked for obvious defects. This inspection in no way qualifies as a certification or determines the chimney system as being safe and/or functional. We recommend the system be thoroughly inspected by a qualified chimney contractor prior to use.

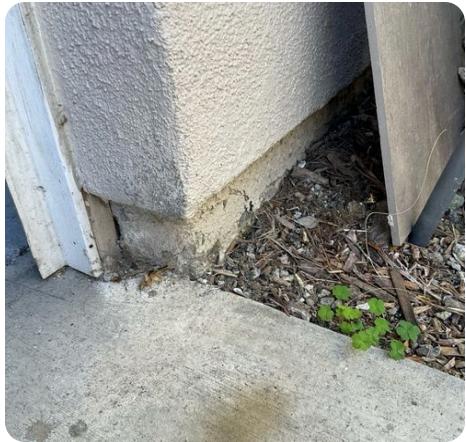
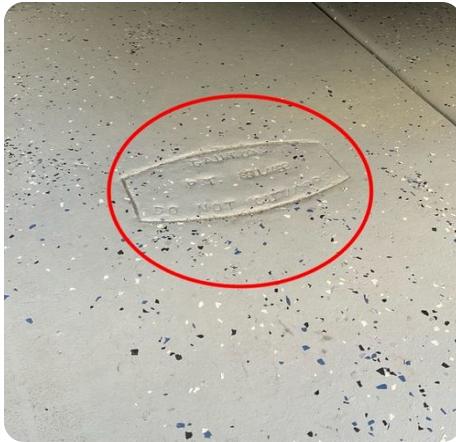
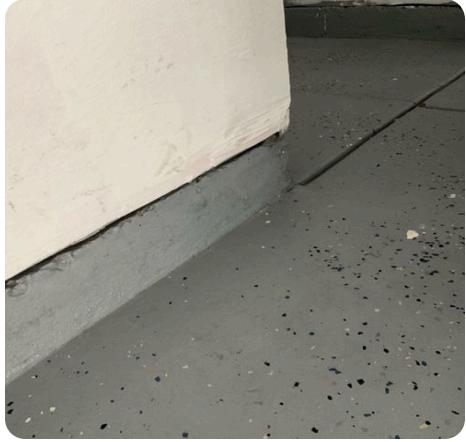
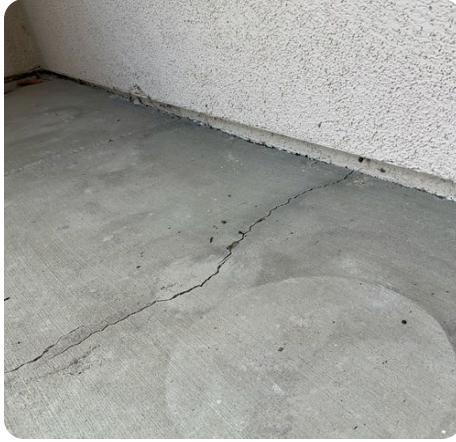
📍 Location: Garage, Exterior

The foundation/slab was visually assessed during the inspection and appeared to be in functional condition with no immediate concerns noted. As part of routine maintenance, we recommend regularly monitoring the foundation for any signs of cracks, shifting, or water intrusion to address potential issues promptly and ensure long-term structural integrity.

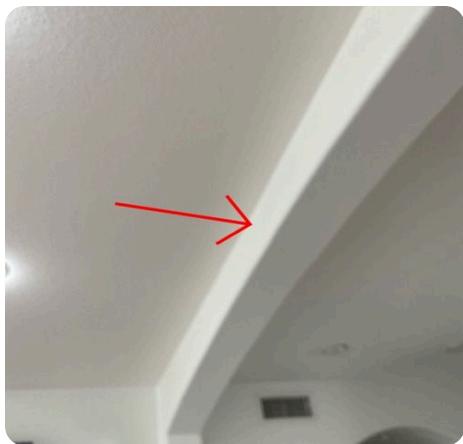
12.3 Structural Components > Joists and Framing

Joists and framing members are typically concealed within the construction and are not fully visible during a standard home inspection. However, the accessible portions that were inspected appeared to be in satisfactory condition, with no significant issues or concerns identified at the time of the evaluation.

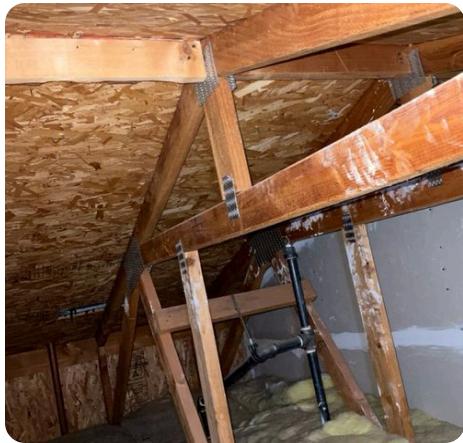
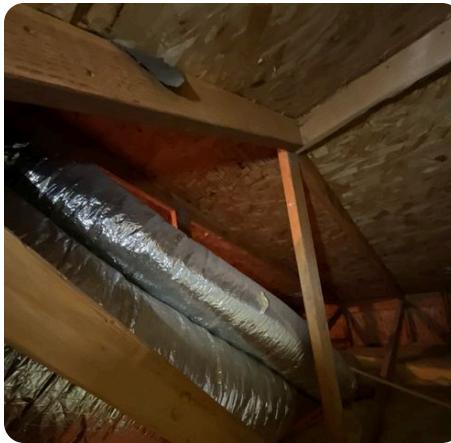
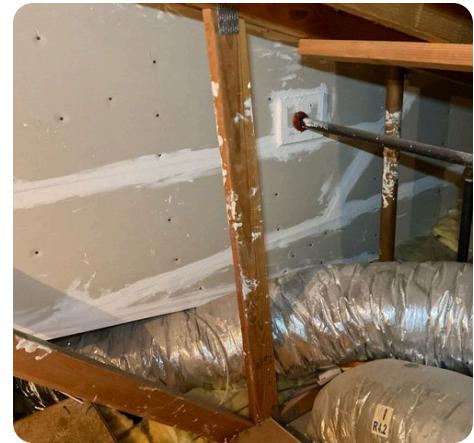
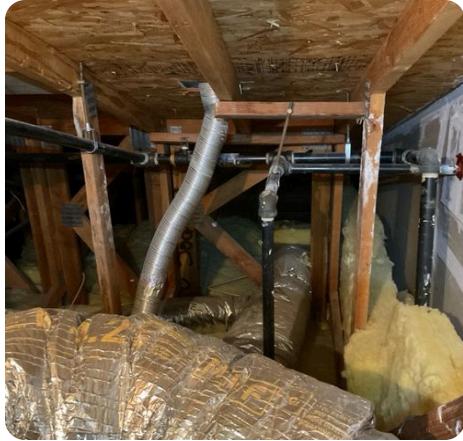
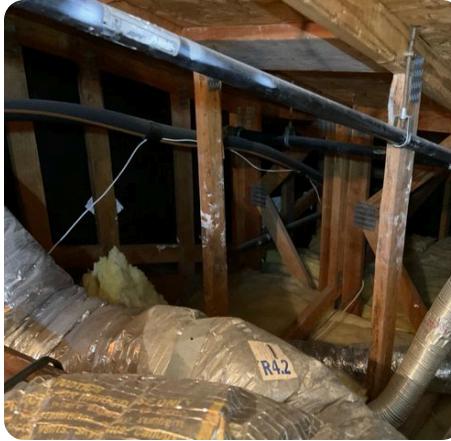
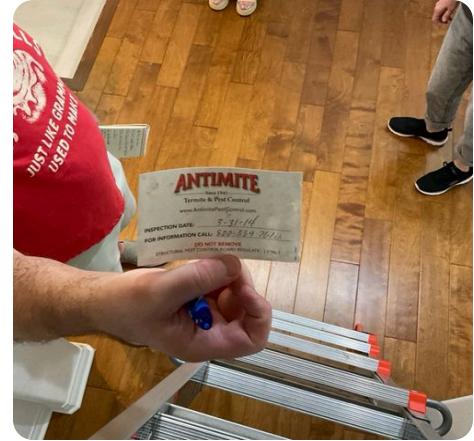
Missing Ceiling Insulation

The ceiling insulation in the attic is incomplete, which can lead to heat loss and increased energy bills. Evaluate and repair the missing insulation to ensure proper energy efficiency and temperature regulation in the home. It is recommended to hire a qualified insulation contractor to assess and complete the insulation coverage. There was drywall above this area and likely has insulation above. Question the builder or HOA regarding insulation in this area.

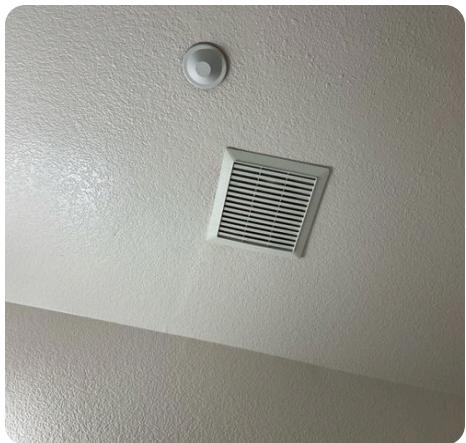
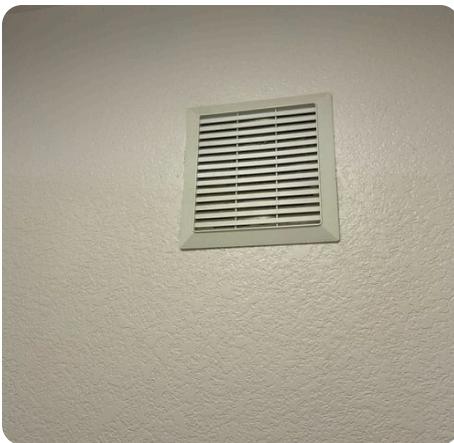
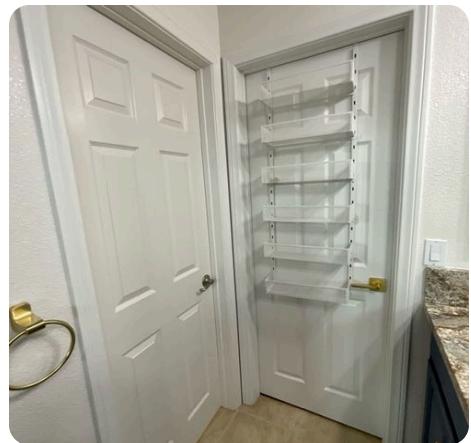
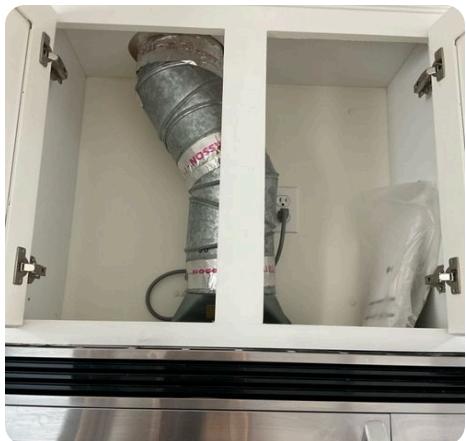
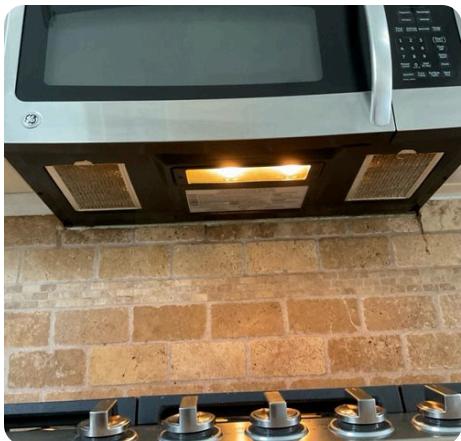
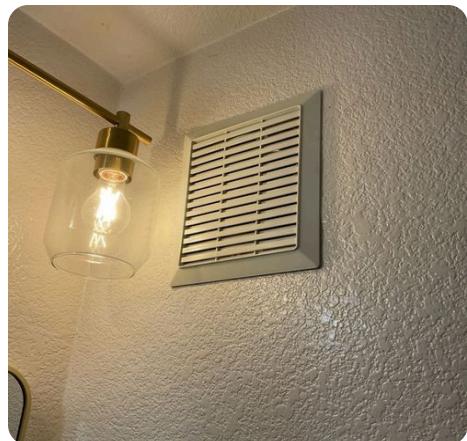
The bathroom and kitchen ventilation fans were tested and appeared to be functional at the time of the inspection. Cleaning the vent fan in the primary bathroom is recommended.
