**Property Address:** 123 Sample Drive, Clemson, SC 29676

## WIN Home Inspection

### Full Home Inspection

**Service Date:** 11/17/2023

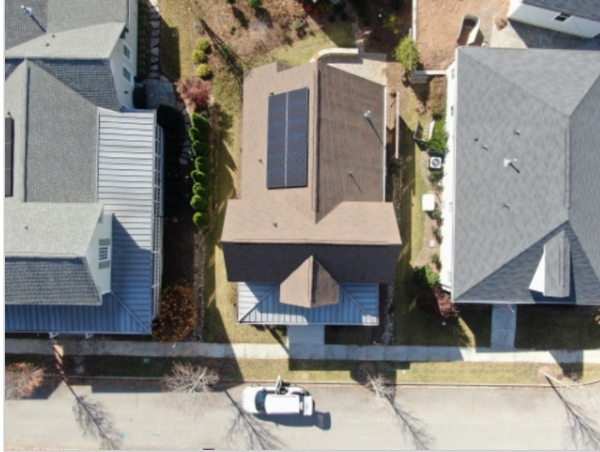
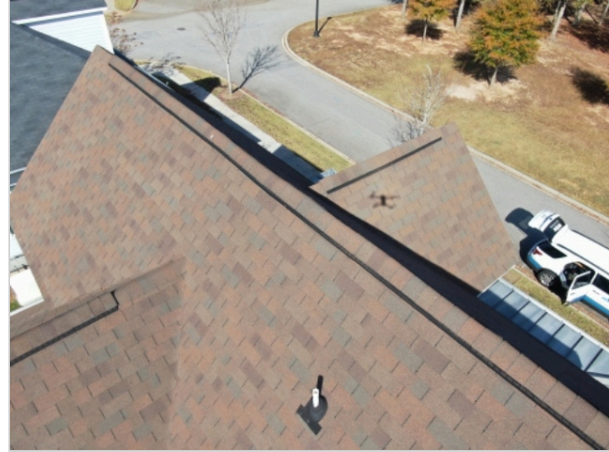
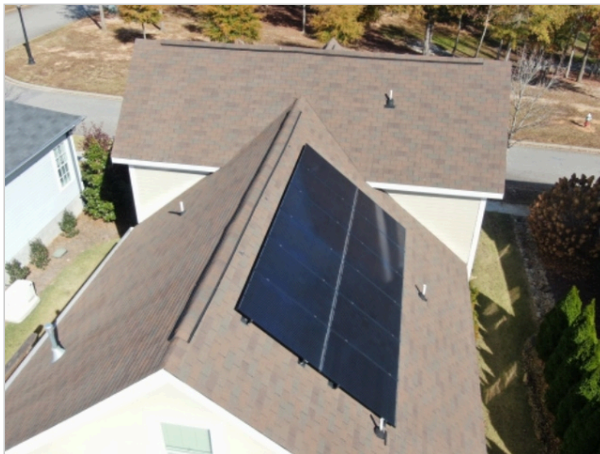
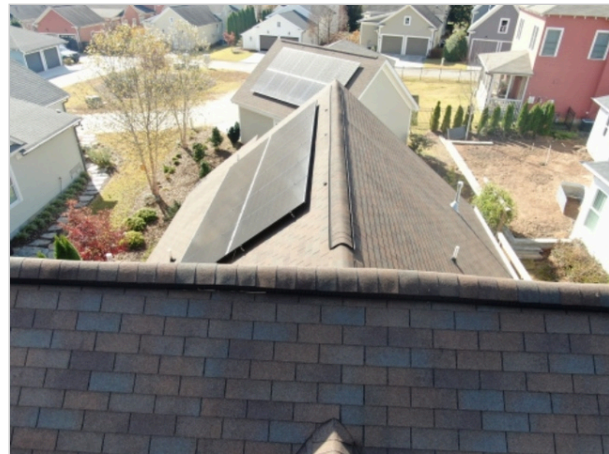
Aerial Drone

There were areas that were not fully accessible for inspection due to the roof slope and high elevation. The inspector was able to capture images of the roof using an aerial drone.

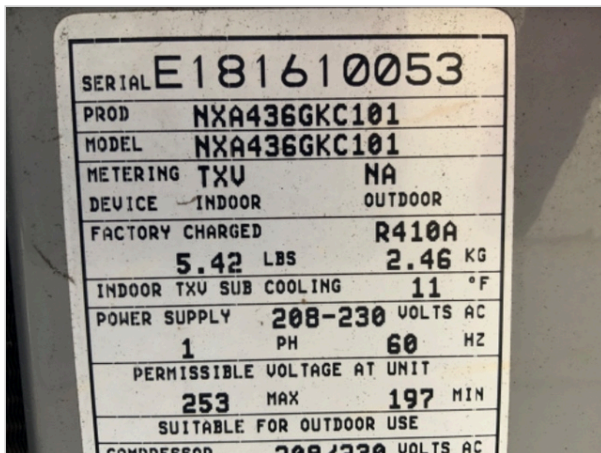
Manufactured 2018

The average life of an air conditioner is 15-20 years but can certainly last longer if it is serviced regularly.

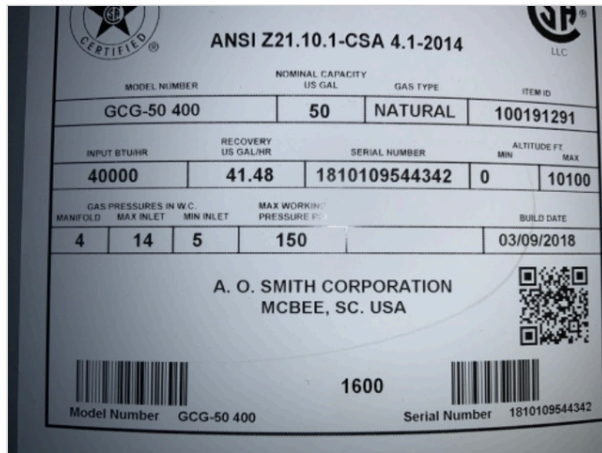
The life expectancy of a water heater is typically 8-12 years from the date of installation, although there are exceptions on both sides of this range.

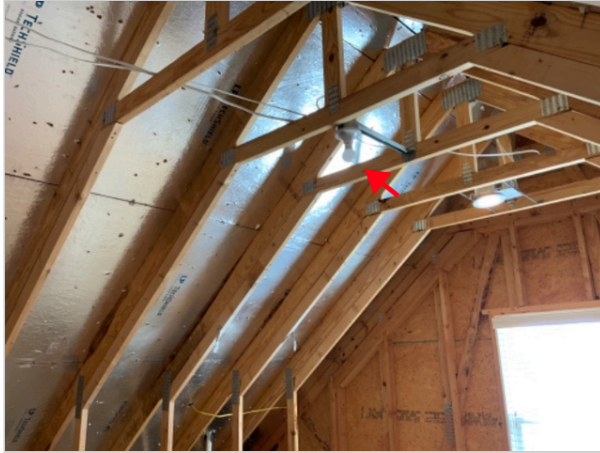
Attic

The inspector recommends replacing or installing any light bulbs that are missing or not working then testing. If they do not function, then the inspector recommends contacting an electrician for further evaluation and repair.
