**Service:** Full Home Inspection

Site Address: **Quality Drive, Vacaville, CA, 95688**

Service Date And Time: **August 31, 2026 At 10:00 AM**

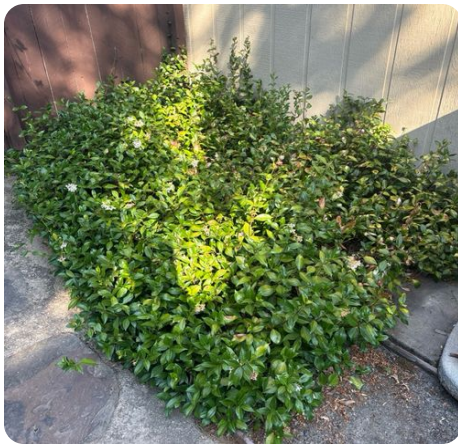
Vegetation was found to be in direct contact with the exterior siding and/or roofing surface at the time of the inspection. Vegetation growth limits siding and trim ventilation while providing a conducive condition for pest infestation. It is recommended that vegetation be trimmed and maintained away from the structure.

Vegetation in contact with exterior siding material.

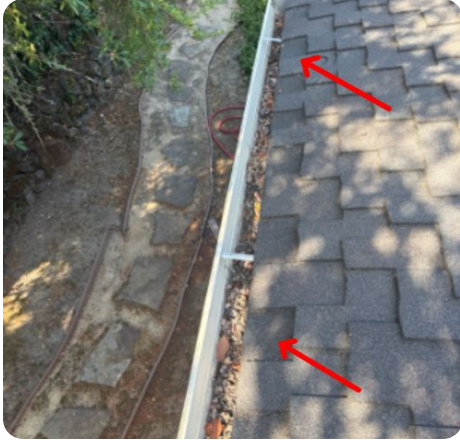
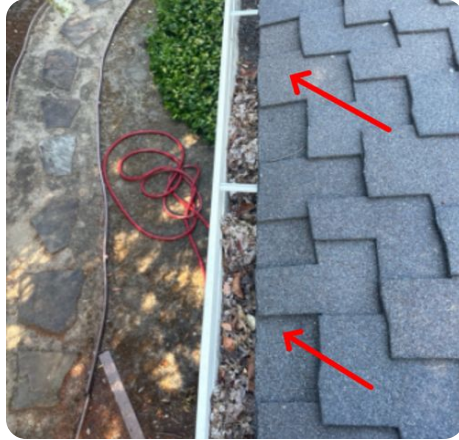
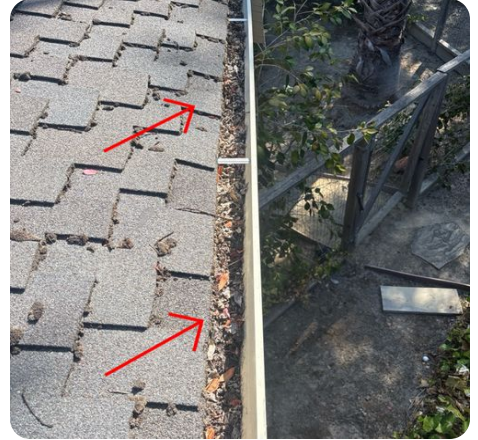
The gutter system was found to contain debris and it is recommended that the gutters and downspout system be periodically evaluated and maintained to ensure positive drainage during inclement weather conditions. Portions of the gutter system are equipped with screen material.

Debris accumulation within gutter system.

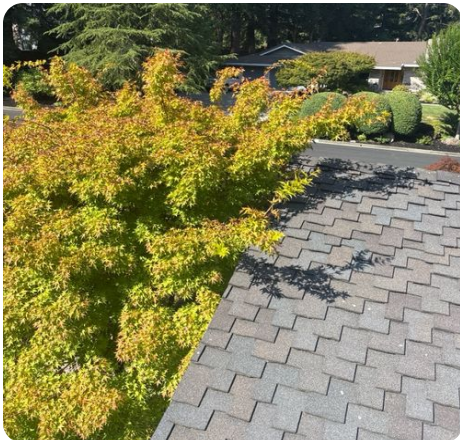
The trees located at the exterior of the home were found to overhang or be in contact with the roof surface at the time of the inspection. It is recommended that the trees be trimmed and maintained away from the structure to limit premature wear.

Tree overhanging garage roof surface.

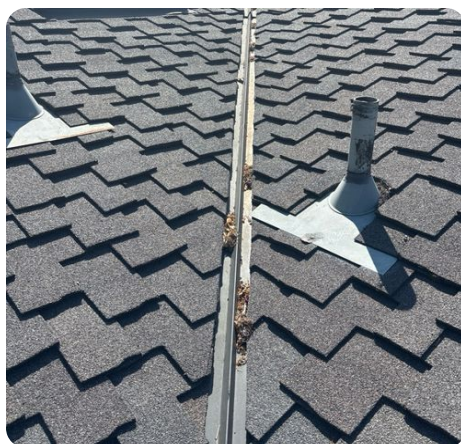
Debris accumulation was observed at the roof surface at the time of the inspection and it is recommended that debris be periodically removed to promote positive drainage.

Debris accumulation at roof surface.

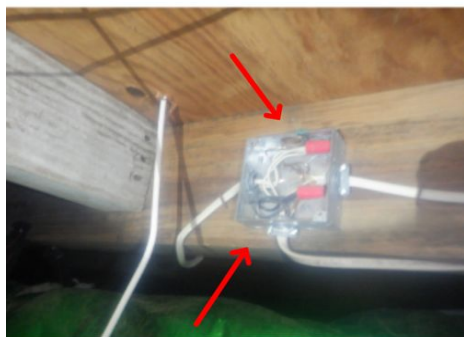
📍 Location: **Crawl Space Below Bedroom 2**

An open junction box containing exposed wire connections was observed within the home at the time of the inspection. Junction box covers offer protection to the wire connections, limits debris and rodent access, while containing any potential arcing within the box. It is recommended that an approved cover be installed by a qualified professional.

Open junction box within crawl space below bedroom 2.

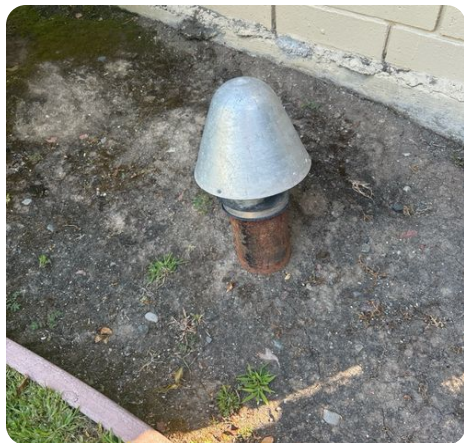
Location: Bedroom 3 Exterior

Due to the age of the home and the presence of mature vegetation and/or trees, it is recommended that the sewer line be invasively evaluated by a plumber or qualified drain service to determine the current condition of the installation. The sewer line clean out is located at the front of the home.

Sewer clean-out at front of home.

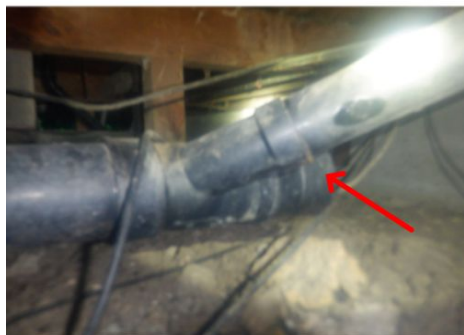
An active plumbing leak was observed within the crawl space at the kitchen sink drain and it is recommended that the pipes, fittings, and connections, be further evaluated and repaired by a plumber or other qualified professional.

Leaking waste fitting below kitchen.

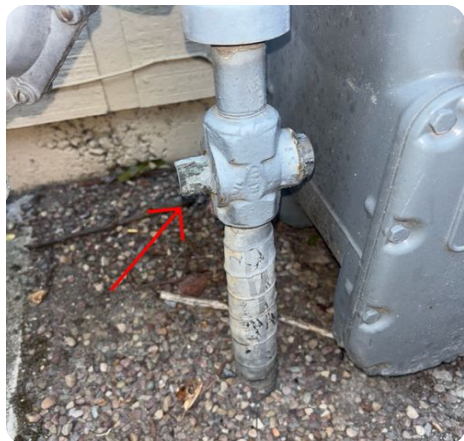
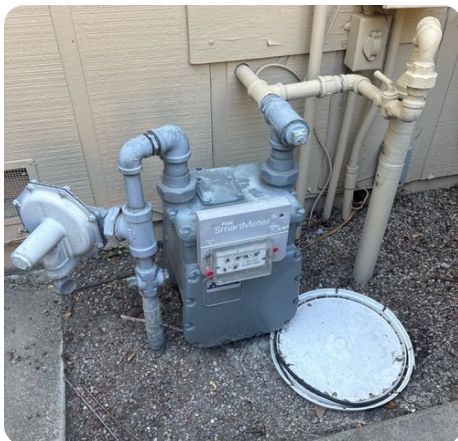
📍 Location: Garage Exterior

Natural gas service to the home can be terminated at the meter in the event of an emergency or should a gas odor be identified within the structure. The meter is not equipped with a seismic control or excess flow valve designed to terminate gas service in the event of an earthquake or other significant service issue. Unincorporated areas of Contra Costa county require the installation of a seismic control valve and it is recommended that a plumber be contacted to address this issue. Storing a gas pipe safety wrench near the meter is recommended.

Natural gas control valve at meter riser.

Natural gas meter at garage exterior.

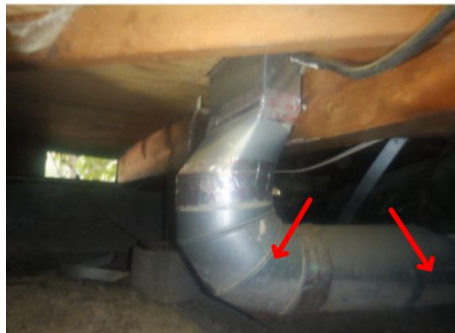
Water/silt lines at cooktop fan ducting.

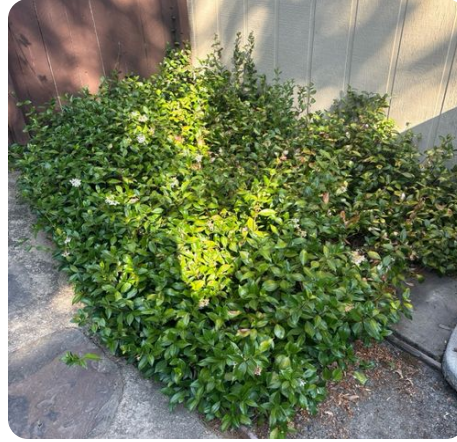
Vegetation in contact with exterior siding material.

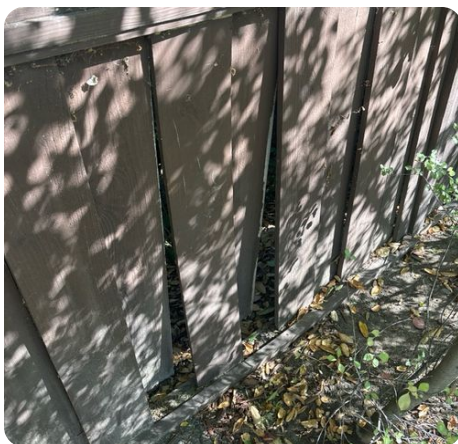
Unsecured boards at perimeter fence.

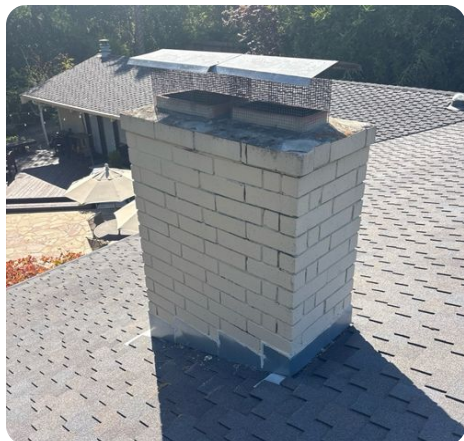
A visual inspection of the chimney and chase systems did not reveal any issues that would require service at this time. Periodic evaluation and maintenance is recommended for the continued safe operation of the system. Please refer to the fireplace/chimney report for additional information regarding the status of the installation.

Functional chimney structure as viewed from roof surface.

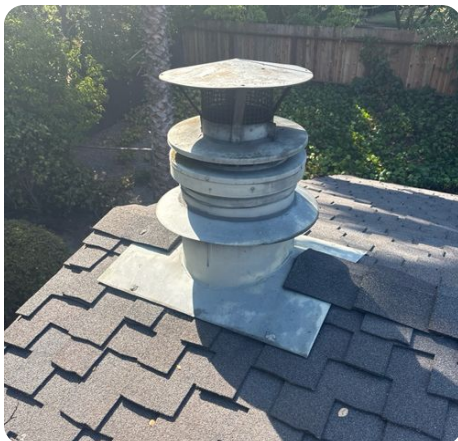
Fireplace chase cap as viewed from roof surface.

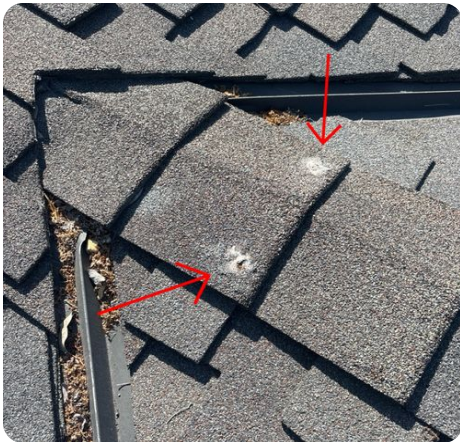
Exposed nail heads were observed at the ridge shingles and caps and it is recommended that the nail heads be sealed by a qualified roof professional to prevent moisture intrusion.

Exposed nail heads at ridge shingle.

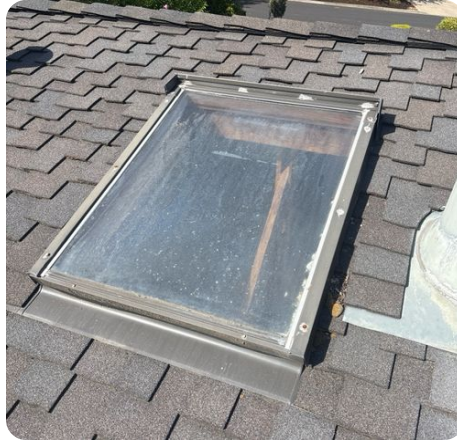
Functional skylight as viewed from roof surface.

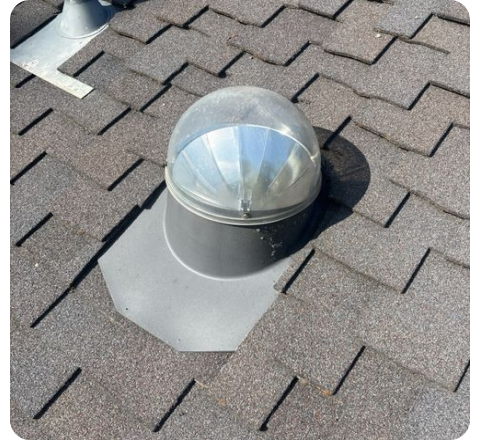
Functional tubular skylight as viewed from roof surface.

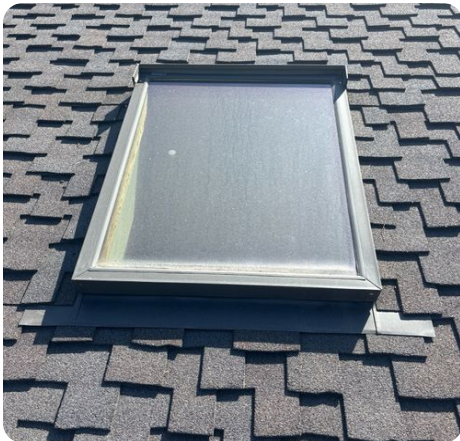
Functional skylight as viewed from roof surface.

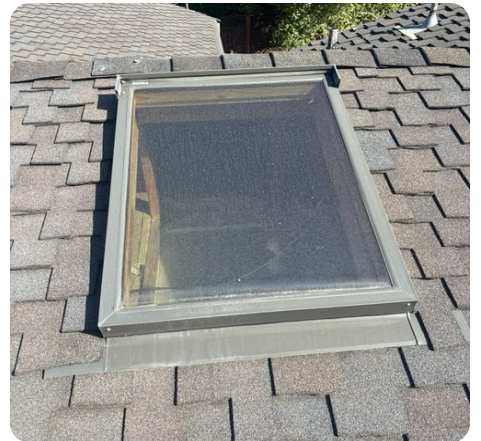
Functional skylight as viewed from roof surface.

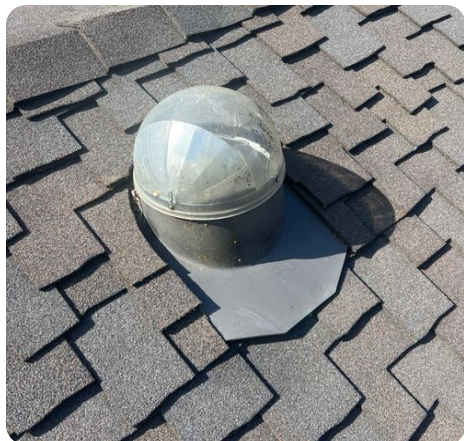
Functional tubular skylight as viewed from roof surface.

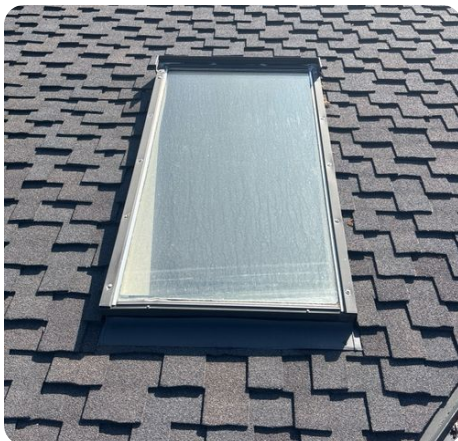
Functional skylight as viewed from roof surface.

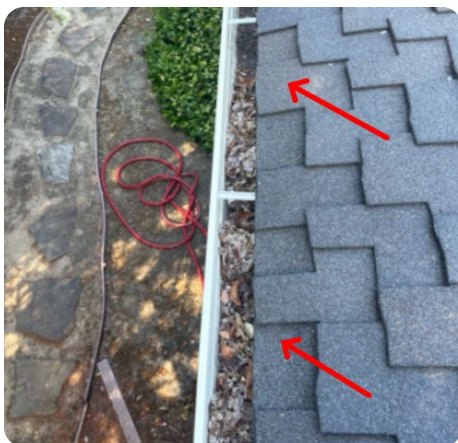
The gutter system was found to contain debris and it is recommended that the gutters and downspout system be periodically evaluated and maintained to ensure positive drainage during inclement weather conditions. Portions of the gutter system are equipped with screen material.

Debris accumulation within gutter system.

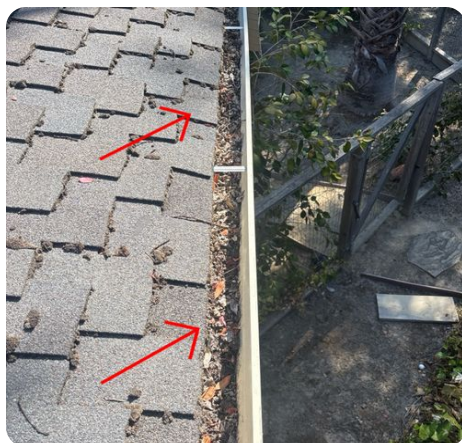
Debris accumulation within gutter system.

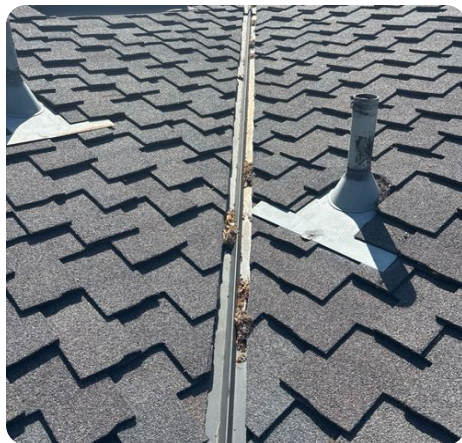
Debris accumulation was observed at the roof surface at the time of the inspection and it is recommended that debris be periodically removed to promote positive drainage.

Debris accumulation at roof surface.

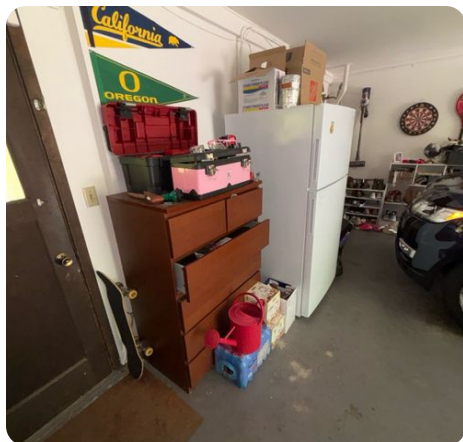
The garage contained stored personal items at the time of the inspection which may obscure a concealed condition. Further evaluation of the garage once the home has been cleared of stored personal items is recommended.

Stuart personal items within garage at time of inspection.

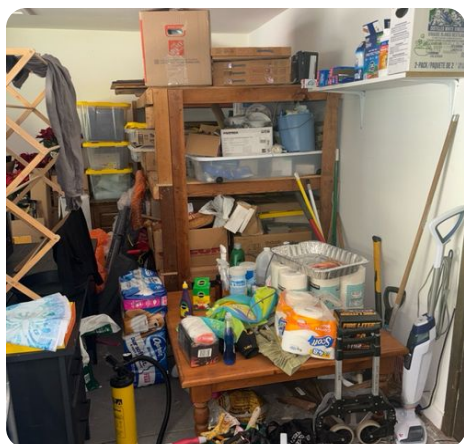
Stored personal items within garage at time of inspection.

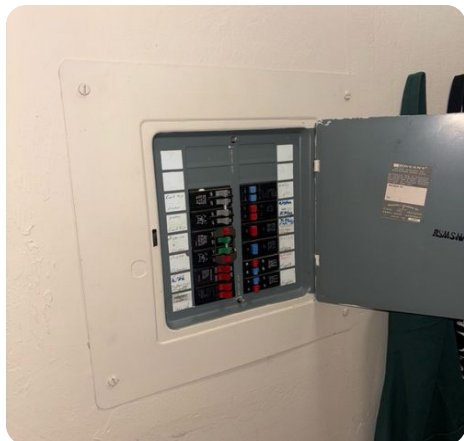
Original interior sub-panel within kitchen pantry.

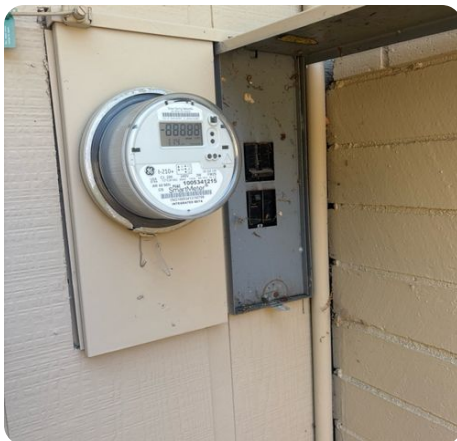
Original main service panel at garage exterior.

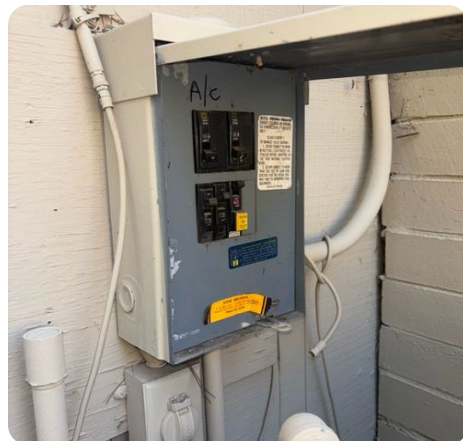
Supplemental sub-panel at garage exterior.

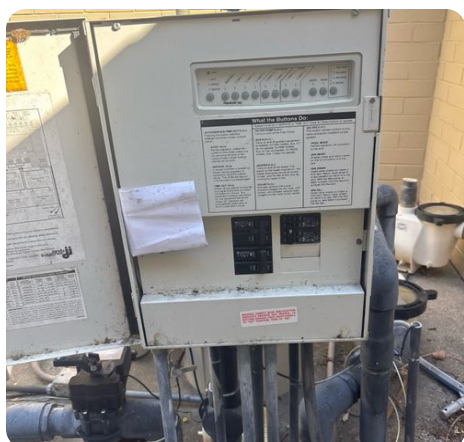
Auxiliary service panel supporting pool equipment.

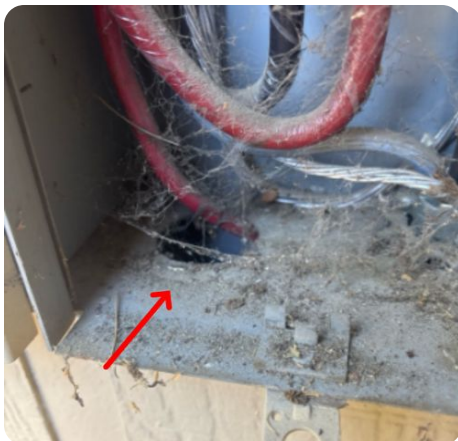
An open knock-out was observed at the top of the main electrical panel, while the knock-out at the base of the panel lacks a bushing designed to secure and protect the electric cable. The openings provide an entry point for pests and debris and it is recommended that the openings be capped, sealed, and secured to address these concerns.

Knock-out lacks a bushing at base of main panel .

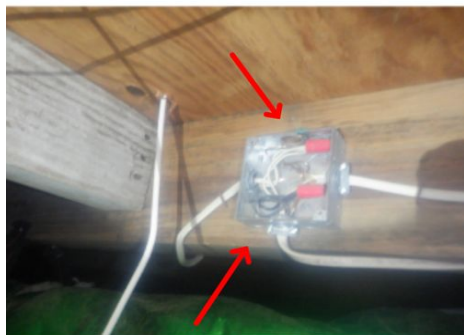
Location: Crawl Space Below Bedroom 2

An open junction box containing exposed wire connections was observed within the home at the time of the inspection. Junction box covers offer protection to the wire connections, limits debris and rodent access, while containing any potential arcing within the box. It is recommended that an approved cover be installed by a qualified professional.

Open junction box within crawl space below bedroom 2.

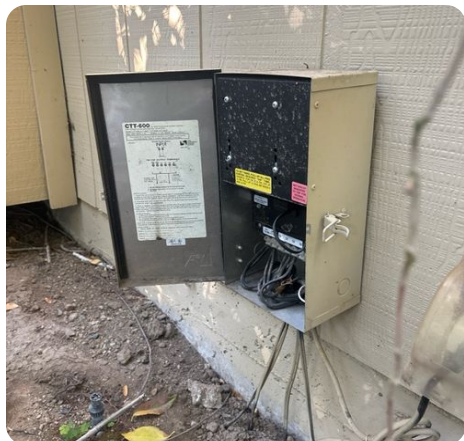
Low-voltage transformer at bonus room exterior.

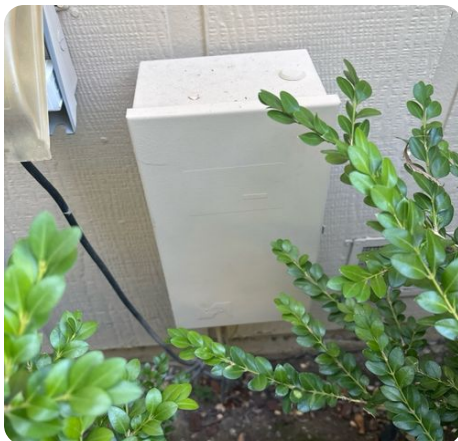
Low-voltage transformer at family room exterior.

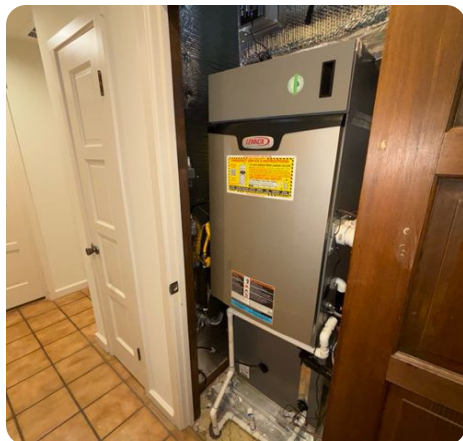
Location: Utility Closet

The Lennox branded, high-efficiency, natural gas furnace functioned normally when tested in a limited fashion and it is recommended that the current homeowner be consulted regarding the date of installation and service history of the system if known. Periodic evaluation and maintenance by a heating and air conditioning professional is recommended to ensure safe and efficient operation. High-efficiency furnaces utilize over 90% of the fuel consumed to create heat, compared to 60-80% for older units.

Lennox branded, high efficiency, natural gas furnace within hall utility closet

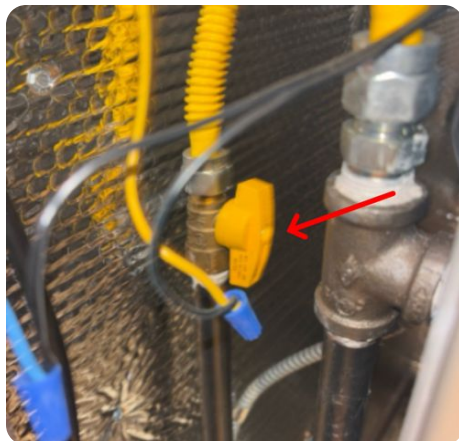
Natural gas control valve serving furnace.

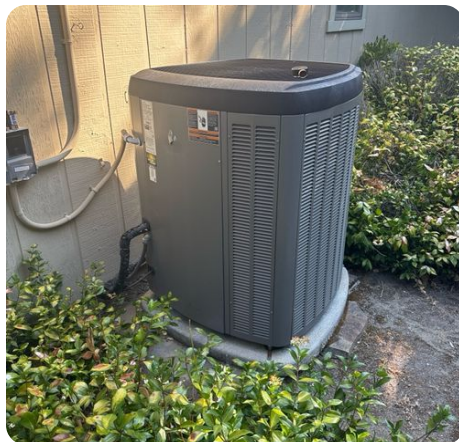
Location: Hall Bathroom Exterior

The Lennox branded condensing unit functioned normally when tested in a limited fashion and it is recommended that the current homeowner be consulted regarding the date of installation and service history of the appliance if known. The unit was found to be level and appropriately installed at the time of the inspection. Maintaining vegetation away from the appliance is recommended to ensure adequate airflow. The service disconnect contained appropriately sized cartridge fuses.

Lennox branded condensing unit at hall bathroom exterior.

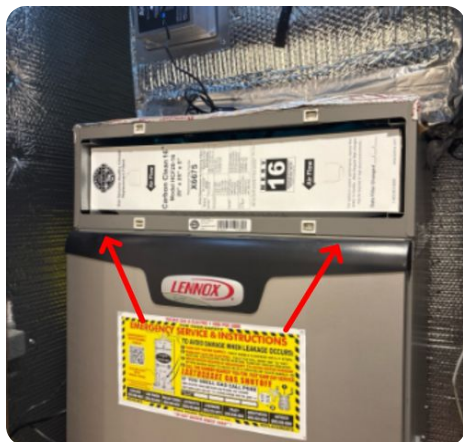
Location: Filter Enclosure

The disposable HVAC filter was found in functional condition at the time of the inspection and it is recommended that the filter be evaluated quarterly and replaced as needed. Filter size can be found on the unit edge and care should be exercised to ensure the filter is facing the correct direction. Arrows printed on the edge of the filter indicate intended airflow.

Clean disposable HVAC filter at enclosure above furnace.

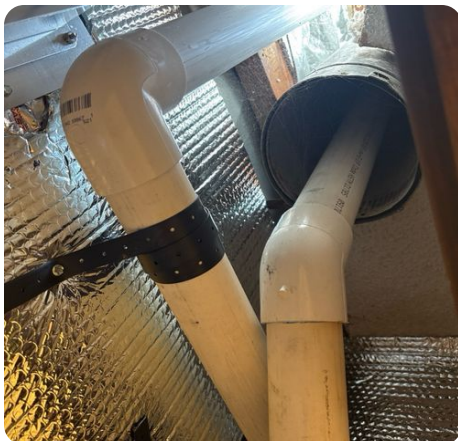
The visible and accessible segments of the HVAC system vents and flues were found in functional condition at the time of the inspection.

Functional furnace exhaust flue.

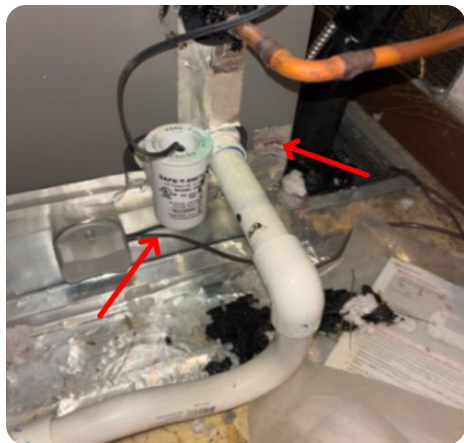
The HVAC condensate drain system was found in functional condition at the time of the inspection.

HVAC condensate drain line with safety switch serving evaporation coil.

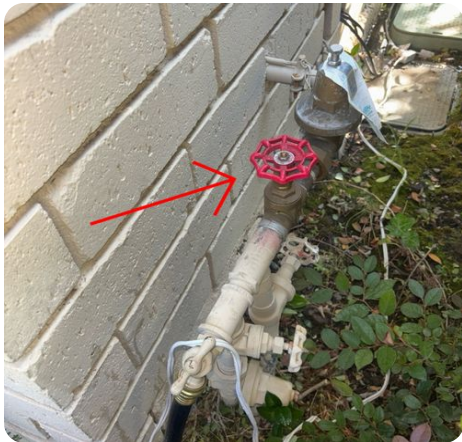
The main water supply valve is located at the exterior of the structure.

Main water control valve at garage exterior.

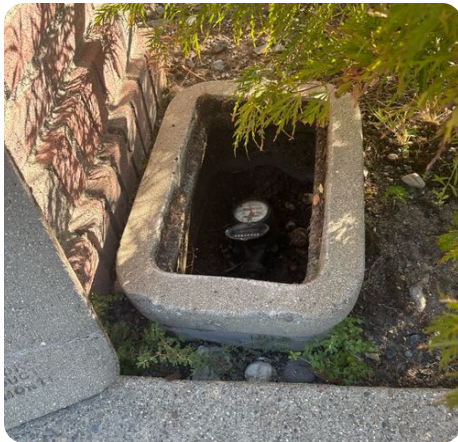
Water meter in landscaping strip adjacent to curb.

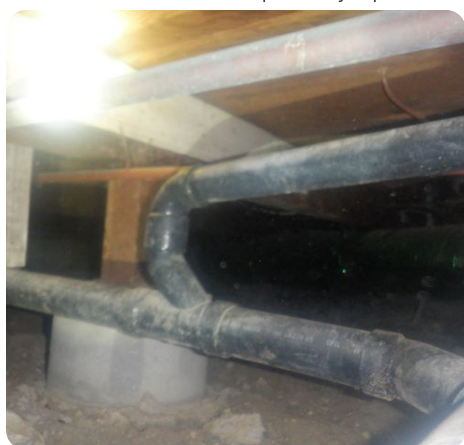
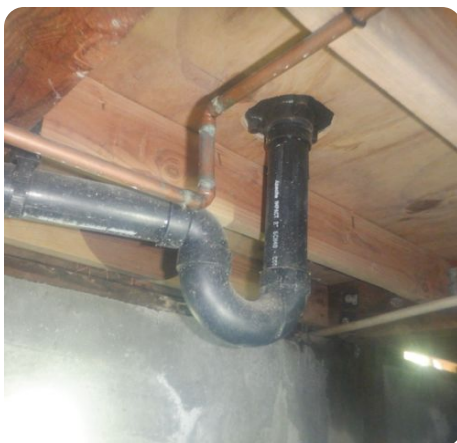
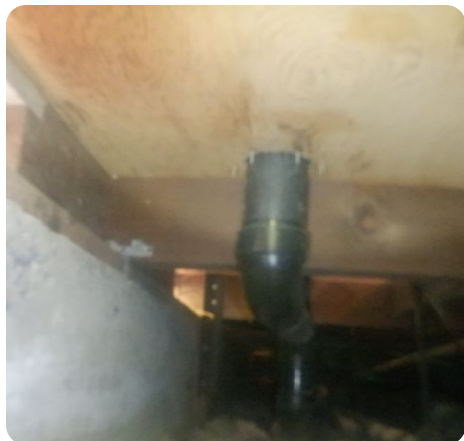
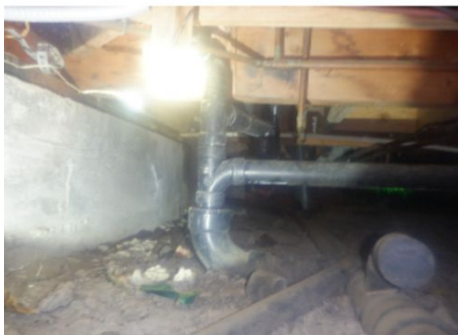
Functional ABS waste plumbing within crawl space.

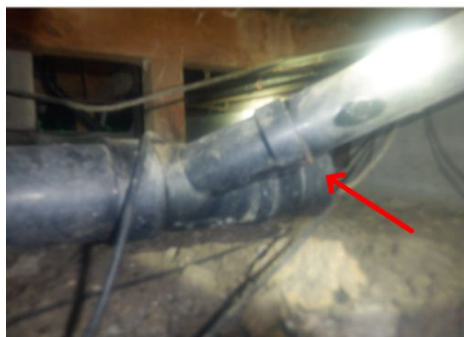
An active plumbing leak was observed within the crawl space at the kitchen sink drain and it is recommended that the pipes, fittings, and connections, be further evaluated and repaired by a plumber or other qualified professional.

Leaking waste fitting below kitchen.

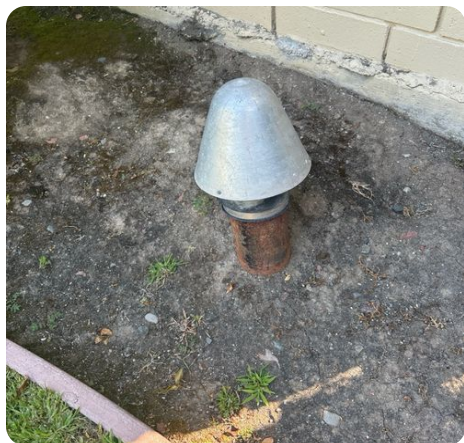
Location: Bedroom 3 Exterior

Due to the age of the home and the presence of mature vegetation and/or trees, it is recommended that the sewer line be invasively evaluated by a plumber or qualified drain service to determine the current condition of the installation. The sewer line clean out is located at the front of the home.

Sewer clean-out at front of home.

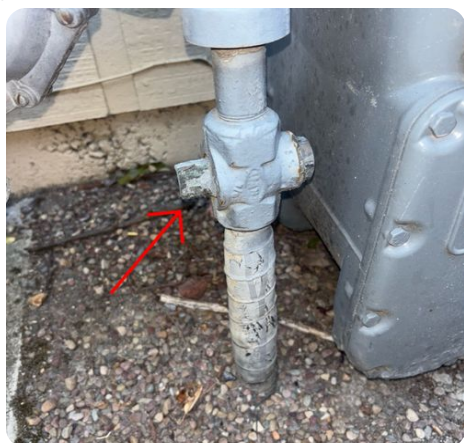
Natural gas service to the home can be terminated at the meter in the event of an emergency or should a gas odor be identified within the structure. The meter is not equipped with a seismic control or excess flow valve designed to terminate gas service in the event of an earthquake or other significant service issue. Unincorporated areas of Contra Costa county require the installation of a seismic control valve and it is recommended that a plumber be contacted to address this issue. Storing a gas pipe safety wrench near the meter is recommended.

Natural gas control valve at meter riser.

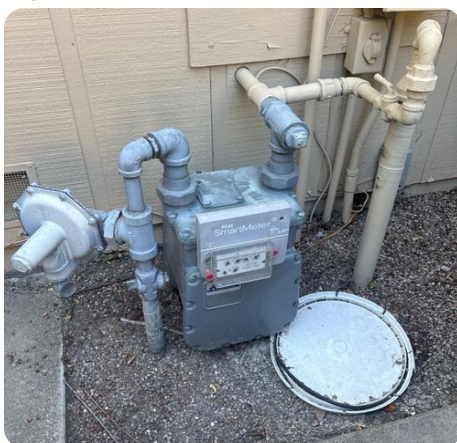
Location: **Garage Exterior**

Natural gas meter at garage exterior.

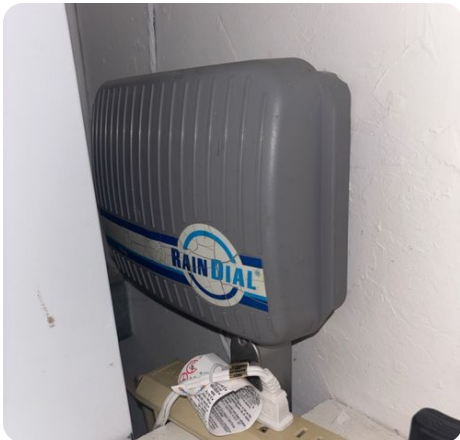
The irrigation system falls outside the scope of a residential home inspection as the concealed nature of the components prevents a comprehensive physical examination of the installation. It is recommended that the current homeowner be consulted regarding the effectiveness, service history, and operating procedures of the existing system. The irrigation control module is located within the garage.

Irrigation control module within garage.

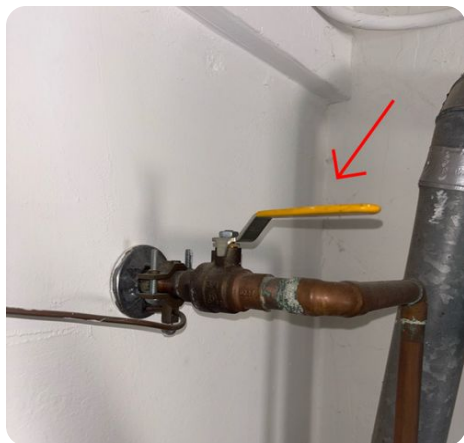
Cold water supply valve serving water heater.

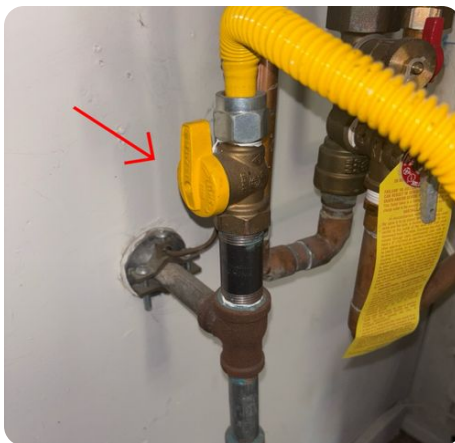
Natural gas control valve serving water heater.

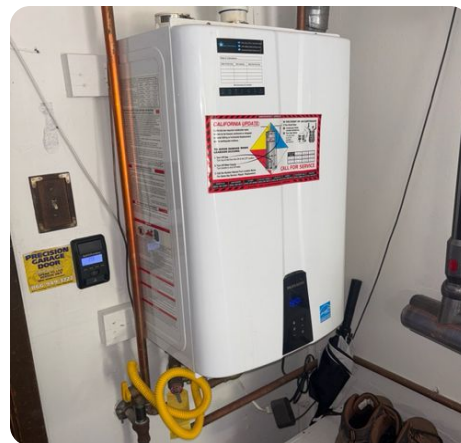
Location: Garage

The tankless, high efficiency, on demand water heater functioned normally when tested in a limited fashion. Tankless water heaters ignite as demand is created at the interior service points and ceases as demand is satisfied. Tankless water heaters require periodic maintenance to address internal mineral deposits and scale accumulation and it is recommended that the manufacturer's service directives be followed to enable the unit to operate optimally. Tankless water heaters enjoy a service life expectancy of approximately 20 years from the date of installation, although other mitigating factors may play a role in longevity. Consulting the current homeowner regarding the service history of the system is recommended.

Navien branded, high efficiency, tankless natural gas water heater within garage

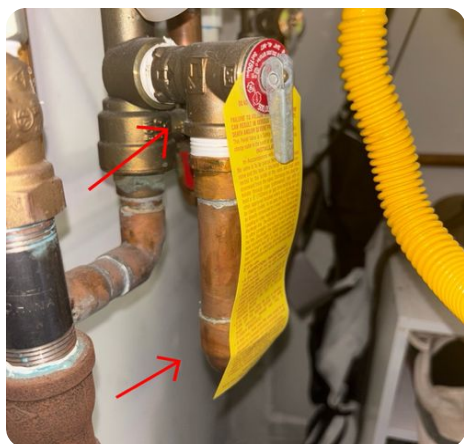
The water heater is equipped with a temperature pressure relief valve designed to allow water and or steam to escape should the pressure or temperature within the tank exceed a predetermined level. The valve was not tested during the course of the inspection as they tend to leak due to infrequent usage. Leaking or frozen valves should be replaced by a plumber or qualified professional. The discharge pipe terminates at the exterior.

Water heater TPR valve with discharge tube.

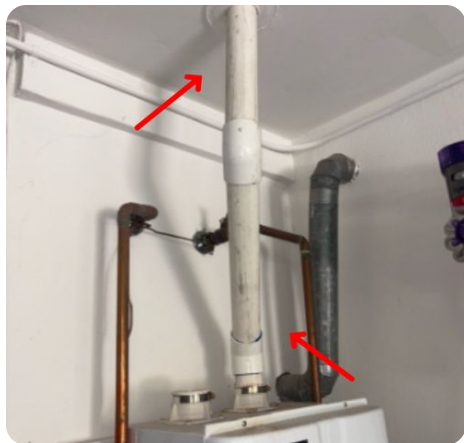
The visible and accessible segments of the water heater exhaust flue was found in functional condition at the time of the inspection.

Functional water heater exhaust flue.

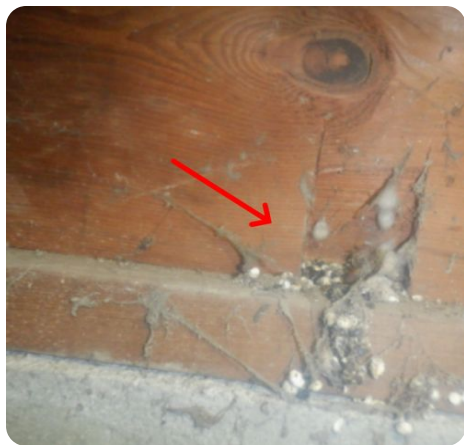
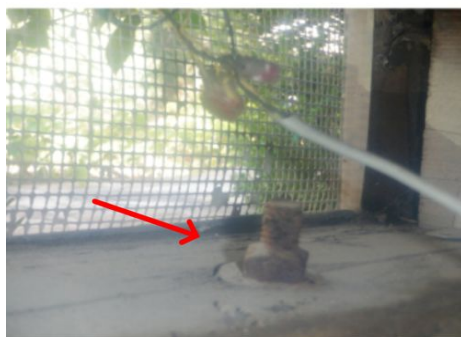
The home is structurally supported by a perimeter concrete foundation, concrete stem walls, and wooden posts installed upon concrete piers and footings. Sill plate anchors were verified to be in place. Supplemental angle iron straps securing the foundation and framing have also been installed.

Sill plate anchor within crawl space.

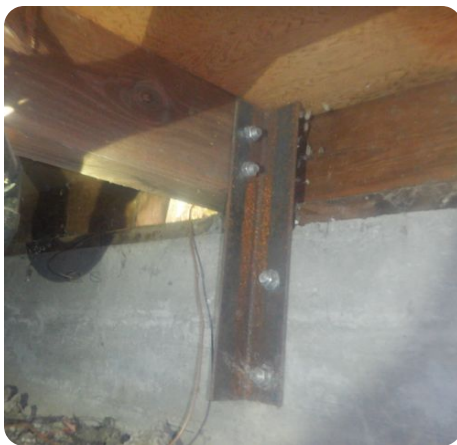
Supplemental angle iron straps securing foundation and framing.

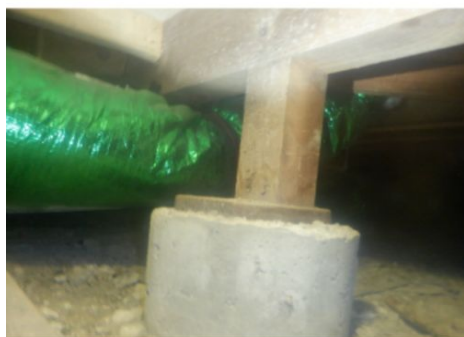
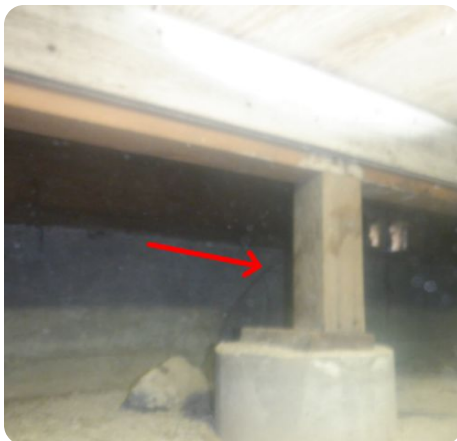
Post & pier construction within crawl space.

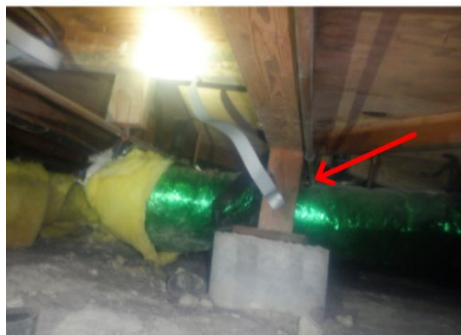
Post & pier construction within crawl space.

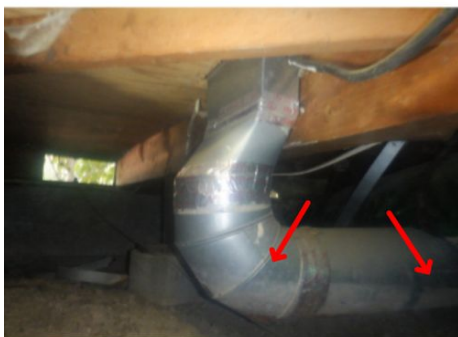
The crawl space soil was found to be dry at the time of the inspection, but contained indications of elevated moisture levels at some point in the past. Water/silt lines were observed at the cook-top ventilation ducting and HVAC ducting. Consulting the current homeowner for additional information regarding this observation is recommended.

Water/silt lines at cooktop fan ducting.
