Prepared For: Jane and Jack Buyer

Property Address: 8320 Vista Monterra, Monterey, CA 93940

Inspector: Robert Vierra
Company: RLV Inspection Services
dba WIN Home Inspection Monterey
(831) 637-2194
rvierra@wini.com

Full Home Inspection

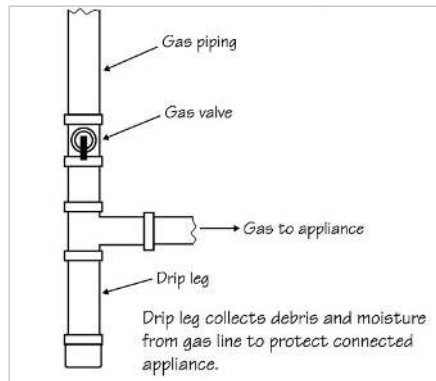
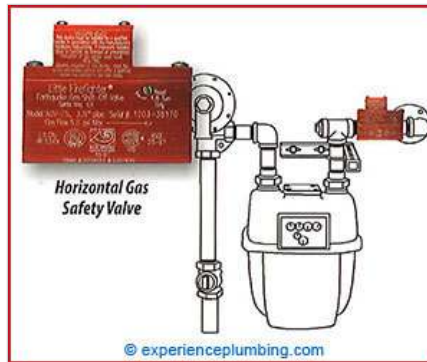
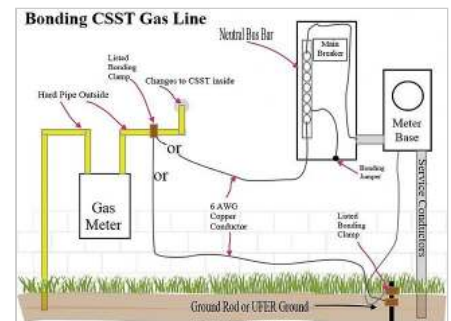
Note 3: Direct bonding is required as of 2019, for gas piping systems incorporating standard (yellow) or uncoated CSST whether or not the connected gas equipment is electrically powered. The inspector did visually identify CSST piping at areas of the property. Improperly bonded or non-bonded CSST piping can present a potential safety hazard. The home inspector cannot verify if the piping has not been properly bonded. If CSST piping is present, we recommend you contact a qualified electrician to determine if proper bonding is present.

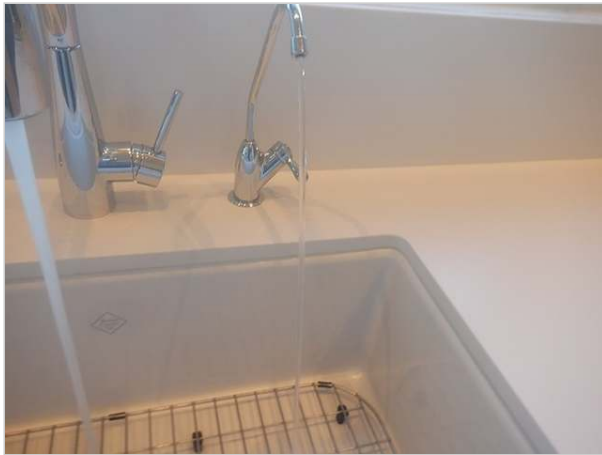
There is a water filtering system for the kitchen area; however, this inspection does not cover the adequacy or extent of the system. We recommend you ask the owner about the condition and maintenance on this item. We recommend you contact an appropriate trade for maintenance of the system.

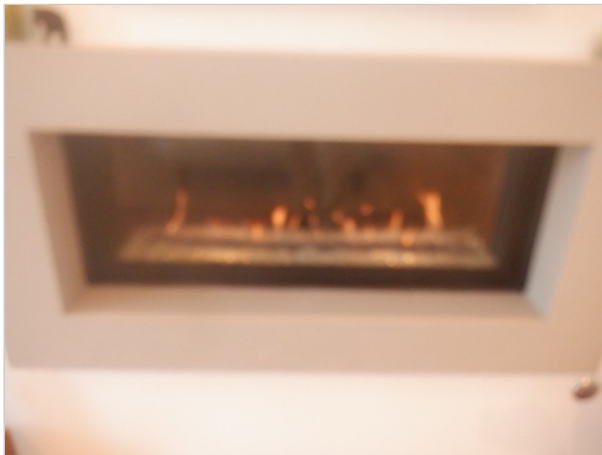
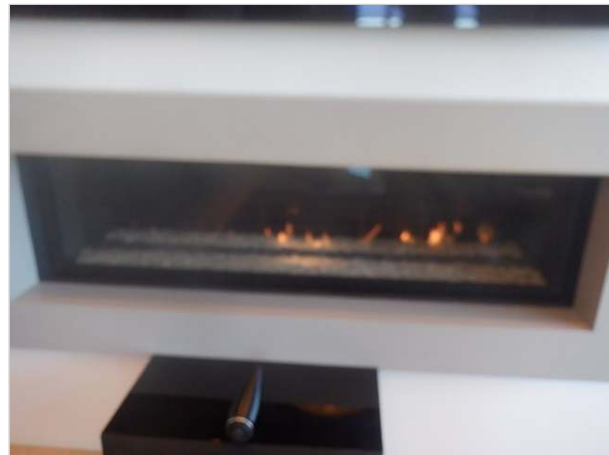
There are gas-log fireplaces in the home which appear to be in satisfactory condition. The sealed units were ignited/tested at the time of the inspection. The gas valve system at the living room was turned and did supply gas; however, it was not ignited. We recommend you verify or further investigate the current condition and any potential issues or disclosure items. Contact a qualified chimney inspection company for a detailed inspection prior to use.

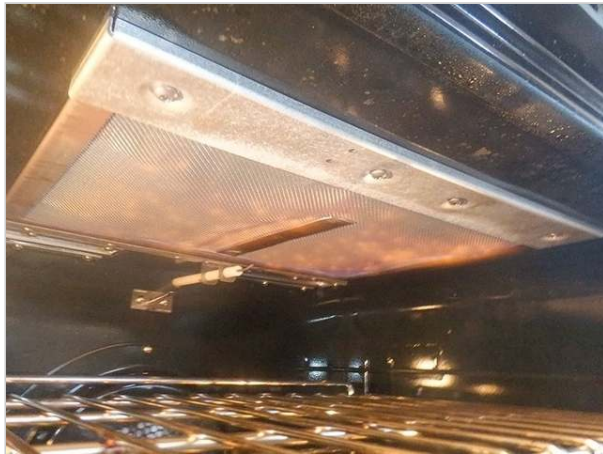
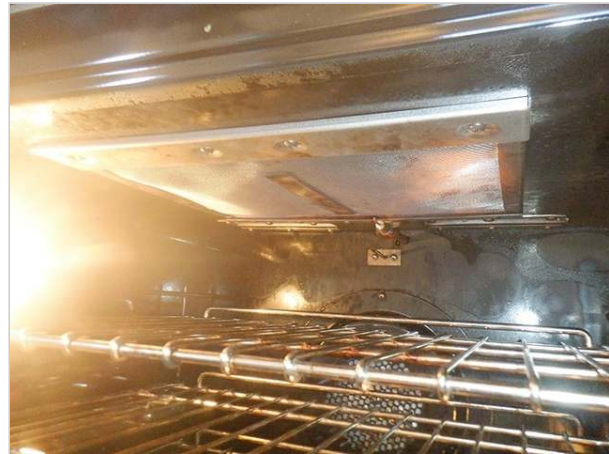
The bake and broil cycles were functional at the time of the inspection. This is an "on/off" test conducted on the oven. We suggest you ask the owner as to the current condition of the unit. Note: Timer, clocks, convection fans, and self-cleaning systems are not tested.

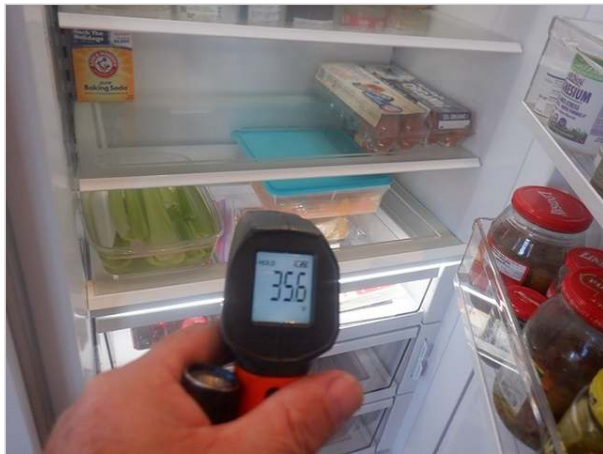
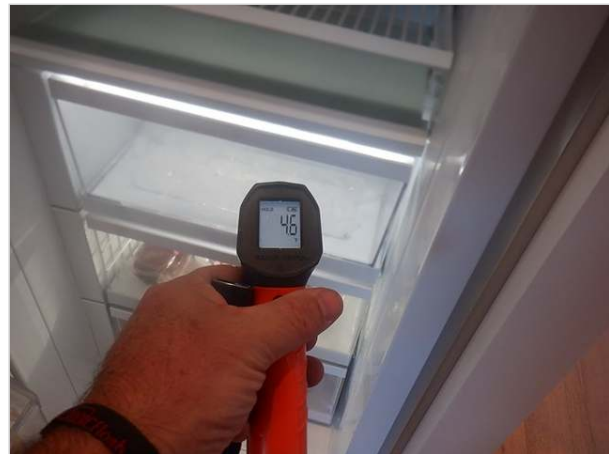
There is a water line connection for the refrigerator. This water supply is used and required for automatic ice machines. Also, the interior of the refrigerator and freezer were cold when opened; however, a thorough inspection/test of this system is not conducted. If the unit is to remain as part of the transaction, we recommend you further investigate the actual condition and/or ask the current owner as to the actual condition of the appliance. **Note:** Inspecting refrigerators is **NOT** within the scope of a home inspection, and are typically **NOT** covered by most standard home warranty policies. If the unit is built-in unit, we recommend verifying the age and current condition of the unit.

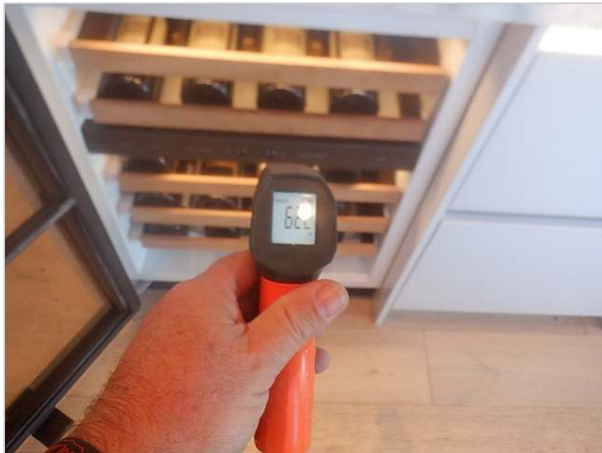
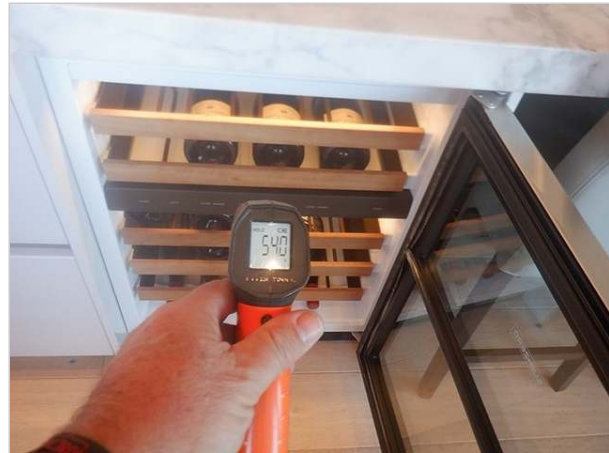
-There were two wine/bar refrigerators located in the kitchen area. The items appeared to be operating at the time of the inspection. We recommend you further investigate the actual condition and operation of the unit, as well as testing prior to closing.

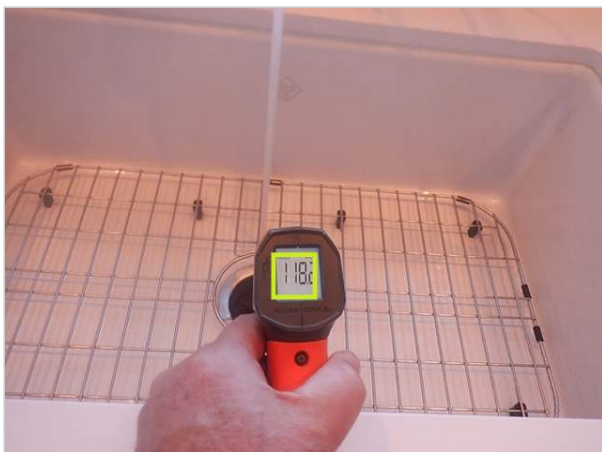
The generally **accepted safe temperature** from fixtures produced by the water heating system should not exceed 120 degrees. Water heater manufacturers recommend this temperature to reduce potential for burns and scalds. The structures temperature at the time of inspection at a fixture was reading approximately 118°.
