**Prepared For:** Sample Homebuyer

**Property Address:** 1234 Easy St., Cape Coral, FL 33993

**Inspector:** Jason Vernier  
**Company:** Vernier Enterprises, Inc.  
dba WIN Home Inspection Fort Myers  
jvernier@wini.com

## Standard Full Home Inspection

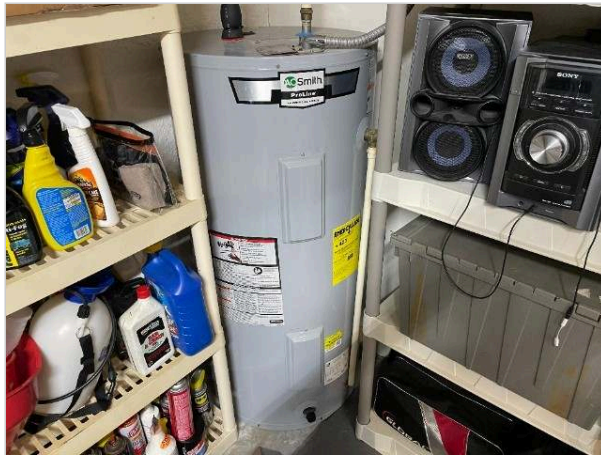
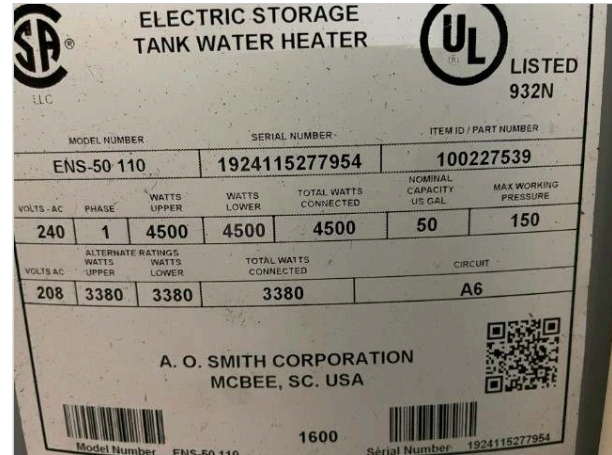
Manufacturer Date: July 2019

The life expectancy of an electric water heater is typically 8-12 years from the date of installation, although there are exceptions on both sides. As a preventative maintenance recommendation, it is recommended that water heaters be drained periodically to remove sediment buildup in the tank. The recommended setting for a residential water heater is 120 degrees Fahrenheit.

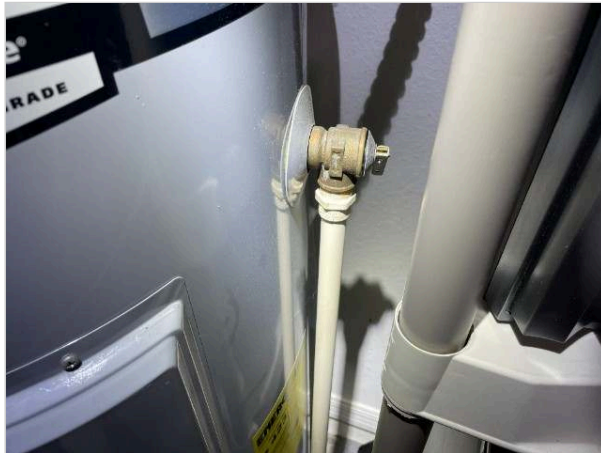
The water heater is equipped with a temperature and pressure relief valve as required. The valve lever should be operated per manufactures recommendations to ensure that waterways are clear. Naturally occurring mineral deposits may adhere to the valve, rendering it inoperative. If water does not flow freely when the lever is operated, replacement of the valve is recommended.

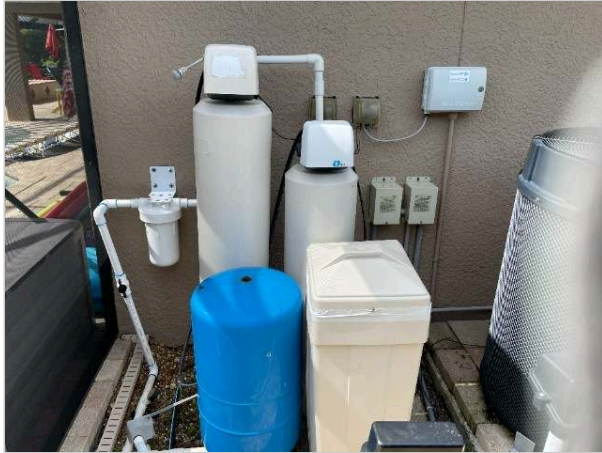
There is a soft-water system in this structure.

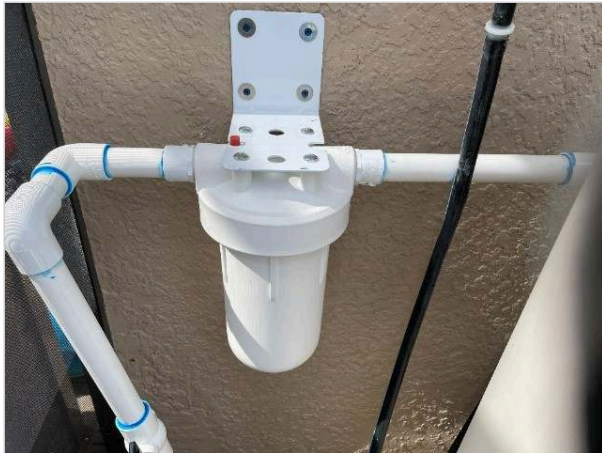
There appears to be an active whole home water filtering system.

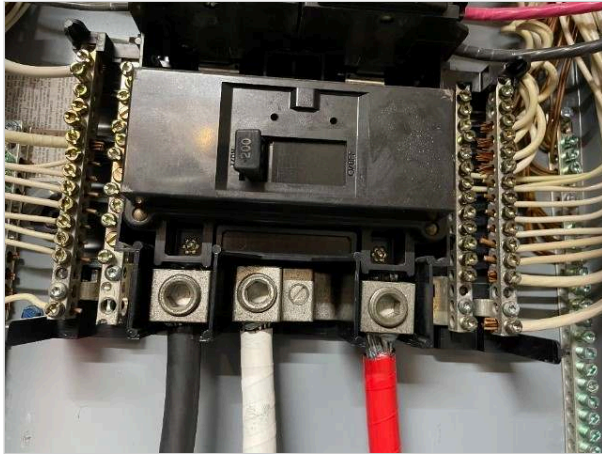
The wiring service to the panel.

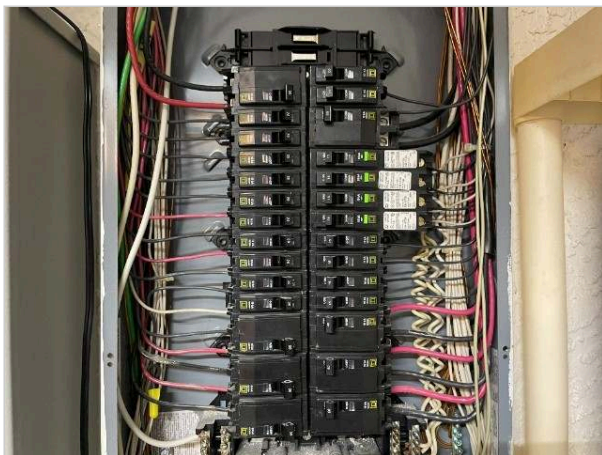
The face plate of the electrical panel was removed at one or more of the electrical panels to provide the inspector visual access for verification.

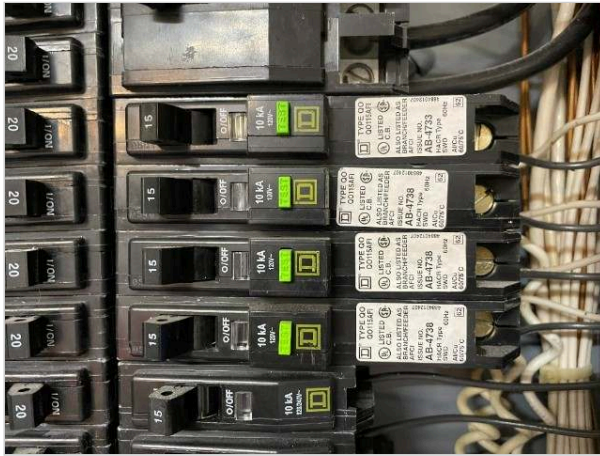
An Arc Fault Circuit Interrupter (AFCI) is a circuit breaker that breaks the circuit when it detects an electric arc in the circuit it protects to prevent electrical fires. An AFCI selectively distinguishes between a harmless arc (incidental to normal operation of switches, plugs, and brushed motors), and a potentially dangerous arc (that can occur, for example, in a lamp cord which has a broken conductor). This structure has installed AFCI.

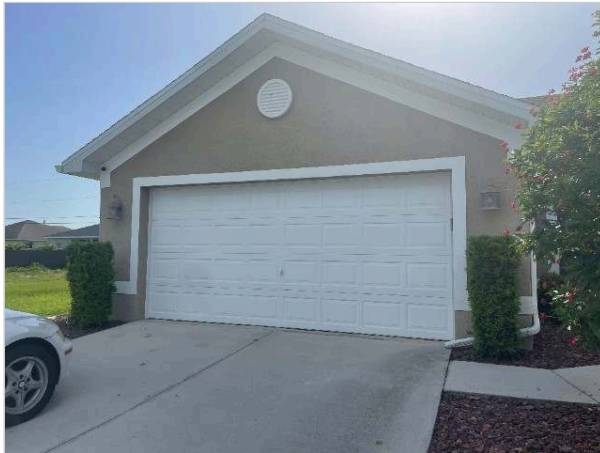
Exterior of the garage.

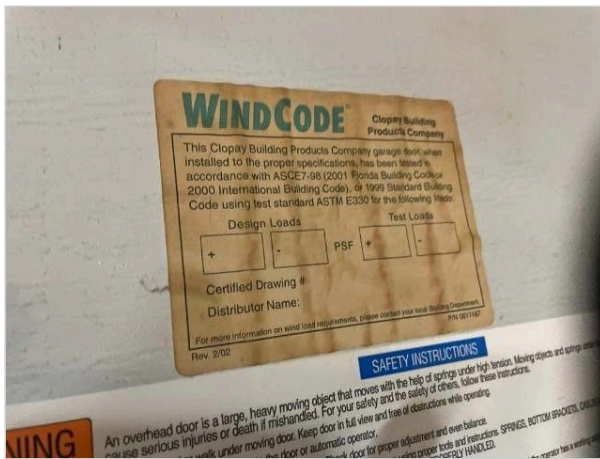
The garage door is in a functional condition. While a garage door has a service life expectancy of 20-25 years, an automatic garage door opener can be expected to last 8-12 years.
