Gopherwood Ventures

12/2/2023

TREC Inspection - Amarillo

# PROPERTY INSPECTION REPORT FORM

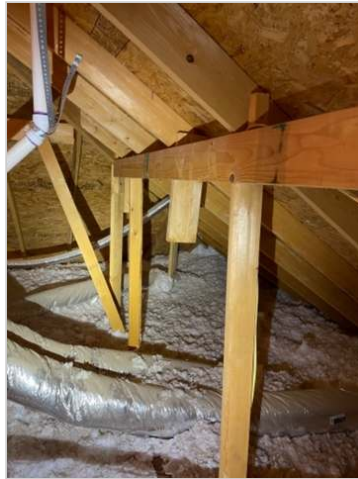
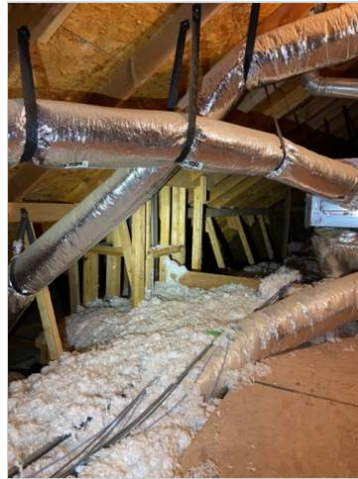
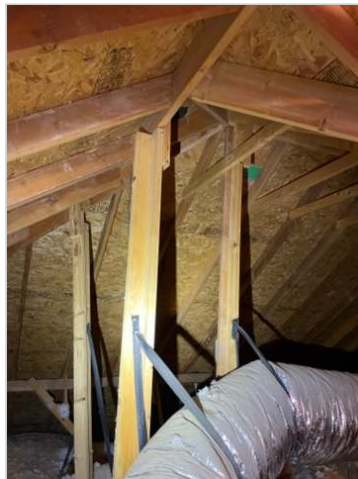
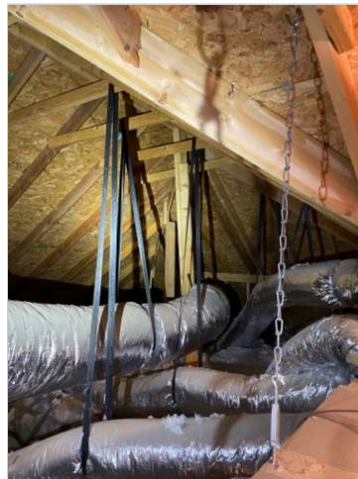
Thin service decking

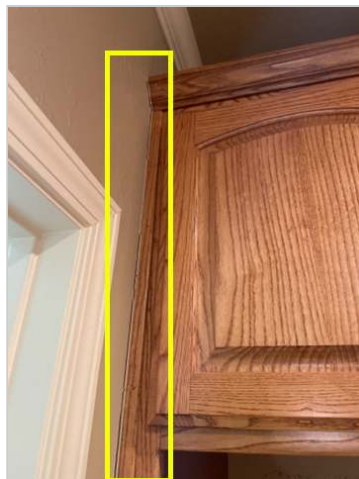
Kitchen

- Minor cracking in drywall material - kitchen

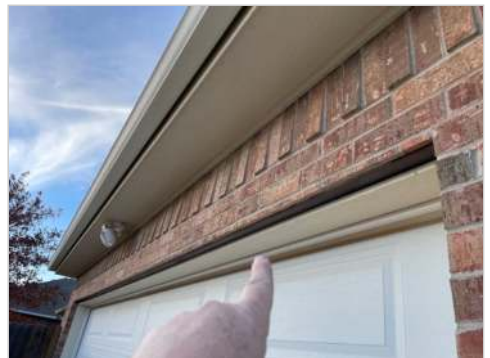
Missing caulk

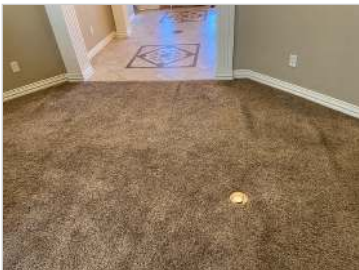
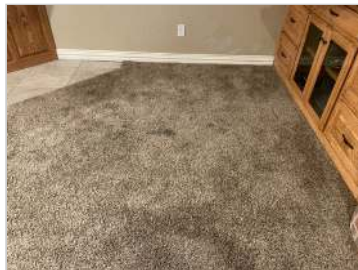
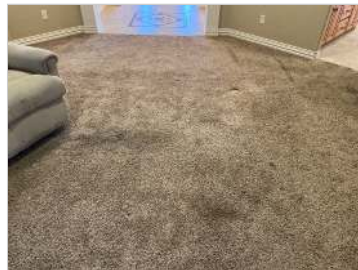
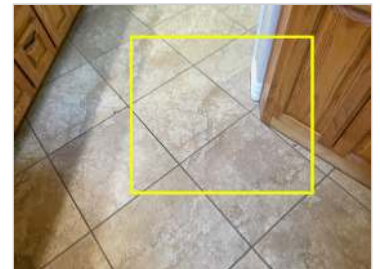
Master bathroom

\*\*\* Areas of stained carpet - living area

\*\*\*Area of hollow sounding tile. - master bathroom

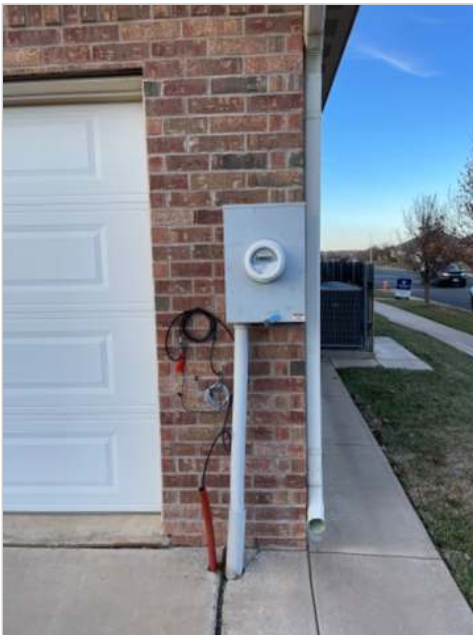
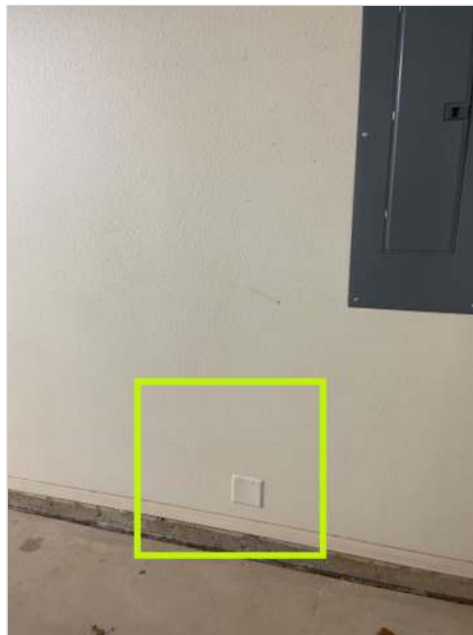
Cover to ufer ground

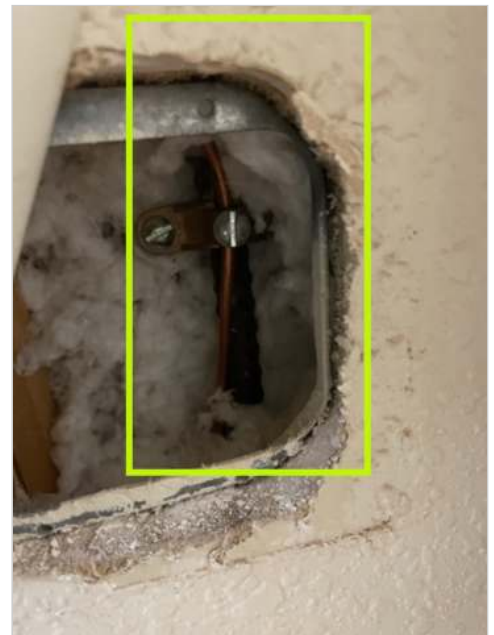
Ufer ground

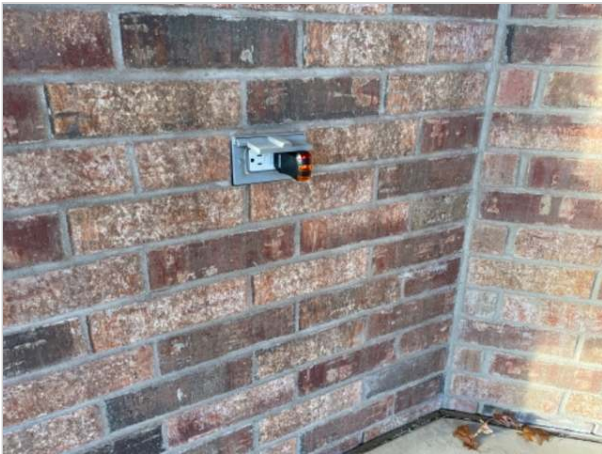
\*\*\*Reversed polarity - back exterior GFCI outlet

Reverse polarity

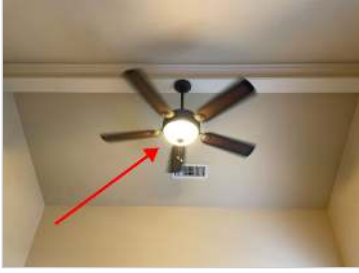
North bedroom

\*\*\* Some light bulbs were not working or missing at the time of the inspection. Uncertain if it was only the light bulb.

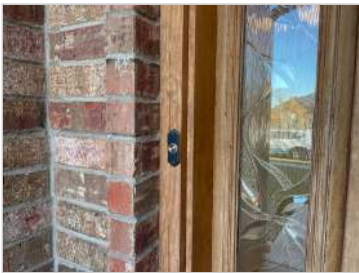
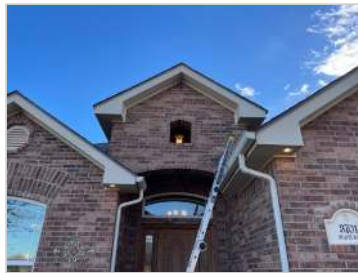
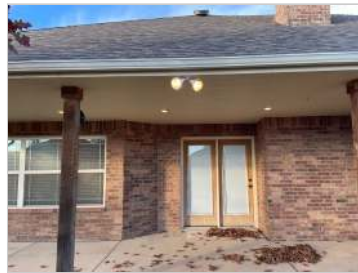
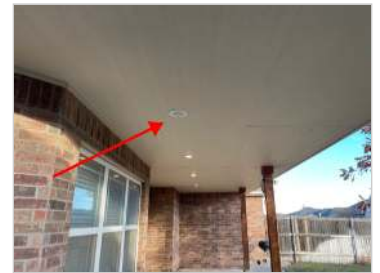
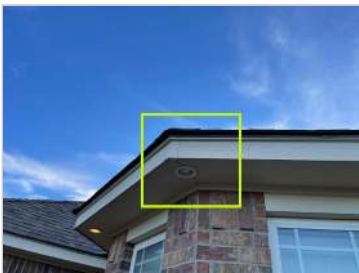
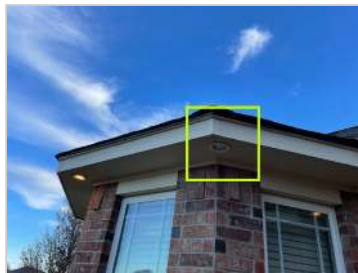
Back porch light: \*\*\*Present, one light was not working.

\*\*\* Soffit accent lights were present, but some were not working. Recommend further evaluation.

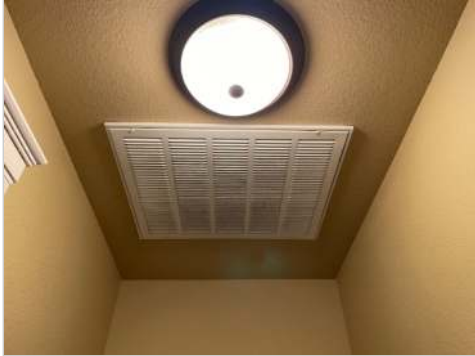
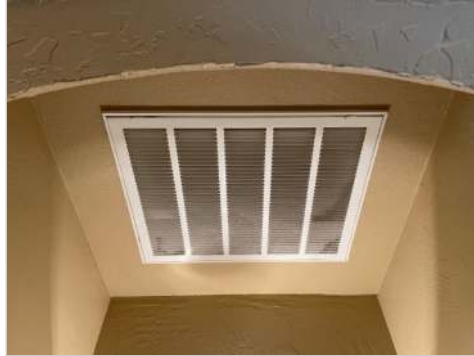
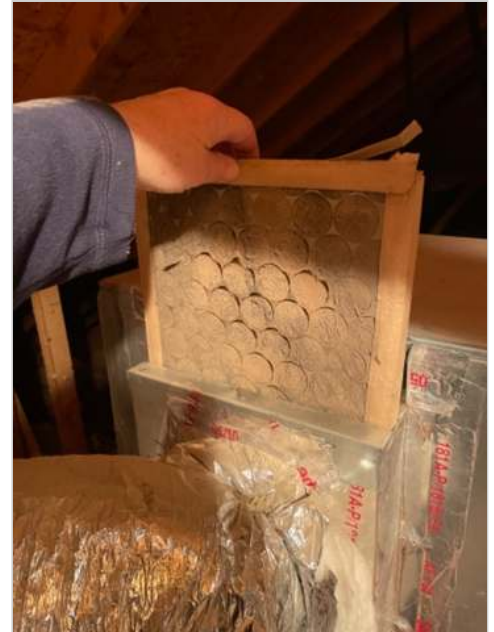
Condition of filter(s): \*\*\*One or more dirty at the time of the inspection. Recommend changing.

Condition of fresh air filter at unit in attic: \*\*\*Very dirty. Recommend replacement.

Note - The air filter inside the grill should be replaced regularly. The general recommendation is to replace once a month.

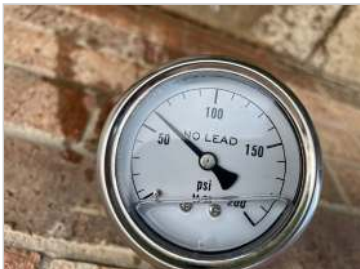
**Exterior hose bib:** East side - north exterior hose bib was present and working at the time of the inspection. An anti-siphon device was present which helps prevent backflow into the water supply.

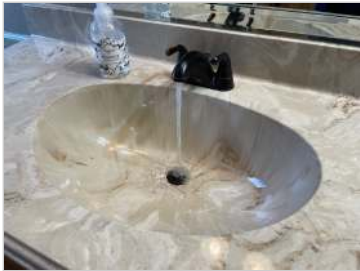
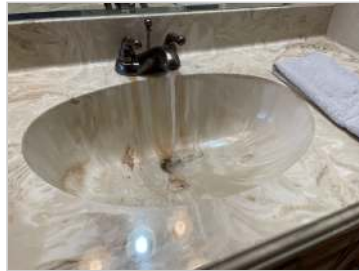
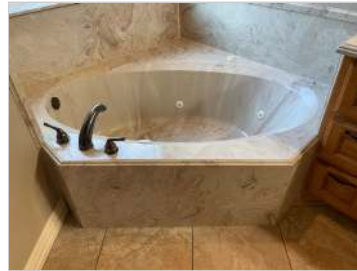
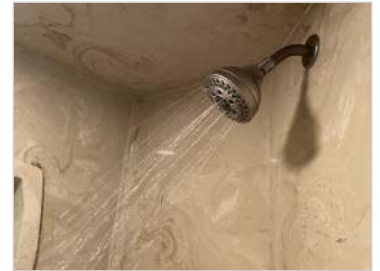
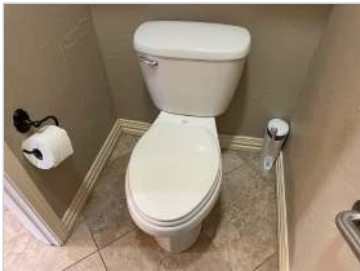
**Location of bathroom:** Jack and Jill bathroom

Condition of lavatory faucet: Satisfactory.

Condition of shut-off valves: Present and satisfactory.

Condition of bathtub fixtures: Faucet(s) were satisfactory. The diverter valve was satisfactory.

Condition of shower fixtures: \*\*\*Shower head leaking at thread connection. Recommend correction.

Condition of toilet: Secure to the toilet flange. The toilet did flush when the handle was pushed.

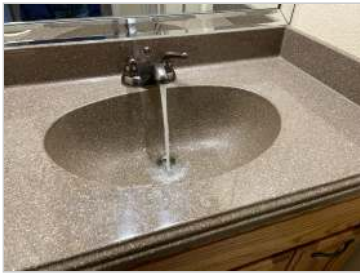
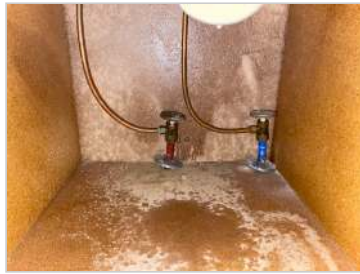
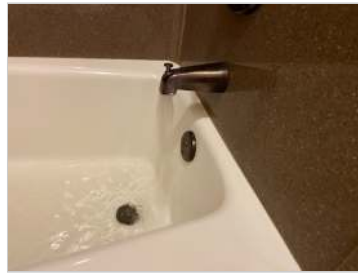
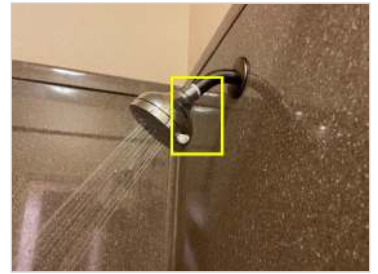
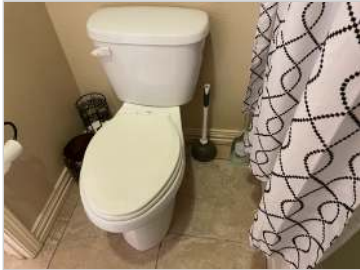
**Location of bathroom:** 1/2 Bath

Condition of lavatory faucet: Satisfactory

Condition of shut-off valves: Present and satisfactory

Condition of toilet: Secure to the toilet flange. The toilet did flush when the handle was pushed.

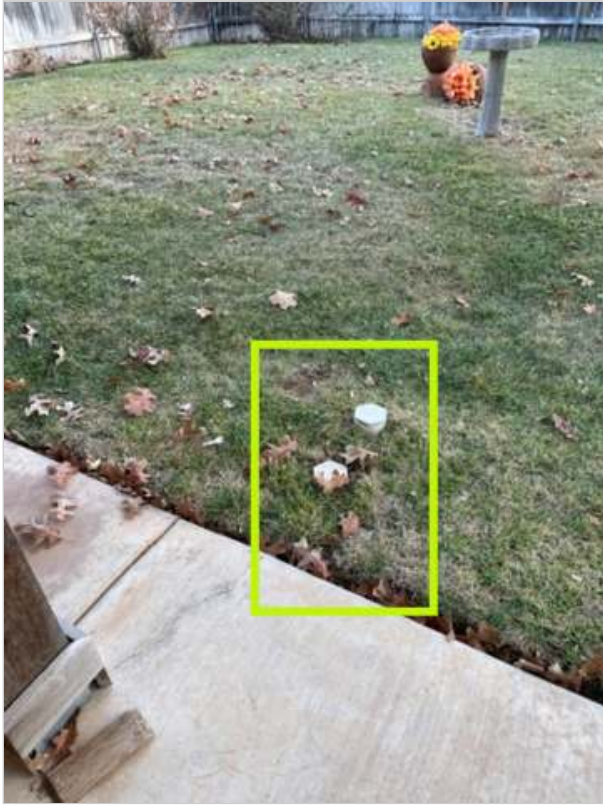
Leak

\*\*\*Leak at drain pipe - Jack and Jill lavatory

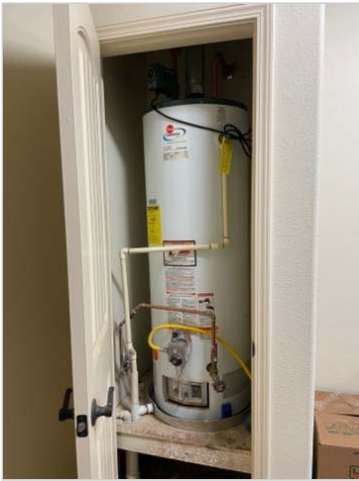
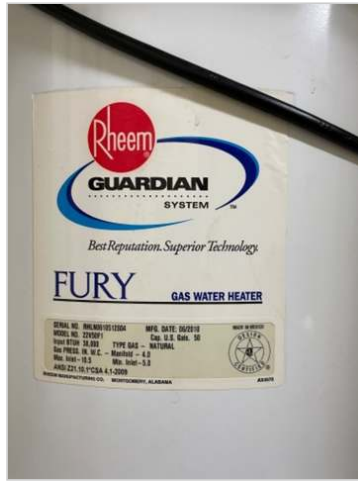
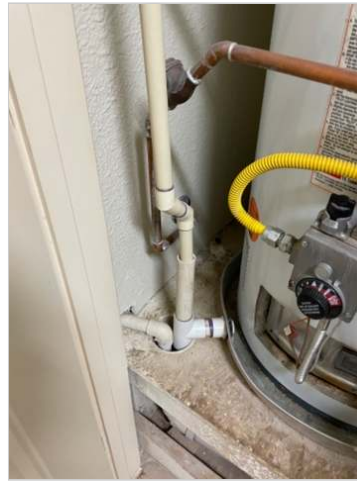
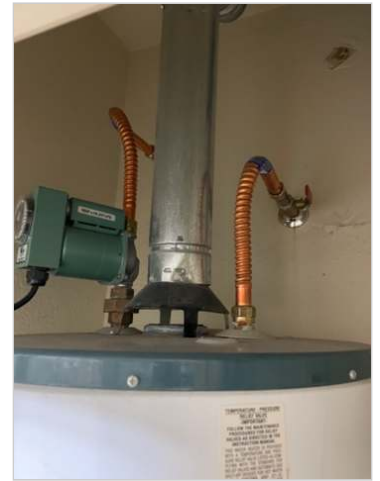
Hot water: Present. The water heater was working.

Noted possible signs of rust at bottom of tank. Recommend closely monitoring.

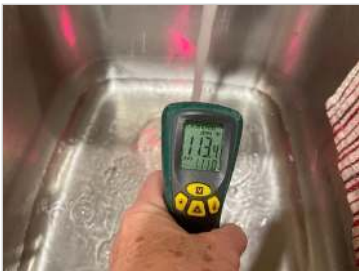
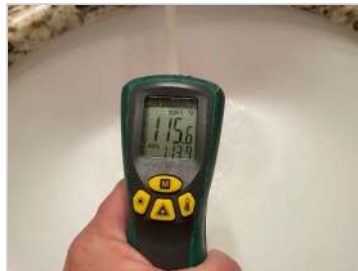
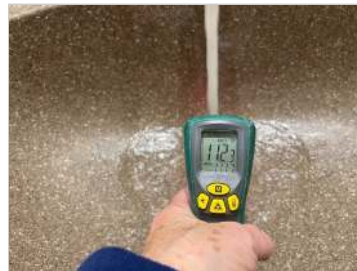
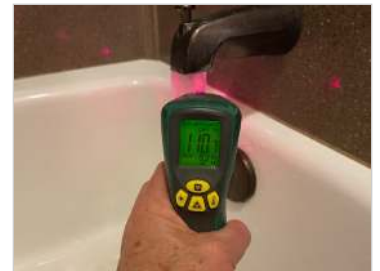
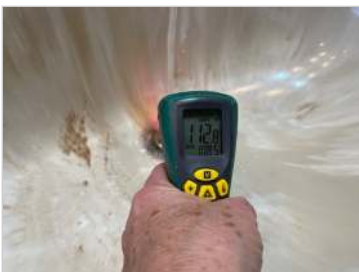
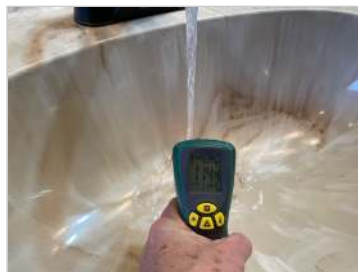
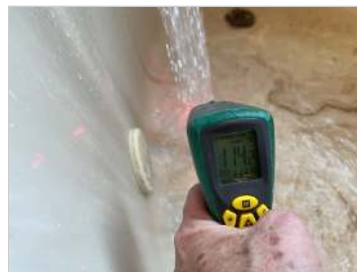
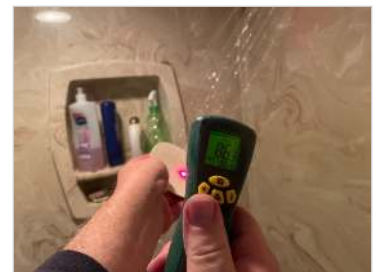
Pictures of water heater temperatures at plumbing fixtures...

Condition of temperatures: Satisfactory

\*\*\*Note - water at master shower was warm not hot - control valve may need adjusting

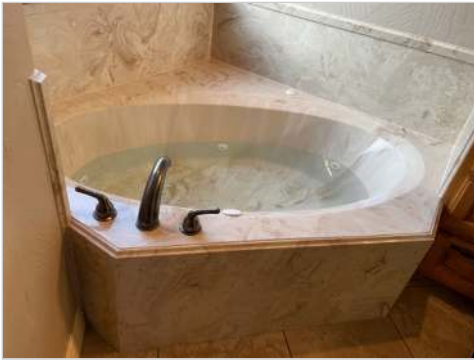
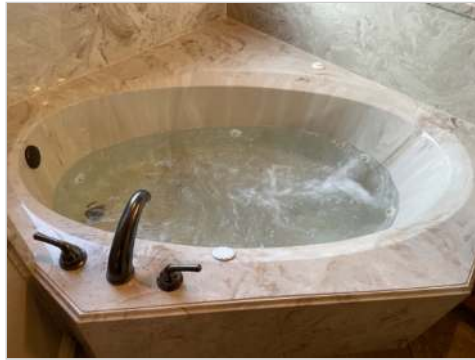
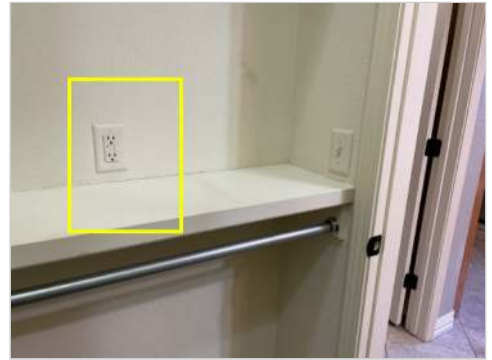
Access panel: \*\*\*Not present. A readily accessible panel is recommended for inspection and service purposes.

Leaks: Unable to determine due to lack of access panels.

GFCI protection: Was present. Reset was at master bedroom closet behind the closet door.

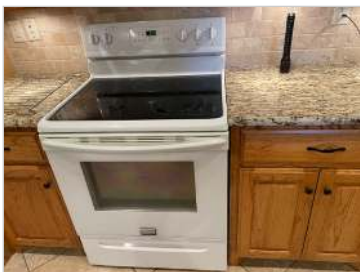
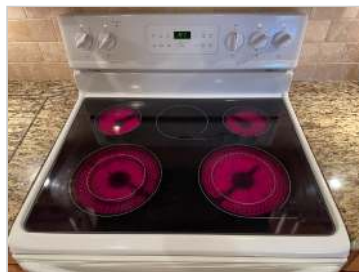
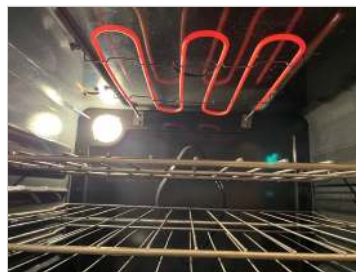
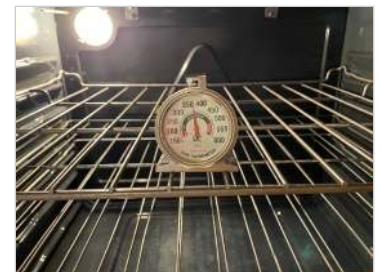
Anti-tip device: Not present at the range. \*\*\*Recommend the addition of an anti-tip device to prevent the range from tipping over.

A gas line was present behind the range.
