**Property Address:** Avon, IN 46123

Extended Full Home Inspection  
Radon Testing, Pool Inspection

### Extended Full Home Inspection

**Service Date:** 7/11/2023

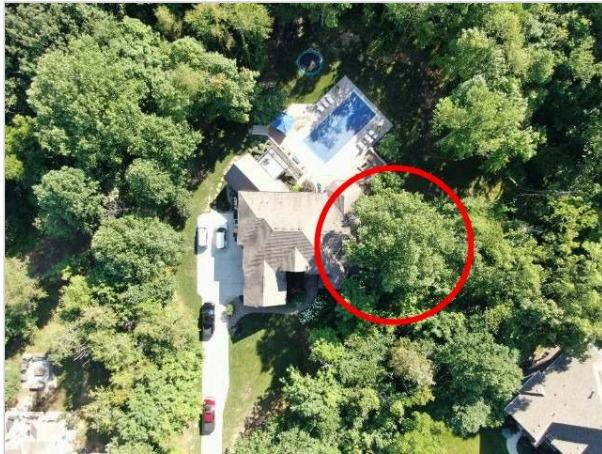
One or more trees are overhanging the roof or in direct contact with the structure. Tree branches overhanging the roof are a hazard. They drop debris, which can damage the roof and may create excessive shade, which may allow the growth of moss or microbial growth. They may allow a common avenue for pest and rodent infestation. Trees can also damage sewer lines when in close proximity. All tree branches should be trimmed as to not overhang the roof and be at least 6 - 12 inches away from the structure exterior. Recommend repair by a qualified arborist.

Large tree on SE side is overhanging the roof.

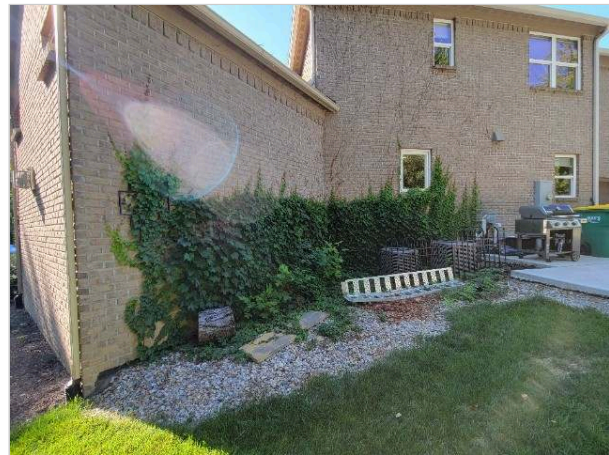
There is vegetation close to or in direct contact with the structure. All vegetation should be trimmed at least 6 - 12 inches away from the structure exterior to prevent damage and to eliminate a common avenue for pest infestation. Vegetation overgrowth may limit the view of the area for the inspector. An unknown condition may exist. Recommend repair by a qualified specialist.

Large cluster of vines on NW side.

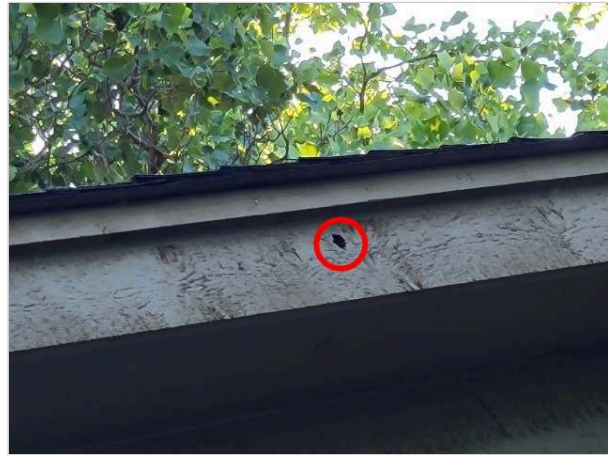
One or more areas of the trim are damaged, loose, gaped or missing. Repairs are needed to prevent moisture penetration damage and pest intrusion. These areas may be damage from carpenter bees. Recommend evaluation by a qualified exterminator and repair by a qualified contractor.

Front side trim.

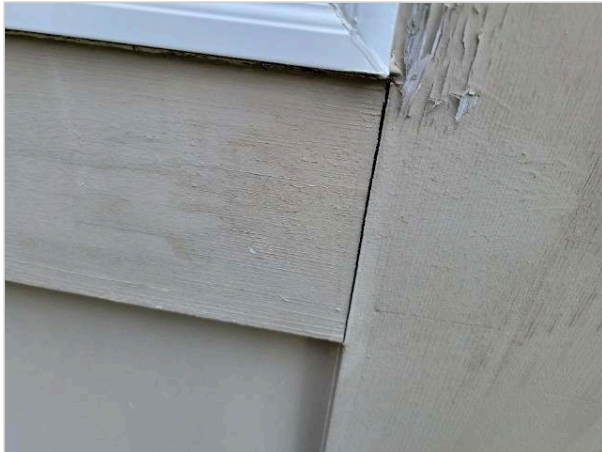
One or more areas of the exterior caulking or sealant is damaged or missing. Sealant is vital to prevent pest intrusion and moisture related damage to building materials and requires frequent maintenance. Recommend repair by a qualified specialist. *Note: The pictures below are samples. All affected areas may not be shown.*

Front side. Dining room window trim.

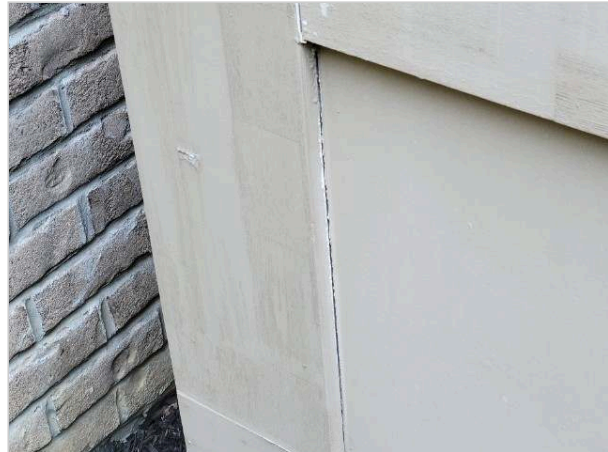
Front side. Dining room window trim.

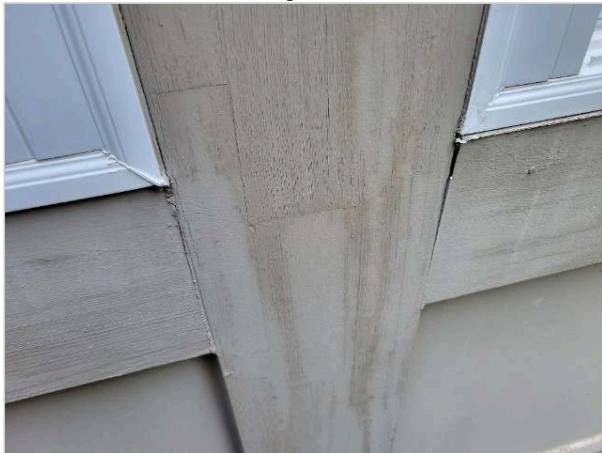
Front side. Dining room window trim.

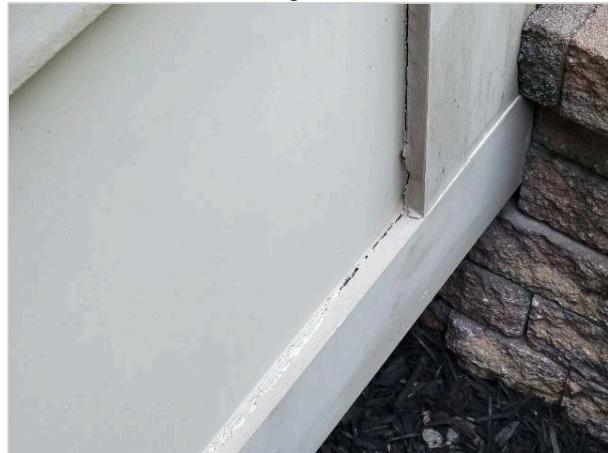
Front side. Dining room window trim.

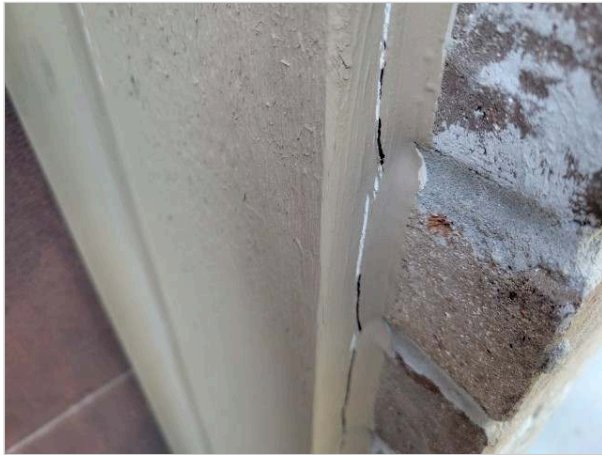
Garage door trim.

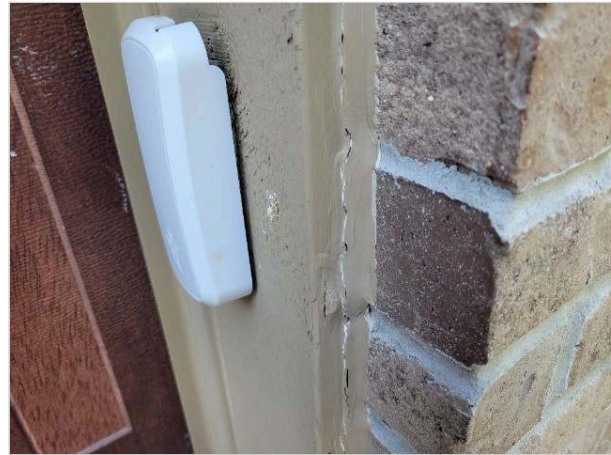
Garage door trim.

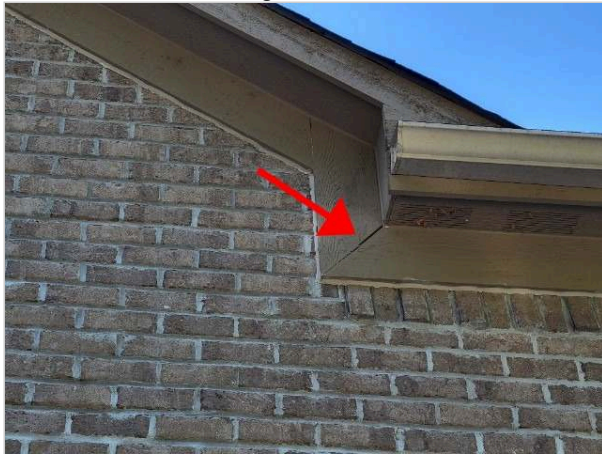
Above garage doors.

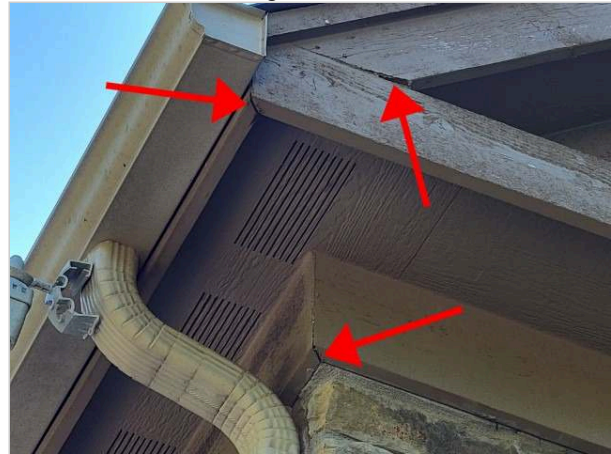
West corner.

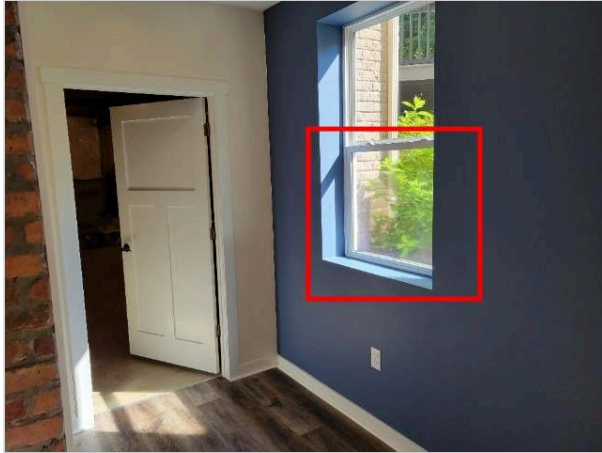
Basement window. Bottom of stairs.

One or more double pane insulating glass windows or doors have lost the thermal seal between the panes of glass. There may be condensation, corrosion or deterioration between the panes. This condition can usually be repaired, but replacement may be indicated depending on the cost of repair. A visual inspection of the windows may not disclose deficiencies in all windows, which may only be visible at certain times of the day or under certain meteorological conditions at the time of inspection. Recommend evaluation and repair or replacement by a qualified window specialist.

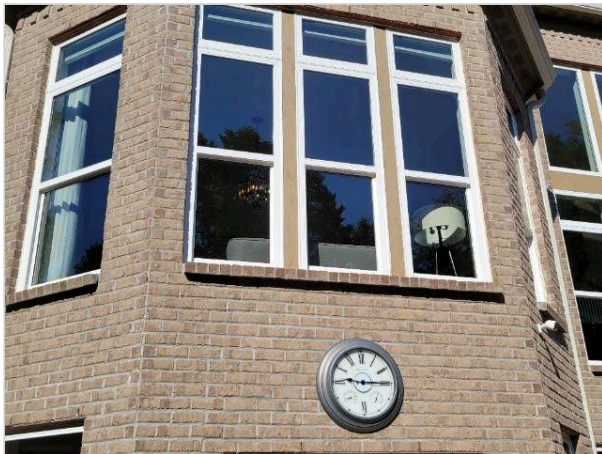
Most of the window screens are missing. Screens were found stored in the basement. Recommend installation or replacement for the desired service by a qualified specialist.

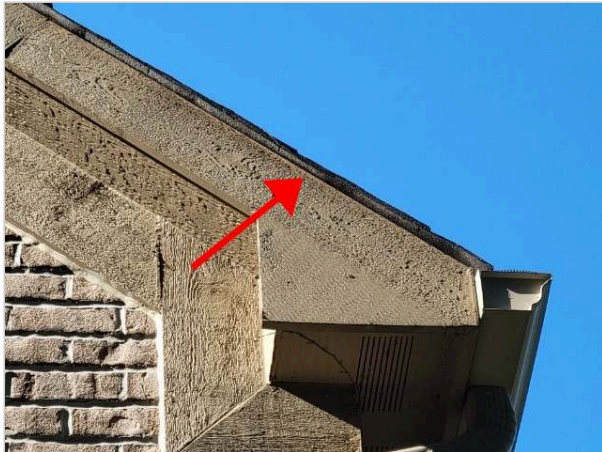
One or more areas of the drip edge is missing, damaged or installed improperly. Drip edge flashing supports the edges of the shingles, provides resistance to moisture from entering the attic and protects fascia and sheathing from damage. Most roofing cover manufacturers require a drip edge. Recommend repair or installation by a qualified roofing contractor.

No drip edge installed.

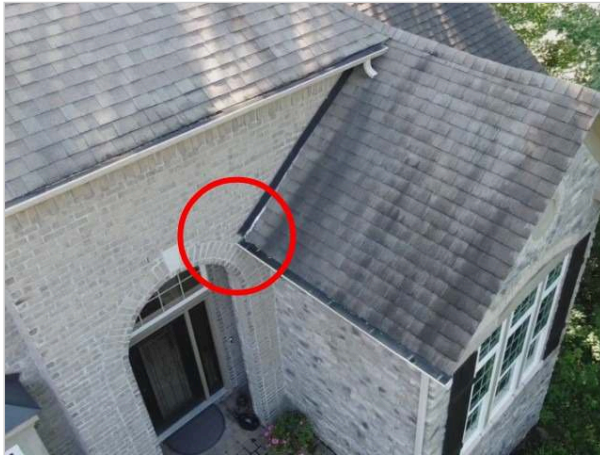
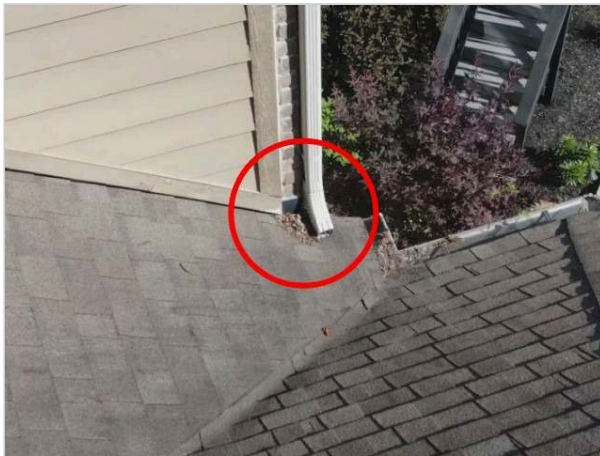
One or more areas of the roof is missing kickout flashing. Where a roof eave (end) meets a vertical wall, kickout flashing is required. Rain water coming down the roof may spill over the gutter onto the exterior wall. This may lead to staining, but can allow moisture to enter the wall behind the siding material, potentially causing extensive damage. Recommend evaluation and repair or installation by a qualified roofing contractor.

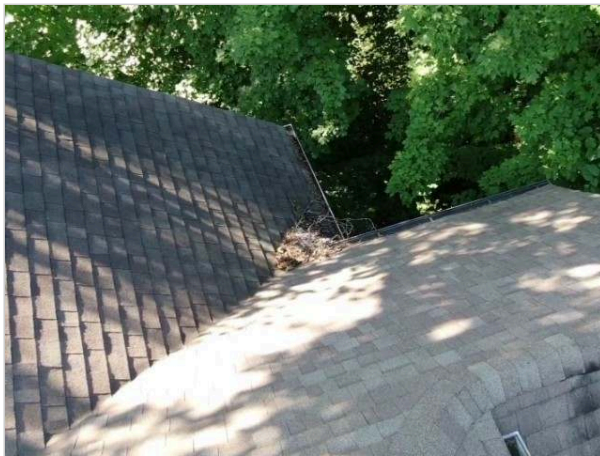
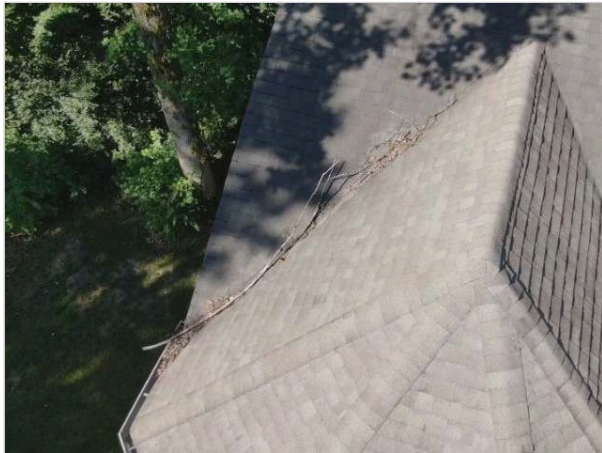
There was debris on the roof at the time of the inspection. Debris should be cleaned off the roof surface as a proper care and maintenance recommendation. Recommend removal and cleaning of debris from the roof by a qualified specialist.

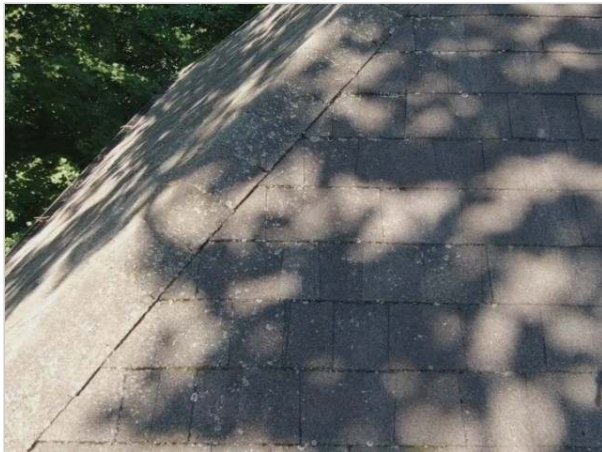
One or more areas of the exterior has moss growth or microbial growth. This condition typically occurs in locations that experience high moisture exposure and/or may not receive sufficient sunlight to allow the area to adequately dry. The growth should be removed to extend the life of the underlying material. Recommend repair by a qualified specialist.

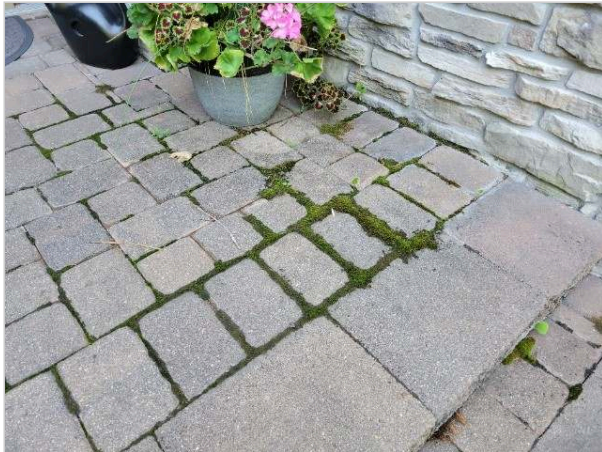
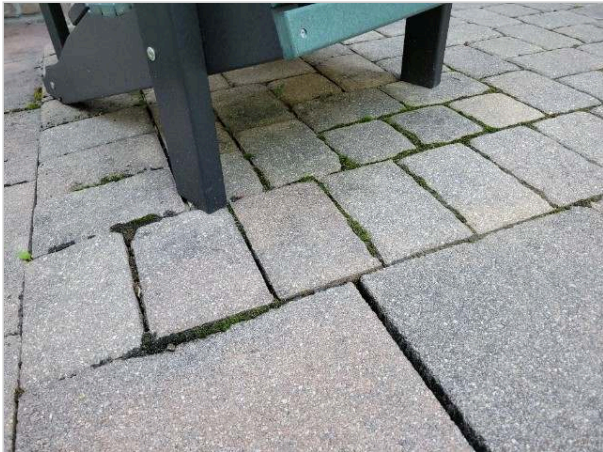
The front steps have moss growth. It appears this area does not receive sufficient sunlight to adequately dry out the surfaces after periods of rain. Moss growth, while considered attractive to some, may pose a potential trip hazard. Recommend evaluation and correction for the desired outcome by a qualified specialist.

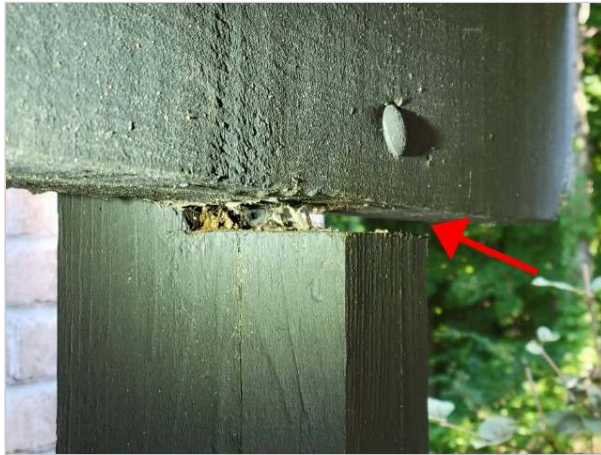
There is a large gap between one of the beams and a post. The beam should be resting on the post with no visible gap present. Recommend evaluation and correction by a qualified deck contractor.

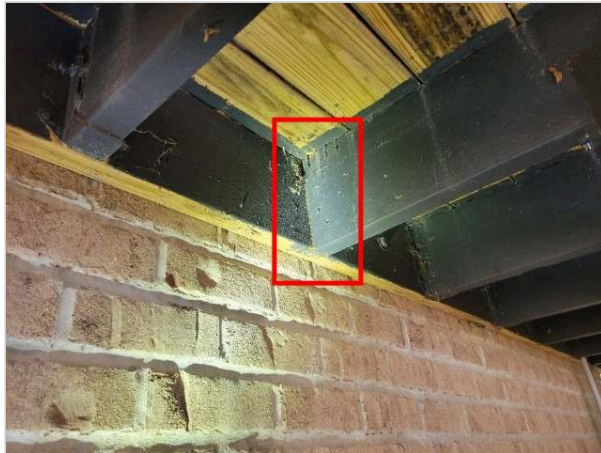
There are several joists that are missing a required joist hanger. Recommend repair by a qualified contractor.

Joist hangers missing.

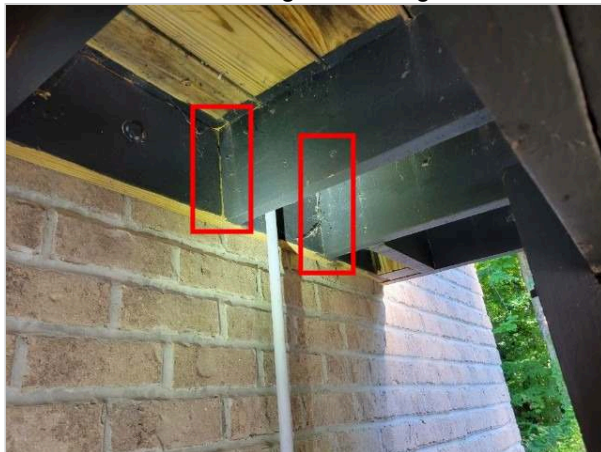
Joist hangers missing.

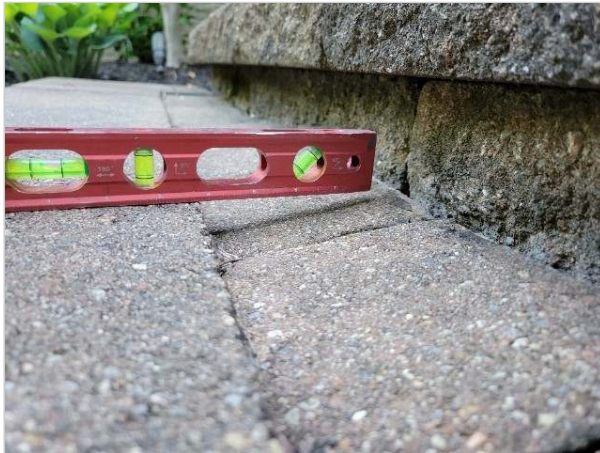
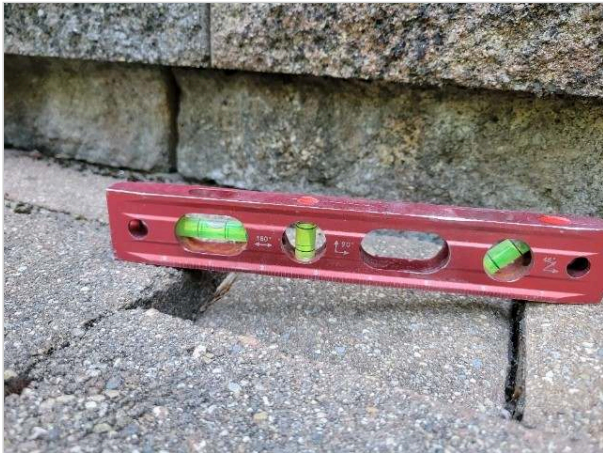
The front steps' pavers have areas that are not level and may pose a trip hazard. The bottom right side of the steps is sloping away to the right, which has created large gaps between the pavers. Removal and rebuilding of the steps may be required. Recommend evaluation and correction by a qualified contractor.

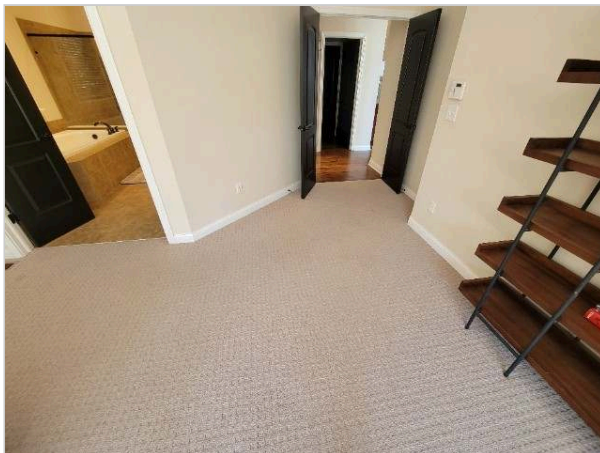
Master bedroom.

The floor is "squeaky" in one or more areas. Squeaky or noisy floors are primarily caused by loose fasteners in wood boards or sub-floor and generally considered an annoyance rather than a structural defect. Products are available for non-invasive repair of the condition. Recommend evaluation and repair for the desired service by a qualified specialist.

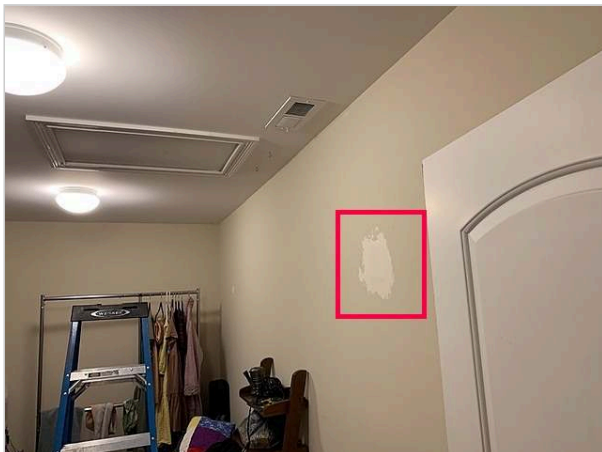
One or more areas of the interior walls and/or ceilings appear to have been repaired in the past. These areas appear to be functional; however, it could not be determined what was repaired or what issue was corrected. Recommend asking seller about this condition. In the absence of seller disclosure, recommend further evaluation by a qualified specialist.

Previous repair primary bedroom closet.

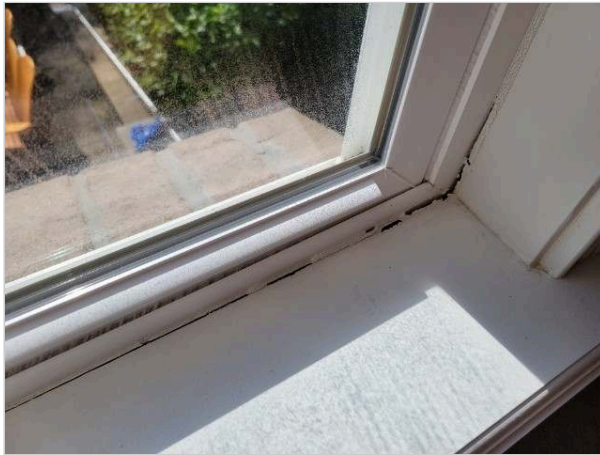
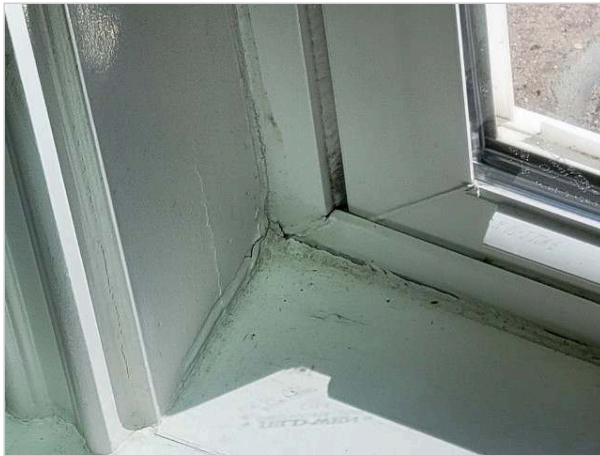
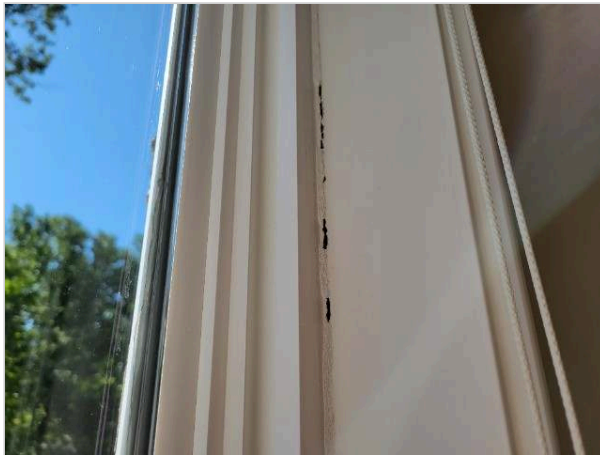
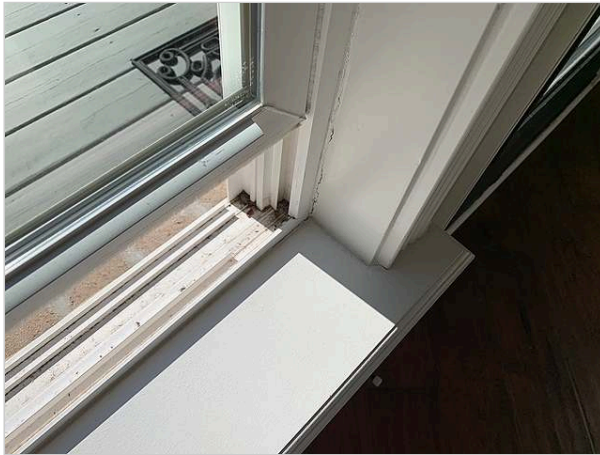
Several areas of the master bedroom window interior caulk has separated. The area was scanned with a moisture meter and no evidence of moisture penetration was observed. There were no moisture stains in the area. This is likely the result of fluctuating exterior temperatures. Recommend repair by a qualified specialist.

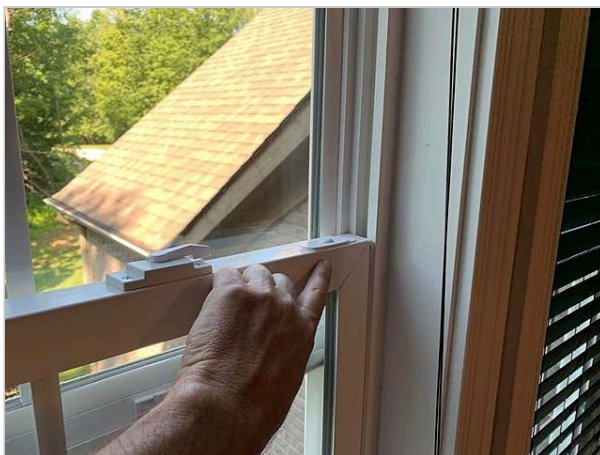
It appears the tilt latch, used to secure the window and tilt open the lower pane is damaged. Recommend evaluation and repair by a qualified specialist.

Tilt latch is damaged.

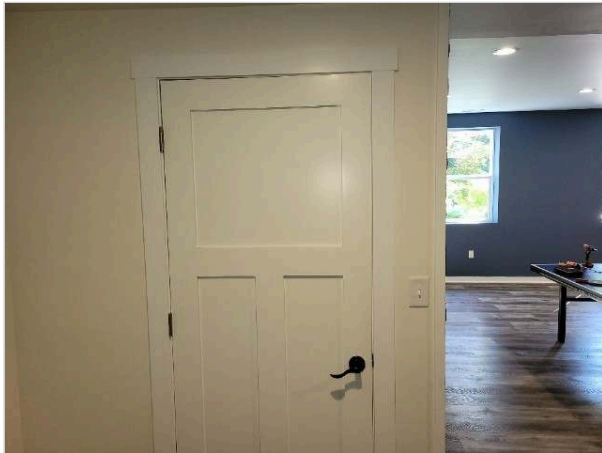
One or more doors needs fit adjustment for the desired service and ease of use. Recommend evaluation and repair by a qualified specialist.

Door does not close. Basement stored closet under the stairs.

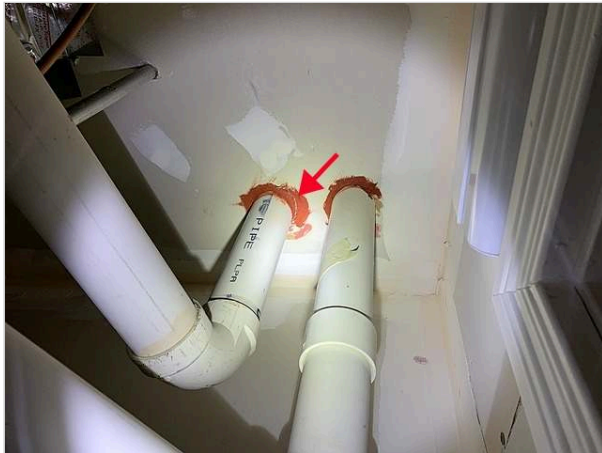
One or more areas of the interior walls and/or ceiling is damaged or has gaps that need to be repaired and/or sealed with a heat resistant caulk. This is a fire safety requirement due to the presence of gas appliances in the area. Recommend repair by a qualified specialist.

Area needs re-sealed with fire rated caulk, upper furnace.

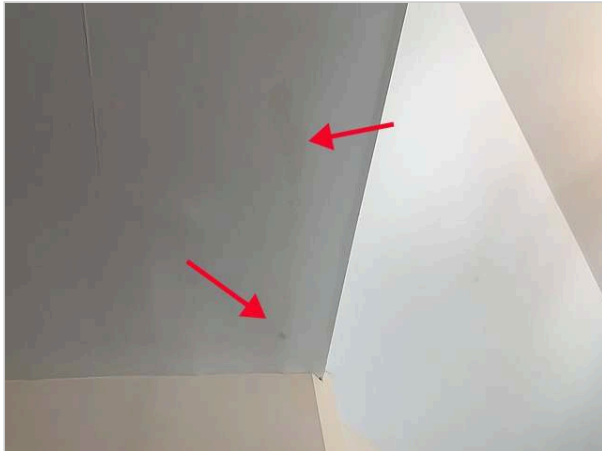
One or more areas of the interior walls or ceilings appears to have an active leak. The affected area was scanned with a moisture meter, which revealed the presence of active moisture. Corrective action should be taken immediately. Moisture leaks can cause extensive and costly damage to building materials. A home inspection is a visual-only, non-invasive inspection. Invasive inspection is required to determine the extent of damage. Recommend asking seller about this condition. Recommend further evaluation by a licensed plumber and/or qualified roofing contractor.

Moisture stains at kitchen ceiling.

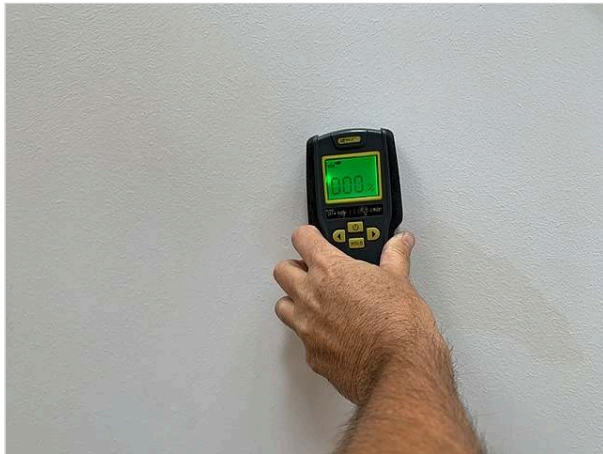
No elevated moisture at larger stain.

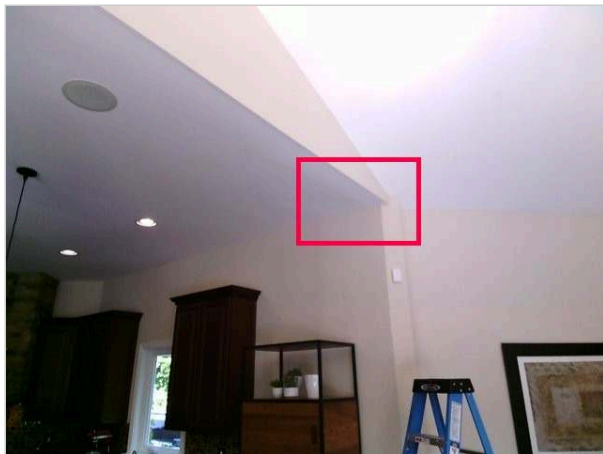
Affected area.

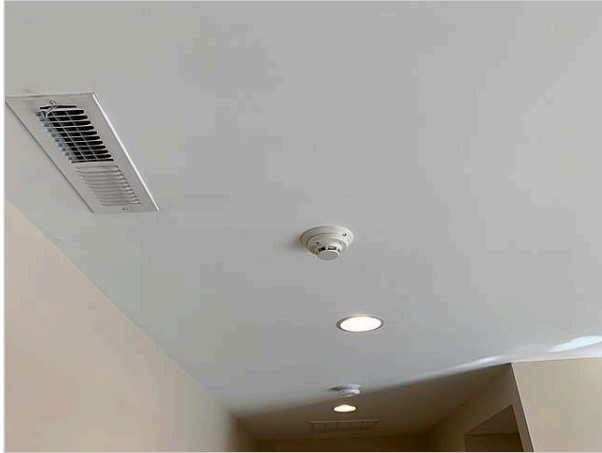
One or more smoke detectors were NOT tested due to their integration into the security system. Testing the alarm may notify emergency services. Recommend checking with the seller as to the operation and functionality of the system. All dwellings should have at least one functioning smoke alarm installed outside each sleeping area and on each level of the structure.

Integrated system, not tested.

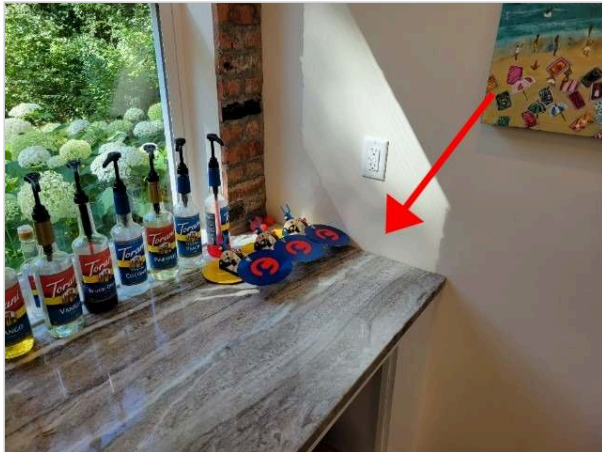
The kitchen counter top does not have an installed sidesplash. The current condition does not protect the walls and unseen areas from moisture damage. Recommend installation of the required splash by a qualified specialist.

No side splash. Basement bar.

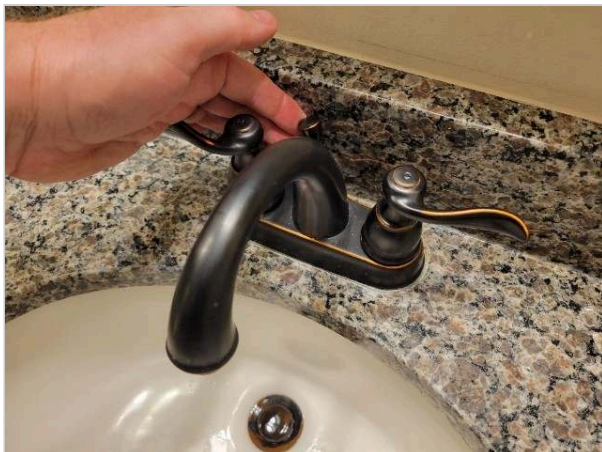
The master bathroom sink drain stoppers are difficult to operate. Recommend repair by a qualified specialist.

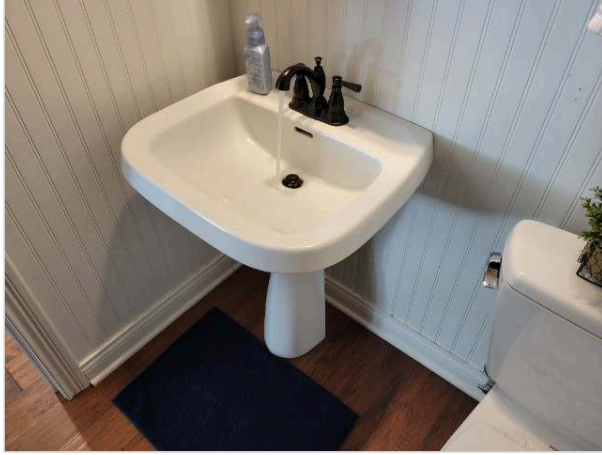
One or more pedestal sinks or bases are not secured or damaged. Recommend repair by a qualified specialist.

Pedestal sink is not secure. 1/2 bath.

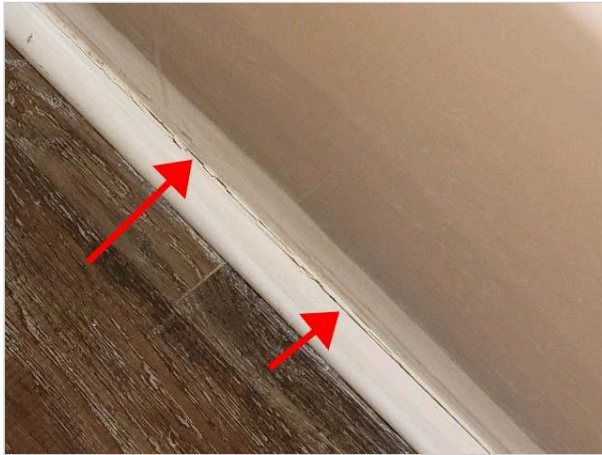
Basement bath.

One or more areas in the bathroom has insufficient sealant. Moisture leaking through unsealed areas can cause structural damage. There may be unseen or hidden damage. Invasive inspection may be required to determine the extent of damage. Recommend repair by a qualified specialist.

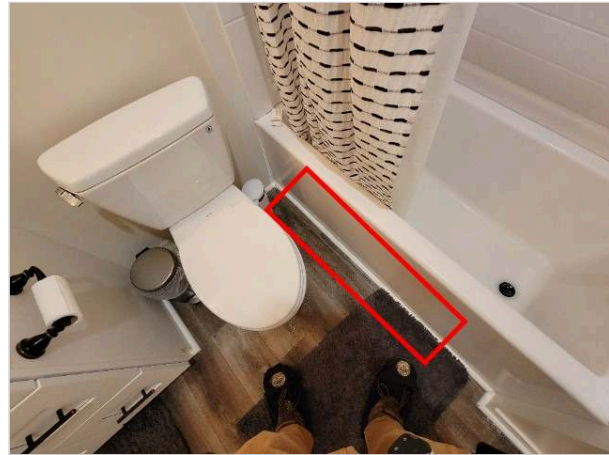
Affected area.

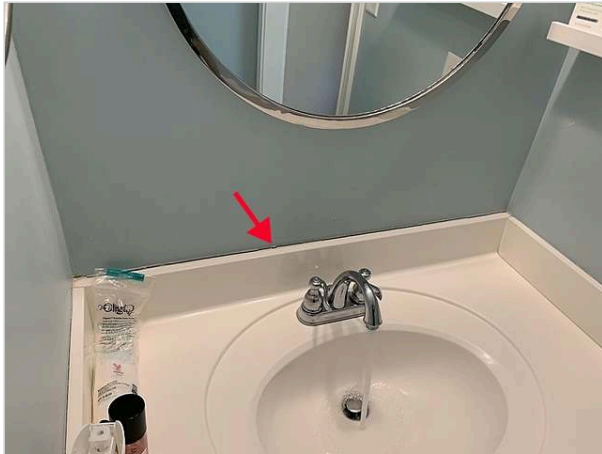
Sealant needed.

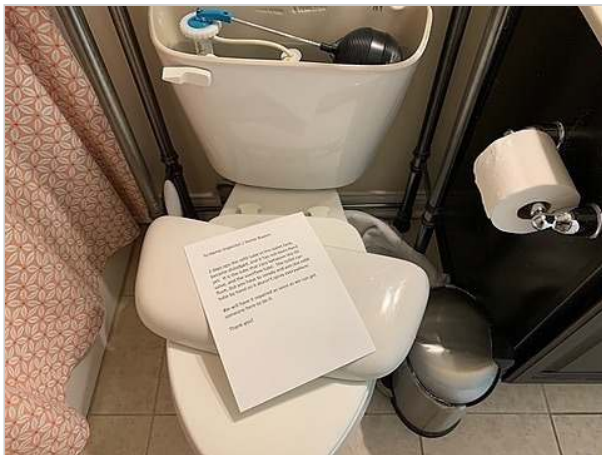
One or more bathroom toilets were not functional at time of inspection. Recommend evaluation and repair by a licensed plumber.

Not tested.

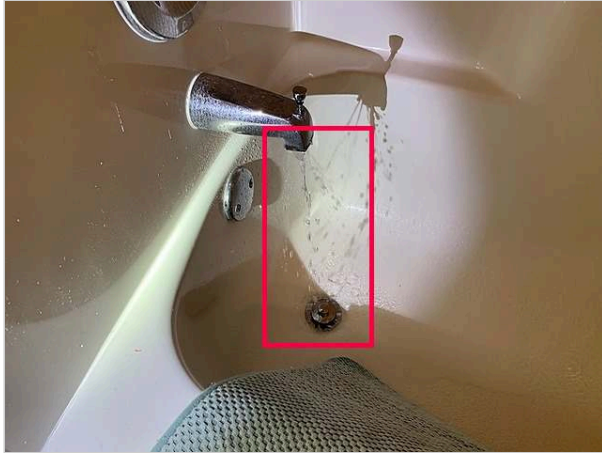
One or more shower diverters appeared to be damaged. The shower diverter changes the direction of water flow from the tub faucet up to the shower head. When the shower head is active and water is still coming out of the tub faucet, the shower diverter is damaged and replacement is indicated. Moisture related damage may be hidden or otherwise undetectable by the inspector at the time of inspection. Invasive inspection may be required to determine the extent of damage. Recommend repair by a licensed plumber.

Damage to diverter.

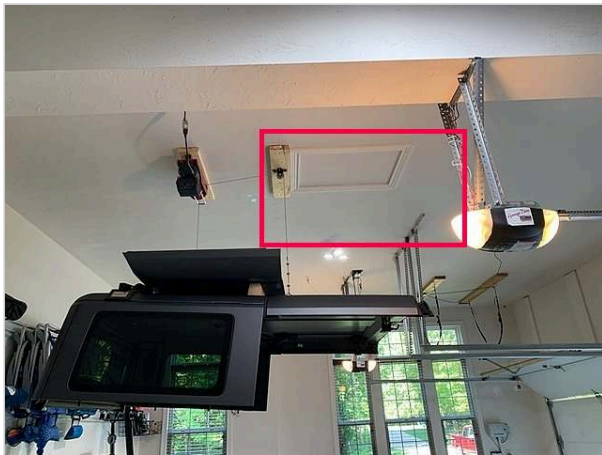
Access to the garage attic was not provided. The attic access opening cover was blocked and the attic could not be inspected. Recommend inspection of the space when access is provided.

Garage attic access blocked.

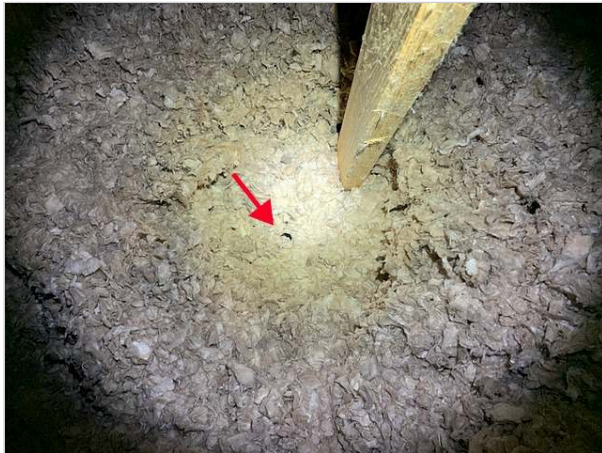
Multiple locations: There is evidence of vermin activity in one or more areas of the structure. Recommend implementation of preventative treatment methods and if needed further evaluation by a licensed exterminator.

Vermin tunnel at attic.

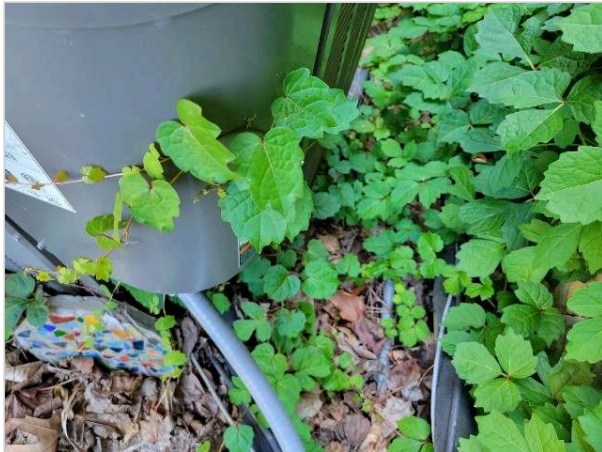
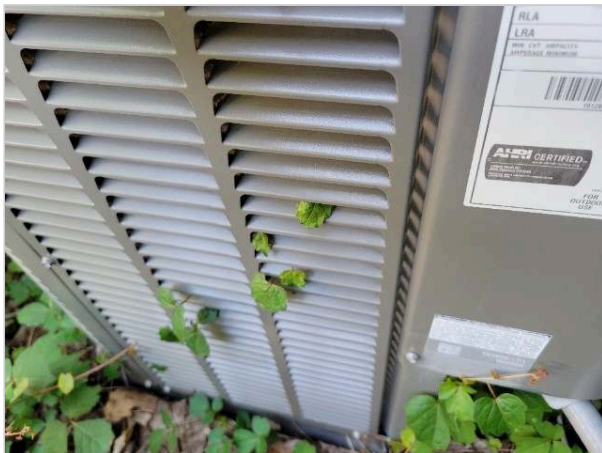
The outdoor portion of both air conditioners has insufficient clearance from nearby vegetation growth. There are vines growing inside the units. This can reduce the efficiency of the unit and may cause damage. A minimum of 12 inches of clearance is recommended. Recommend repair by a qualified specialist.

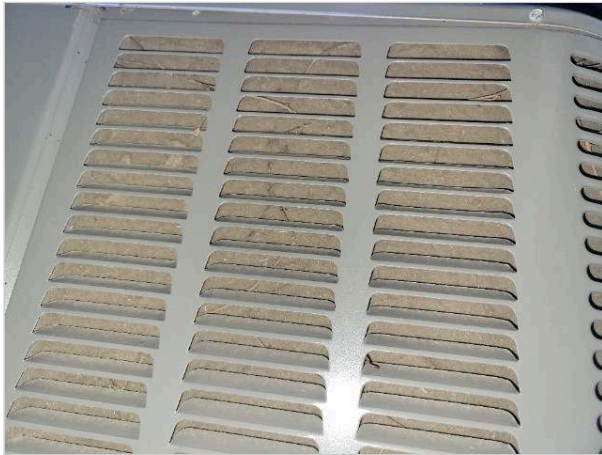
The condensing units are very dirty. Debris buildup can cause system malfunction, premature deterioration of the appliance and loss of energy efficiency. Recommend cleaning by a qualified HVAC technician.

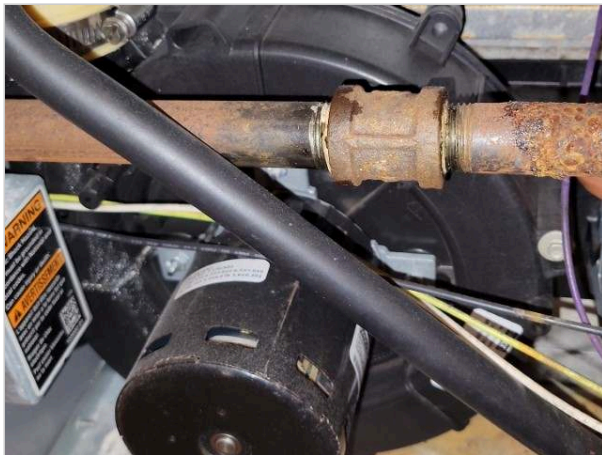
Unit 1

A loud or unusual noise was observed at the furnace during operation that may indicate a damaged component. Recommend evaluation and repair by a qualified HVAC technician.

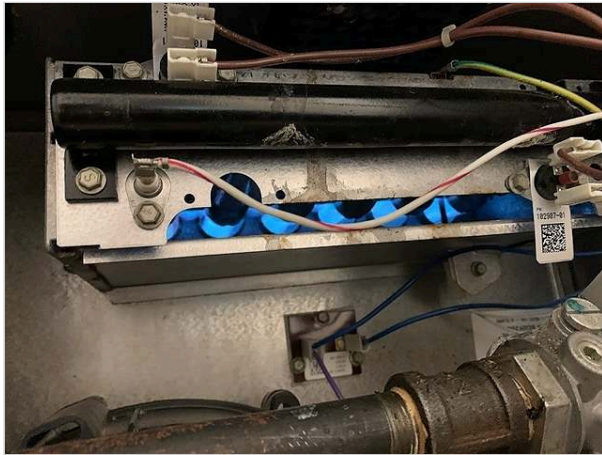
The heating system burners were dirty and need to be cleaned. There is uneven, flickering flames visible when operating the unit. Recommend an evaluation and service of the burners, vents and flues by a qualified HVAC technician.

Unit 2 burners are dirty.

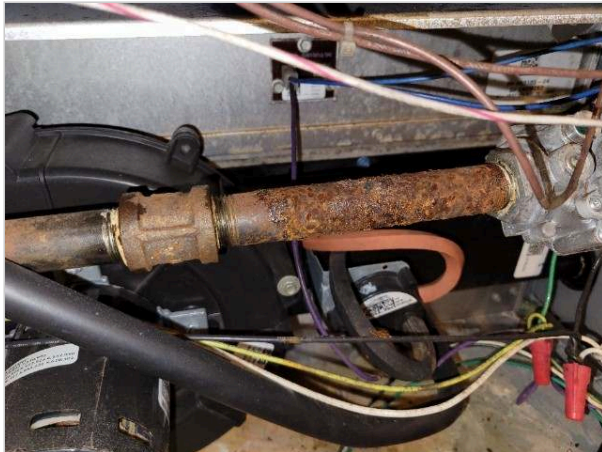
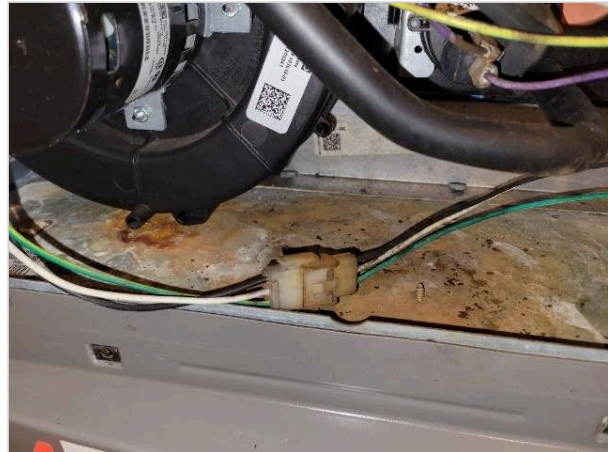
Unit 1

Dry moisture stains or corrosion was observed inside or near the air handler/furnace below the cooling coil. It appears this condition was the result of a previous leak. The defect may have been repaired or may only occur under specific conditions. Recommend evaluation by qualified HVAC technician.

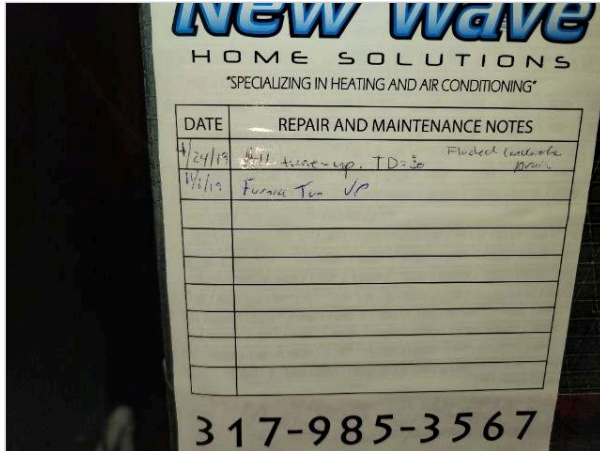
There does not appear to be any visible posted service notes of recent documented service within the last year of the HVAC system. Annual maintenance of all HVAC equipment is vital to prolonged lifespan. Recommend complete evaluation and service by a qualified HVAC technician.

Unit 1 - Last service: 2019

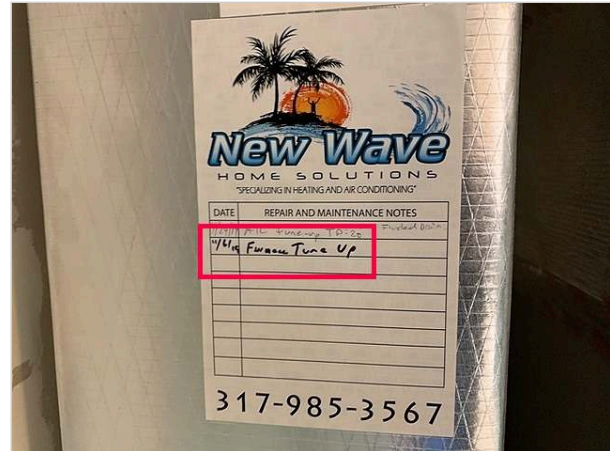
Unit 2, last service 2019.

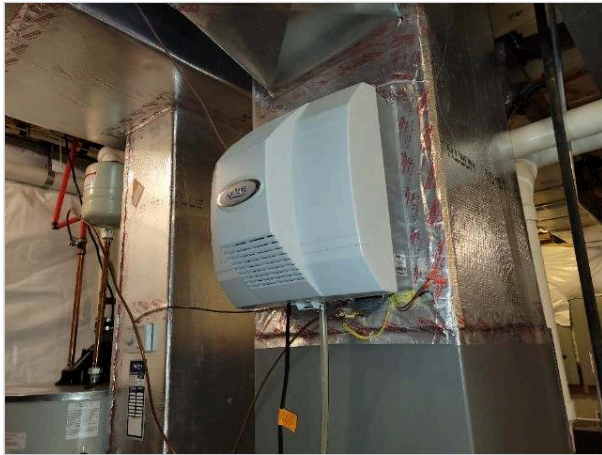
There is a whole-house humidifier system installed. The system was not inspected or tested as it is beyond the scope of the standard of practice. Whole-house humidifiers can be prone to mold growth. The units must be maintained and cleaned regularly. Many styles of humidifiers contain a media pad that should be replaced annually. The average service life of a humidifier is 5-7 years. Recommend asking seller about the operation of the unit and/or evaluation by a qualified HVAC technician.

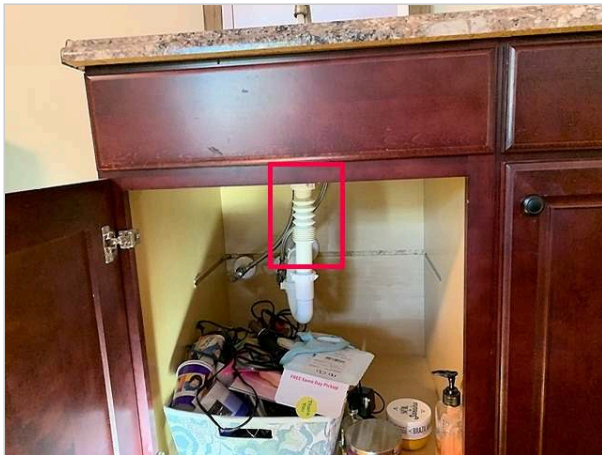
One or more waste drains are constructed of flexible plumbing. Flexible plumbing may obstruct drainage flow and can harbor bacteria. Waste plumbing shall have a smooth interior waterway. Recommend evaluation and replacement by a qualified specialist or plumber.

Flexible plumbing at primary bedroom sink.

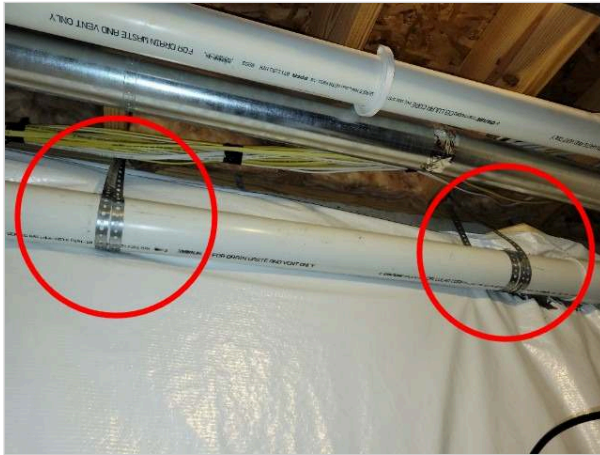
One or more areas of the PVC or plastic waste plumbing has metal straps. Metal or wire straps should not be used to secure plumbing waste drains. Straps may fail to resist upward thrust and lateral movement from water surge and expansion and contraction. The resulting movement may cut and damage the piping. Plastic straps should be used. Recommend replacement by a licensed plumber.

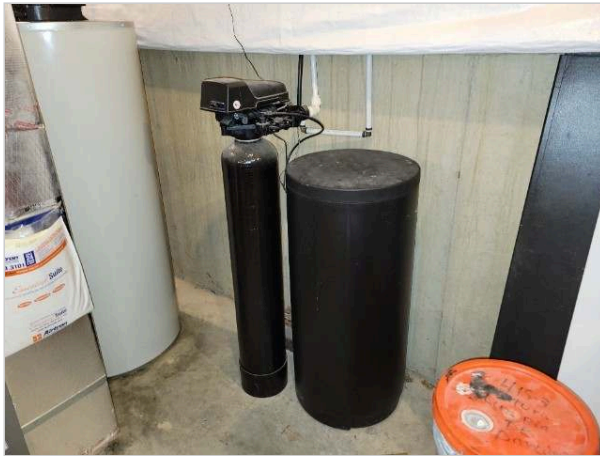
There is a soft-water system installed in the basement. The system appeared to be constantly draining. There may be a defect with the system or setting that needs to be modified. Some of the many benefits of a water softener is increased service life of the water heating system, reduction of mineral deposits, better performance of the dishwasher and general water quality. Testing of the system is beyond the standards of practice of a home inspection. Functionality, operation and adequacy were not verified. For further analysis, recommend evaluation by a licensed plumber or qualified technician.

Softener system in the basement.

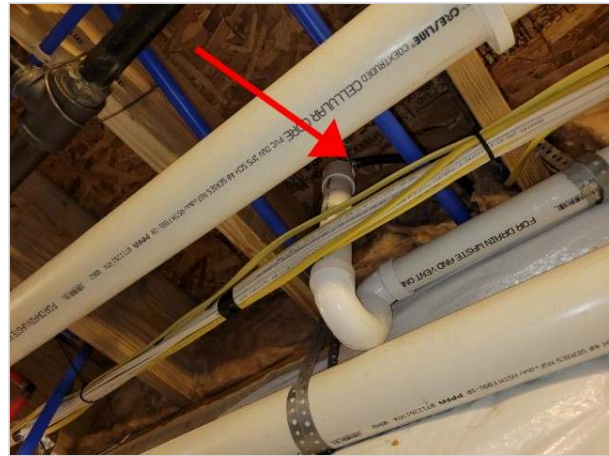
Softener drain.

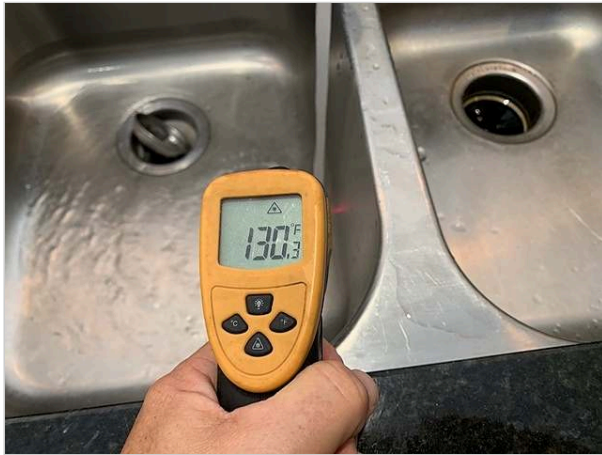
The temperature of the water at one or more fixtures exceeded the recommended setting of 120 degrees Fahrenheit. If the temperature is set too high, accidental burning may occur. Children are burned at a lower temperature than adults. Recommend setting the water heater to 120 degrees for safety by a qualified specialist.

Water temperature too hot at 130.3, kitchen sink.

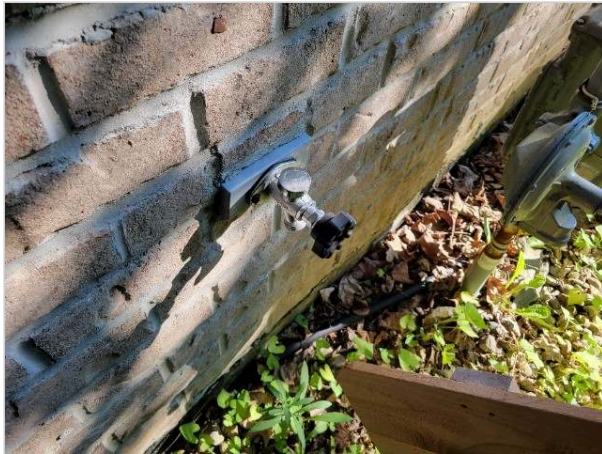
One or more exterior hose bibs were not functional. There may be a defect with the hose bib operation. The water service may also be intentionally turned off for winterizing, if the house is vacant or another unknown reason. Recommend asking the seller about this condition. If indicated, recommend evaluation and repair by a licensed plumber.

Hose bib not functional. SE side, near gas meter.

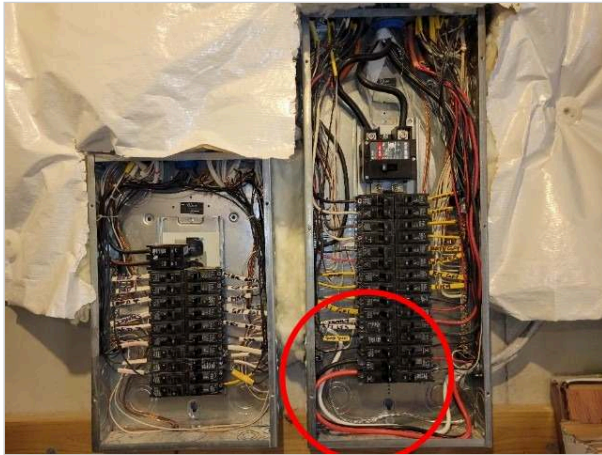
The panel cover is missing an accurate circuit breaker location legend. A location legend is an important safety feature for verification of circuits and to provide quick identification of service disconnects in the event of an emergency. Recommend identification and installation of an accurate circuit location legend by a qualified specialist.

100amp breaker in large panel is not identified.

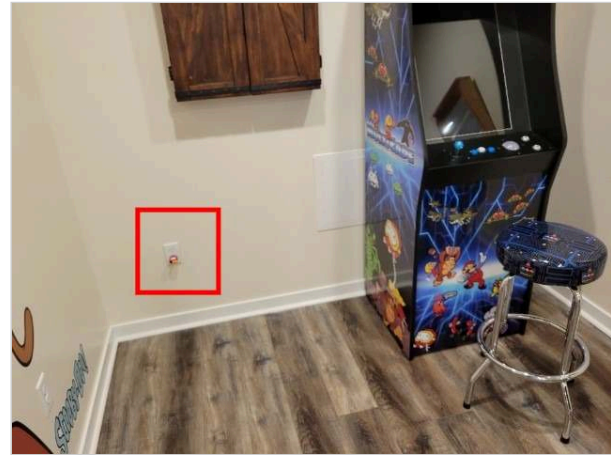
There are one or more outlets that are damaged, loose or not functional. This condition could lead to electrical shock. Recommend evaluation and repair by a licensed electrician.

Outlet not secure. Basement.

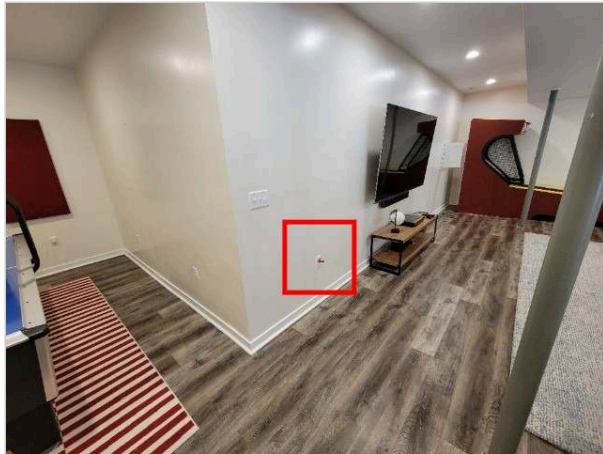
Outlet not secure. Basement.
