**Property Address:** Avon, IN 46123

Extended Full Home Inspection  
Radon Testing, Pool Inspection

### Extended Full Home Inspection

**Service Date:** 7/11/2023

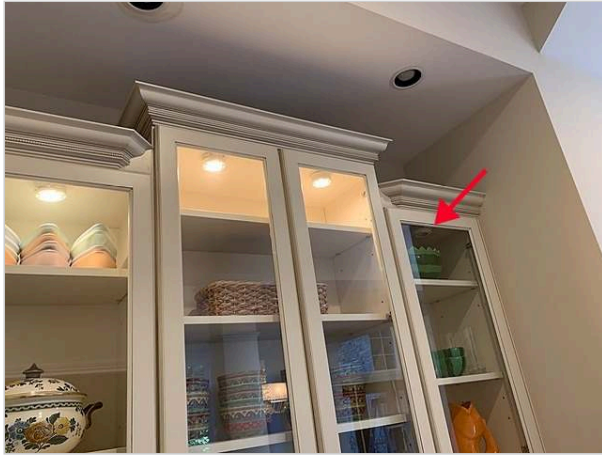
There are one or more light(s) in the structure that did not illuminate when operated. This condition could be simply a light bulb that is burnt-out or another condition that could not be identified by visual inspection. Repair or replacement is recommended by a qualified specialist.

Light not functional.

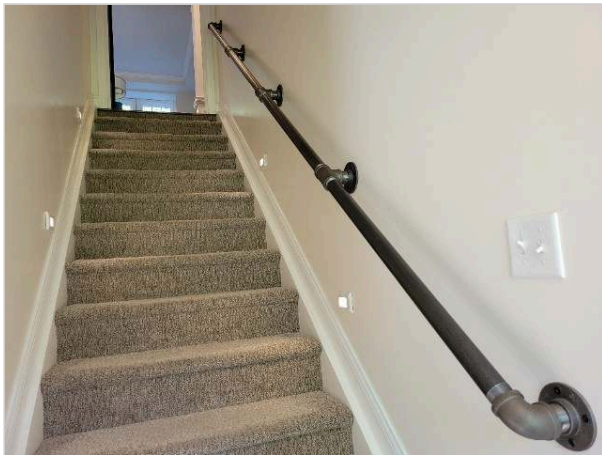
All stairway handrails should be continuous within the full length of each stair flight. The basement custom handrail is secured to the wall in several locations. This requires occupants to release their grip on the handrail temporarily. Recommend evaluation and if indicated, repairs or replacement by a qualified contractor.

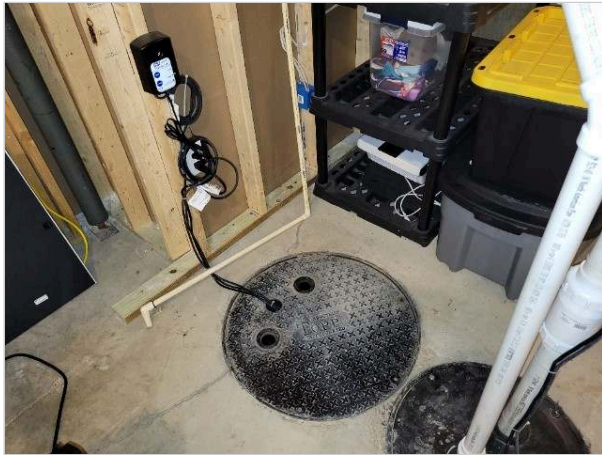
There is a sump pit with a sump pump in the basement. The installed sump pump was tested for functionality and appeared to be functional at the time of inspection. There is no battery backup system installed. In the event of a power loss, the sump pump will not be functional. Overflow of the sump pit may create substantial damage to surrounding building materials. Recommend installation of a battery backup system by a qualified specialist.

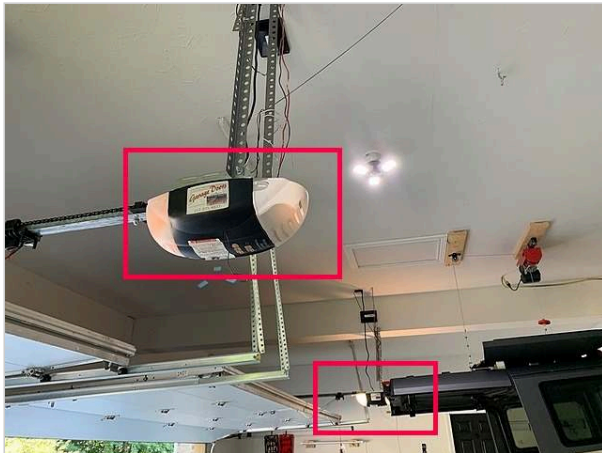
One or more garage door opener's auto-reverse function is damaged or needs adjustment. When an overhead garage door is closing, a built-in sensor should detect any resistance. If an object is in the path of the door, the door should stop and reverse. This safety feature has been standard on all garage door openers manufactured since 1991. Many automatic openers allow for the adjustment of the sensitivity of this feature. If the affected opener does not, it should be replaced. Recommend evaluation and repair by a qualified overhead garage door specialist.

Both units: Safety reverse feature not functional.

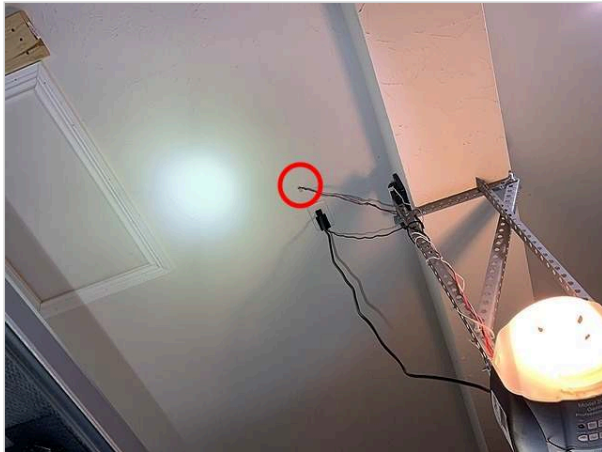
One or more areas of the garage fire-separation wall is inadequate or damaged. The ceiling and any walls between the attached garage and the interior shall be covered with drywall, a fire-resistant material. Drywall seams shall be tapped and mudded. Large holes should be repaired and all smaller gaps should be sealed with a fire-rated caulk. The fire-separation wall must resist the free passage of flames and the products of combustion for safety. Recommend repair by a qualified specialist.

Area needs sealed with fire rated caulk.

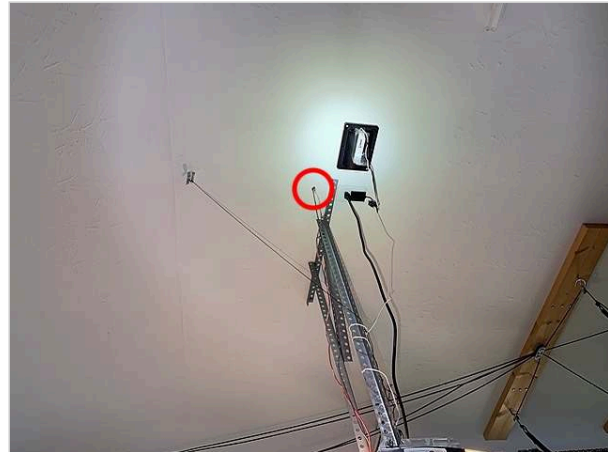
Area needs sealed with fire rated caulk.

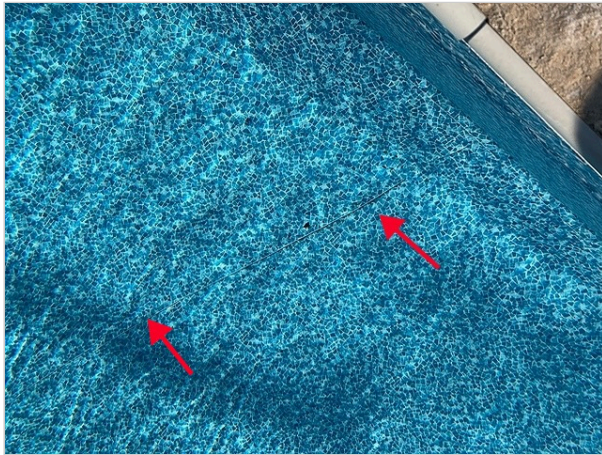
Pool liner wrinkles and gaps in the liner fit have been found. Pool liner wrinkles can happen for a number of different reasons. They can develop suddenly, or slowly over a long period of time. Wrinkles can also happen when the liner is first installed if the liner is not measured correctly, manufactured correctly or it is oriented poorly during the installation. In most cases this is not an immediate concern. However these areas can be prone to developing holes since they are physically raised above the surface of the pool. The areas found in this pool appear functional and recommend monitoring these areas for leaks or further wrinkle development. For further information, recommend evaluation by a qualified pool install contractor.

Wrinkle at liner.

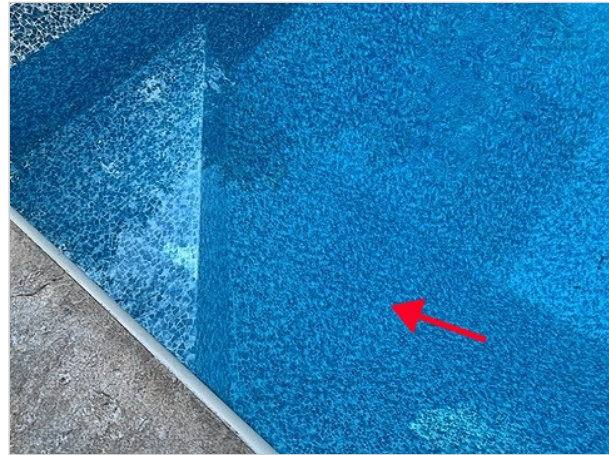
Wrinkle at liner.

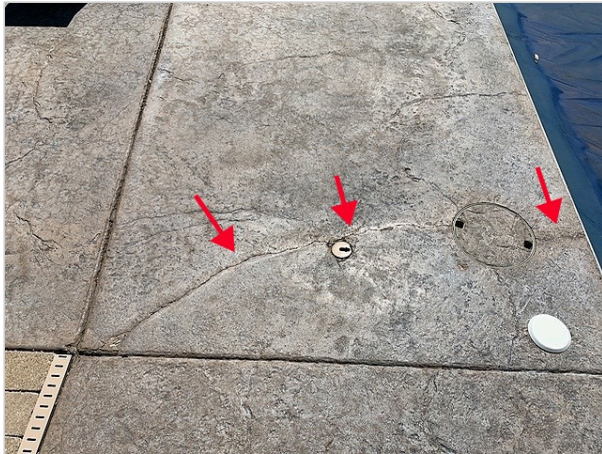
One or more areas of the concrete is cracked. All concrete is subject to cracks and chips. Most cracks are a natural cause of being exposed to the elements and simple settling. Larger cracks may be a sign of improperly compacted soil, faulty foundation or construction methods, or excessive moisture exposure. Recommend evaluation and repair by a qualified specialist.

Minor crack at pool sump pit.

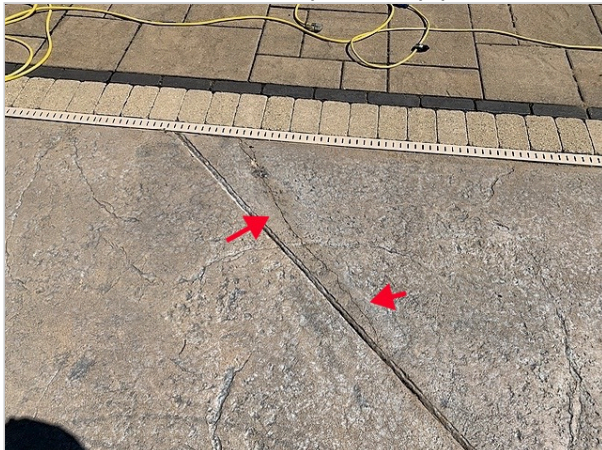
Minor crack at deck surface.

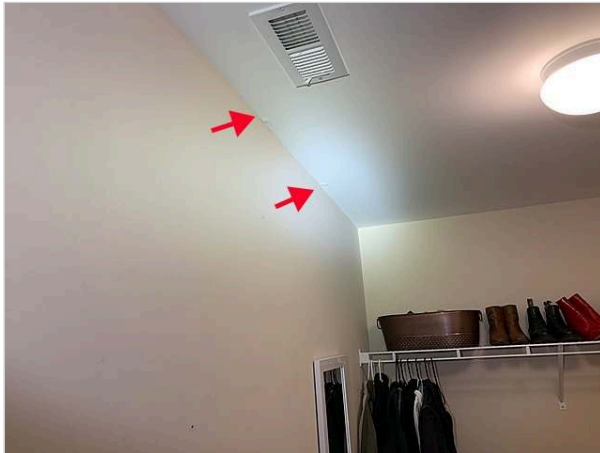
Nail pops at upper bedroom closet.

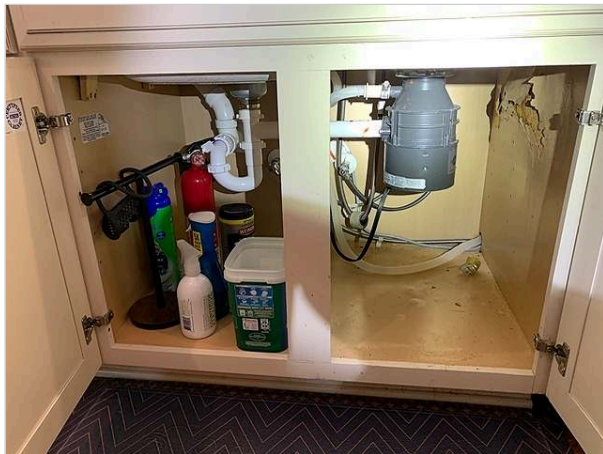
*The bottom of the sink base cabinet is stained, warped, damaged or missing likely due to a current or past plumbing leak or cleaning chemical spill. There may be unseen or hidden damage. Invasive inspection may be required to determine the extent of damage. Recommend evaluation and repair or replacement by a qualified specialist.*

Stored items under the sink may limit the view for inspection. An unknown condition may exist. The areas that were visually clear appeared to be functional.

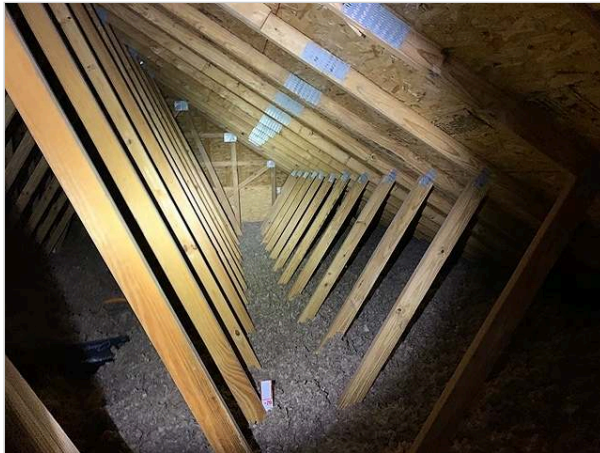
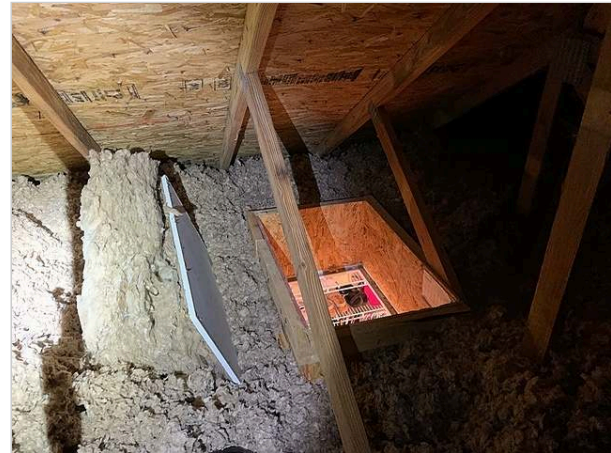
Yes - Vermin Activity

*Multiple locations: There is evidence of vermin activity in one or more areas of the structure. Recommend implementation of preventative treatment methods and if needed further evaluation by a licensed exterminator.*

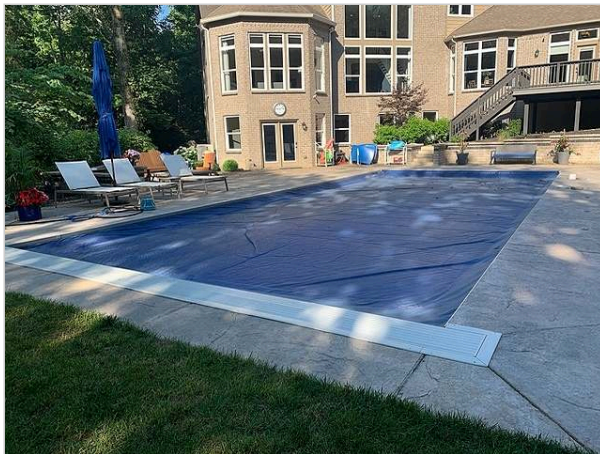
Maintenance - Liner Wrinkles

The installed pool is a concrete poured, vinyl lined pool. Vinyl is the more popular option as it comes with the smallest upfront cost. Additionally, you can customize a vinyl pool liner to any shape and size you want. And this type hinders algae growth. Vinyl pool liners have a higher lifetime cost as replacement and/or repairs are much more common. They're also more susceptible to damage. The service life of a vinyl liner is up to 10 years.

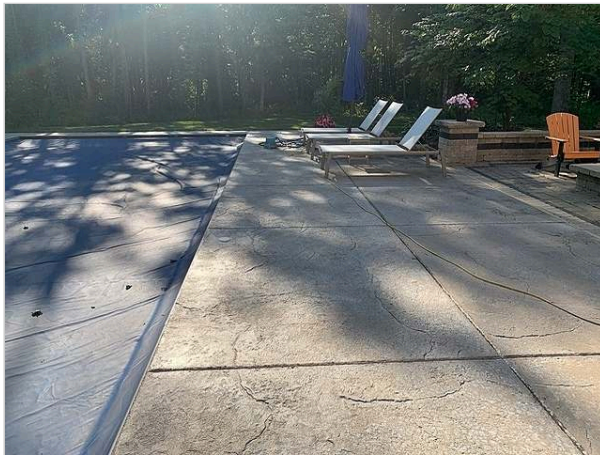
*One or more areas of the concrete is cracked. All concrete is subject to cracks and chips. Most cracks are a natural cause of being exposed to the elements and simple settling. Larger cracks may be a sign of improperly compacted soil, faulty foundation or construction methods, or excessive moisture exposure. Recommend evaluation and repair by a qualified specialist.*

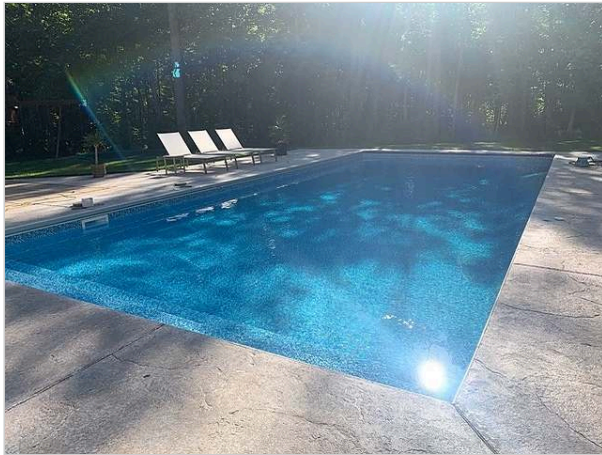
Open and safety close functional.

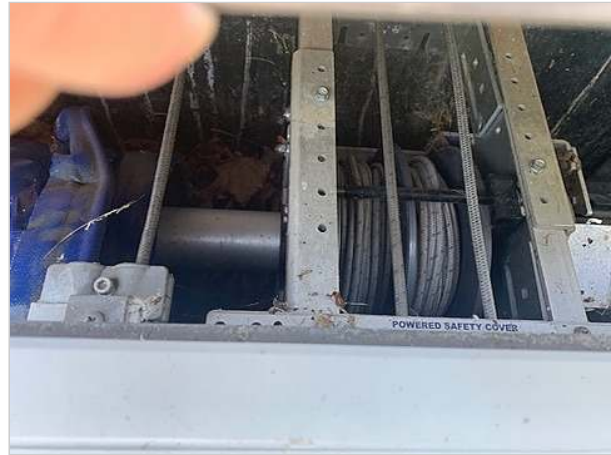
Ropes satisfactory.

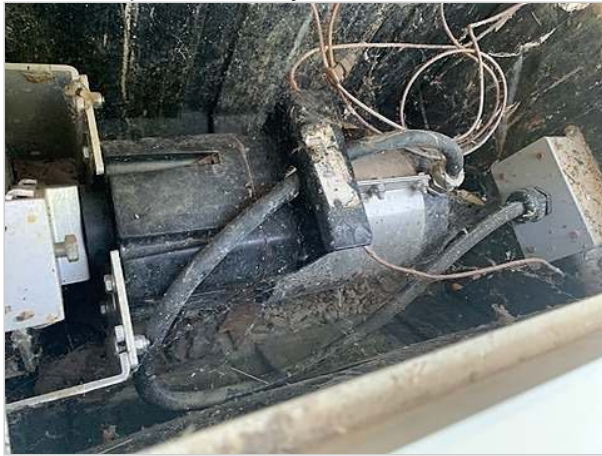
Motor housing satisfactory.

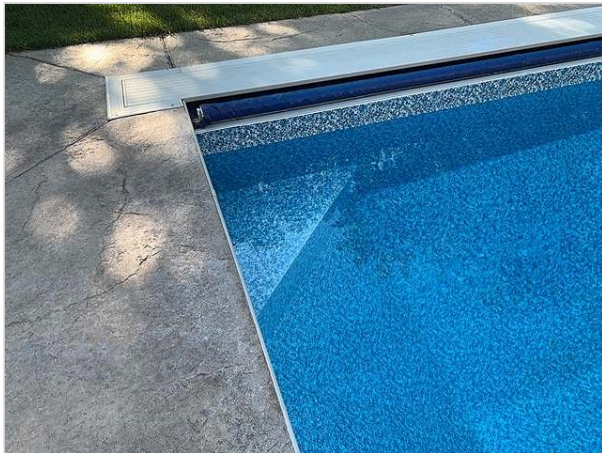
Step at deep end, steps at shallow.

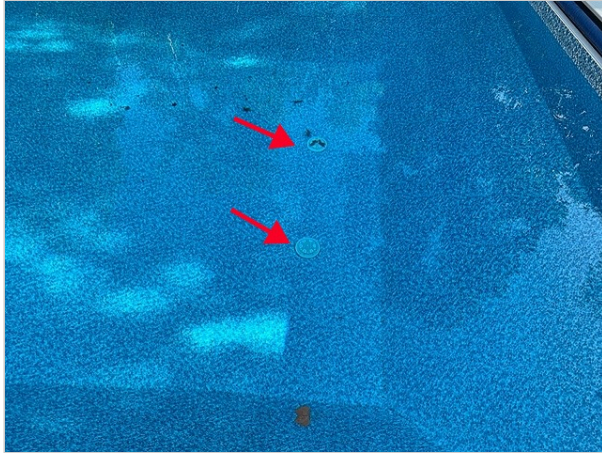
Drain covers.

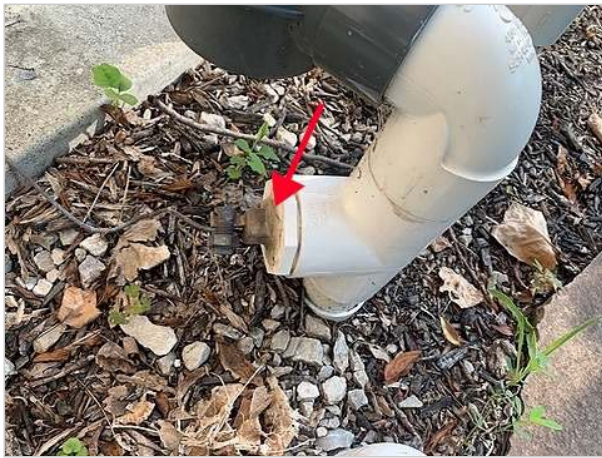
Bonded to pool.

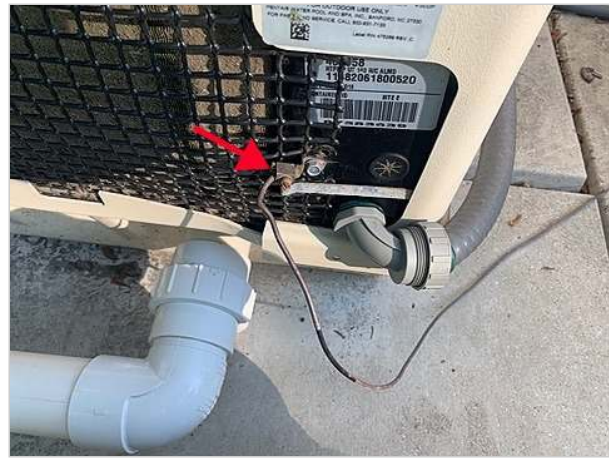
Bond at heater.

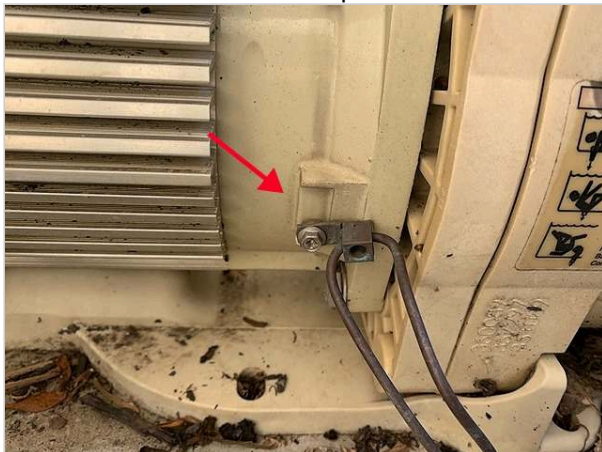
Bond at pump.

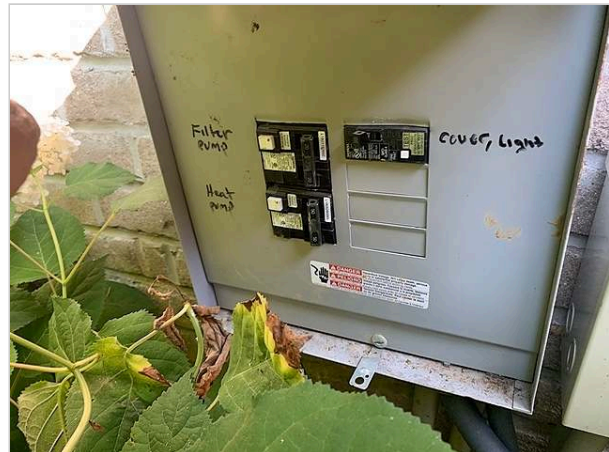
GFCI breakers.

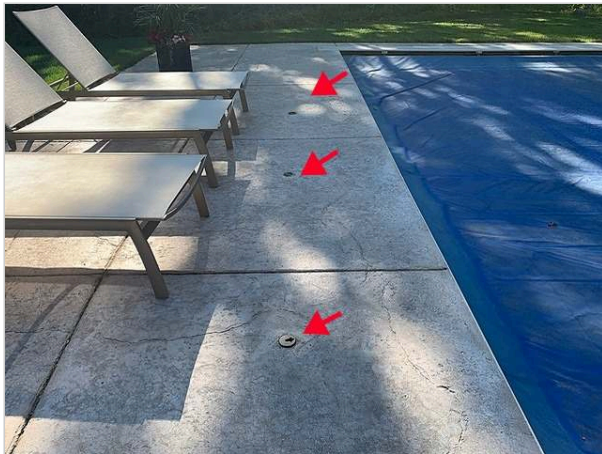
Installed not tested.

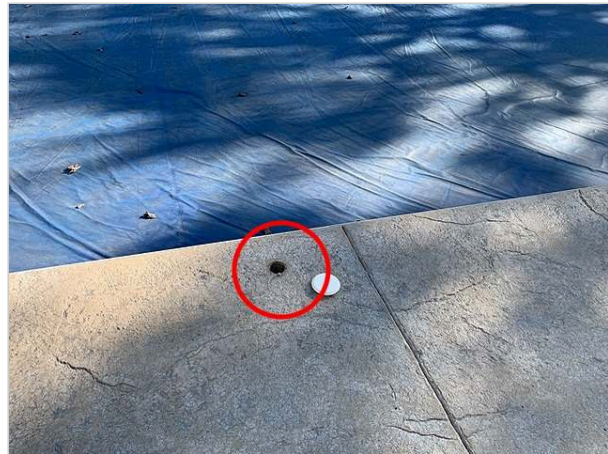
Recreational anchors installed.
