**Service:** Full Home Inspection

Site Address: **Quality Drive, Vacaville, CA, 95688**

Service Date And Time: **August 31, 2026 At 10:00 AM**

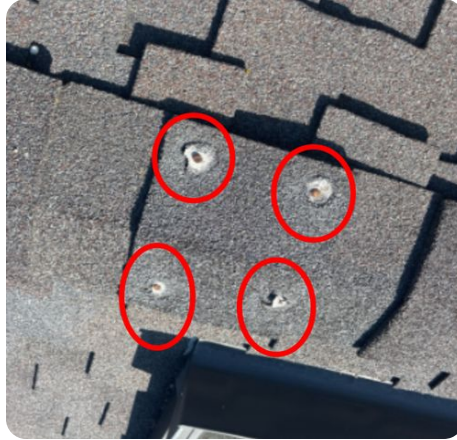
Exposed nail heads were observed at the ridge shingles and caps and it is recommended that the nail heads be sealed by a qualified roof professional to prevent moisture intrusion.

Exposed nail heads at ridge shingles.

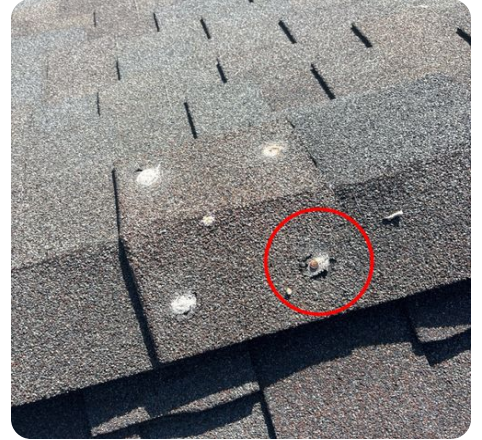
Exposed nail heads at ridge shingles.

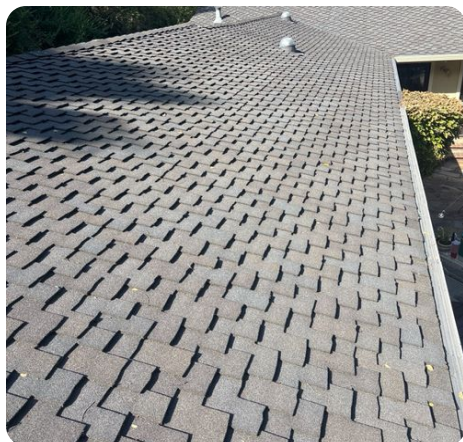
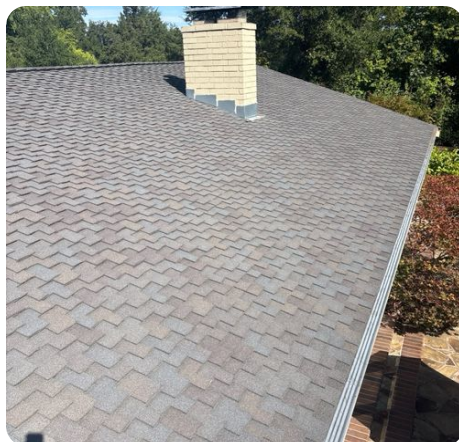
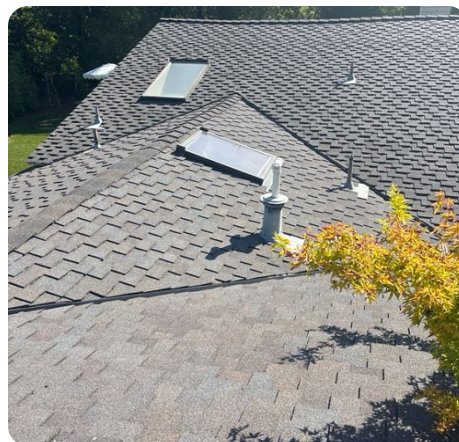
The roof surface is composed of a composition shingle product of an undetermined age and it is recommended that the current homeowner be consulted regarding the actual date of installation if known. The roof surface displayed signs of age and wear in the form of granulation loss. Service life expectancy depends on the thickness and grade of the shingle, the pitch of the roof surface, and the amount of weather exposure the material is subjected to. Mechanical damage from tree branches and foot traffic also contributes to the wear placed on the roof surface. The concealed nature of the installation process prevents verification that the installation was completed to the manufacturer's specifications or local building standards.

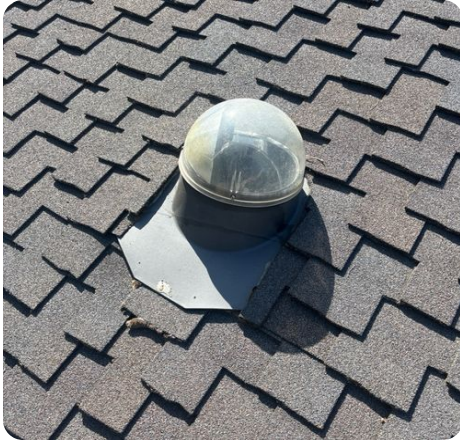
Functional tubular skylight as viewed from roof surface.

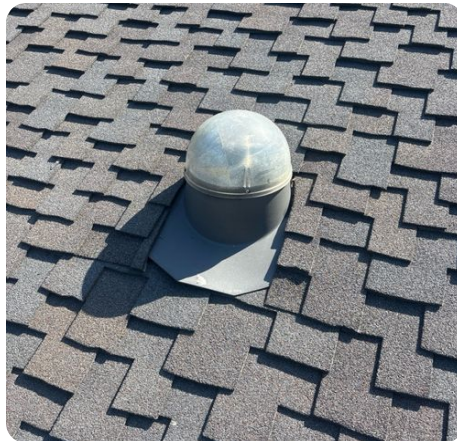
Functional tubular skylight as viewed from roof surface.

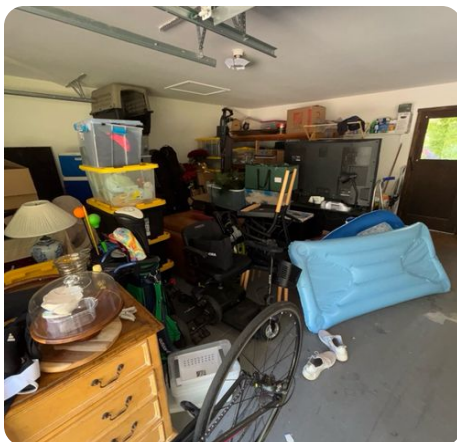
The garage contained stored personal items at the time of the inspection which may obscure a concealed condition. Further evaluation of the garage once the home has been cleared of stored personal items is recommended.

Stored personal items within garage at time of inspection.

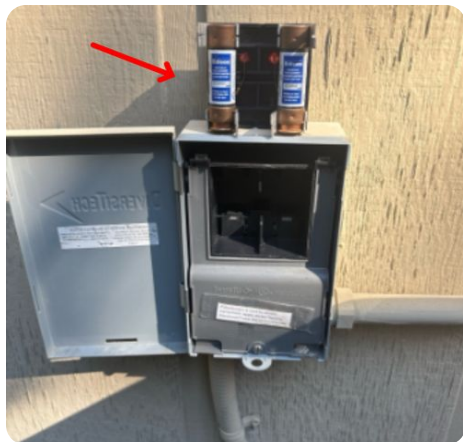
Appropriately sized condensing unit cartridge fuses at service disconnect.

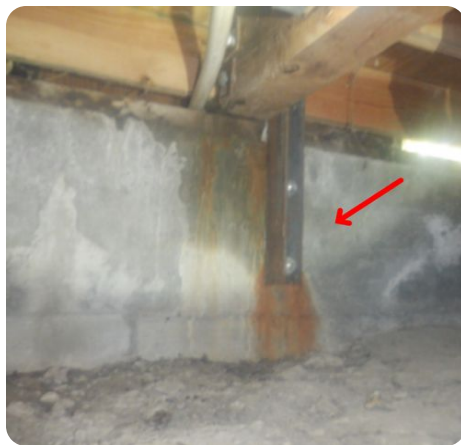
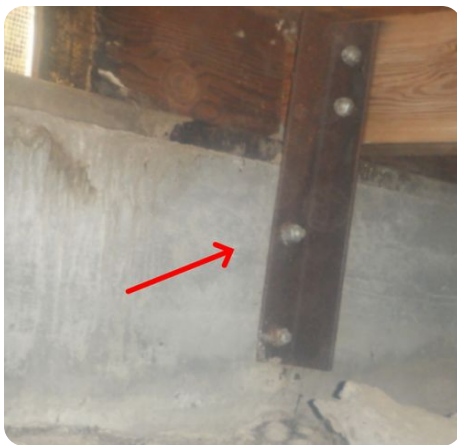
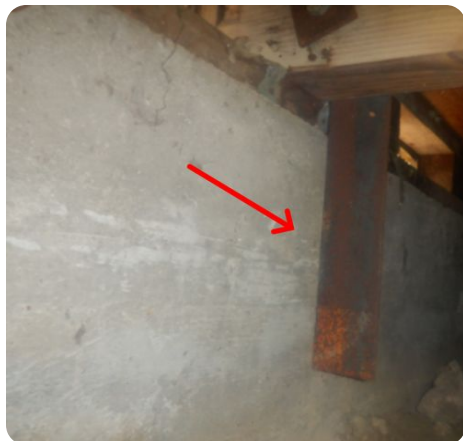
The home is structurally supported by a perimeter concrete foundation, concrete stem walls, and wooden posts installed upon concrete piers and footings. Sill plate anchors were verified to be in place. Supplemental angle iron straps securing the foundation and framing have also been installed.

Supplemental angle iron straps securing foundation and framing.
