Property Address: 506 Madison Ave, Brentwood, NY 11717

Inspector: Santo Guinta
Company: Brookhaven Home Inspections, LLC
dba WIN Home Inspection Long Island
(631) 874-0011
wininspection.santo@gmail.com

Standard Full Home Inspection

Work Order Number: 022121SG

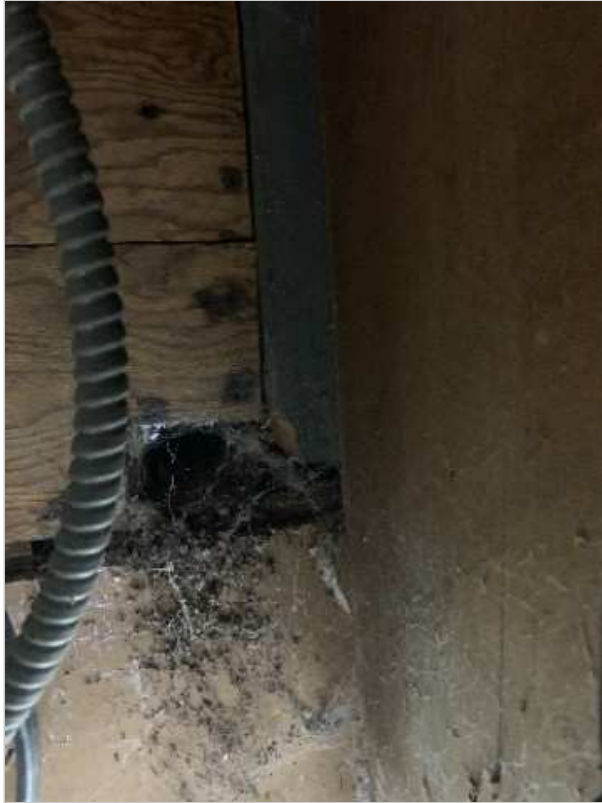
rt side electrical box

hole next to electrical box shows rodent tunnel

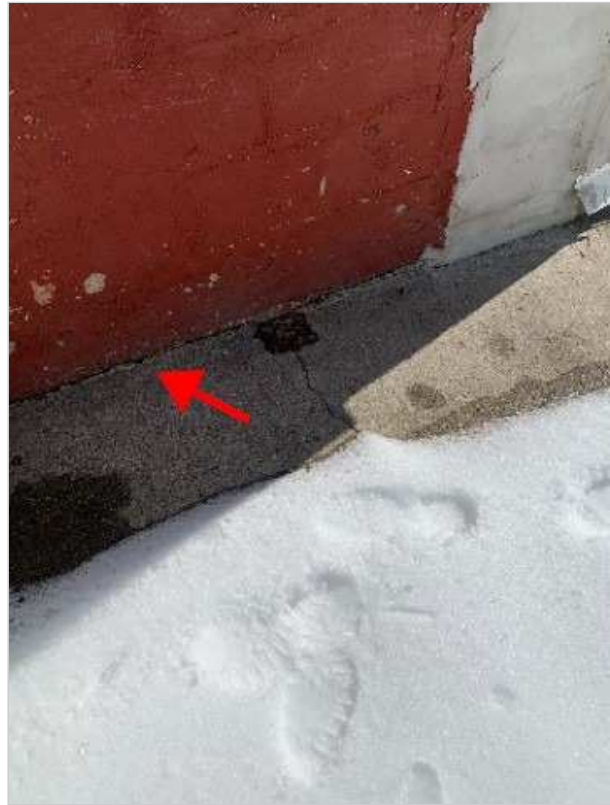
back

There was a crack with about a 1/4 inch in size. Recommend having the crack patched and sealed as well as any others along the walls and floor. Recommend questioning the seller on any related issues. Suggest contacting a contractor for estimates and evaluation of repair.

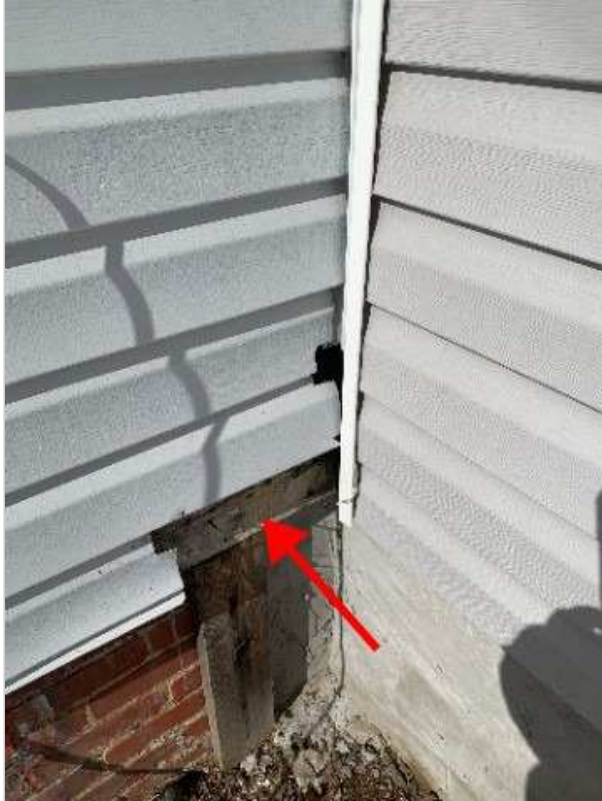
missing siding exposing wood

Replacing the damaged and/or missing siding is recommended to prevent potential moisture penetration from occurring. Recommend having a contractor evaluate and repair/replace as needed.

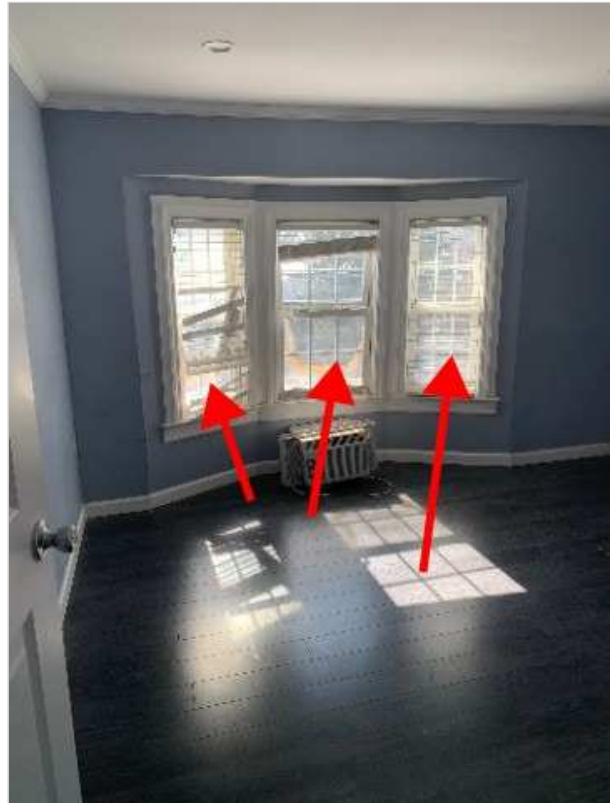
master bedroom front

The inspection has identified a double pane insulating window that has lost its vacuum seal between the panes of glass. The condition is identified by signs of fogging or condensation build up in between the glass panes. This condition will reduce visibility out of the window over time. The condition reduces the insulating value only slightly. Replacing the window glass may be considered at some time in the future as the visibility out the window reduces.

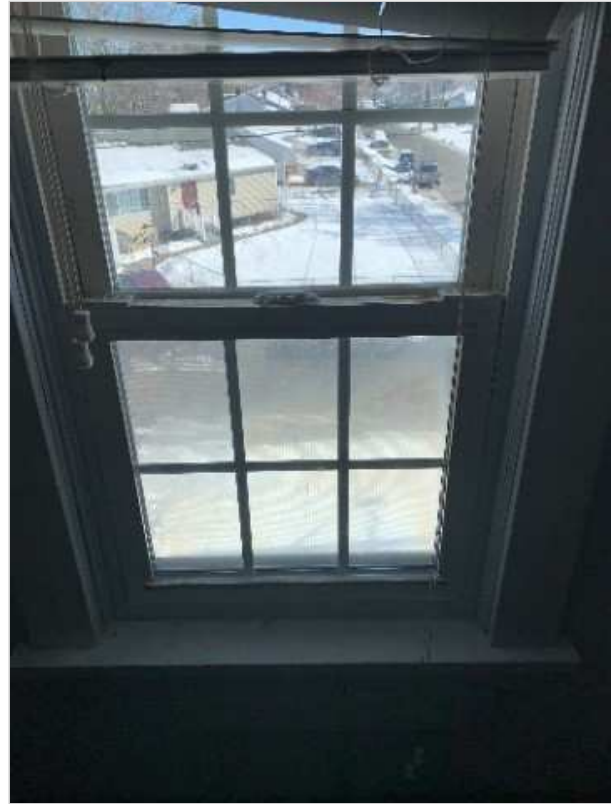
right side top floor

Many windows through out the house do not stay raised in place. It appears that the sash cords are in need of replacement/repair. Contacting the window manufacturer is recommended.

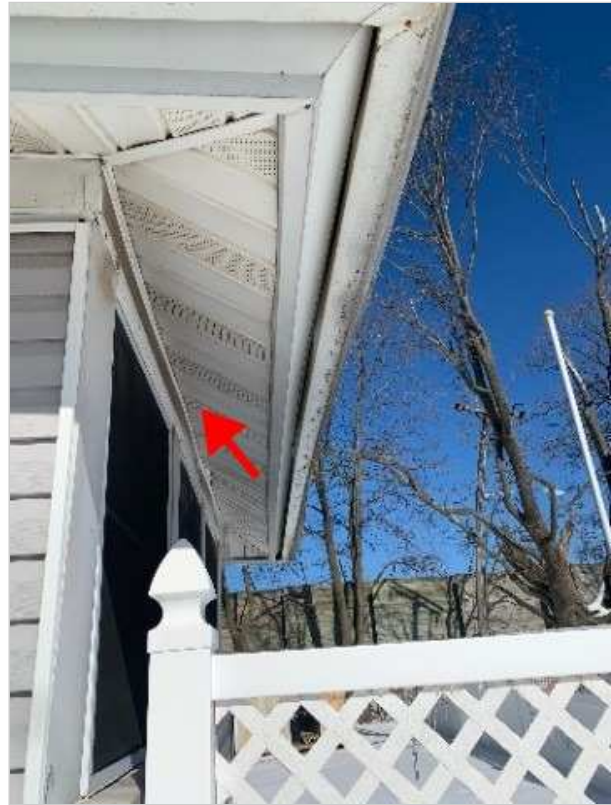
The inspector has noted a wood deterioration on the eave/soffit areas around the structure. Recommend repairing as required.

pulling away from house

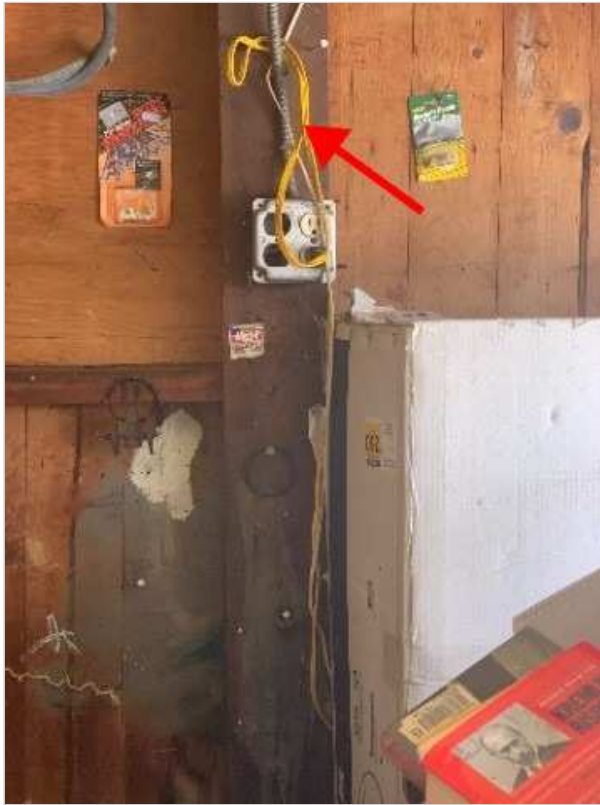
garage opener should have its own electrical outlet not extension cord for power

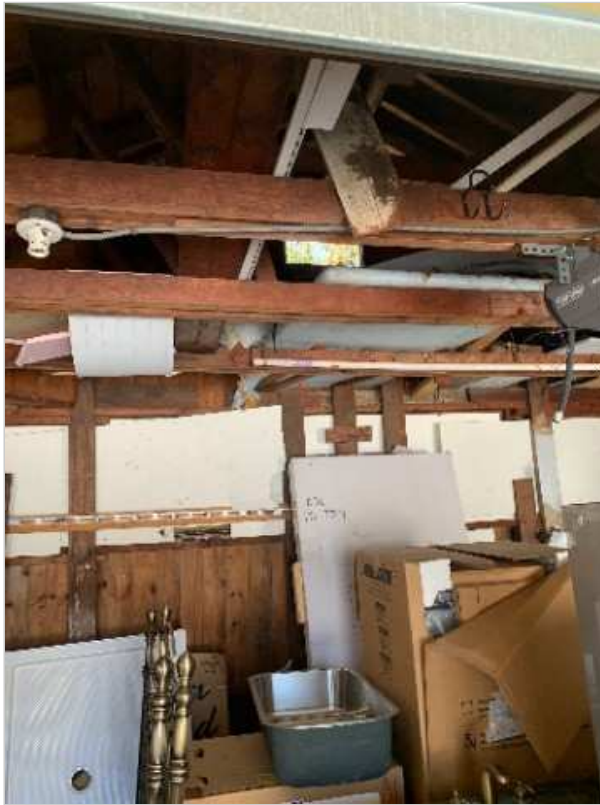
The accessible areas of the garage floor appeared to be functional at the time of the inspection. There were many areas that were inaccessible to inspection due to the large amount of stored items in the garage (cluttered condition). A condition may exist that was not visible at the time of the inspection. Reinspecting the garage area is recommended as issues may become visible once the structure is vacated.

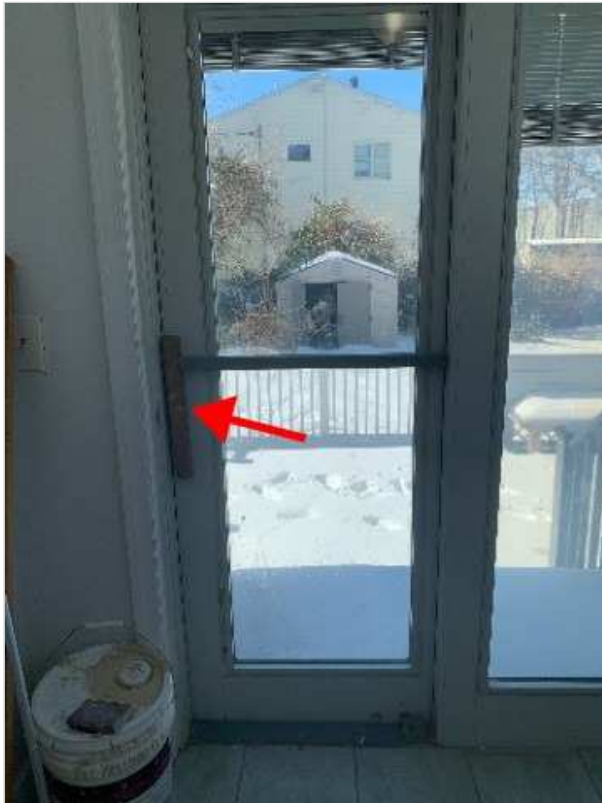
could not be opened closed shut with wood

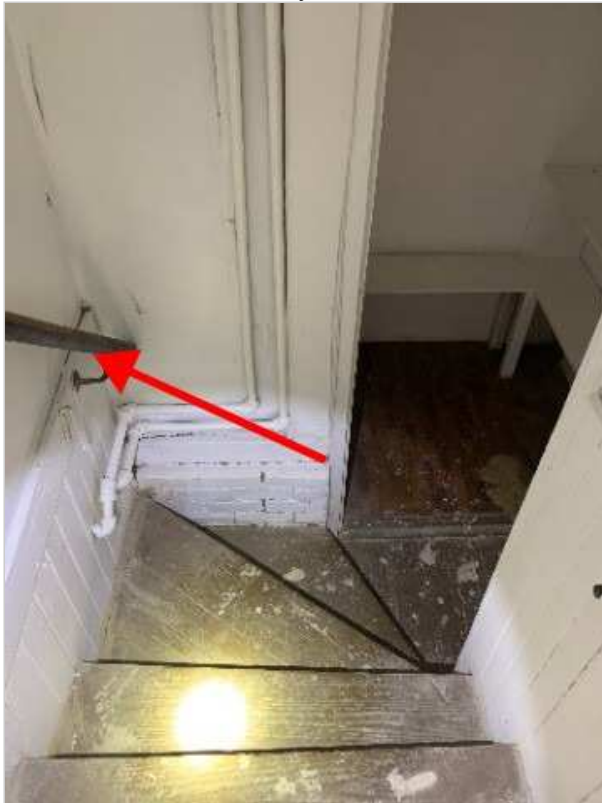
second set of stairs to basement are narrow and have no back plate recommend contractor evaluate

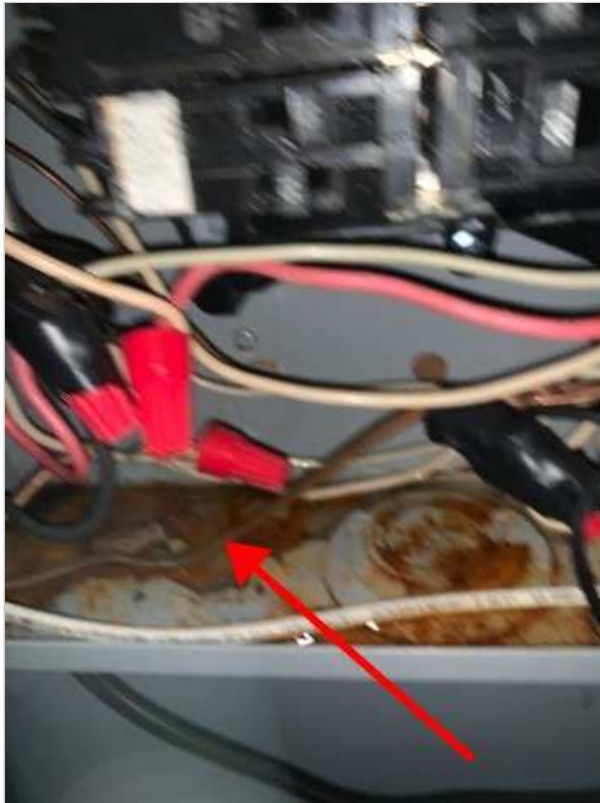
inside panel shows moisture recommend electrician evaluate

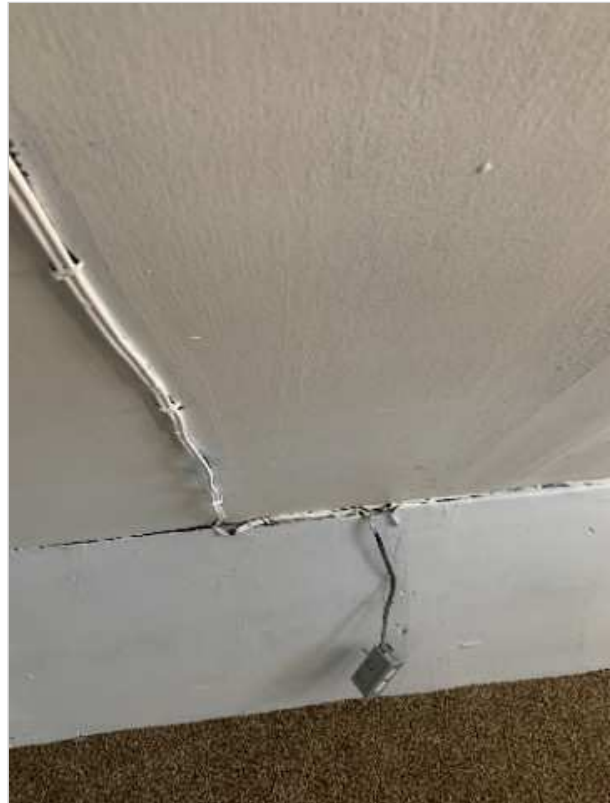
exposed wire and outlet box

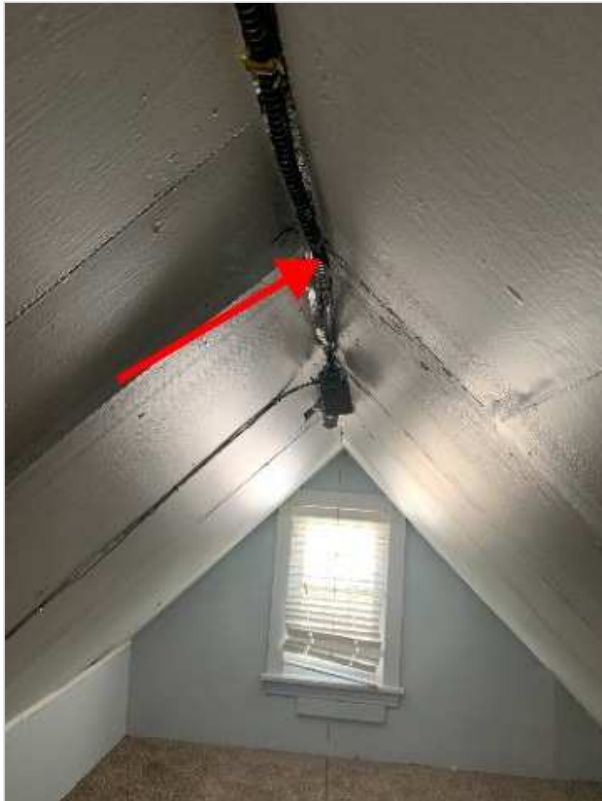
exposed wire

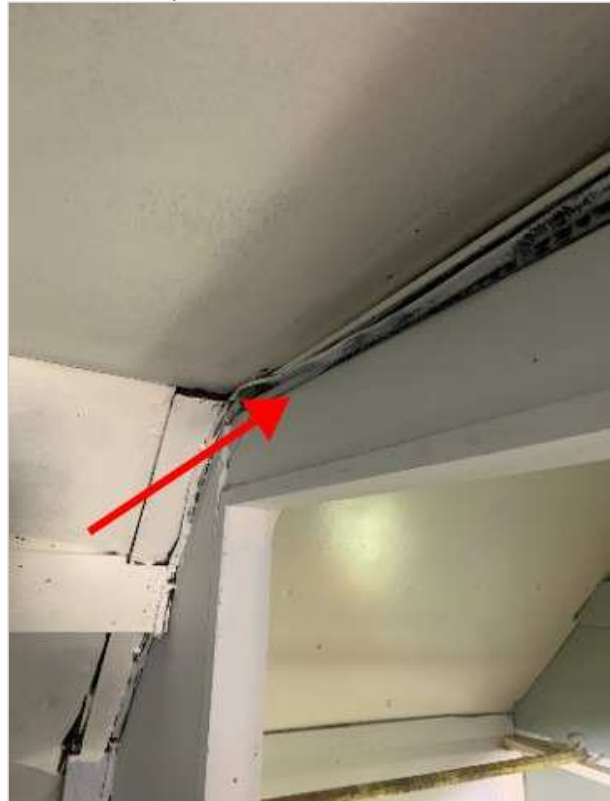
exposed wire before attic closet

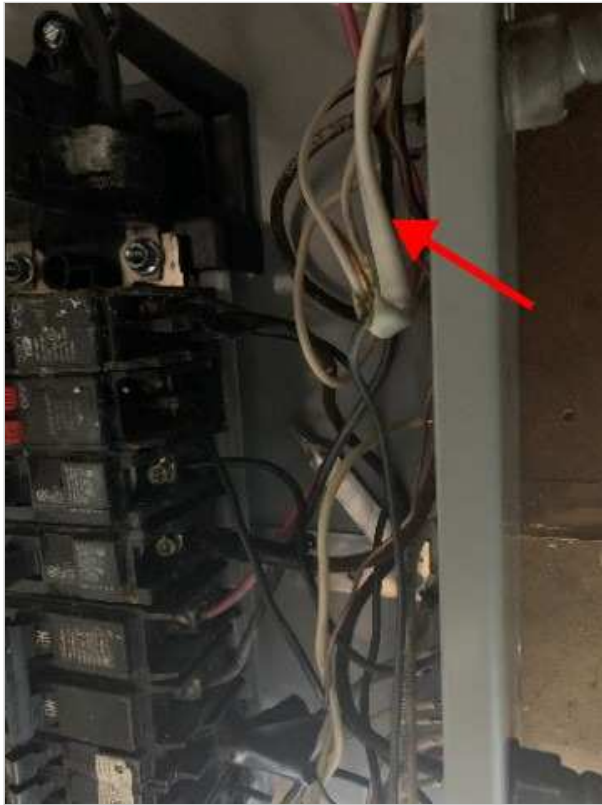
wire not unsheathed and no electrical nut
connecting to panel

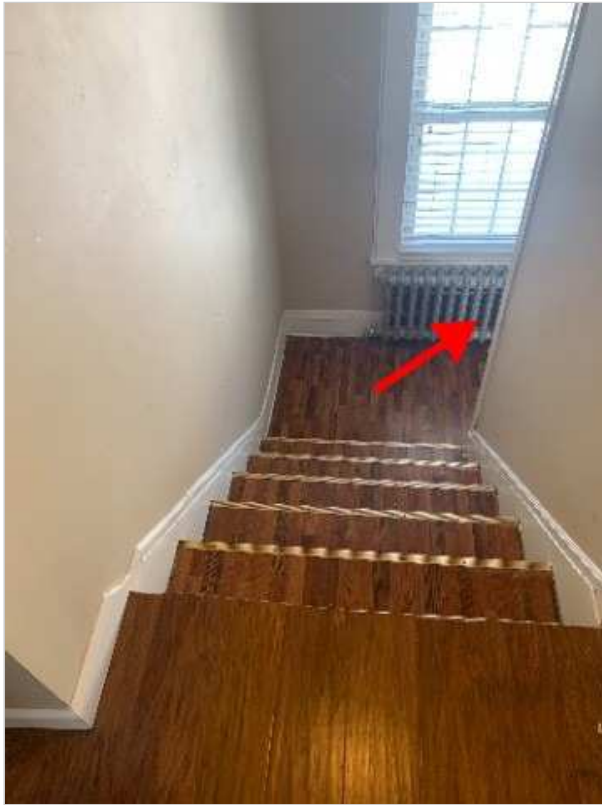
stairway radiator

many of the baseboard and radiator did not respond when heat was tuned up and exposed piping to baseboard

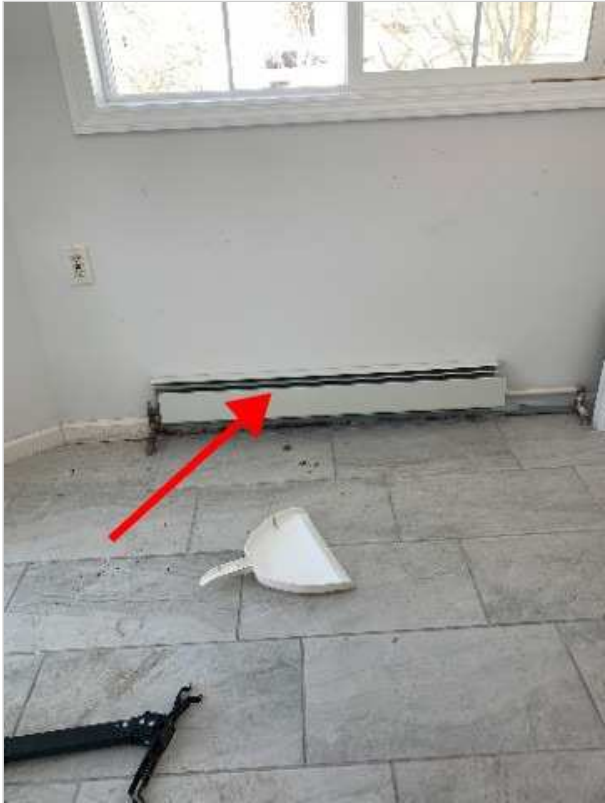
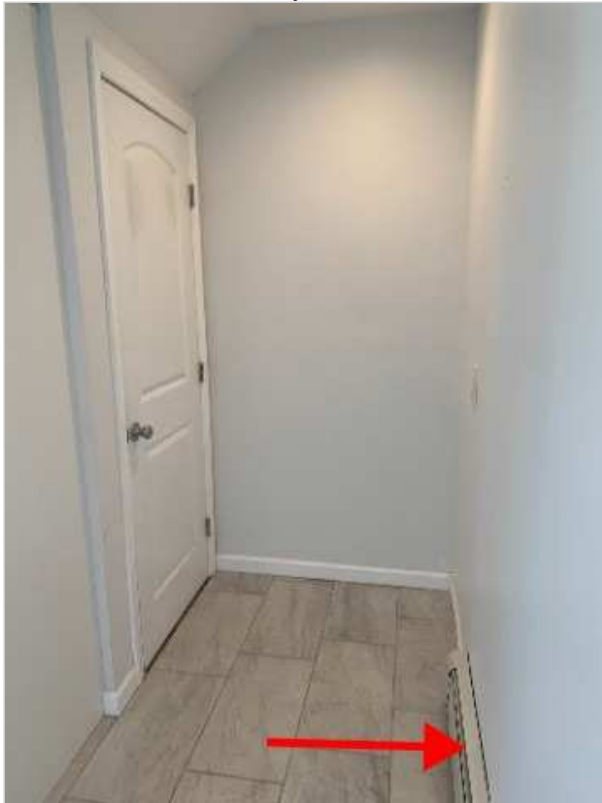
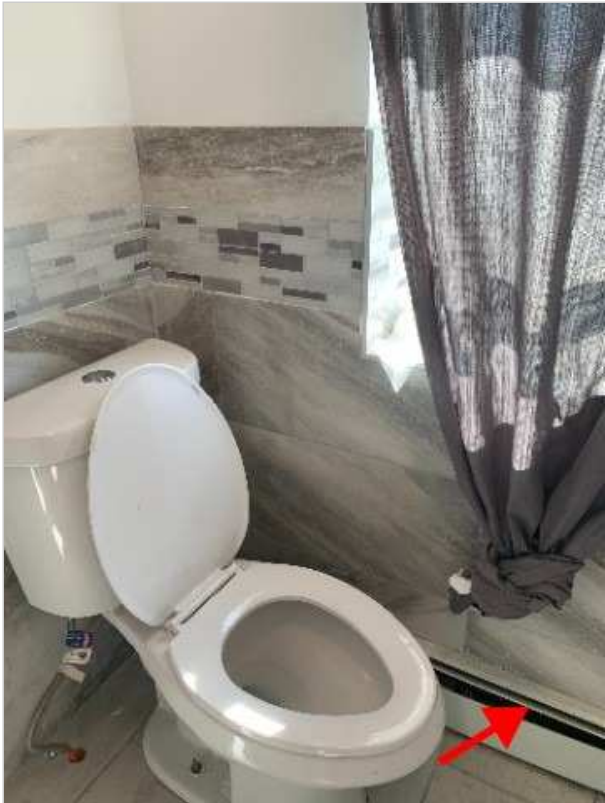
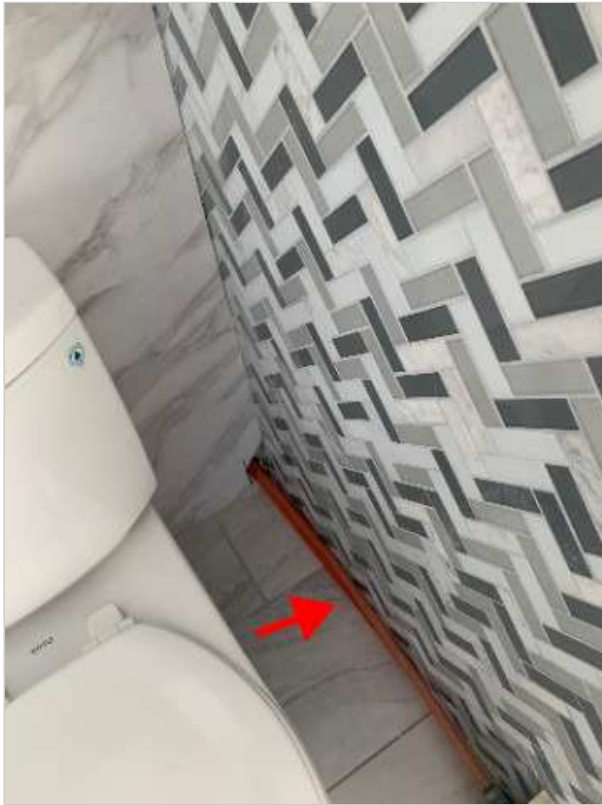
exposed pipes

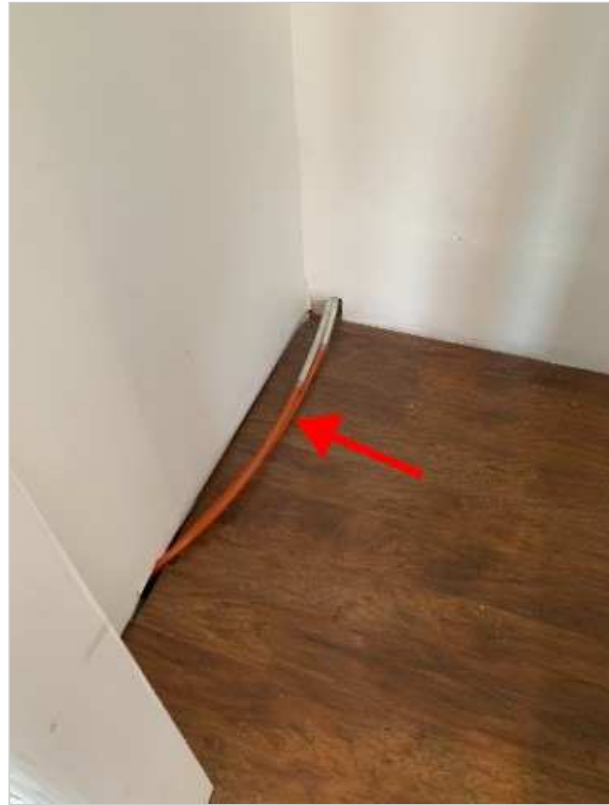
exposed pipe

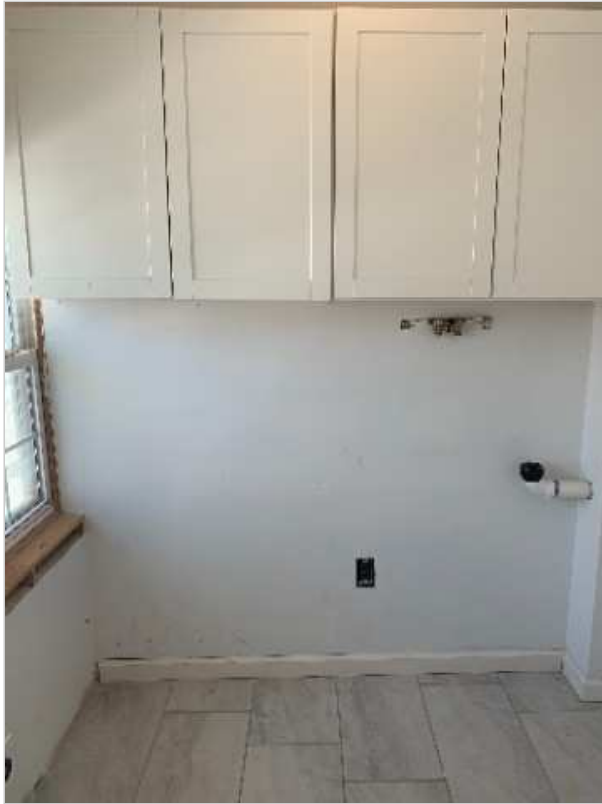
no washer and dryer units were installed and could not be tested for hook up and water drainage

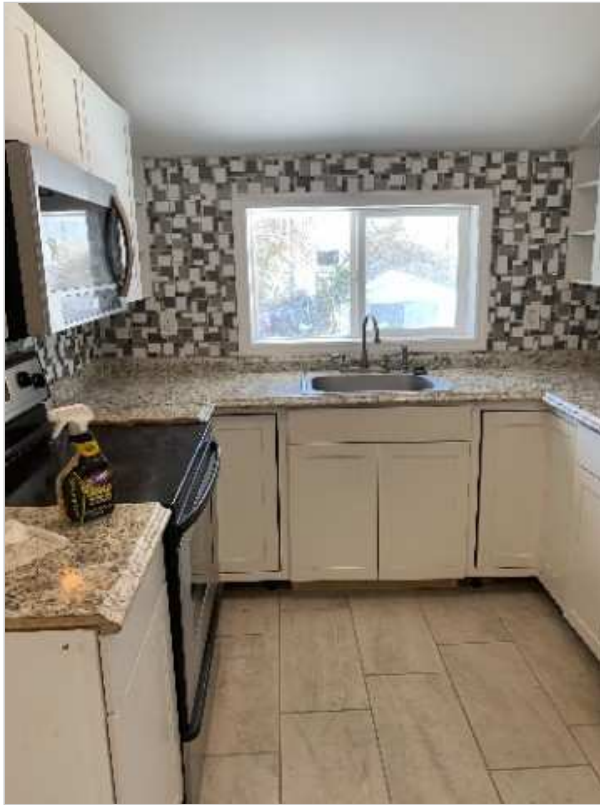
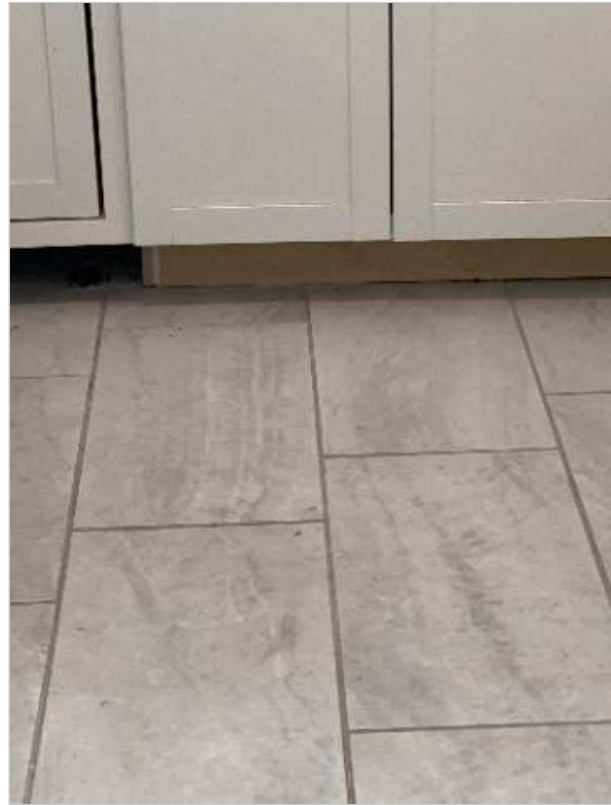
under cabinets not finished

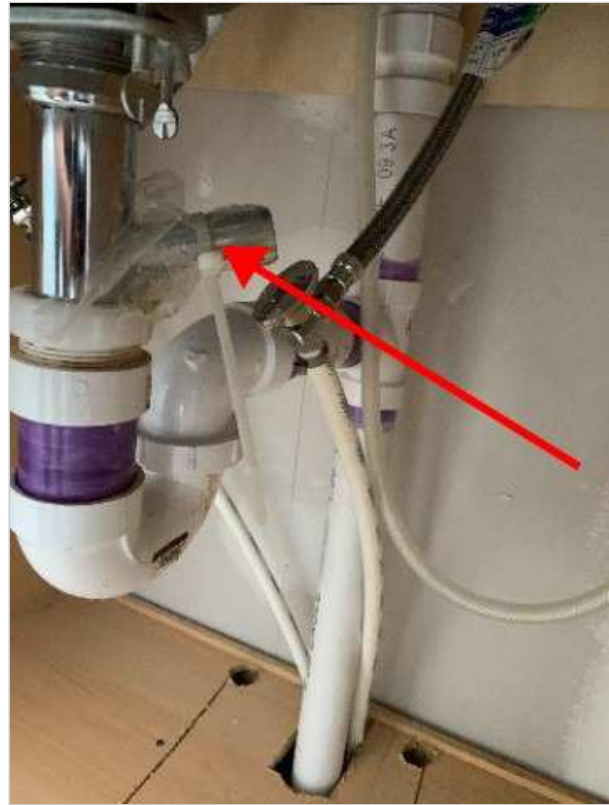
The dishwasher was not found to be functional at the time of inspection. Recommend having an appliance technician evaluate and repair/replace as needed.

dishwasher line not connected

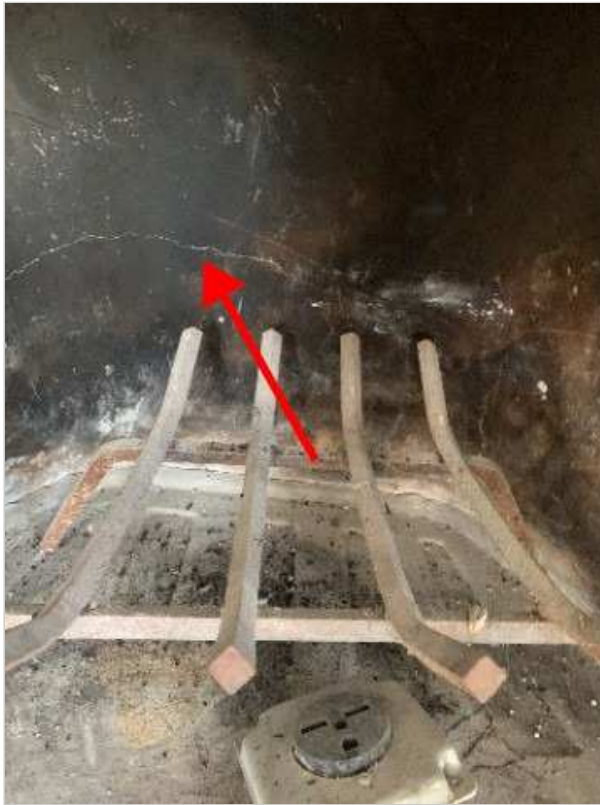
cracks along back

The inspector recommends having the fireplace firebox system professionally evaluated and cleaned annually as a preventive maintenance/fire safety measure and prior to 1st use.

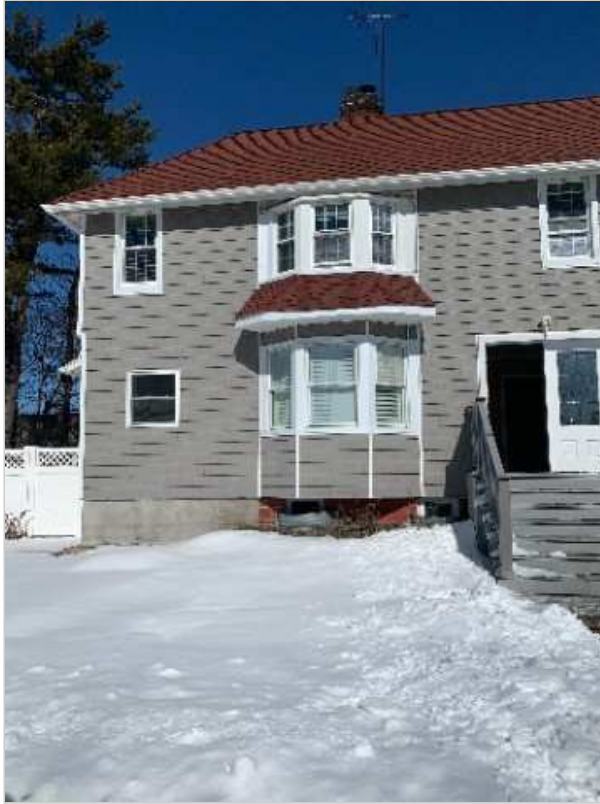
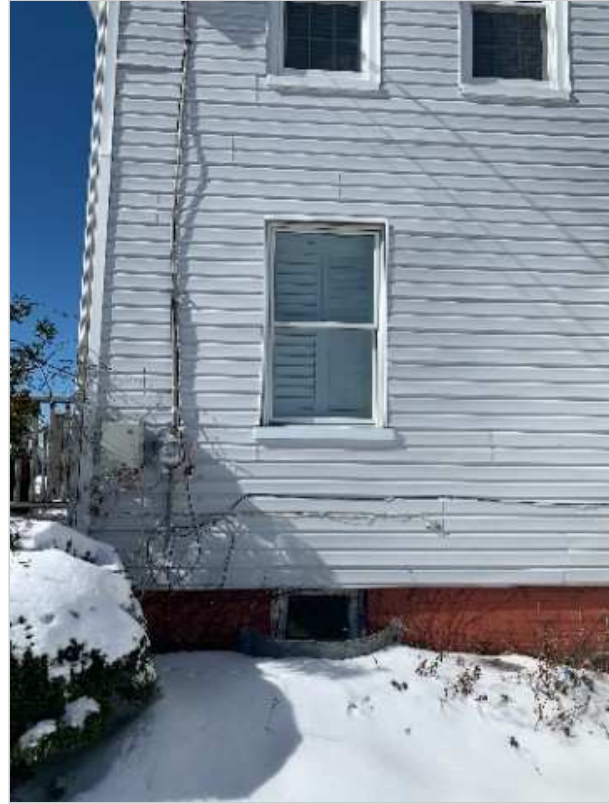
The grading around the perimeter of the structure should slope one inch for every foot away from the structure. This will help prevent water from penetrating into and around the structure.

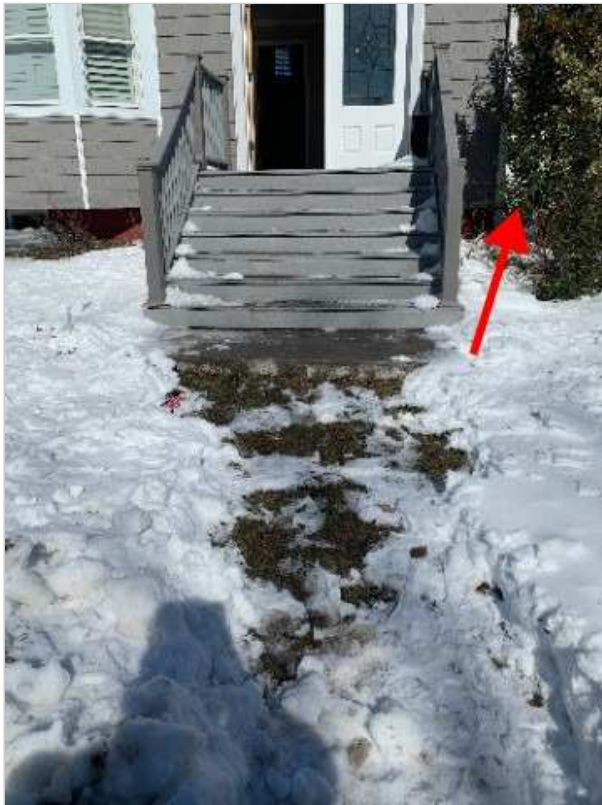
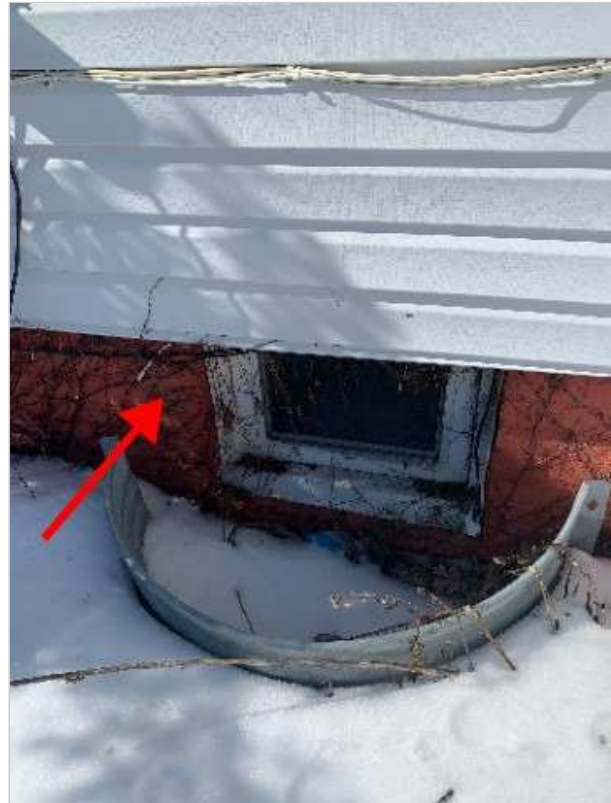
left side

There is vegetation growing up against the exterior surface material. All vegetation should be trimmed at least 6-12 inches away from the structure to eliminate a common avenue for pest infestation and damage to the exterior structure material as well as limiting the view of the home. It is recommended that any over-hanging tree branches be trimmed.

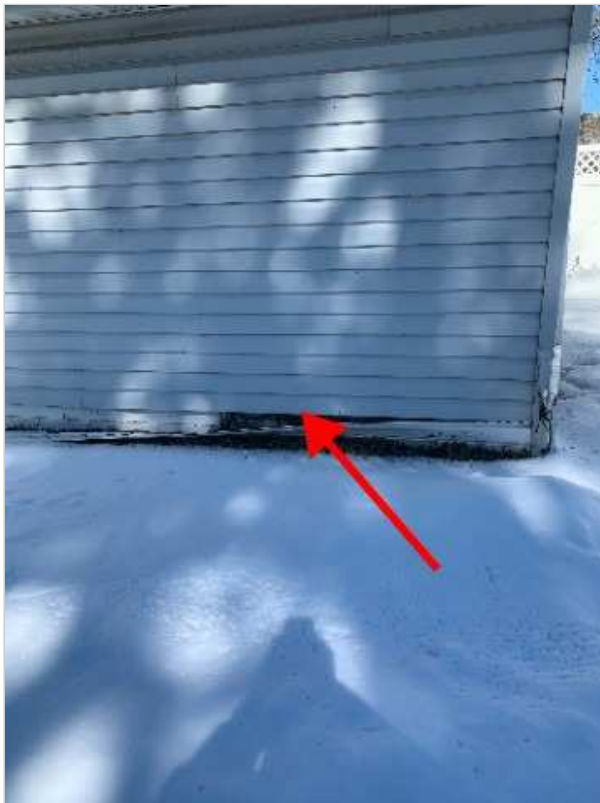
siding pulling away from garage

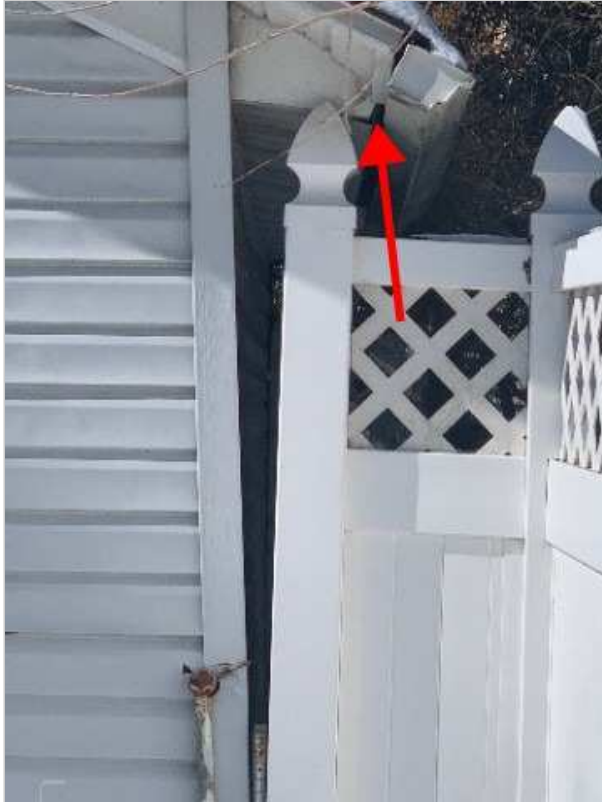
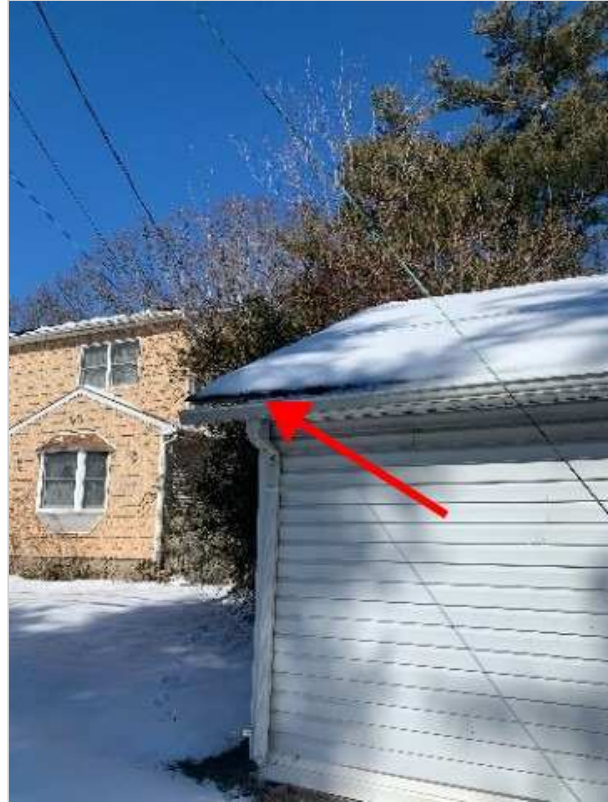
roof covered with snow recommend roofer evaluate

gutters are pulling away from garage downspouts should be pitched 4-6 ft from building

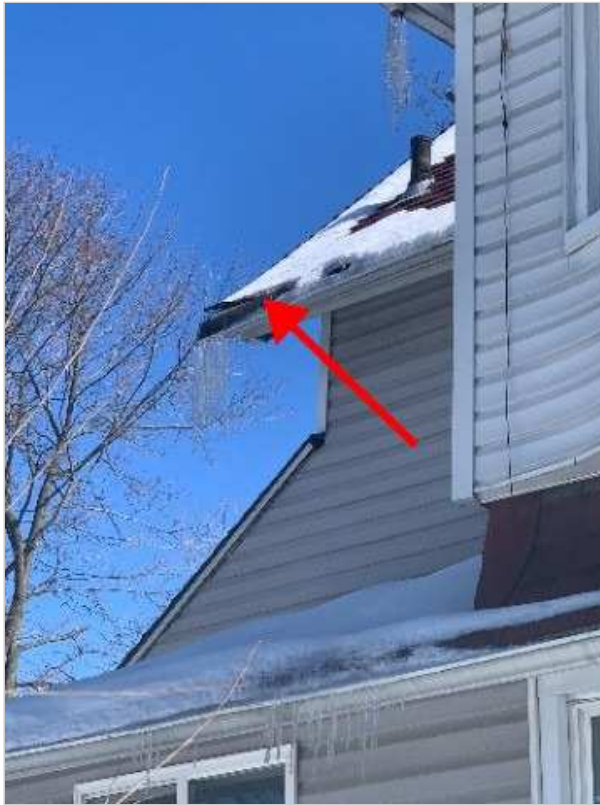
back left

gutters are separating from house recommend repair

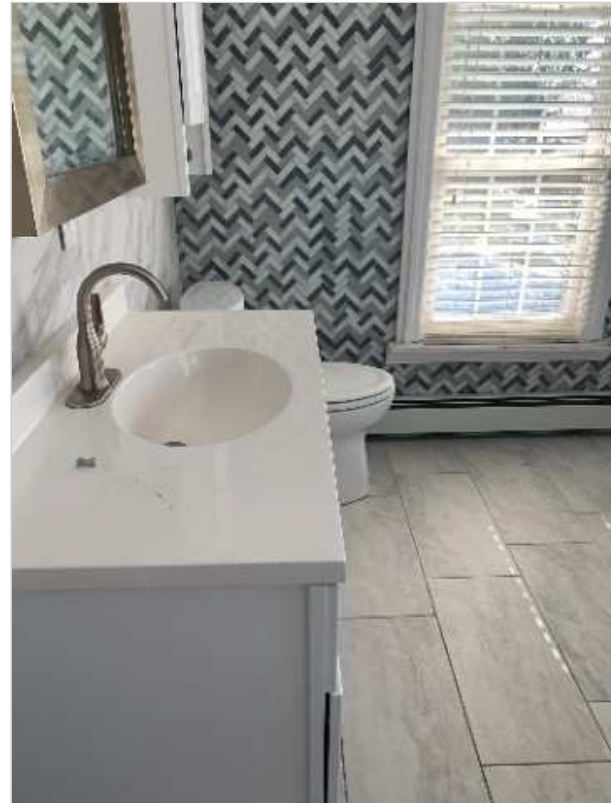
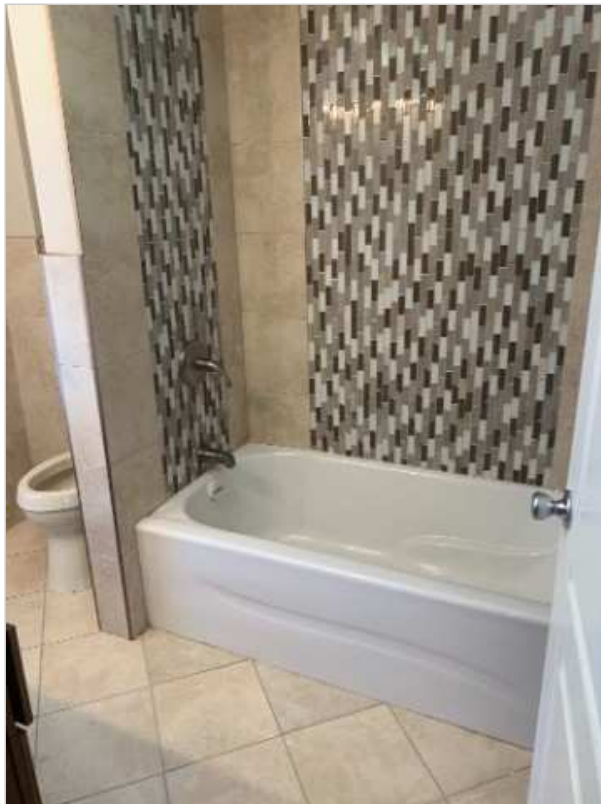
master tub and faucet not installed properly recommend plumber evaluate and repair

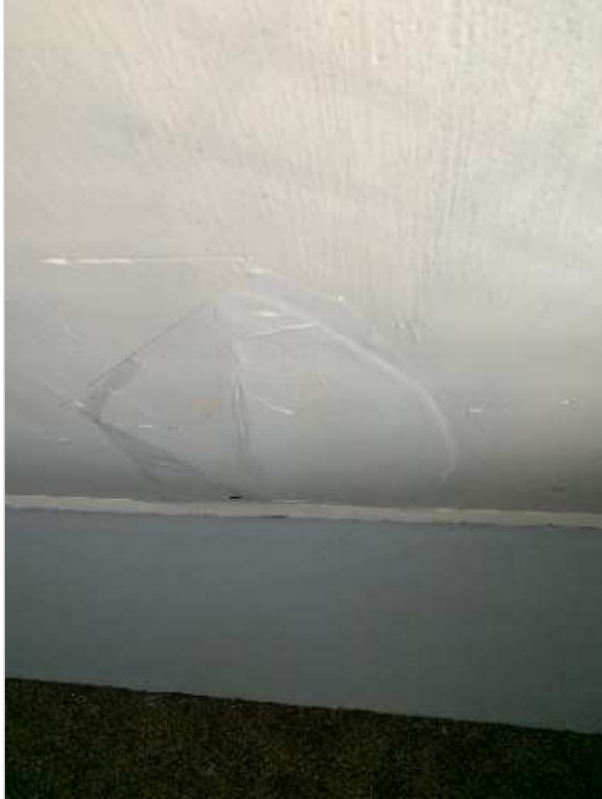
Various ceiling repairs visible in 3rd floor Recommend questioning the seller as to the extent of repair and why.

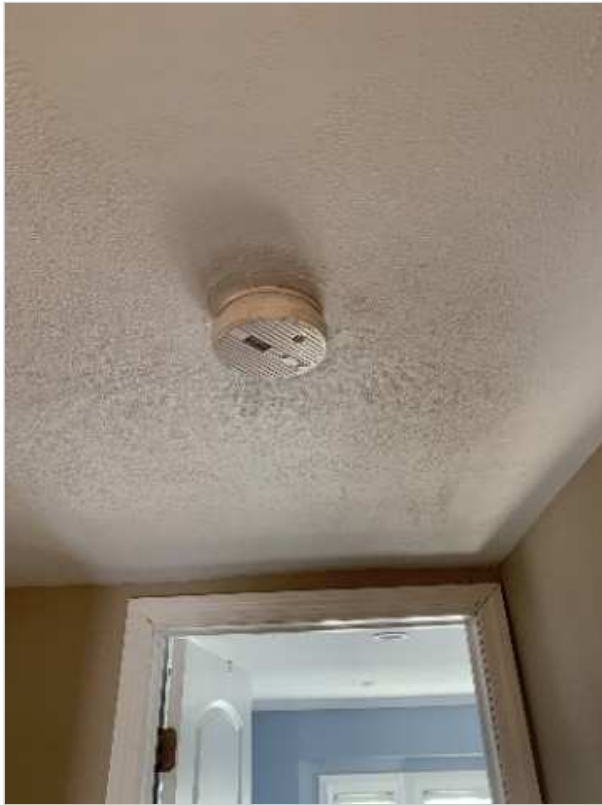
6. Smoke Detector(s)

The inspector noted the presence of one or more smoke/fire/CO detectors inside the structure. The inspector recommends testing the units prior to occupying the structure and every month to identify functional operation of the battery powered detectors. Functional smoke/fire detectors on each level of the structure is recommended outside any sleeping areas for increased safety awareness.

Today's NY Standards require either a wired unit or the NEW 10 year sealed battery detectors. It is recommended that they be upgraded as required.

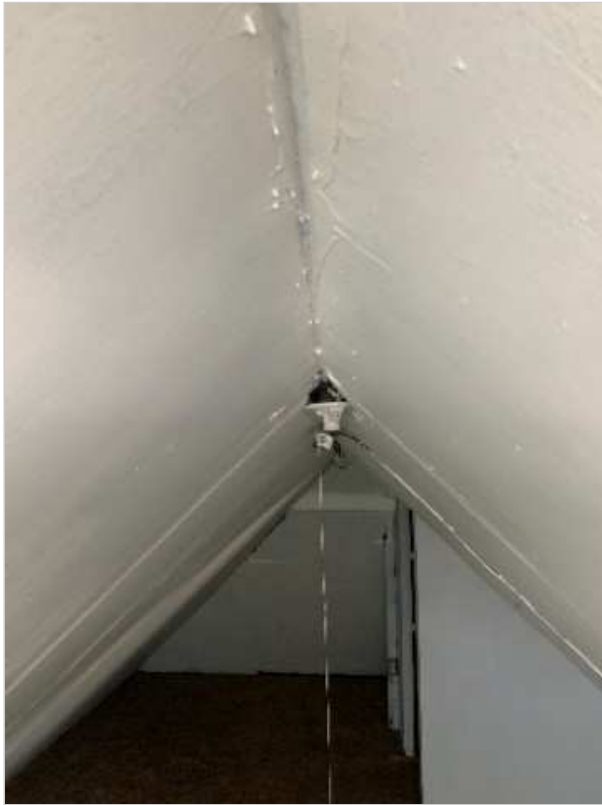
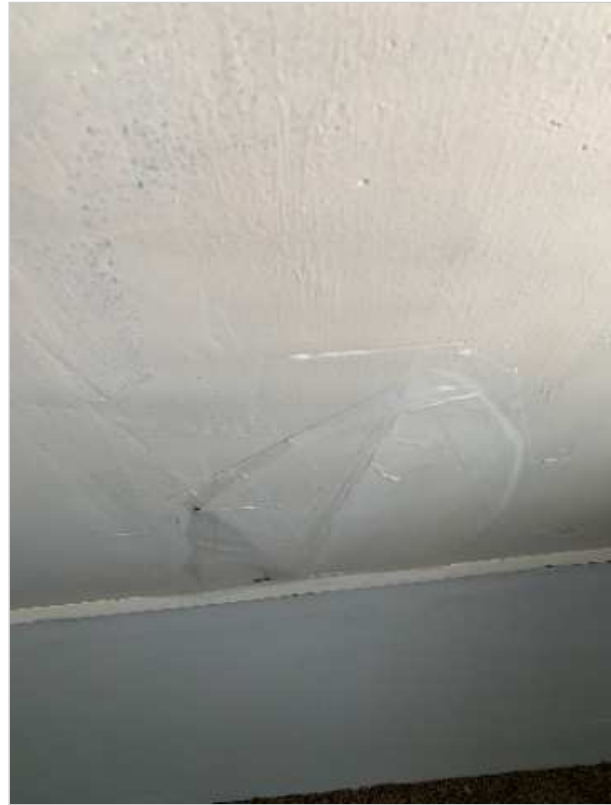
Due to no access to the attic. Recommend making an access to inspect for proper ventilation, insulation and rafter/sheathing condition.

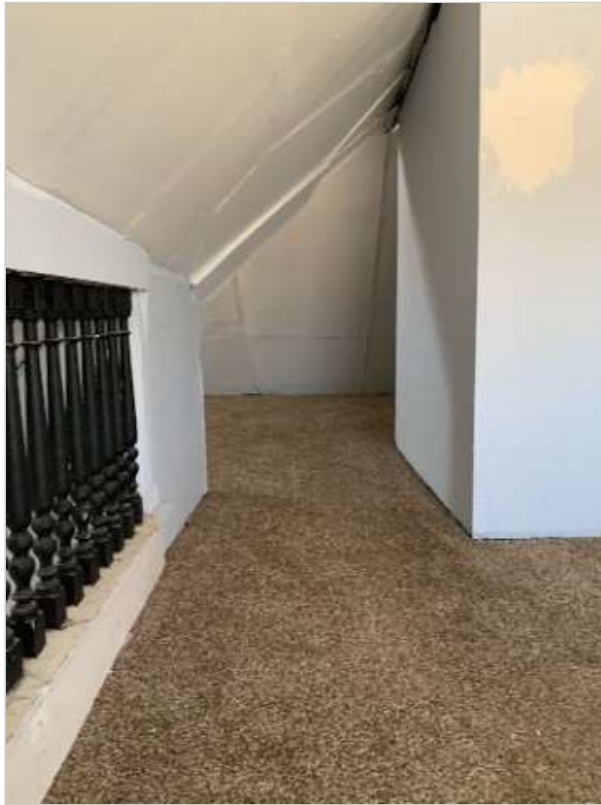
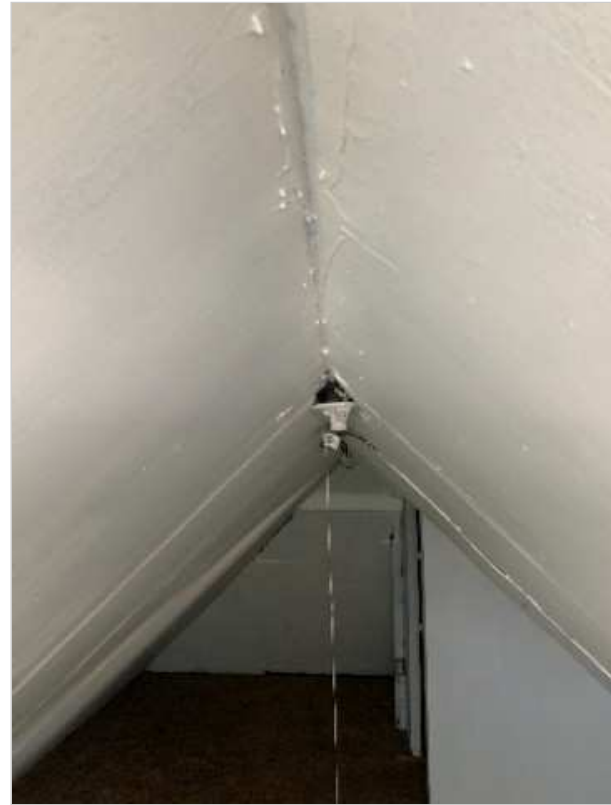
12. Roof Structure

Due to finished attic. Recommend making an access to inspect for proper ventilation, insulation and rafter/sheathing condition.

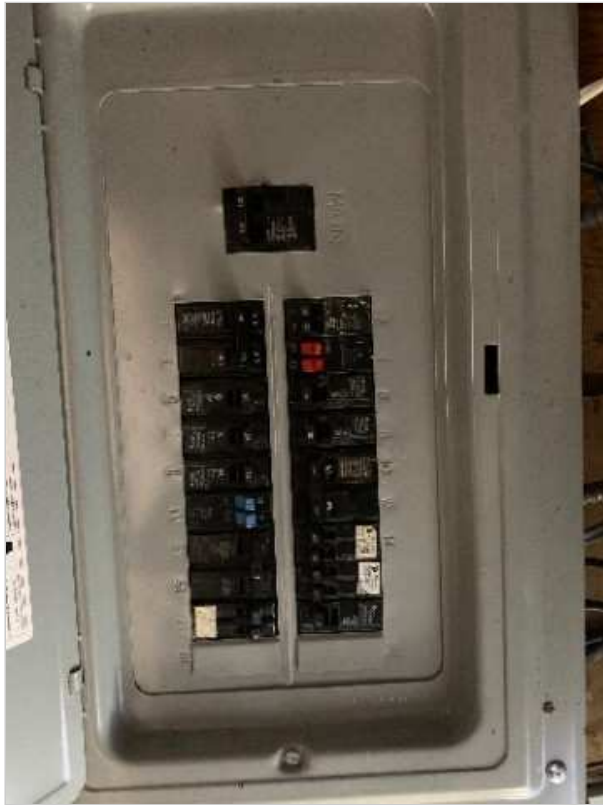
The breakers appear to have the benefit of no service labeling. The inspector recommends labeling the breakers in order to provide quick identification of service disconnects in the event of an emergency. Making sure that the previous owners labels are correct. The inspection does not verify each label to breaker, this is why its important to verify for correctness.

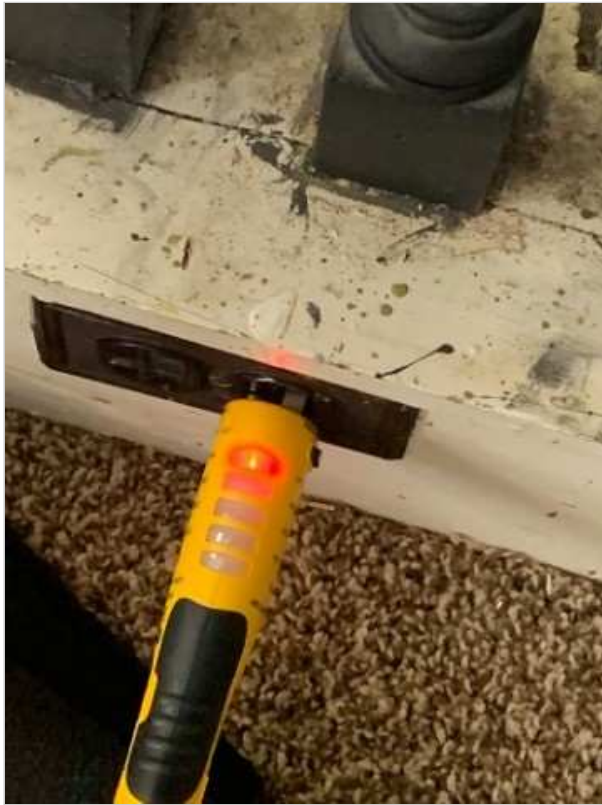
attic

Some of the electrical outlets in the house are two pronged outlets and/or are not equipped with a ground circuit. There is certain electrical equipment that requires a ground circuit for proper operation. Considerations may need to be given to having an electrician install grounded outlets for these types of electrical appliances and/or devices. Considerations may need to be given to upgrading these outlets to GFI outlets to provide a level of ground fault protection and enable the user to plug in a 3 pronged device.
