Property Address: 506 Madison Ave, Brentwood, NY 11717

Inspector: Santo Guinta
Company: Brookhaven Home Inspections, LLC
dba WIN Home Inspection Long Island
(631) 874-0011
wininspection.santo@gmail.com

Standard Full Home Inspection

Work Order Number: 022121SG

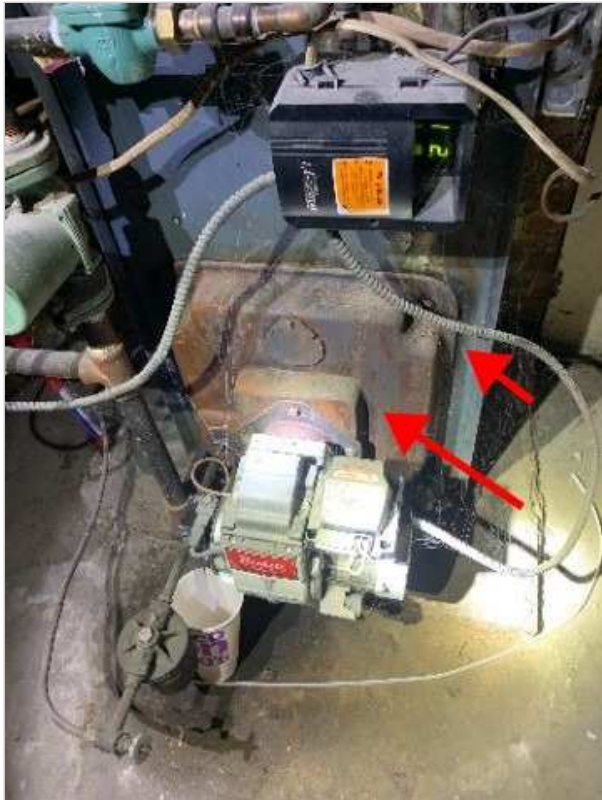
sheetrock need to be replaced over burner

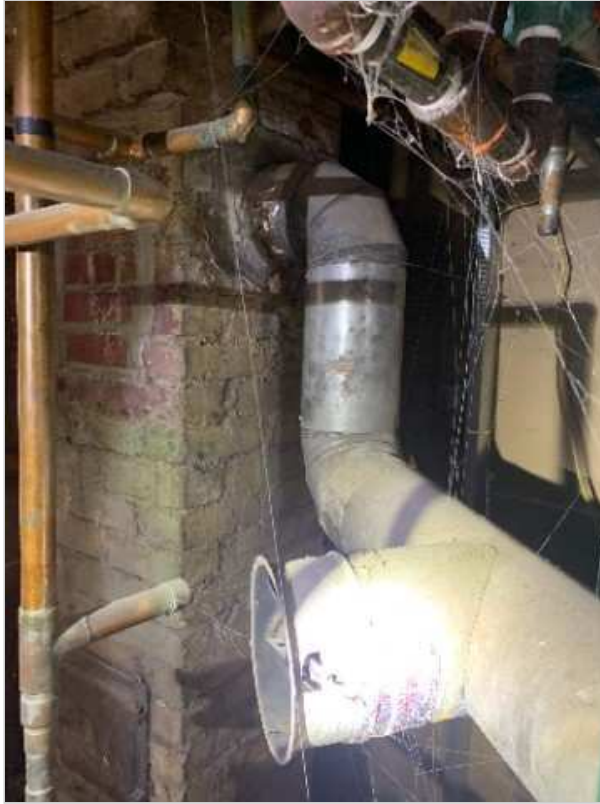
test hole for tech recommend silver tape to cover hole

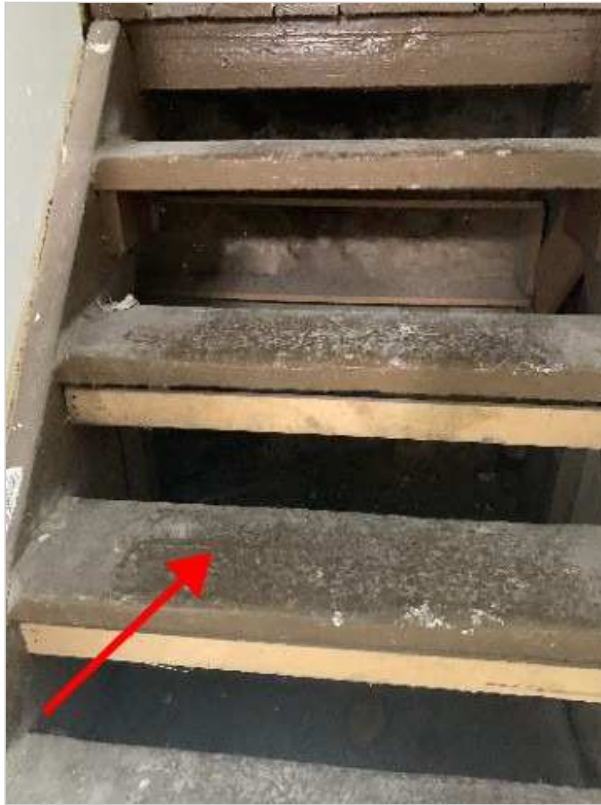
stairs to basement need to be evaluated by contractor

narrow

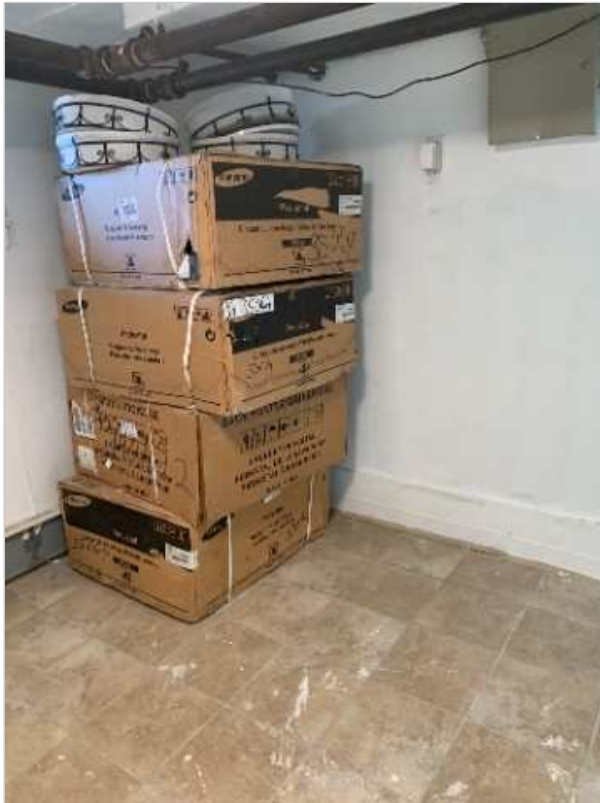
There was efflorescent visible along the perimeter foundation wall. Efflorescence is an indication of small amounts of moisture penetration through the concrete foundation. Correcting the grading, vegetation next to the foundation, redirecting any/all sprinklers away from the structure, and installing splash blocks at the downspouts will help in this area. Sealing the floor/walls with Drylock and adding a dehumidifier is also recommended. Also install a water sensor alarm. [Click for an alarm option](#) Monitoring this area during a heavy rainfall periods is recommended. Also recommend questioning the seller about any past issues.

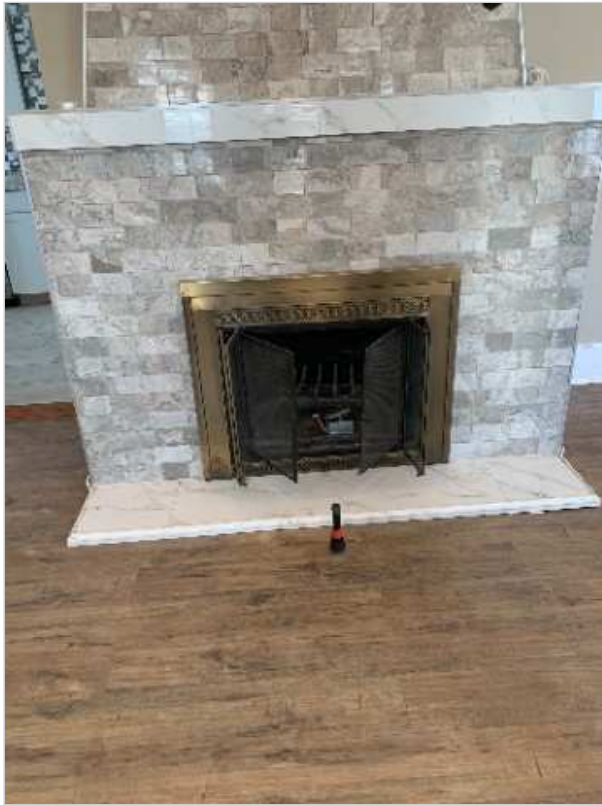
There is a fireplace in this home. This inspection does not cover code clearances and improper installation. Recommend further evaluation and repair by a qualified fireplace professional.
