Property Address: 1111 Right Lane, Dublin, CA

Standard Full Home Inspection

Work Order Number: 112422RC

Service Date: 11/24/2022

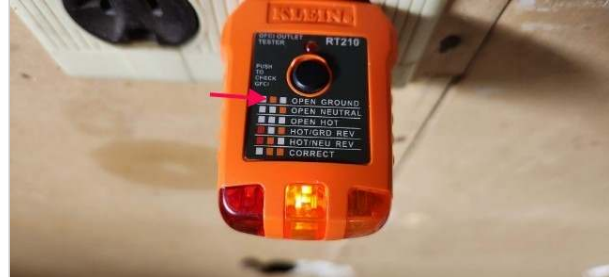
Ungrounded outlet reading

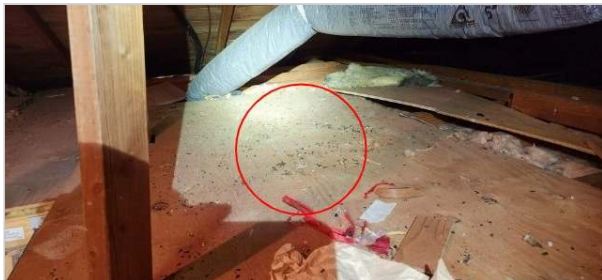
There is evidence of rodent activity in the attic area. If rodents are still present, Extermination and control measures may be needed. Contact a qualified professional for further evaluation and estimates.

Attic - Evidence of rodent activity

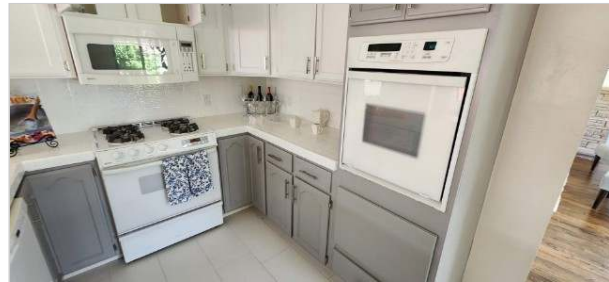
Wall Oven - Functional

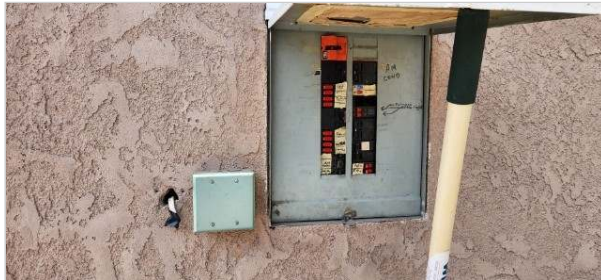
Exterior - Main Service Panel

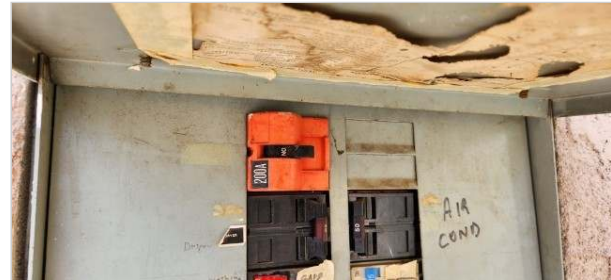
Main Service Shut-off - 200 Amp Service

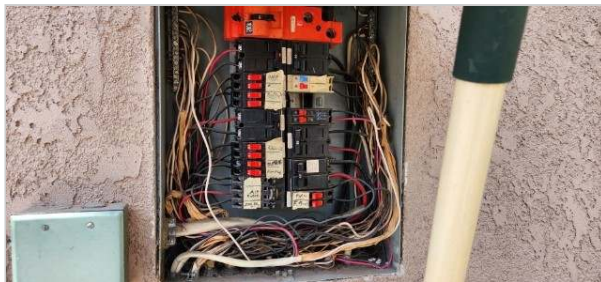
Main Service Panel cover removed

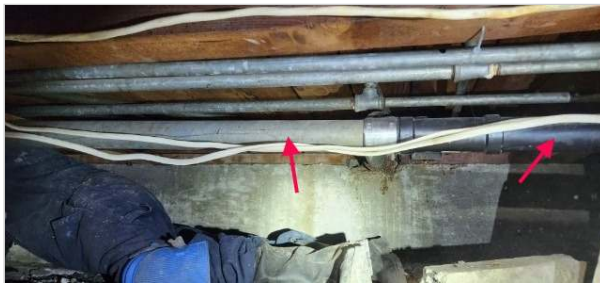
Galvanized Steel / ABS Plastic

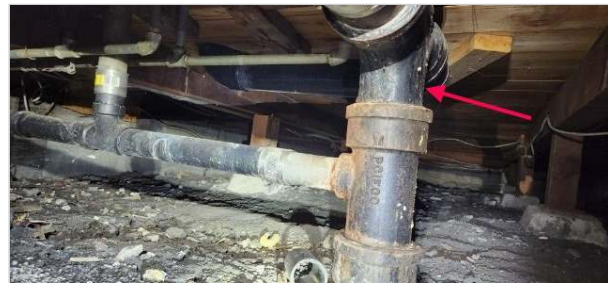
Cast Iron

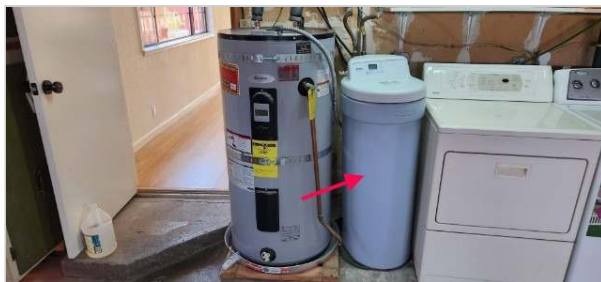
Garage - Water Softener

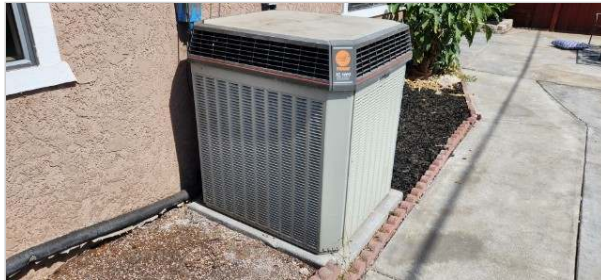
Rear Yard - A/C Compressor Unit

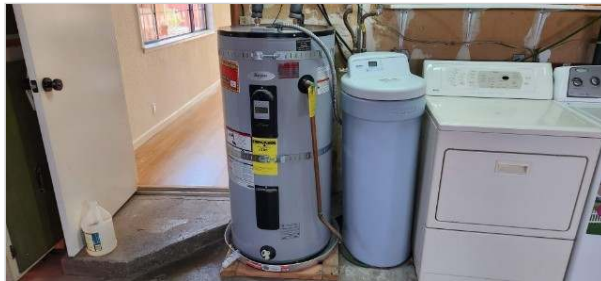
Garage - Electric Water Heater

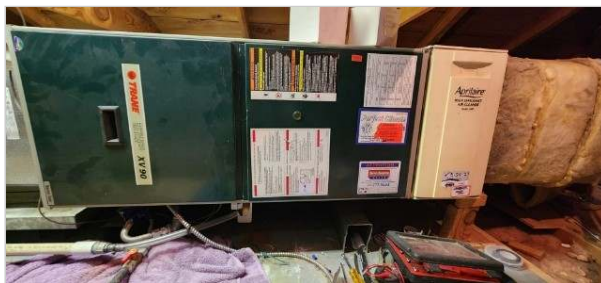
Attic - Furnace

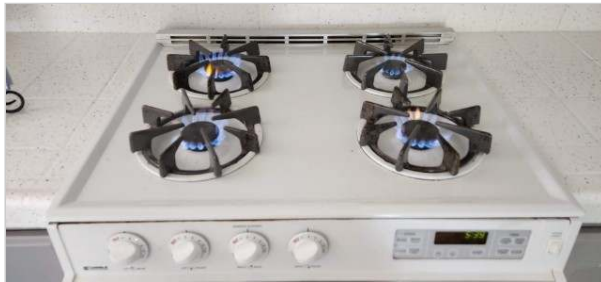
Gas Stove - Functional

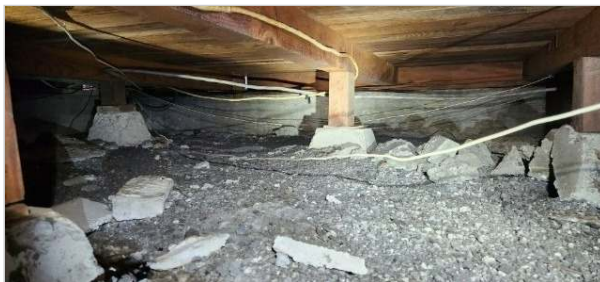
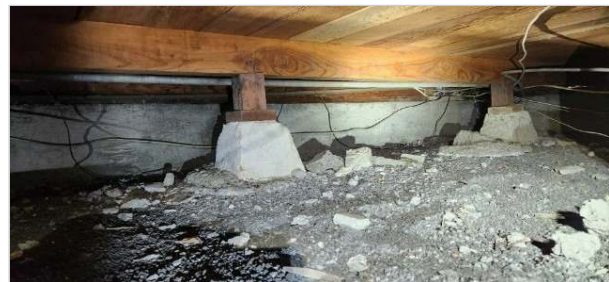
The visible portions of the concrete stem walls appeared to be in serviceable condition. No significant cracks, damage or other reportable deficiencies were visible at the time of inspection.
